Bishop Auckland Bus Station and Surface Car Park

Coal Mining Risk Assessment

BL000034-JAC-XX-XX-AS-G-00001 | P02

Durham County Council

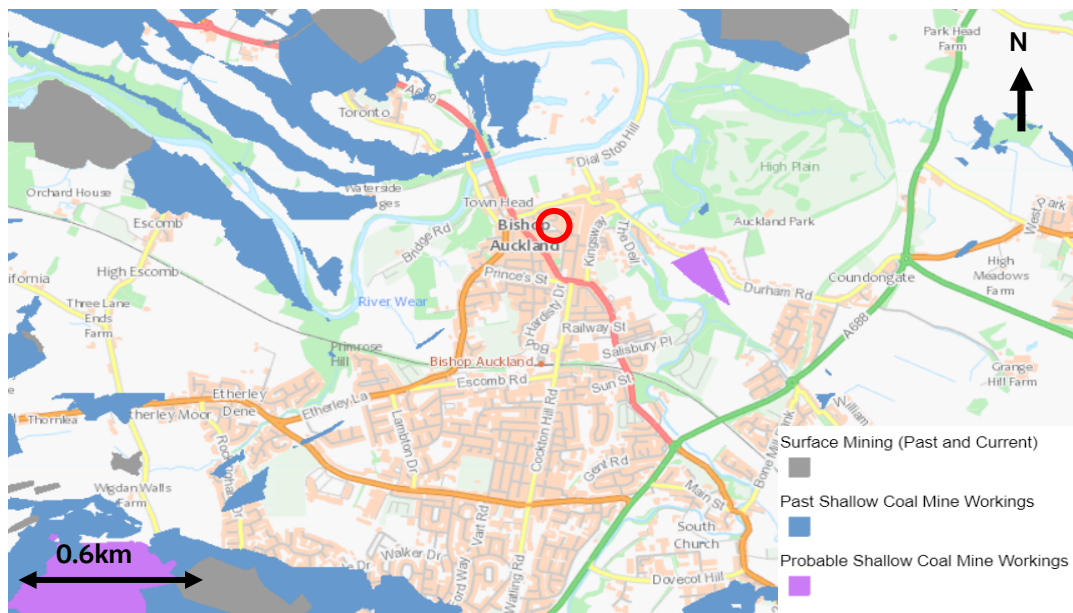
Figure 14 - Surface and shallow mining

Figure 14, also an extract from The Coal Authority's interactive map (6), shows there are no recorded past or present shallow or near surface coal mine workings in proximity to the site.
