PHOTOVOLTAIC INSTALLATION TO
HALL FARMHOUSE
86 HIGH STREET
GREAT ABINGTON
CAMBRIDGESHIRE
CB21 6AE

20.433.1 - 498 C

MAY 2023

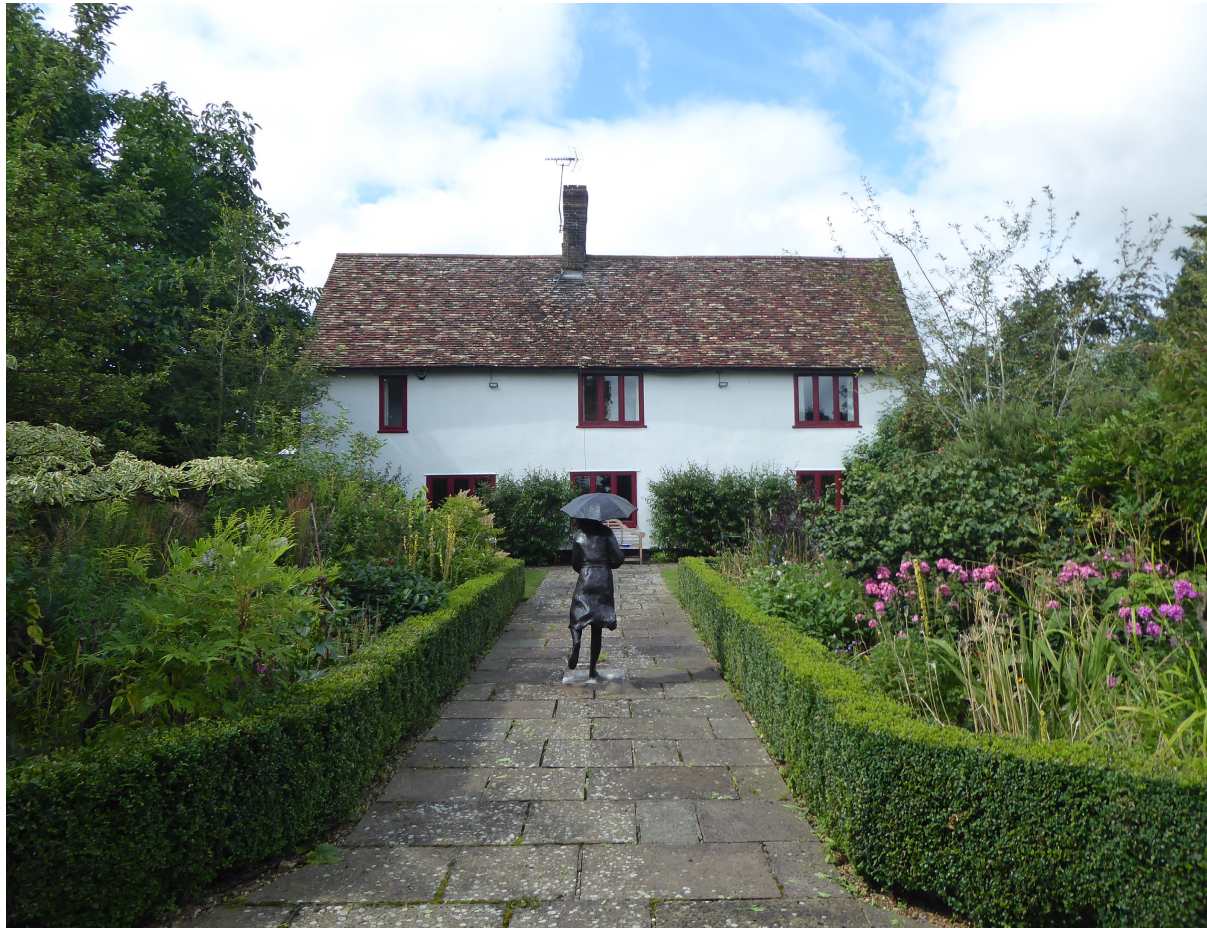
Fig 0.1: East Elevation of Hall Farmhouse from front garden - barn is to the left

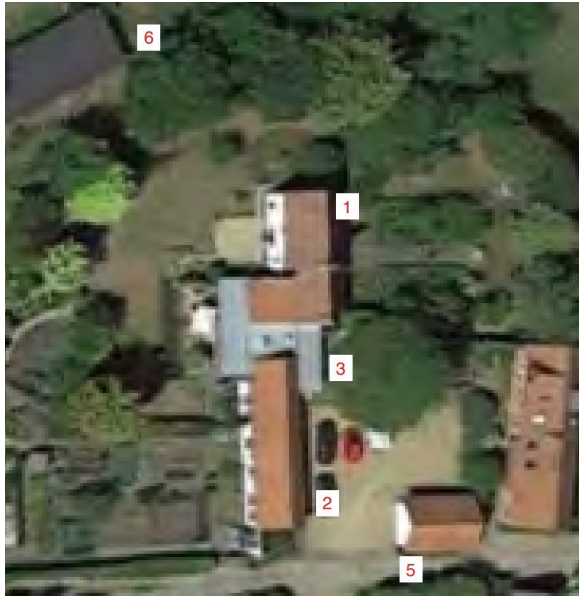
Fig 1.2: .plan of the 6 elements to the current site; 1.The farmhouse. 2. Converted barn. 3. Link 5. Garage 6. Pool house

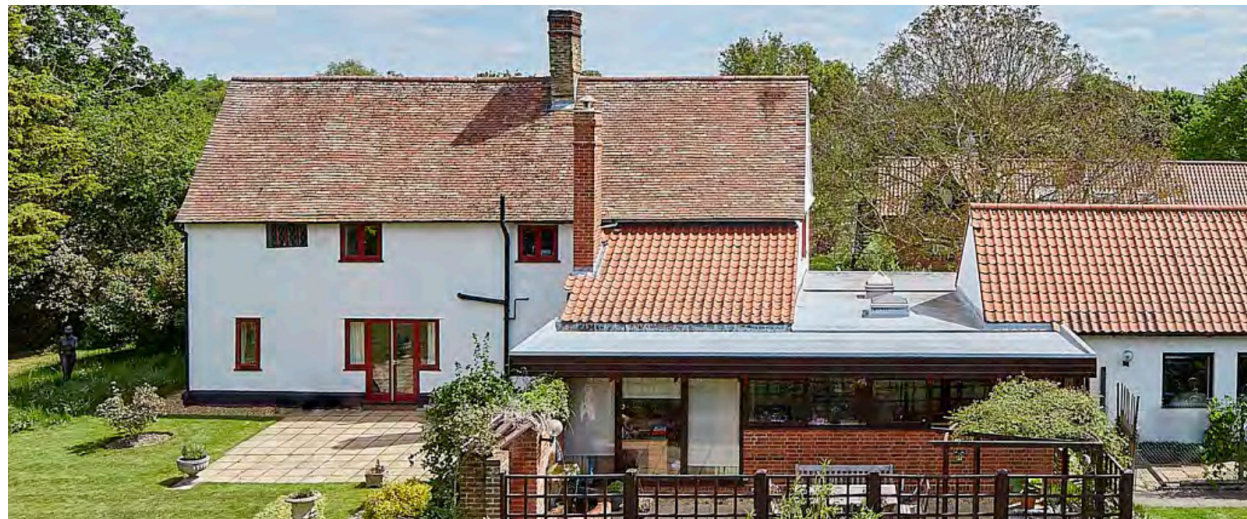
Fig 1.4: view of West elevation showing the hierarchy of house, barn and link and the simple forms,volumes and material palette of the house and barn

The outbuildings consist of a modern two bay garage [Fig 1.4] and a modern pool house [Fig 1.5] in the rear garden of Hall Farmhouse.

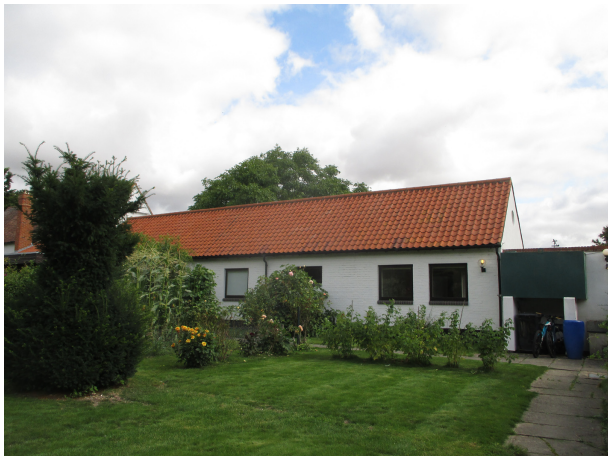
Fig 3.1 View of the barn from the south west from the private garden.

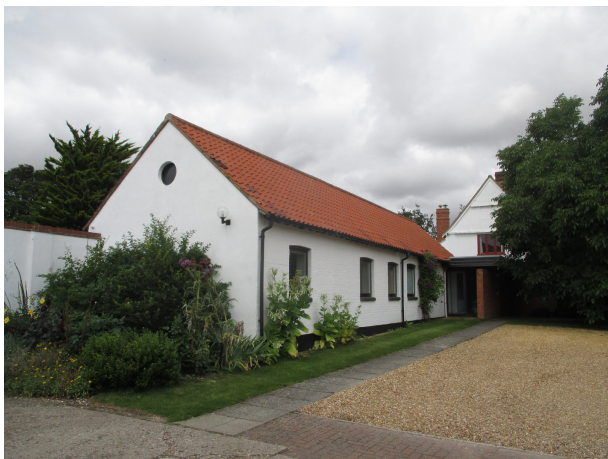
Fig 3.2 View of the barn from the south east showing limited views of the farmhouse due to the walnut tree.

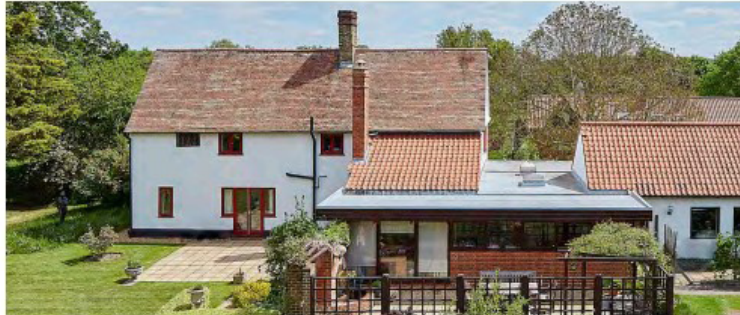
above view of West elevation showing the hierarchy of house, barn and link and the simple forms, volumes and material palette of the house and barn
below view of East elevation

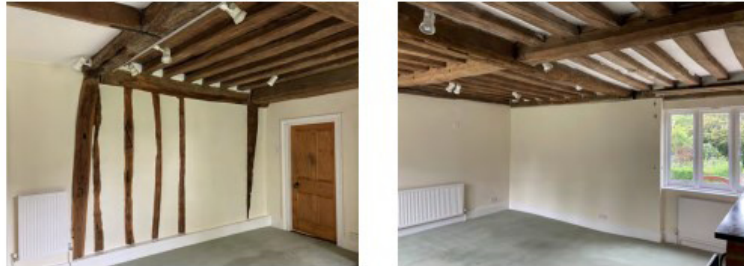
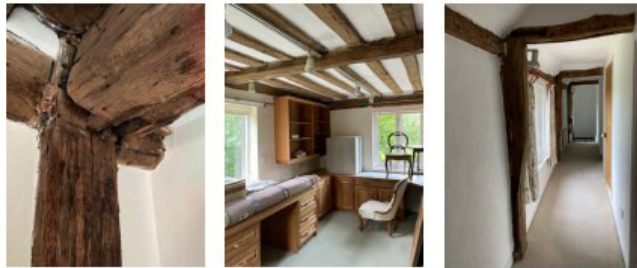
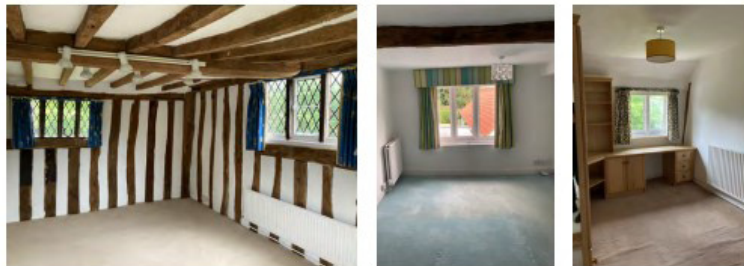
top views of exposed historic timber frame to Hallway and Sitting Room. The latter also showing the flatness and character of the C20th wall finishes
 middle left details of notable timber framing joint,
 centre/right views of framing to old farm office and to first floor corridor
 below views of framing to south bedroom with retained leaded-light windows, and other bedrooms with limited or no exposed framing

Internally, the exposed timber frame has been almost completely retained, sand-blasted and treated.

The impressive expose timber structure includes some notable examples of timber frame jointing and for this as well as for its age and condition is considered to have high heritage significance only vitiated by the C20th installation of panel heating radiators and exposed copper distribution pipework. In addition, the flatness of the external render and the hollowness and planarity of the internal plasterboard mitigate the historic character of both the house exterior and its internal spaces.

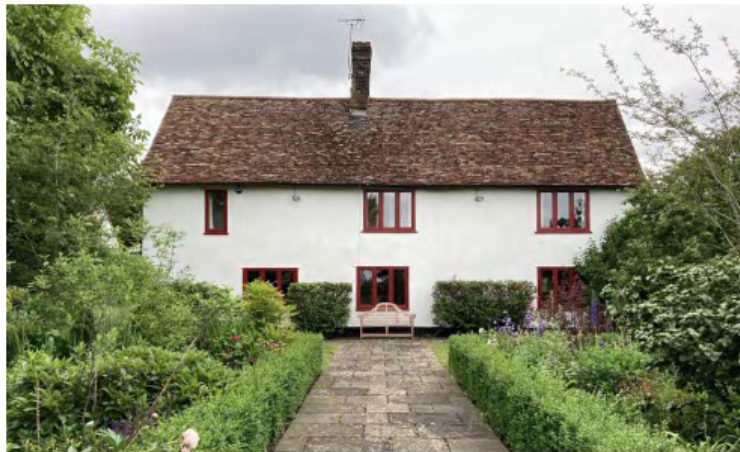
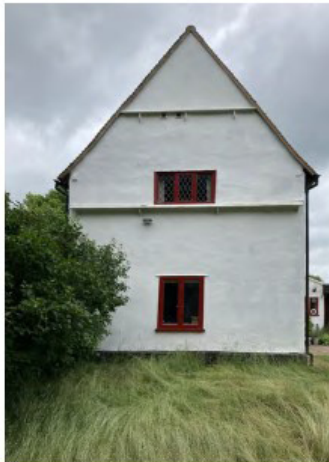
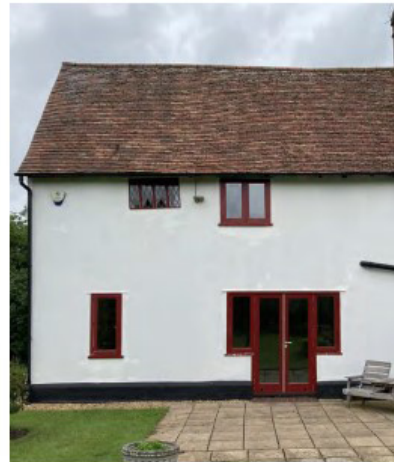
top views of the East elevation showing variation in window shapes and sizes within C20th flat cement render walls and new roof structure
 above left view of South elevation showing the leaded-light window and shedding boards retained/reinstated within the C20th reconstruction
 above right view of West elevation showing the leaded-light window are retained/reinstated within the C20th reconstruction

The windows are an array of variously sized, plain, red-stained, sw windows with double-glazing. These have decayed and distorted and the draught or weather seals no longer function. These require replacement, as a matter of maintenance and repair - with new double- or triple-glazed casement lights with high-performance draught and weather seals. The historic leaded lights should be retained.

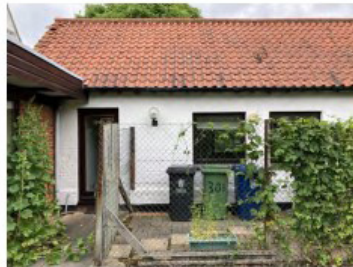
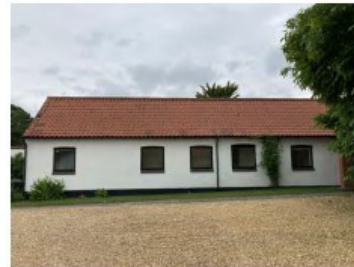
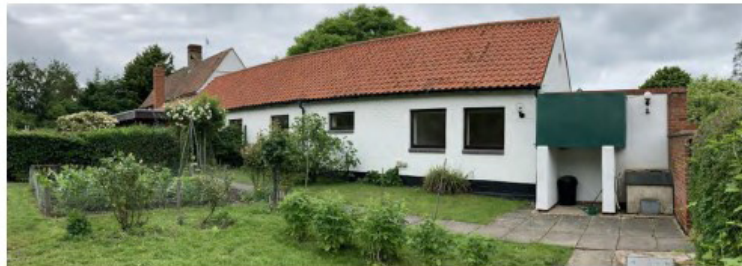
top left views of the West elevation of the Barn at junction with the link building
 top right the barn from the farm court
 above the barn can be seen to form a 'servant' building to the house, addressing the vegetable garden and providing a setting for the oil tank
 below the late C20th interiors retain little of the former agricultural character of a barn

The white-painted fair-faced brick walls have been tidied up during the refurbishment works and have lost any rustic character.

The dark-grey stained, double-glazed sw windows are in need of replacement with higher performance glazing and weather and draught seals. This could probably be done

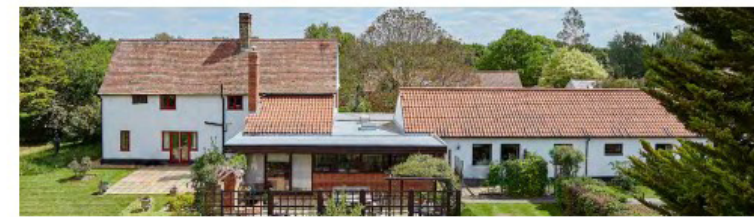
above - view of Link block from West - successfully forming a tertiary element with in the overall grouping, subsidiary to both the Barn and with that, in turn, to the House

Whether the existing link is repaired or replaced, the subsidiarity of this element to both the barn and, more significantly, the house, should be retained together with a modest scale and comparative simplicity of form and materiality that is congruent with the setting and adjacent fabric.

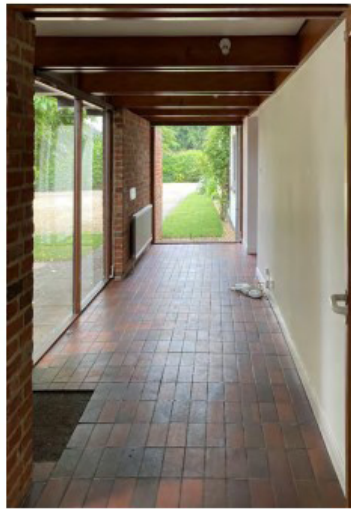
above view within hall of link block showing large glazing areas and exposed timbers of the roof construction
 top right the roof timbers continue through the elevation forming "cold-bridges"
 middle right the kitchen with louvred vents between the joist ends and distorted and decayed large opening lights
 below left to right details of shadow gap abutments of ceiling, roof timbers and recessed strip lights - forming draught penetrations of the construction.
 Single ply roofing with uv-degraded polycarbonate 'turret' rooflights

- The 'layered' detailing has created a very draughty construction with lots of linking shadow gaps/leaks to internal and external soffit boards.
- Structural cracks to brickwork walls over drain connection and all way down flue
- The polymeric membrane roof is at the end of its life
- Large d/g panes in windows have distorted the sw frames and the louvre-lights between cantilever joist ends add to the poor air-tightness
- Mainly quarry-tiled floor on uninsulated slab with vinyl to kitchen.
- A lack of shading to west facing windows - to Kitchen - creates significant over-heating problem
- Conversely, the design of the conservatory - an extension to kitchen space - does not admit enough sunlight for this to work for plant propagation.

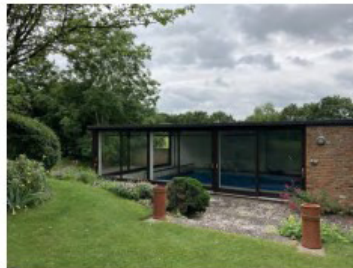
The building has a flat vented metal deck, insulated roof and glazed walls looking, indirectly, towards the house and solid walls to all other elevations.
