HERITAGE STATEMENT

ALTERATIONS TO
2, 4&6 CHURCH WAY
LEIGH COTTAGE
HASLINGFIELD,
CAMBRIDGESHIRE

23.455.1 - 498 C

JUNE 2023

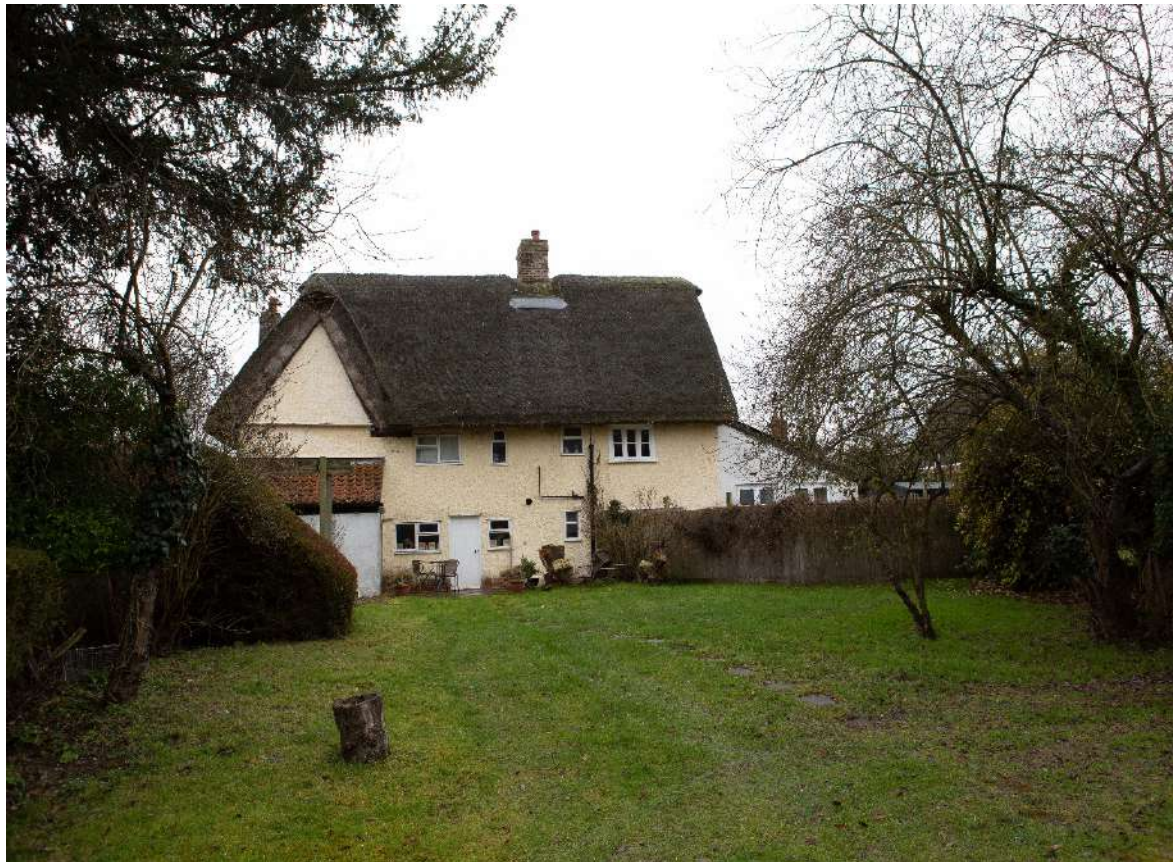
Fig 0.1: Rear/North Elevation of Leigh Cottage from garden of No 4, with No 2 on the far left and No 6 on right beyond fence.

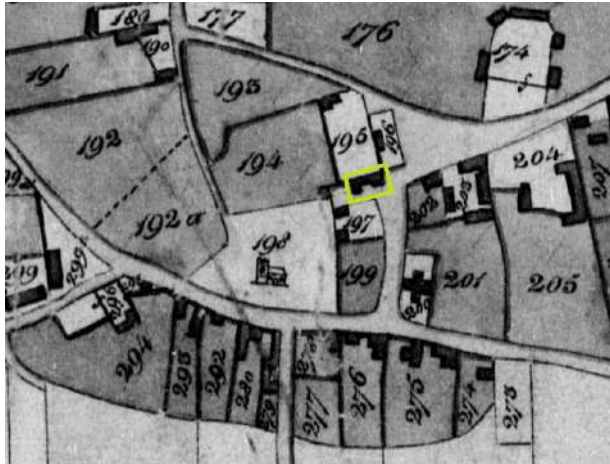
Fig 1.1: 1844 Haslingfield Tithe Map (detail) Showing Leigh Cottage highlighted and single plot of land. (TNA IR 30/4/37 taken from HIA Fig. 10) Note the outbuilding at the NW corner of the plot numbered 196 no longer extant.

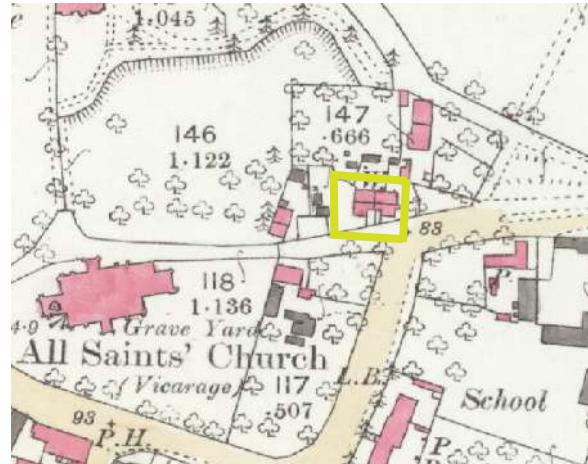
Fig 1.2: 1885 Ordnance Survey map. (detail) showing Leigh Cottage highlighted split into 4 small dwellings.

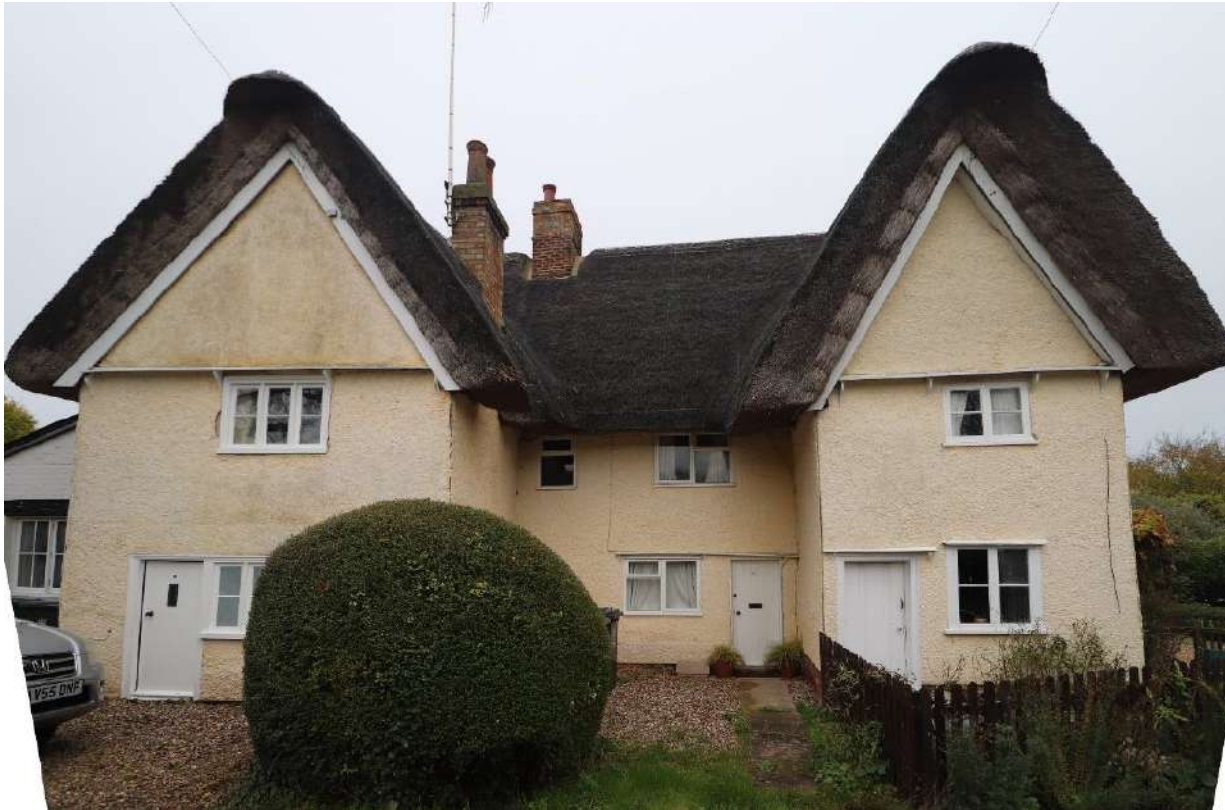
Fig 1.5: Front (S) elevation of Leigh Cottage showing 6, 4 and 2 Church Way, (left to right). [Photo from Heritage Impact Assessment by Richard Hoggett]

Note differences in window types between properties but otherwise consistent thatch, roughcast render and paint finish.

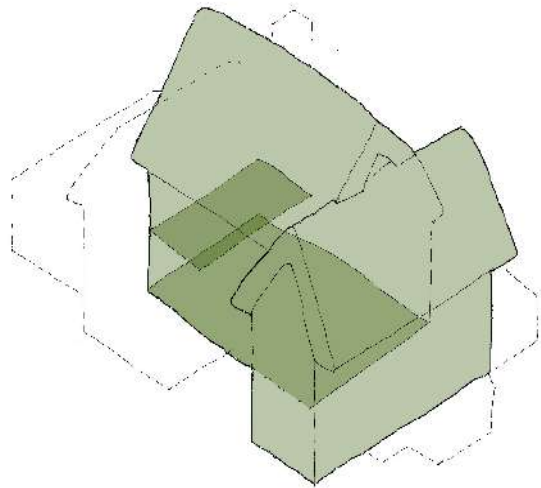
Fig 1.6: Original 16th/17C phase. Open hall showing section of first floor only at west end; with east crosswing.

Please see figures 1.6 - 1.9 for phasing development diagrams of fabric Concentrating on nos 4&6) with colours to match those on the age of fabric diagrams. A Heritage Impact Assessment dated January 2023 was undertaken by Dr Richard Hoggett and is included in this submission and referenced in the following text (HIA).
16-17thC: The main core of the house was built as a timber framed open hall with a lower cross wing to the East end. There was

evidently a portion of first floor (within of No 6) at one end (*HIA 2.3.1.3*) but mostly the hall was likely open to the roof. The cross wing to the east constitutes the structure of what is now No. 2 Church Way.

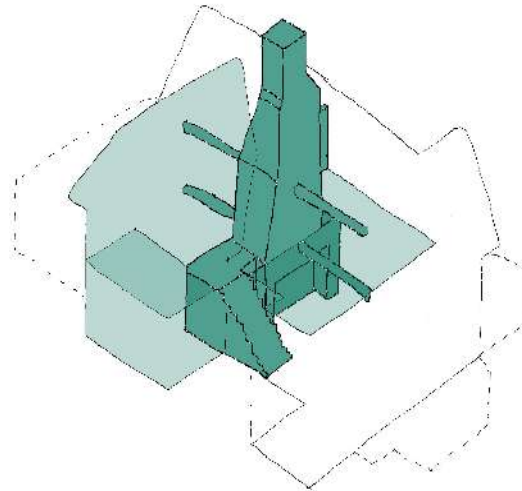
Fig 1.7: 17th/18thC phase. Central brick chimney with integrated first floor within hall and staircase; west cross wing extension.

17th -18thC: The central brick chimney was constructed and a first floor inserted to the open hall (no 4) with large beams built onto the chimney breast masonry. An elaborate staircase with turned banisters was built , its details dateable to early 18th C and partly integrated with the chimney (*HIA 2.3.2.4*). It is of a quality that would only have been invested in the larger single residence prior to separation. The western cross wing extension was also added.

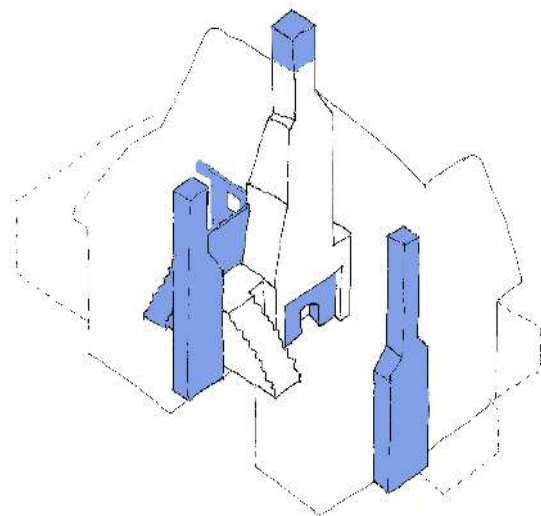
Fig 1.8 19thC phase. Brick chimneys to cross wings; fireplace infill, internal partitions and secondary staircase due to subdivision of single house into multiple dwellings

19thC: The property was subdivided into up to 4 smaller dwellings with internal partitions and a minor staircase added to gain necessary separate first floor access. Large fireplace openings to each living area were infilled to create smaller more manageable fireplaces. Brick chimney stacks were added to the cross wings and central chimney heightened.

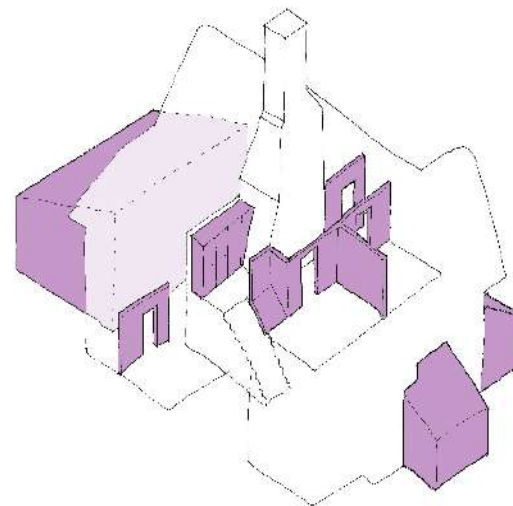
Fig 1.9 . 20th/21stC phase. Modern lean-to extensions; internal partitions and cupboards.

20th-21stC: Subdivisions were altered and required reconstruction of modern partitions to create the existing three properties. Modern cupboards at the top of No 4 staircase. Lean-to extensions were added to No 2 and 6. Unsuitable cementitious materials were introduced to the building internally including cement plaster, and externally including cement

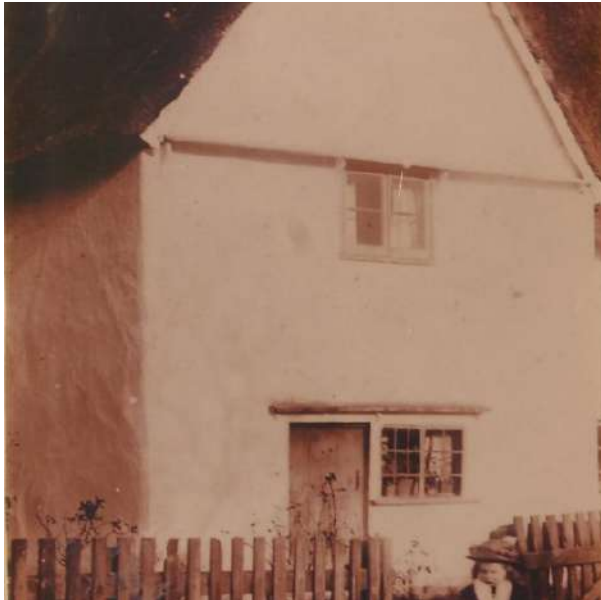
Fig 1.10 No 6. Photo in 1912 showing previous lime render external finish without roughcasting.

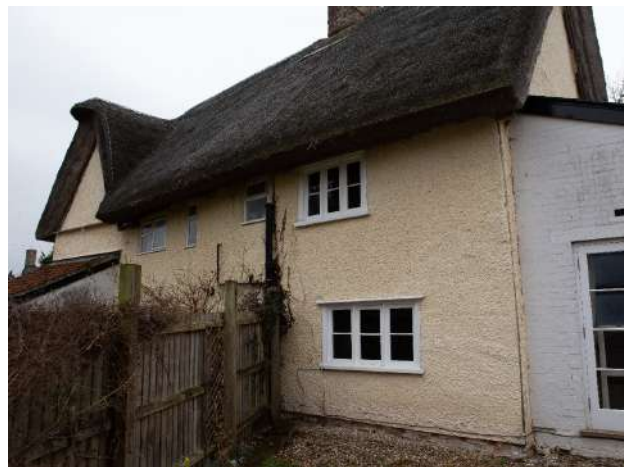
Fig 1.11 No 6 Church Way from NW. No 4 beyond fence which is to be removed. Note gaps to render at corners that will be repaired like for like.

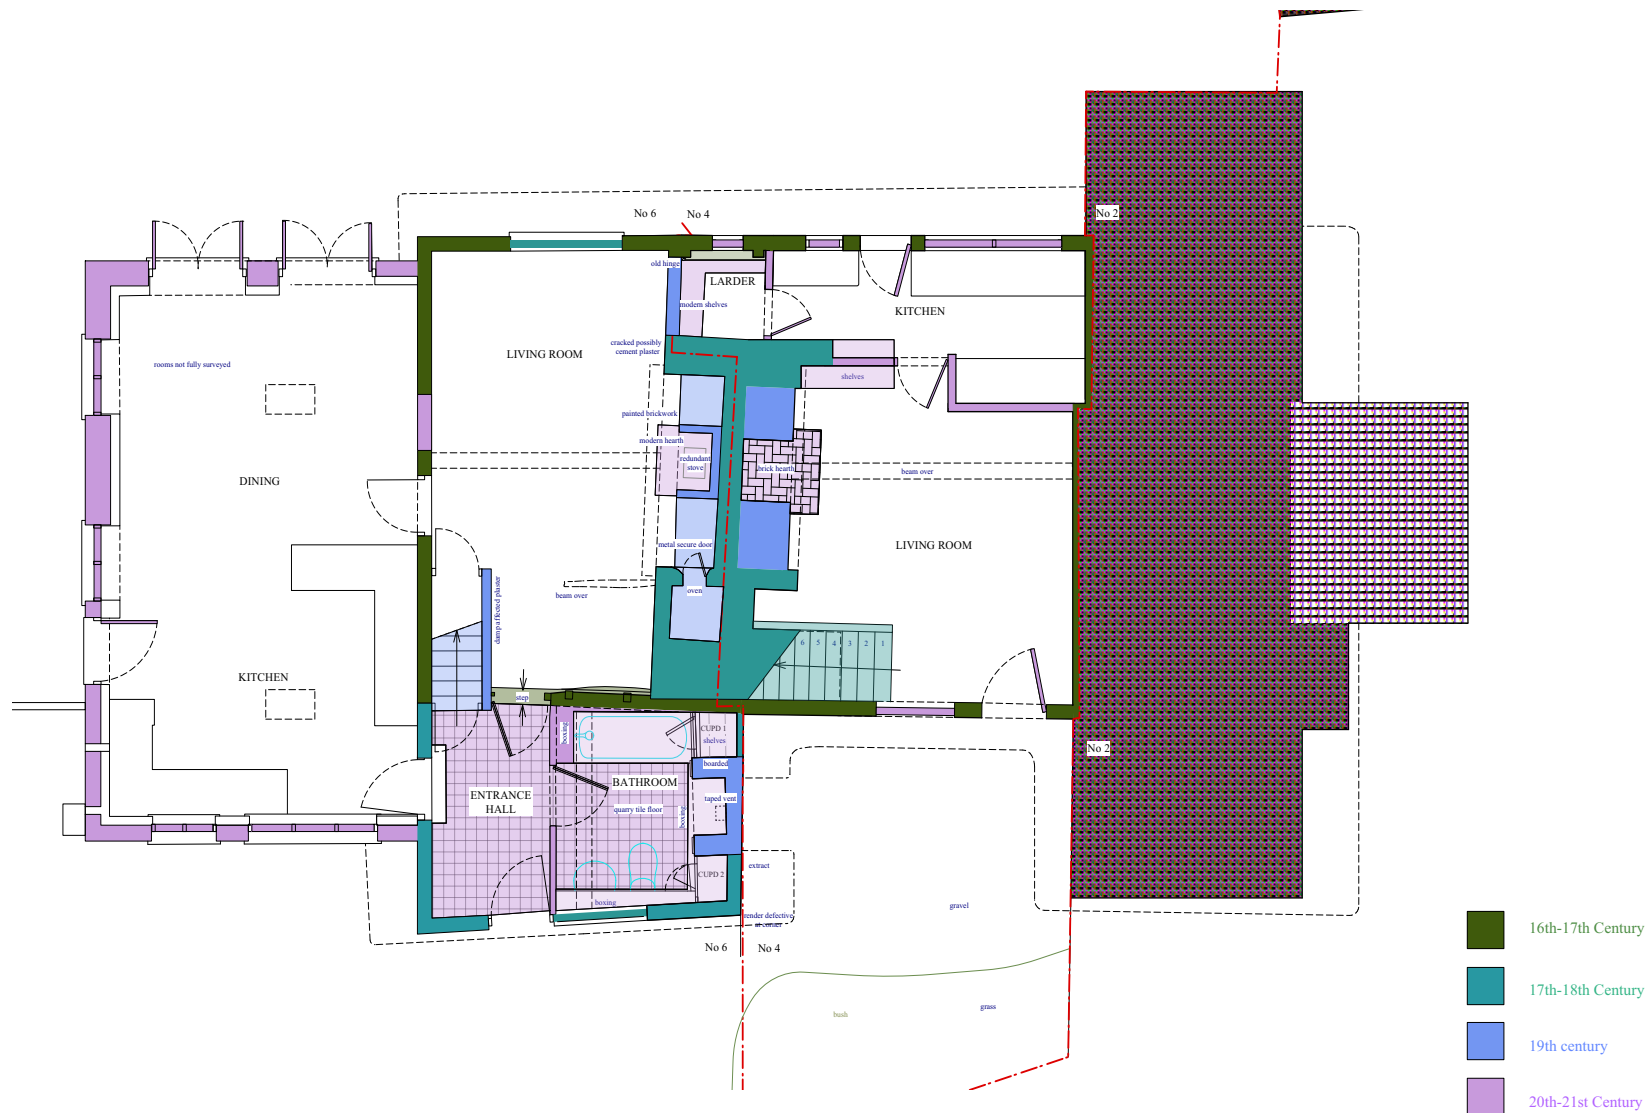
Fig. 2.0 Ground floor Age of fabric diagram

The following diagrams illustrate our analysis, of the approximate age of the fabric [Fig 2.0, 2.1], and the significance of the fabric [Fig. 2.2, 2.3] as deduced from the listing information, the Heritage Impact Assessment, and observation of visible fabric. This identifies that overall form of the building is still generally defined by the fabric from the original construction phase to the main central block of the house all of which is of the highest significance. However, later additions and alterations

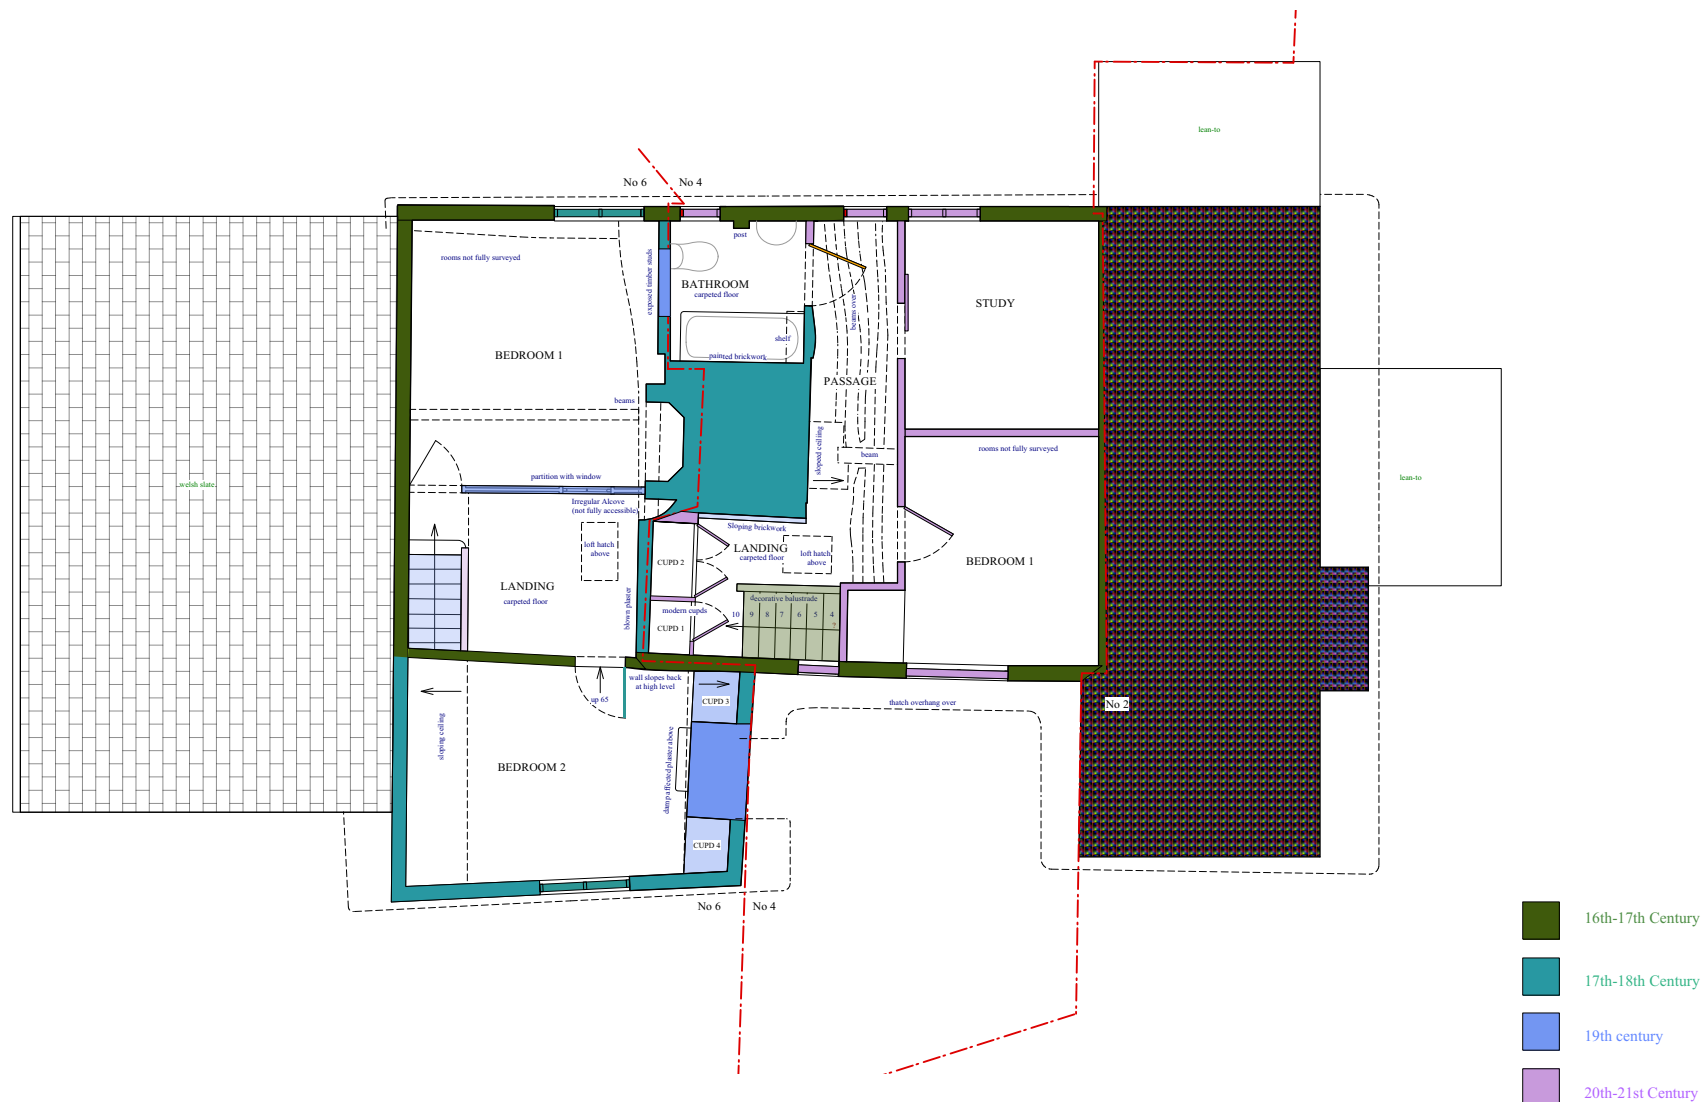
Fig 2.1 First floor Age of fabric diagram

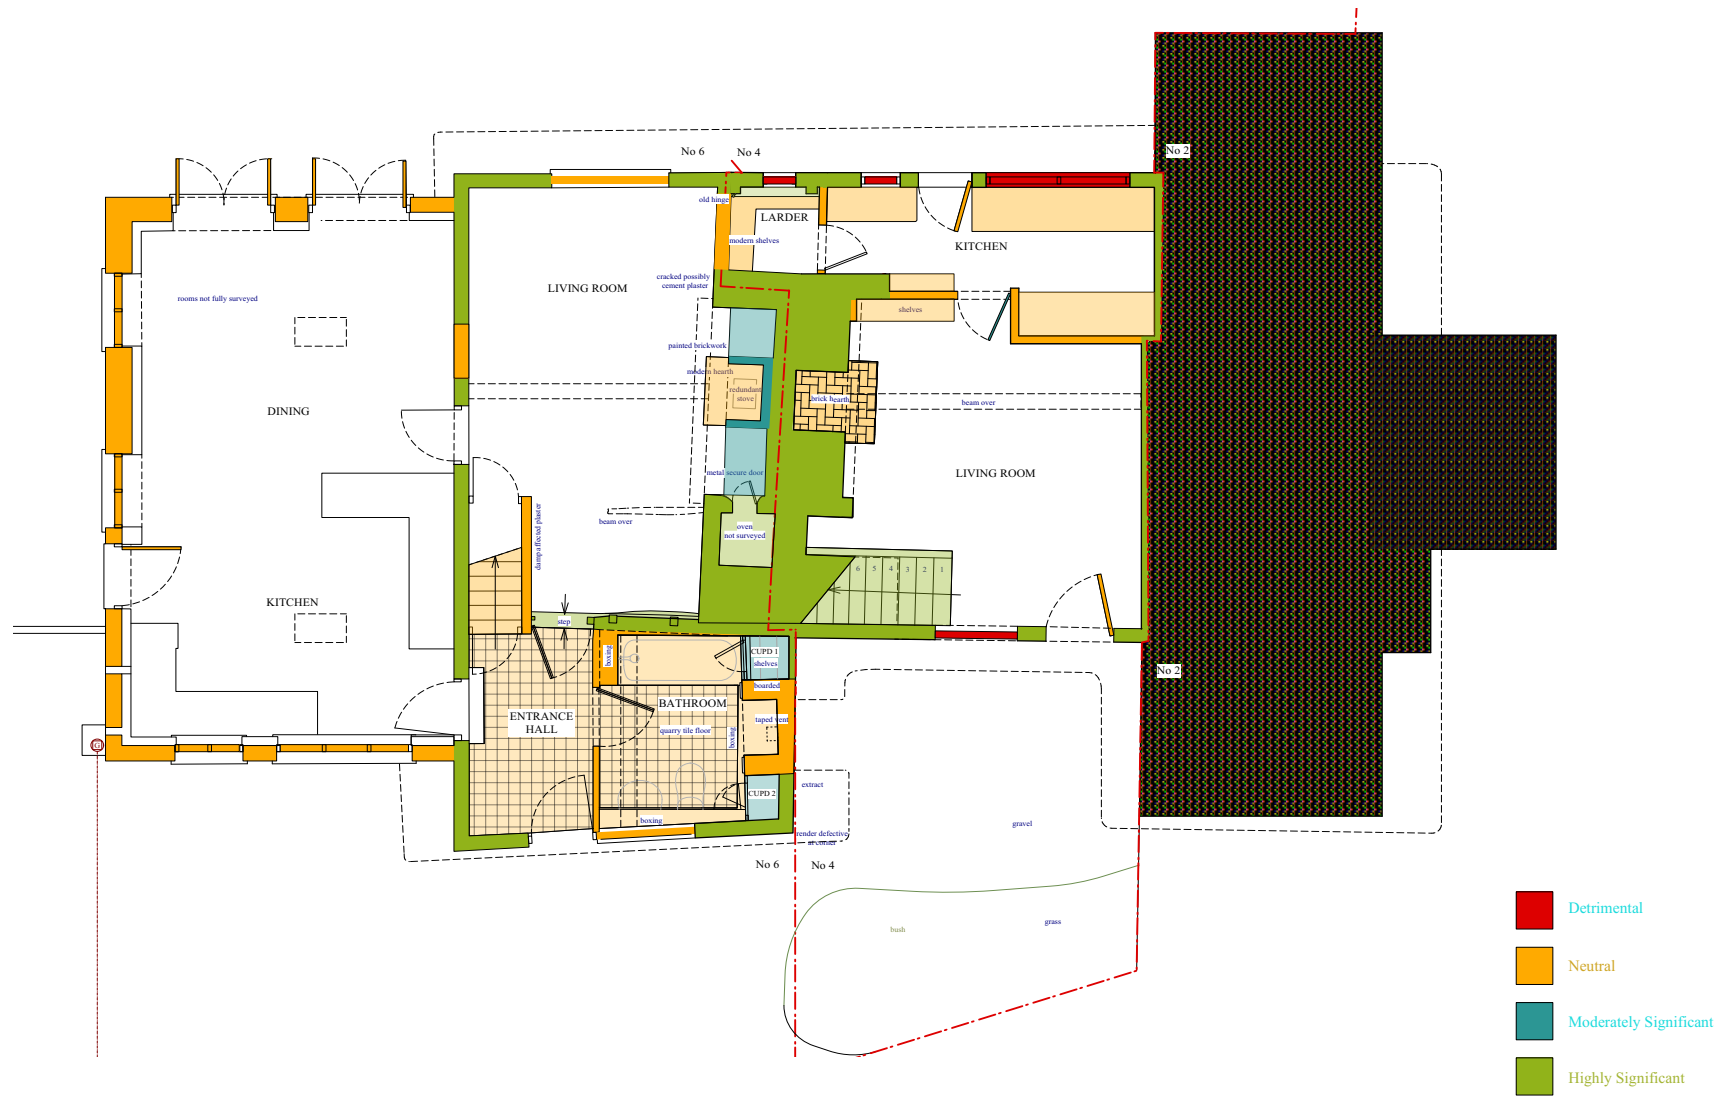
Fig 2.2 Ground Floor Significance analysis of the fabric

particularly the western crosswing, main staircase and chimney hearth have also contributed to the current character of the overall building so have an equally high significance. Other alterations, mainly those to subdivide the property with partitions and provide functional amenity like the brick chimneys and fireplace infills take on a moderate degree of significance as they add to the story of the building to a limited degree but contribute less to the overall character and historic interest of the building. Later additions or alterations that have intruded into the older planform of the overall house and have been altered or are of little historic interest such as modern partitions and extensions are given a neutral significance in that they do not greatly disturb the character of the building but are of little significance themselves. Additions that have been undertaken without sensitivity for the historic nature of the building are given a detrimental status as they detract from the character of the building.

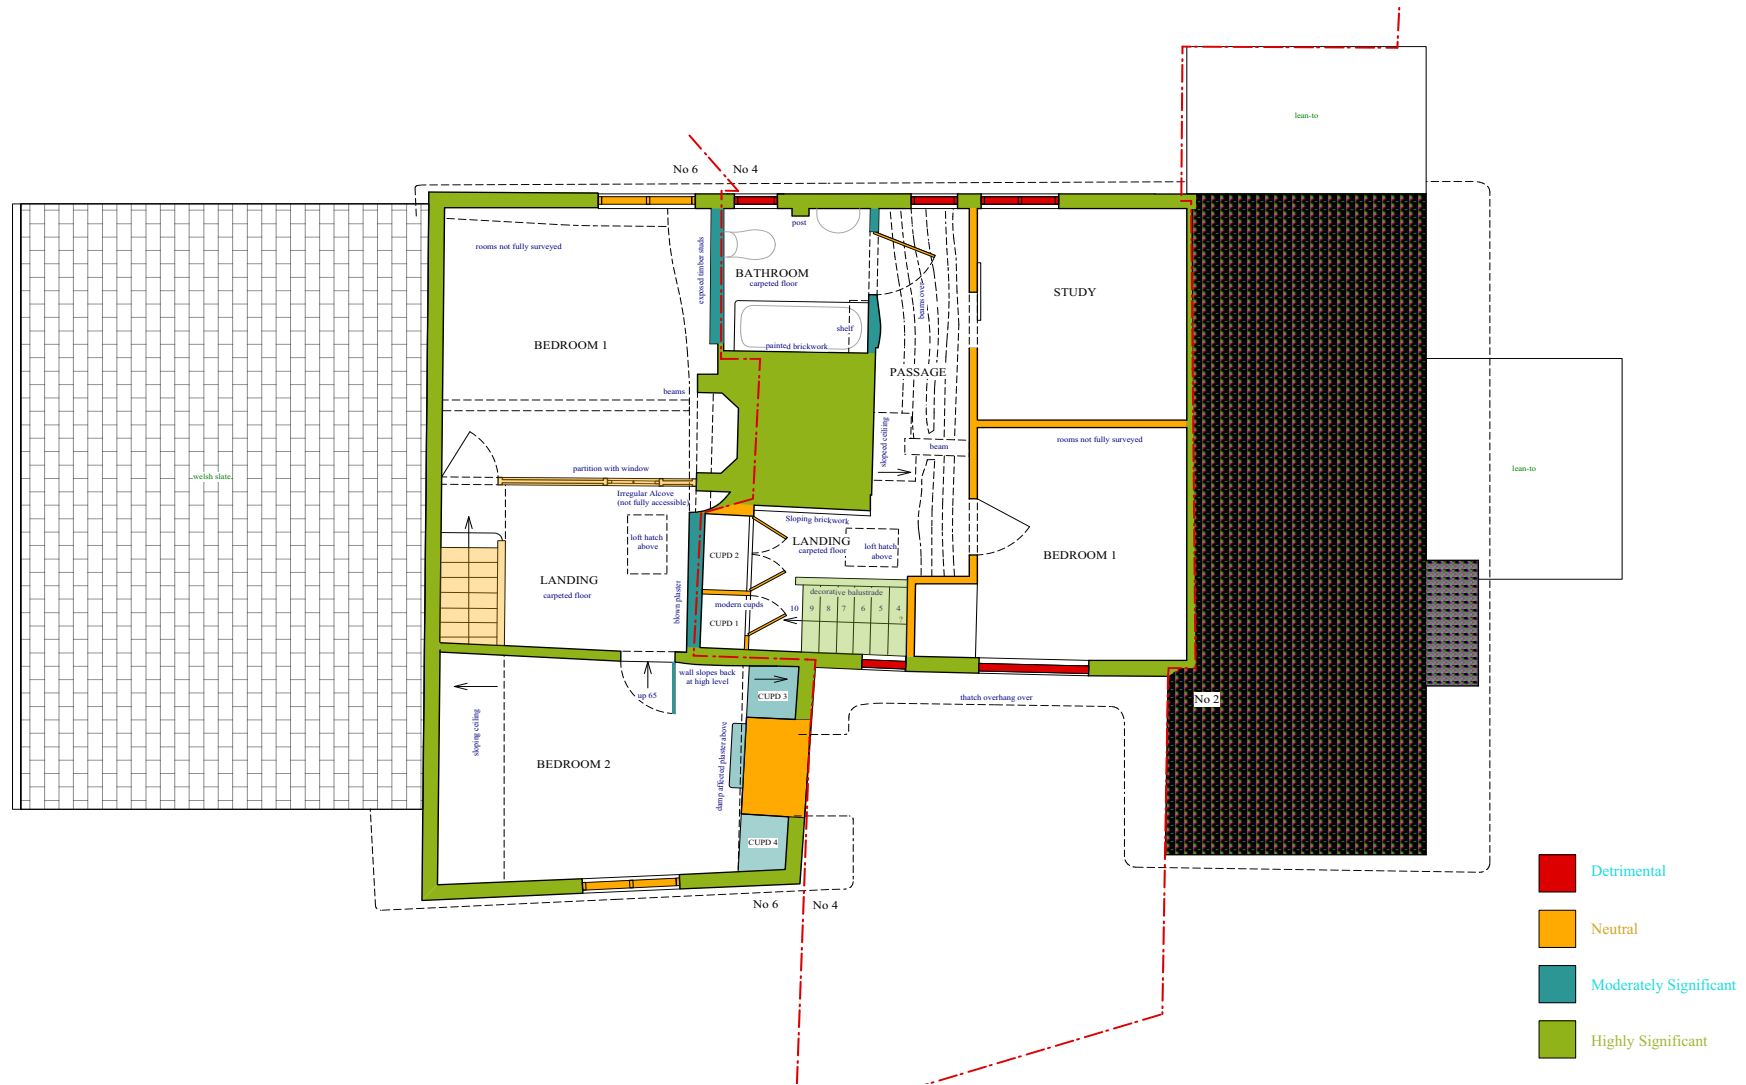
Fig 2.3 First Floor Significance analysis of the fabric

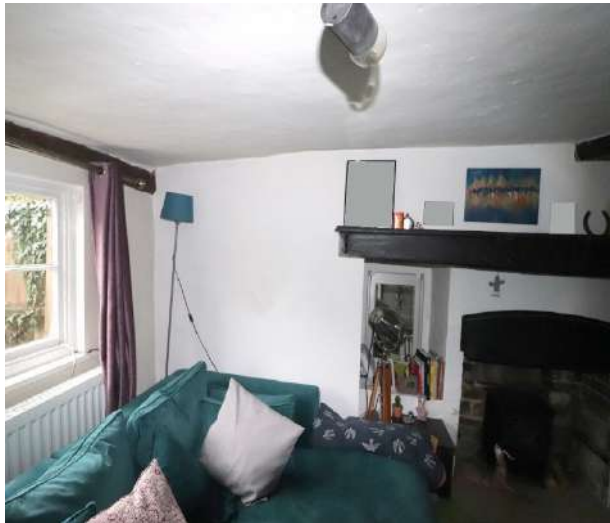
Fig 3.0 Location of Proposed Ground Floor Doorway from No 6 Living Room. [photo from HIA - Hoggett]

wall between the Living Room of No 6 and Larder of No 4 is necessary, to the North side of central chimney, as the oven, and staircase to No 4 block the south side. There is a remaining metal hinge of evident antiquity set within the timber post in the proposed location showing that a door almost certainly existed previously in this wall and since blocked up in the subdivision of the building. A section of hollow sounding plaster indicates an area of an opening previously filled in [HIA 2.3.1.4]. There is no indication of the structure within the partition but no visible features of antiquity are visible and cement plaster has been applied to both sides which is cracked and the area shows sign of dampness which can be addressed whilst removing fabric for the opening. The size of the opening is to be confirmed on site to suit the existing unearthed surrounding framing or studwork closest to the size to suit a 800mm wide door. A new oak frame set flush with the plaster will be fitted and a ledged timber door to match existing other doorways in the house, will be fitted. Visible timbers and metalwork of antiquity in the area will not be disturbed except where minimum needed to fix the new frame which will be fixed using as many existing hidden holes etc as possible. Modern partitions and associated shelves of no historic significance are to be removed from the existing Larder to enable passage through this doorway and enable

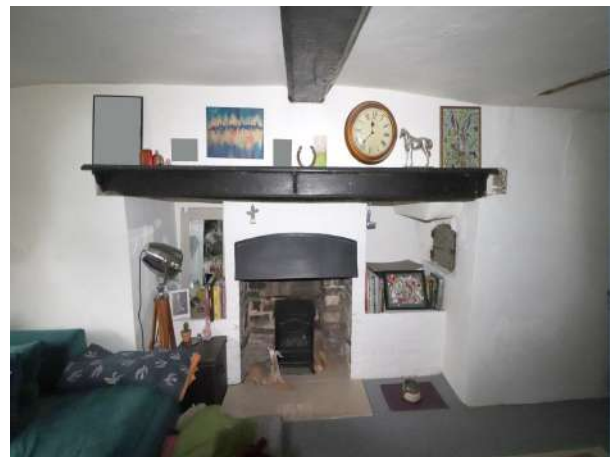
Fig 3.1 Living room to No 6 showing fireplace surround adjacent to where the doorway is proposed. [photo from HIA - Hoggett]

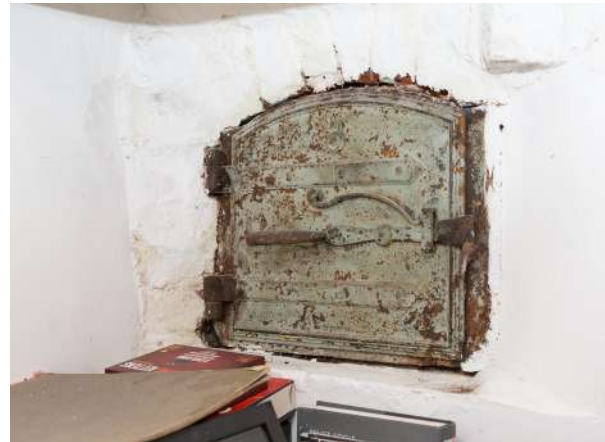
Fig 3.2 Metal door to bread oven in No 6 Living Room which is deteriorating due to damp surrounding brickwork to unventilated oven.

- No 4 New Utility - Cavity membrane to replace cement plaster to chimney breast brickwork.
- No 4 New Utility - humidistat extract fan through wall, with metal airbrick.
- No 6 Bread oven - vent through brickwork from No 4 Living Room to ventilate trapped dampness. Decorative vent in Living Room of No 4 where most discreet.

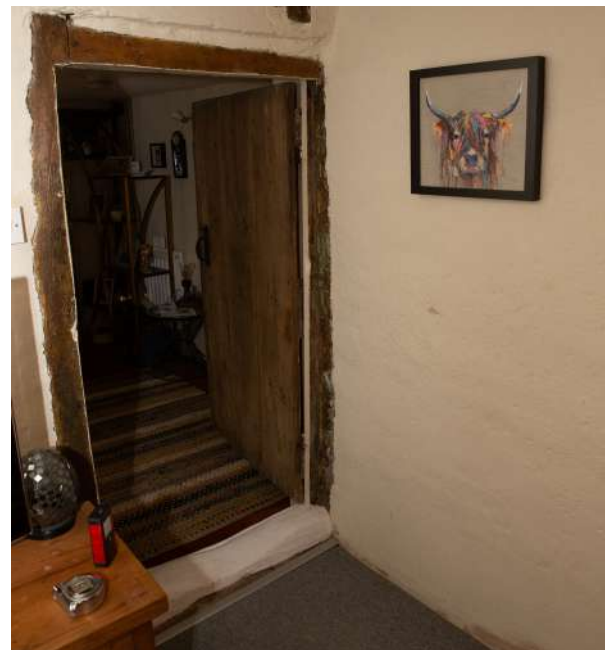
Fig 3.3 Living Room of No 6 showing doorway and ledged door leaf to be referenced in the new doorway design.

better airflow and ventilation in this space. First floor - To allow circulation between the two properties at first floor level an opening is to be made in the partition between the landings of No 4 & 6. This is likely to have been one larger continuous landing when the house was a single dwelling after the central chimney and first floors and main staircase in No.4 were constructed [HIA 2.3.1.5]. The partition itself is believed to have been added later when the house was subdivided and so is less significant and not directly associated with the more significant features of the layout like the 18th C staircase and central chimney. The modern cupboards to the landing of No 4 are to be removed to allow for the new opening and to enable a comfortable landing space. A flush oak frame to match the similar features elsewhere in the house [fig.3.3] will be created - see detail drawing submitted with this application.

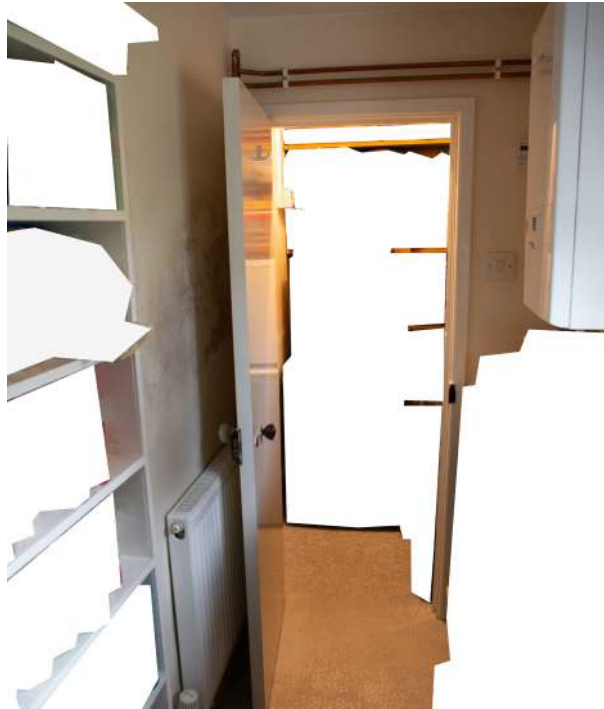
Fig 3.4 Location of Proposed Ground Floor Doorway (straight ahead) from No. 4 Kitchen showing modern doorway/partition and shelves to Larder to be removed.

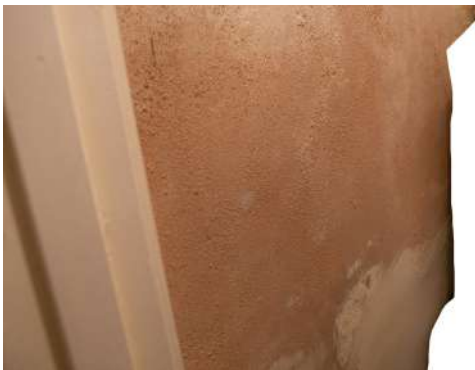
Fig 3.5 Damp patch in Larder of No 4 where studded cavity membrane to be installed to damp wall. Plaster to be removed first

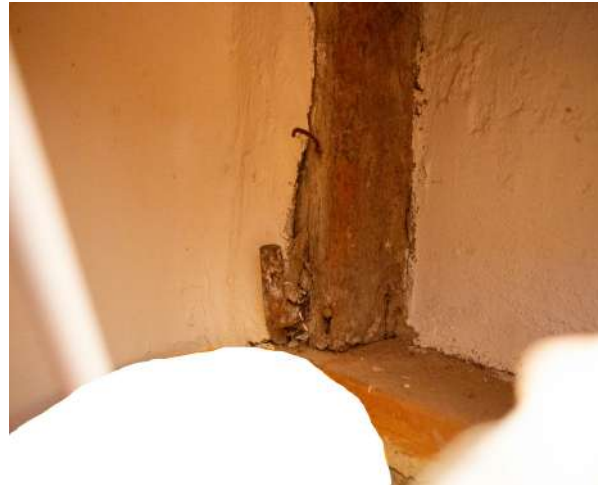
Fig 3.6 Historic metal hinge in Larder of No.4 suggesting existence of old doorway between No 4&6 previously before subdivision of property.

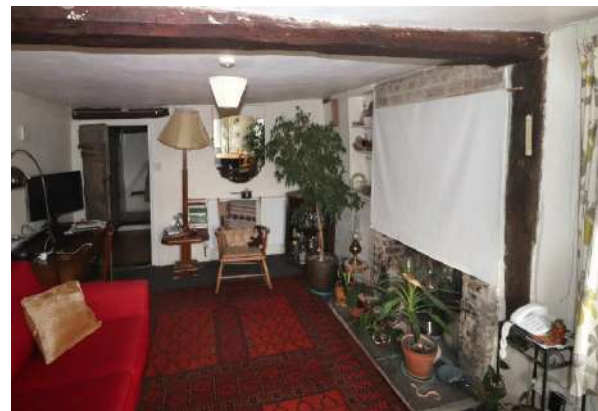
Fig 3.7 No 2 Church Way LivingRoomshowing fireplace at right to receive insulated soffit board and vent. Photo - Hoggett HIA>

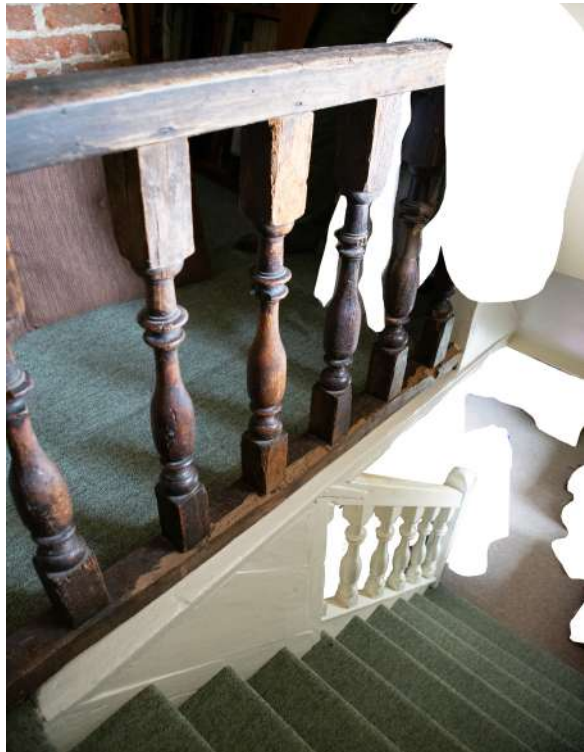
Fig 3.8. Historic staircase to No 4 dated to early 18th C. Of a level of elaboration that is likely from before the property subdivision and is designed to fit with the brickwork central chimney (background).

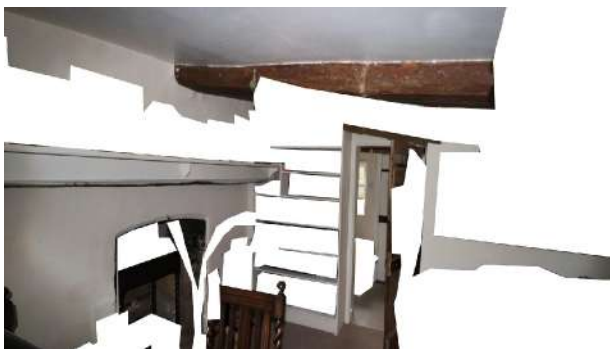
Fig 3.9. First floor beam to No 4 Living area fixed into central chimney structure.

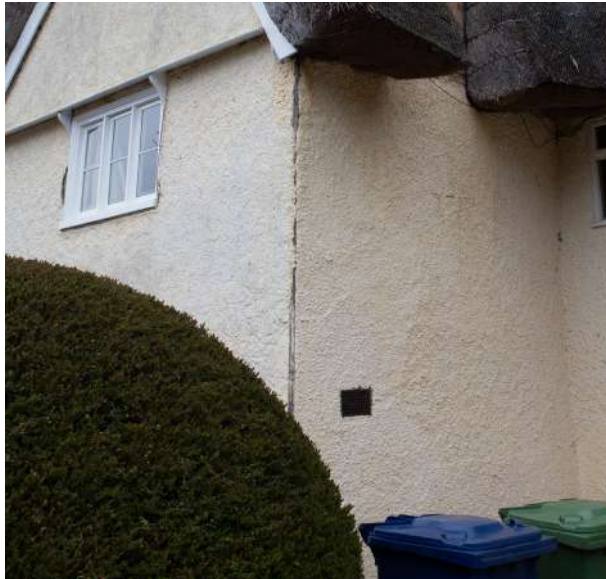
Fig 4.0. Gaps in approx 1930s roughcast cement external finish that require repair

- Replace defective cement chimney stack flashing to thatch roof, with lead flashing.
- Replace cement chimney stack pointing with lime mortar.
- Repair holes and gaps in roughcast cement render and cracks against window door openings .
- New discrete holes near ground level outside No 4& 6 kitchens for electric cables

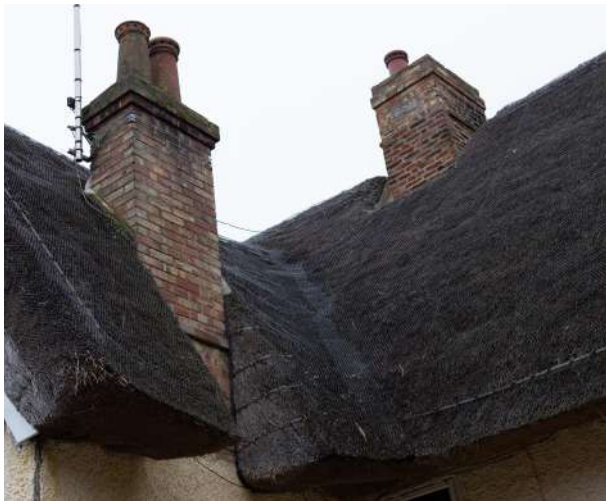
Fig 4.1. 19th C chimney stack with defective cement flashing to be replaced with lead

EXTERNAL					
CHIMNEY STACKS TO No 2, 4 & 6	Cracked cement flashing where chimney meets thatched roof covering. Cement pointing.	High/Neutral (overall structure)	Replacement of defective cement flashing with lead flashing. Replacement of cement pointing with lime mortar pointing repair.	Removal of modern detrimental and defective detail. No loss of historic fabric.	Defective cracked cement flashing and pointing believed to be letting in/trapping moisture causing or exacerbating damp issues to chimney breasts internally.
KITCHENS OF No 6 & 4	Brick wall plinth.	High, Neutral	Creation of small hole for electric cable to run through new connections as shown on drawings.	Very minor hole in fabric.	Located in discrete corner location at very low level so minimal visual disturbance.
ALL ELEVATIONS - WINDOWS AND EXT DOORS	20th C Cement rough-cast painted render	Neutral	Repair /infill of Cracks and gaps in render with like for like render to match..	No loss of significant fabric, will help reduce moisture ingress that may be damaging timber frame.	Will uses like for like render in material and texture to fill gaps and cracks. Traditional burnt sand sealant to be used against window/door joinery currently poorly sealed against walls..
