G&H SPENDER ENGINEERING

Pilcot Mill

Initial conservation assessment / treatment proposals.

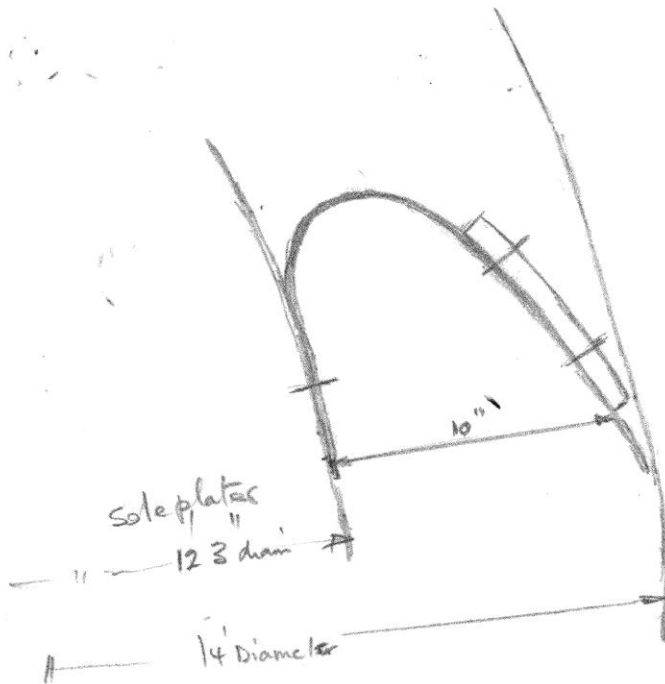
BUCKET PROFILE

STEEL PLATE - Buckets

24" x 1/8" x 70"

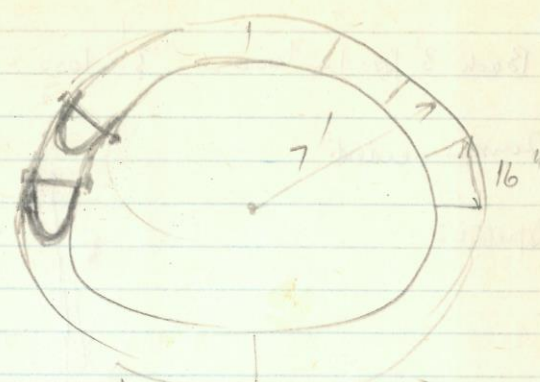
Wheel Diameter 14"
 Width 6"
 No of Buckets 32
 Bucket Plate Length 24"
 Centre Plate length 25"
 Entry position 6" below C of wheel
 " gap 1"
 Flow Velocity 0.5 ft/sec. (to 2.5 ft/sec)
 Vol of flow at entry level. 5 cusecs. (10 ft² * 0.5 ft/sec)
 Say increase at 5 cusecs/foot.
 Head drop say 6 ft. max.
 Water Press (fr 1 head) 0.34 psi
 Water level at entry - 1 ft
 On Min water (1 ft from entry) = 10 cusecs
 Then at 60% of min water
 $hp = \frac{10 \cdot 62.3 \cdot 6 \cdot 0.6}{550} = 4.1 hp$
 At 2' above entry = 15 cusecs available
 Flow power = 6 hp
 Torque = 22 * 14 * 12 = 528
