If required, mitigation measures and recommendations will be made that will enable the site to be suitably developed while actively seeking to reduce flood risk locally.

Hempland Primary School, York is located on Whitby Avenue, Stockton Lane approximately 1.6 miles north-east of York (Grid reference - SE 62430 53001), the site is primarily accessed from Whitby Avenue. The site location is provided in Figure 2.1 (and Appendix A).

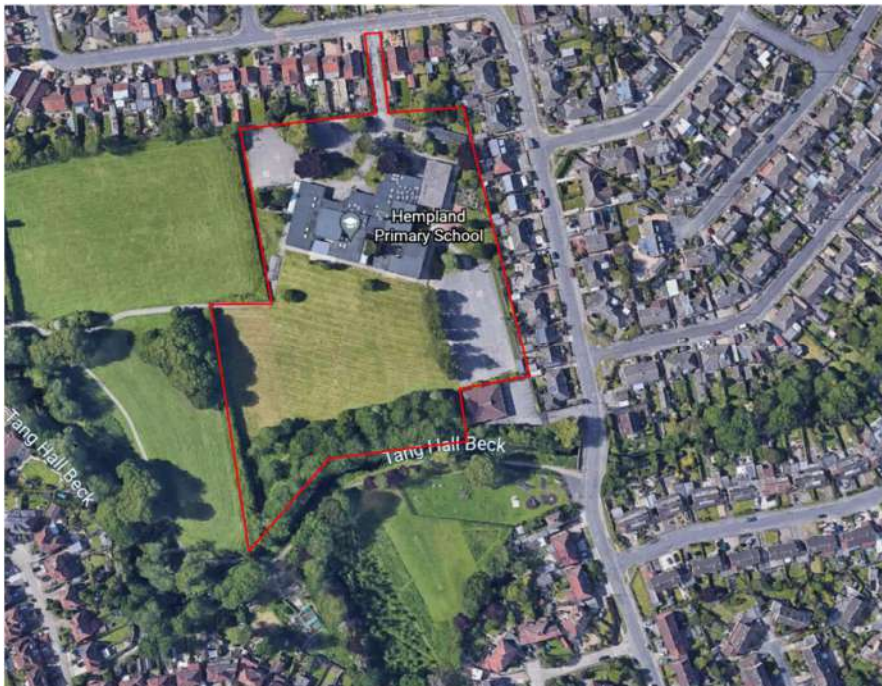
**Figure 2.1: Indicative Site Plan**

The site is bound to the north and east by residential properties. To the immediate south and west are some areas of green space and playing fields beyond the school boundary and beyond those further residential properties. It is also noted that the southern boundary is bounded by a watercourse, known as Tang Hall Beck. Further west of the school are the suburbs of the city of York (see Figure 2.1).

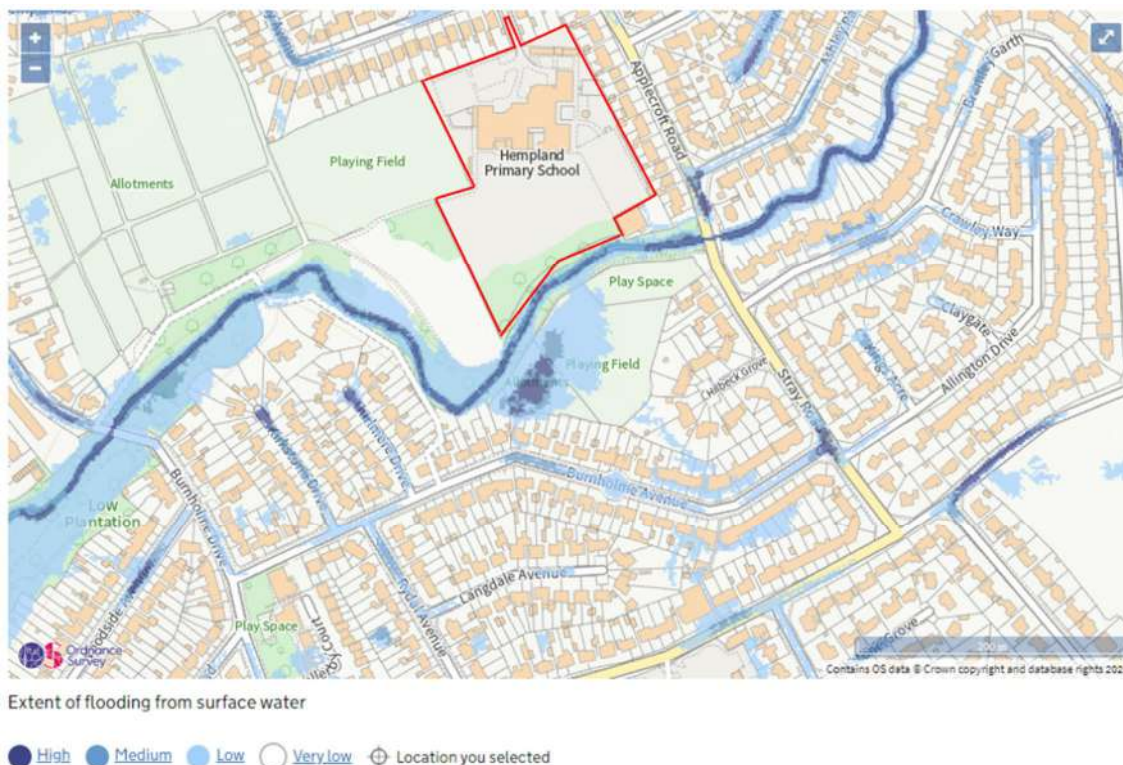
**Figure 3.2: EA online flood map showing surface water flood risk**

The EA's online mapping shows that majority of the site may be at very low risk of surface water flood risk with the exception of southern boundary which has a low to medium pluvial flood risk. As shown in Figure 3.2 below.

**Very low risk** - means that each year this area has a chance of flooding of less than 0.1%. Flooding from surface water is difficult to predict as rainfall location and volume are difficult to forecast. In addition, local features can greatly affect the chance and severity of flooding.

There are areas of low to medium flood risk on the southern boundary which is due to its proximity to the watercourse. This manifests as surface ponding or overland flow. This is located on the bank of the water course along the southern boundary of the development site. An elevated surface water flood risk around a watercourse is to be expected. The mapping does not show this impinging on the playing fields or other areas of the school site. With reference to the topographical data (see Appendix B) it is also noted that the watercourse is approximately 0.45m lower than the lowest level of the sports pitch. There is therefore no flood risk from this source to the operation of the development.

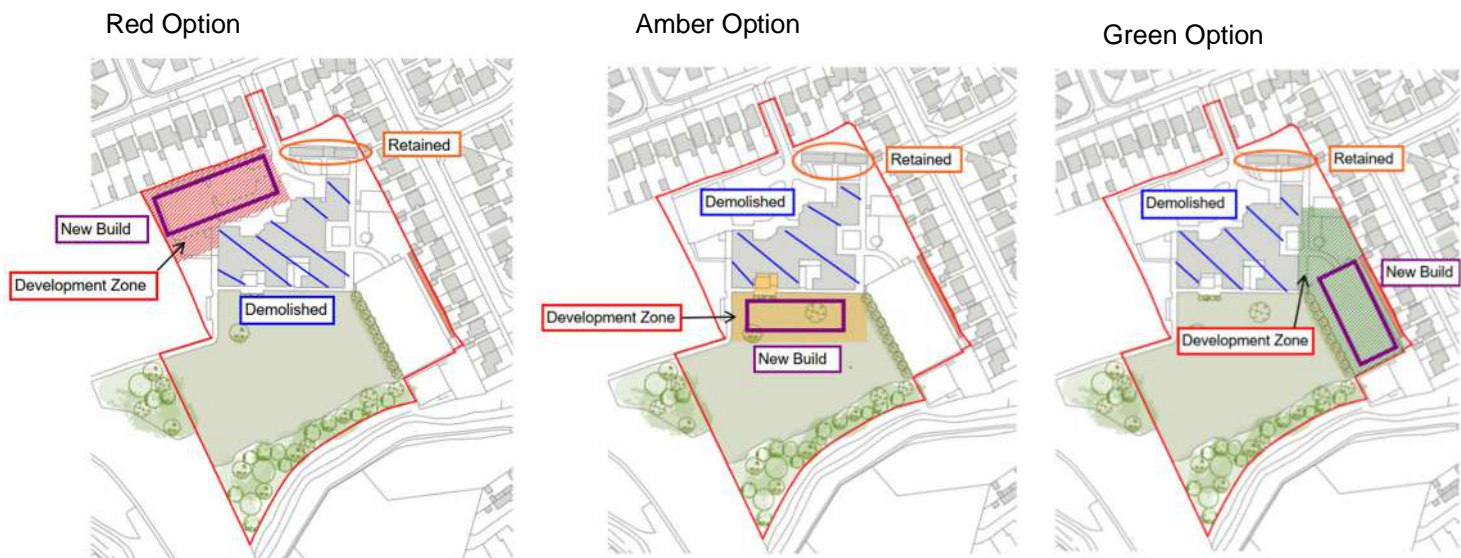
**Figure 3.4: Indicative Proposed Plan Site Options**

The current site options: Green, Amber and Red for the proposed redevelopment of Hempland Primary School are included in Figure 3.4. These options are described in more detail in the report '3047-54-RCA-00-XX-RP-A-0110-S1-P2-Hempland Feasibility - Meeting 2'. All options include the demolition of all the accommodation (excluding all ancillary (ANC) accommodation) which is noted in the CDC report (see Appendix G). It has been advised by the client that the preferred option is the Amber option.

The proposed design of the school development will be developed at future stages using data from this assessment and others. Currently there are three potential development options shown in Figure 3.4.

As the plans change and develop then this area assessment will need to be revisited but the overall principles will be the same.

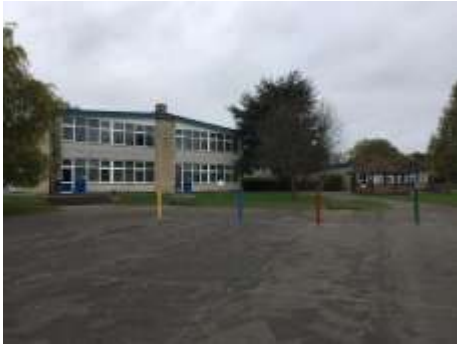
Site	EFA1
<b>Block</b>	<b>EFAA</b>
Building Age	1961-1970
No. of Storeys	2
Basement Area (m2)	0
Gross Internal Floor Area (m2)	3374
Ground Floor GIFA (m2)	2410
Perimeter (m)	353
Average Height (m)	6
Catering Kitchen	Full Kitchen

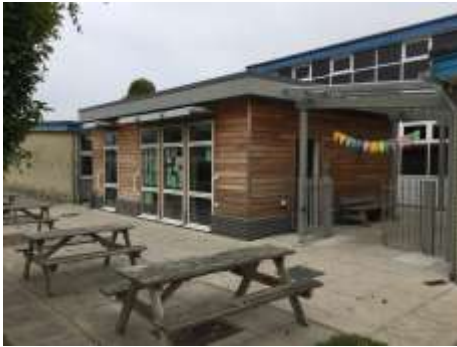
Site	EFA1
<b>Block</b>	<b>EFAB</b>
Building Age	2011-2020
No. of Storeys	1
Basement Area (m2)	0
Gross Internal Floor Area (m2)	36
Ground Floor GIFA (m2)	36
Perimeter (m)	25
Average Height (m)	3
Catering Kitchen	No Kitchen
