## HERITAGE STATEMENT FOR PROPOSED ALTERATIONS TO FENESTRATION AT 31-33 LONG STREET, TETBURY, GLOS, GL8 8AA

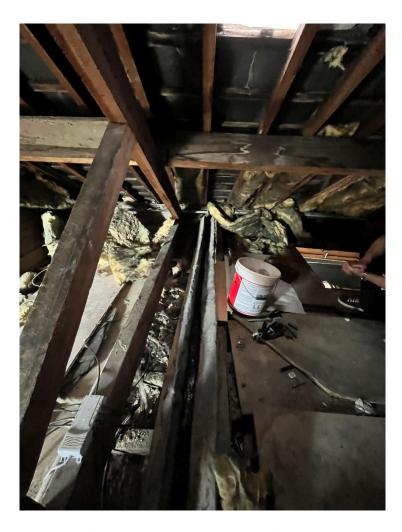
Currently behind the parapet there is a lead valley that runs through a hole in the roof and through a lead lined gulley within the roof space and discharges at the rear elevation. This overflows during very intense rainstorms so we are proposing to substitute the lead gulley with a solid 100mm diameter pipe so there will be no overflows from this gulley in times of bad rainstorms.

Our client is very interested to re-point the stonework in lime mortar as the stonework appears to be reasonable size and good condition. The properties either side are exposed stonework.

Number 31-33 Long Street, known as Gastrell House, is a gallery with a traditional shop front and gallery display on the first and second floors. The main façade is 3 sash windows on the first and second floors with a stone parapet hiding a slate roof behind. The street elevation is finished with a cement render marked out to replace Ashlar. The rendering has faded and is loose in many places, which apart from being unsightly, is also dangerous to the public walking on the pavement below.
