01. Proposed West Facing Threshing Barn Opening - Threshold Section Detail (extract from proposed section AA)

02. Proposed East Facing Threshing Barn Opening - Threshold Section Detail (extract from proposed section AA)

03. Proposed Section Detail - Steps/Ramp Between Existing Floor Levels (extract from proposed section DD)

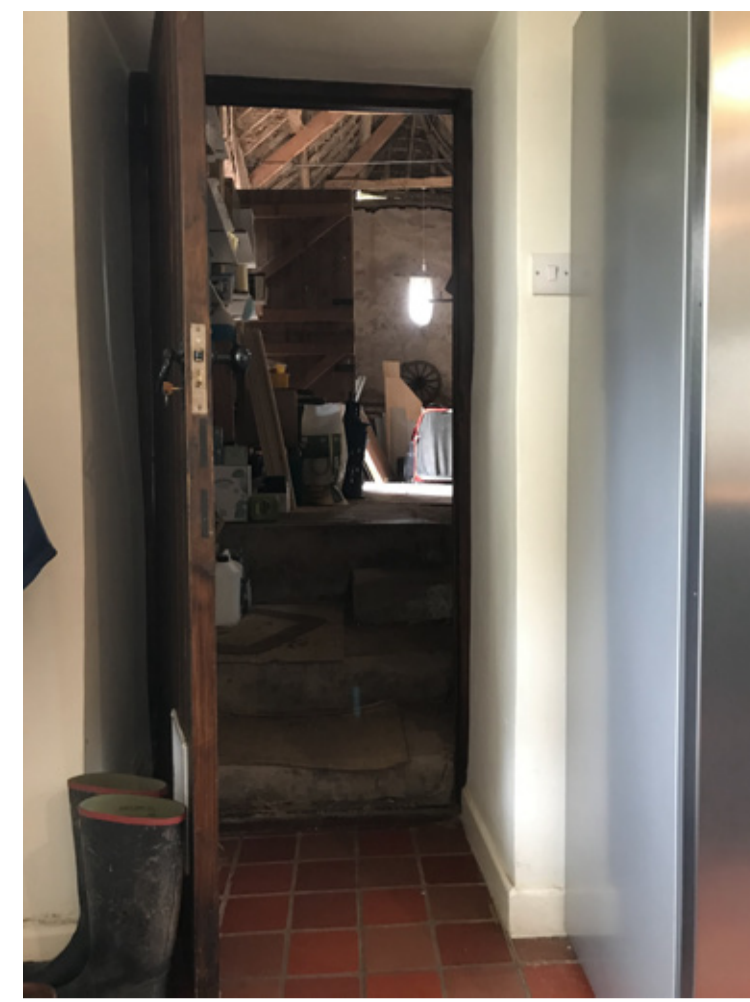
Existing steep concrete steps from Cottage to Threshing Barn

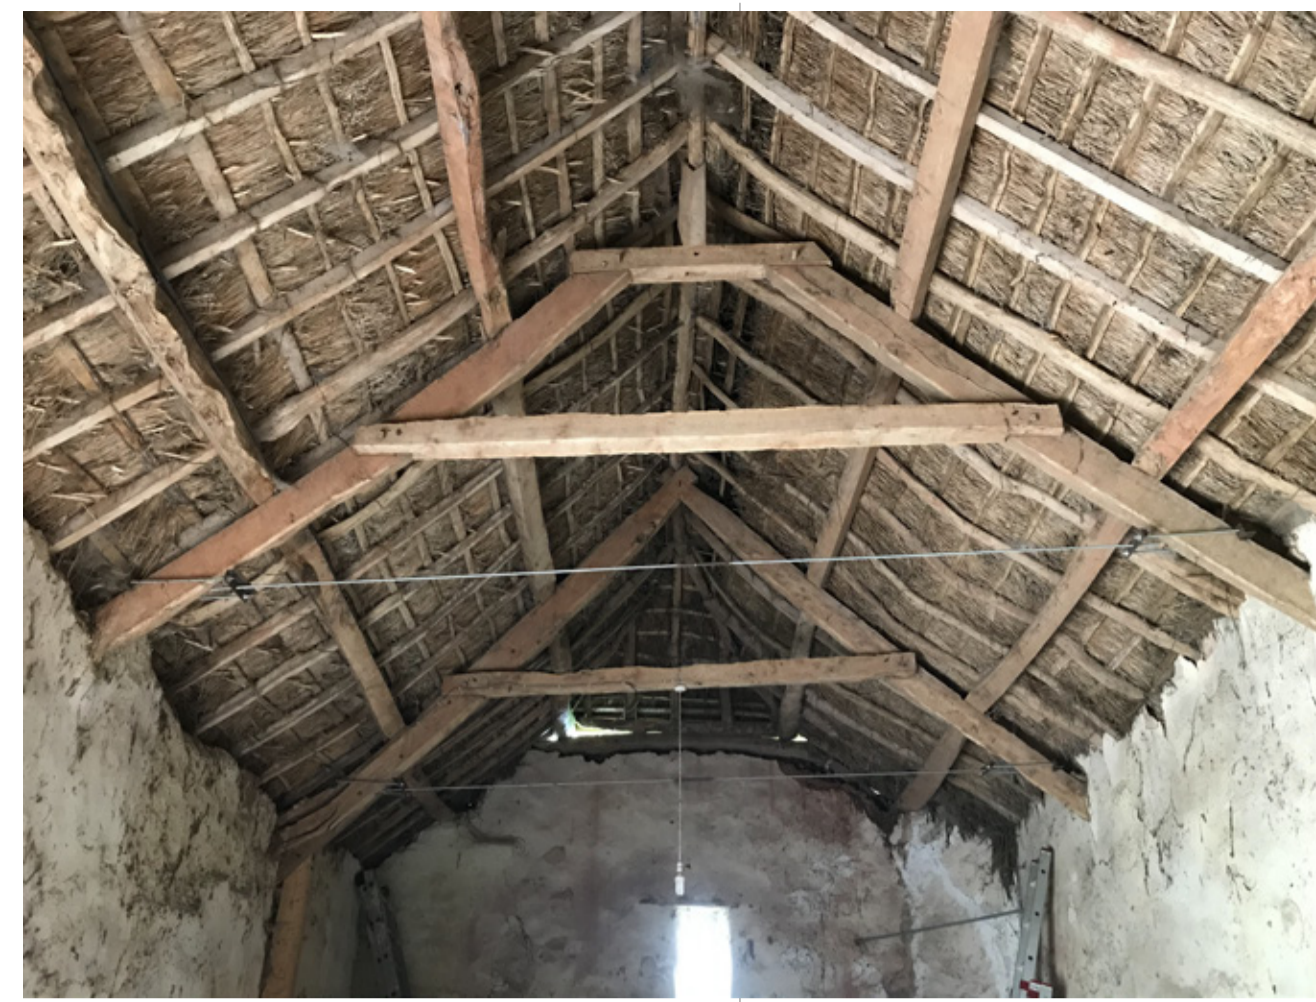
Existing exposed underside of thatched roof and existing plastered walls in need of repair
