Barn at Shornhill Farm, Withington, GL54 4BJ.

## Preliminary Ecological Appraisal

For: SF Planning Ltd

Project Number: 2259

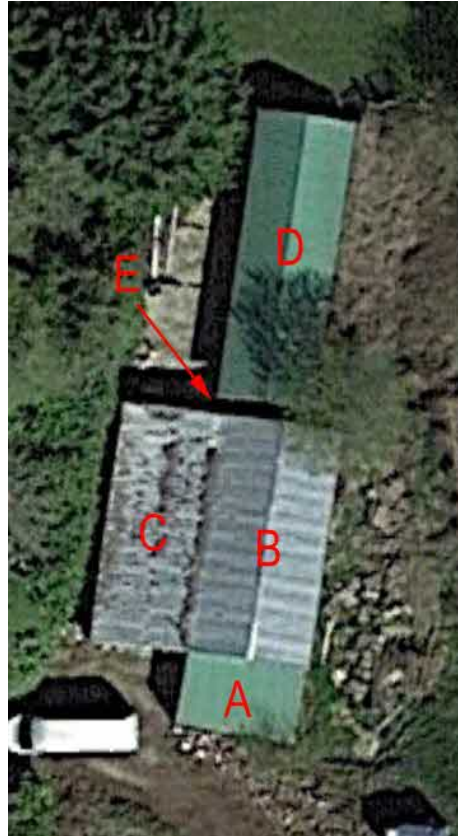
Figure 3: Building sections.

3.10 The two attached barns and lean-tos were inspected for their potential for roosting bats. The building has been separated into the following sections for ease of reporting:

- 3.11 External – Section A is a lean-to type building constructed from concrete blocks and covered with a corrugated metal roof. The eaves are covered with timber fascia boards. Section B is a corrugated metal and rendered barn of gable-end construction. The barn is covered with a corrugated metal roof with the walls extending up to the roofing material. Section C is a lean-to type building constructed from rendered concrete blocks. The building was covered with a flat roofing material. Section D was another corrugated metal barn of gable-end construction with the east wall constructed from concrete blocks. Sections C and D were connected by a walkway covered with a flat bitumen felt and fibreglass roof. This roof extended out to the east to form a porched area over the gap between Sections B and D.

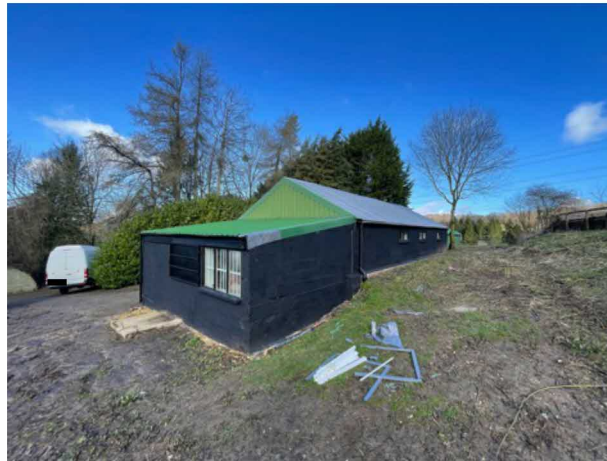
Photograph 11: View of Section A lean-to attached to the gable end barn, Section B.

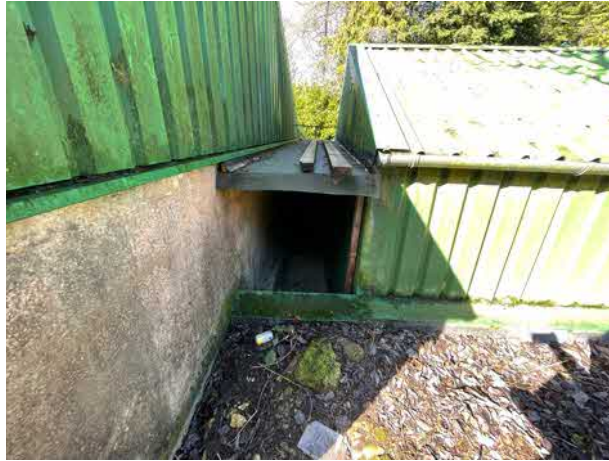
Photograph 16: Porch area between Sections B and D.

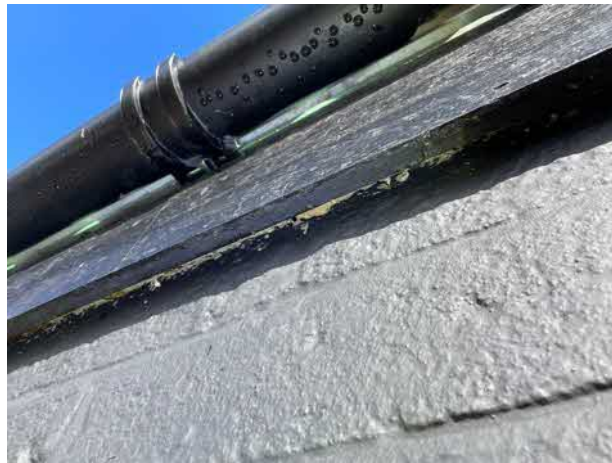
Photograph 17: Gap behind the timber fascia board of Section A.

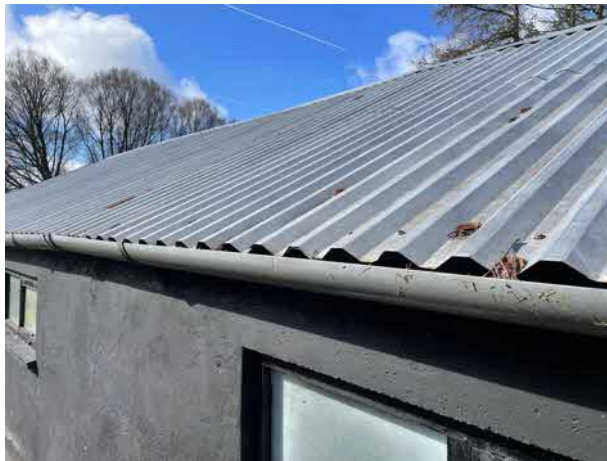
Photograph 19: Gaps along the bottom of Section B corrugated roof.

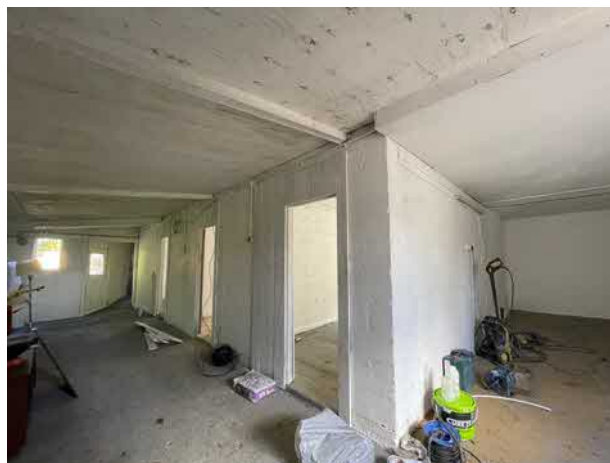
Photograph 20: View of Section B interior with inaccessible roof void above.

and timber sarking boards of Section D. Although this roofing material is not optimal for roosting bats, the roof voids of Section B could not be inspected for bats and could potentially be used for roosting.

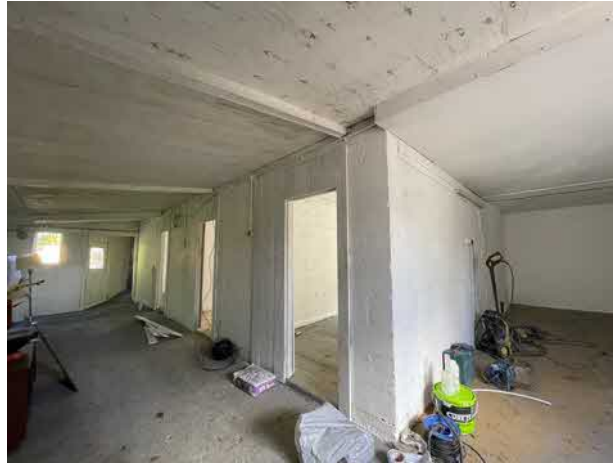
Photograph 20a: View of Section B interior with inaccessible roof void above in 2023.

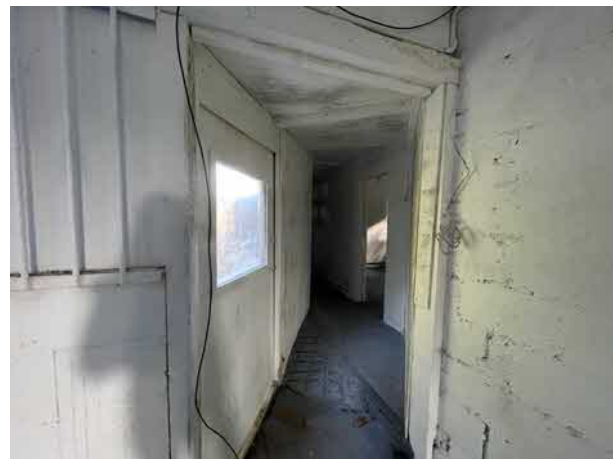
Photograph 22: Section E walkway interior joining Sections C and D.

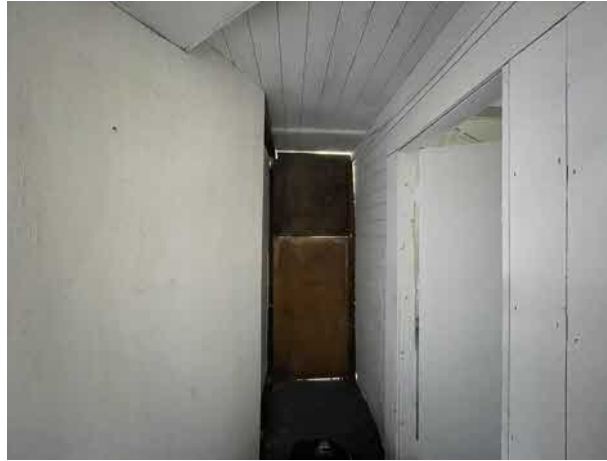
Photograph 22a: Walkway along west elevation of Section D had been sealed off.

- 3.14 In 2023, the building was found to be in the same condition as when first surveyed and remained largely the same. However, the boarded walkway which had been installed along the west elevation of Section D had been removed so this elevation now had a porch area. The porch, doors to the rooms of Section D and the sealed off Section E were well sealed with no potential points of entry to the remainder of Section D and E. The building was deemed to have the same potential for roosting bats and no new evidence of bats was found.

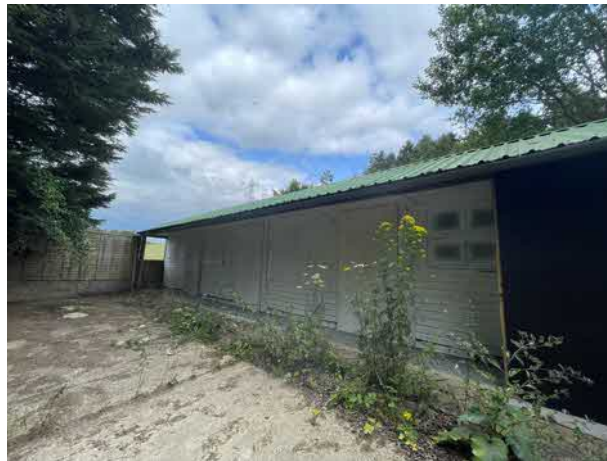
Photograph 22b: New porch area along west elevation of Section D where boarded walkway had been removed.

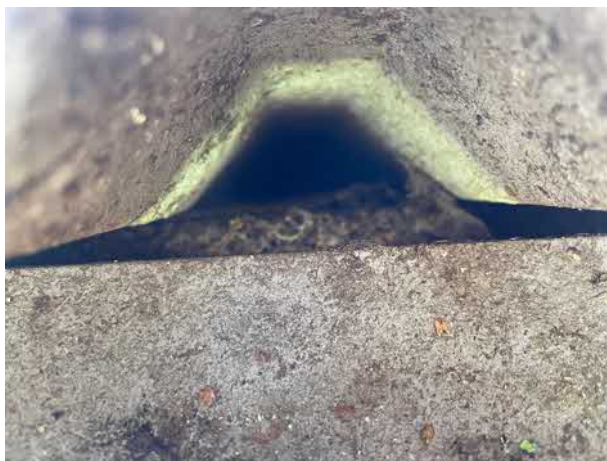
Photograph 23: Gaps along the corrugated roof of Section D.

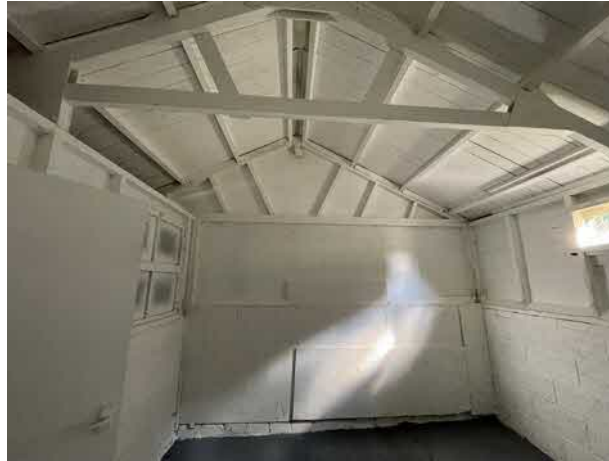
Photograph 24 : Section D interior with timber sarking boards lining the roof.

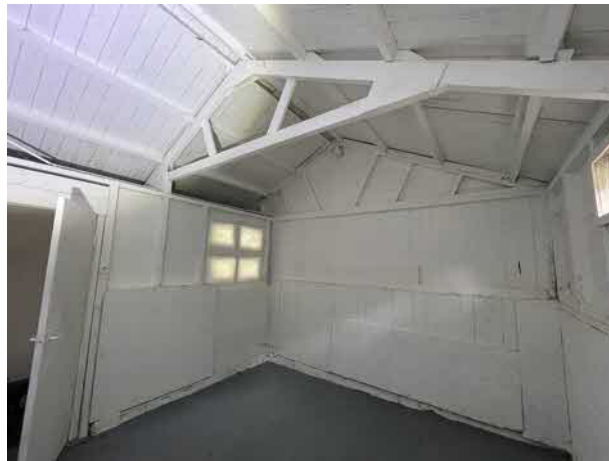
Photograph 24a : Section D interior with timber sarking boards lining the roof in 2023.

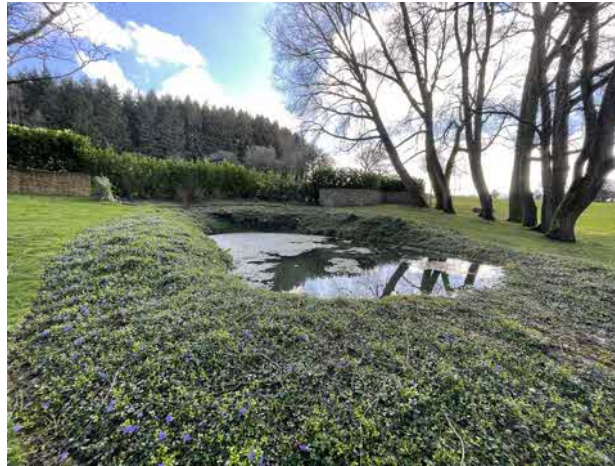
Photograph 25: Pond 1.

- 3.24 Pond 1 – Adjacent to the west boundary of the site and approximately 30m<sup>2</sup> in size. The pond appeared to have moderate water quality and no waterfowl were present but the pond may contain fish and is permanent year-round. The pond had a small amount of macrophyte cover and was mostly unshaded, surrounded by maintained lawn. There are two other ponds within 1 km of the pond.
- 3.25 Pond 2 – Approximately 20 m south of the site and approximately 40 m<sup>2</sup> in size. The pond had moderate water quality and high level of macrophyte cover however, is likely to dry annually. Fish

- 4.18 An eDNA test of Pond 1 was taken in April 2022 which found the pond to test negative for Great Crested Newt eDNA and it can be concluded this species is absent from this pond. Therefore, this species is likely to be absent from the site and no further consideration is required.

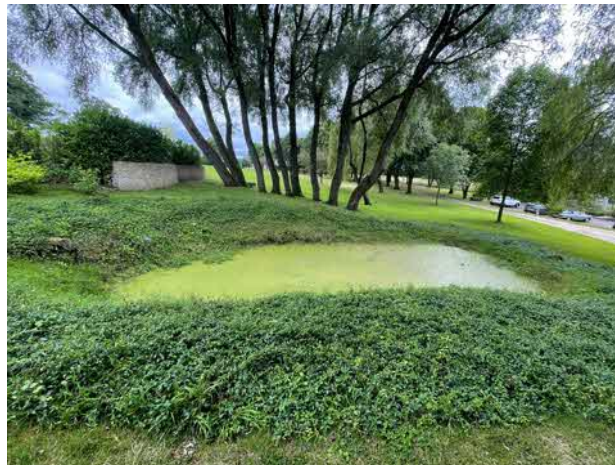
Photograph 25a: Pond 1 in 2023.

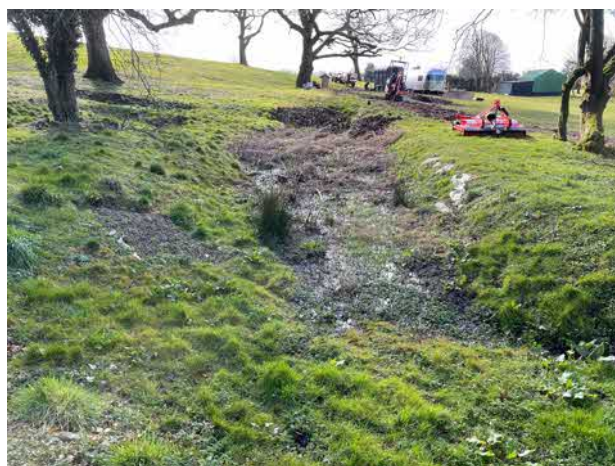
Photograph 26: Pond 2.

and waterfowl were absent and the pond was surrounded by short grassland. There are two other ponds within 1 km of the pond.

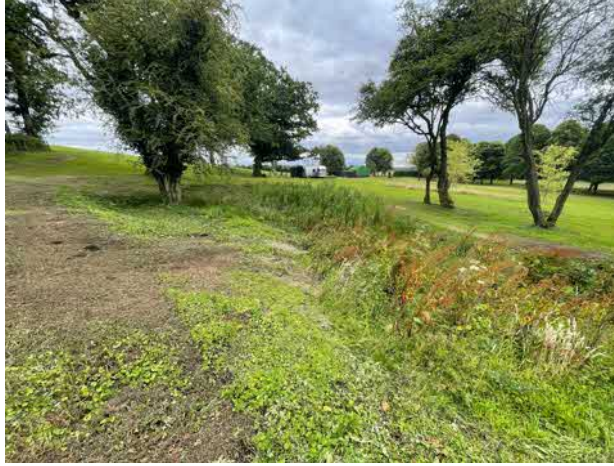
Photograph 26a : Pond 2 in 2023 found to be dry.
