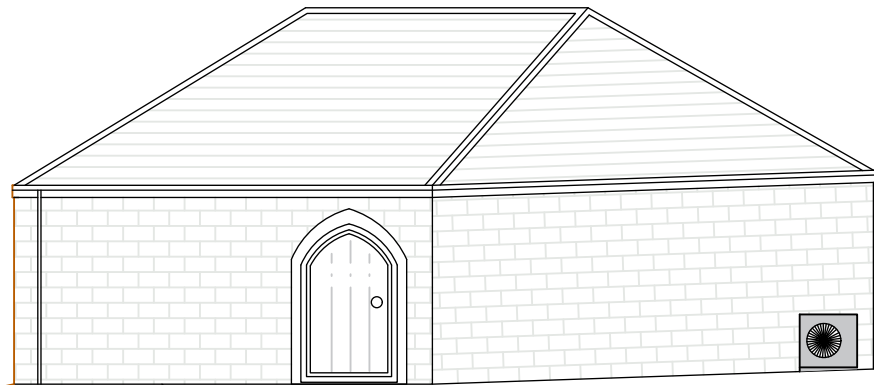
NORTH

North view:
No alterations to building, front door to remain.
