UPDATED SUPPORTING STATEMENT FOR PLANNING APPLICATION SUBMISSION FOR WESTEND COTTAGE, 1 MAIN STREET, LOW VALLEYFIELD, KY12 8TF

Introduction

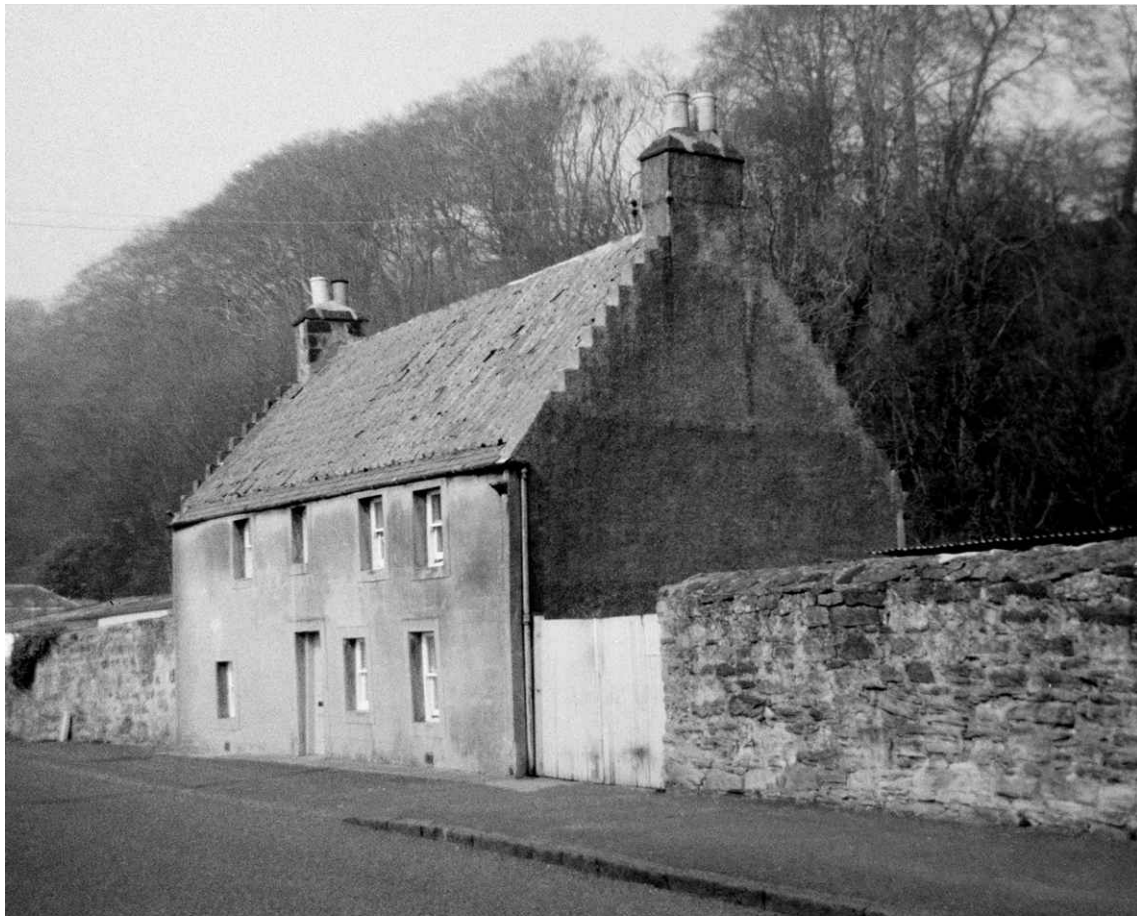
Image of 1 Main Street, circa 1972, Historic Environment Scotland Archives

It is clear comparing the two images that there has been significant change to Westend Cottage since 1971. The existing street level has risen approximately 300mm reducing the size of the front door and forcing the addition of two steps to the interior. The gable wall shows extensive water damage where poor workmanship, and the addition of cement render has negatively impacted the wall and led to water ingress. The roof is substantially different with the removal of the original pan tiles, the replacement of roof infrastructure and the removal of the lower slate roof courses. The change in level of the road and pavement has also led to a change in the building's representative height within the street and therefore it has been compromised in its visual interpretation in the street scene and its historical context.

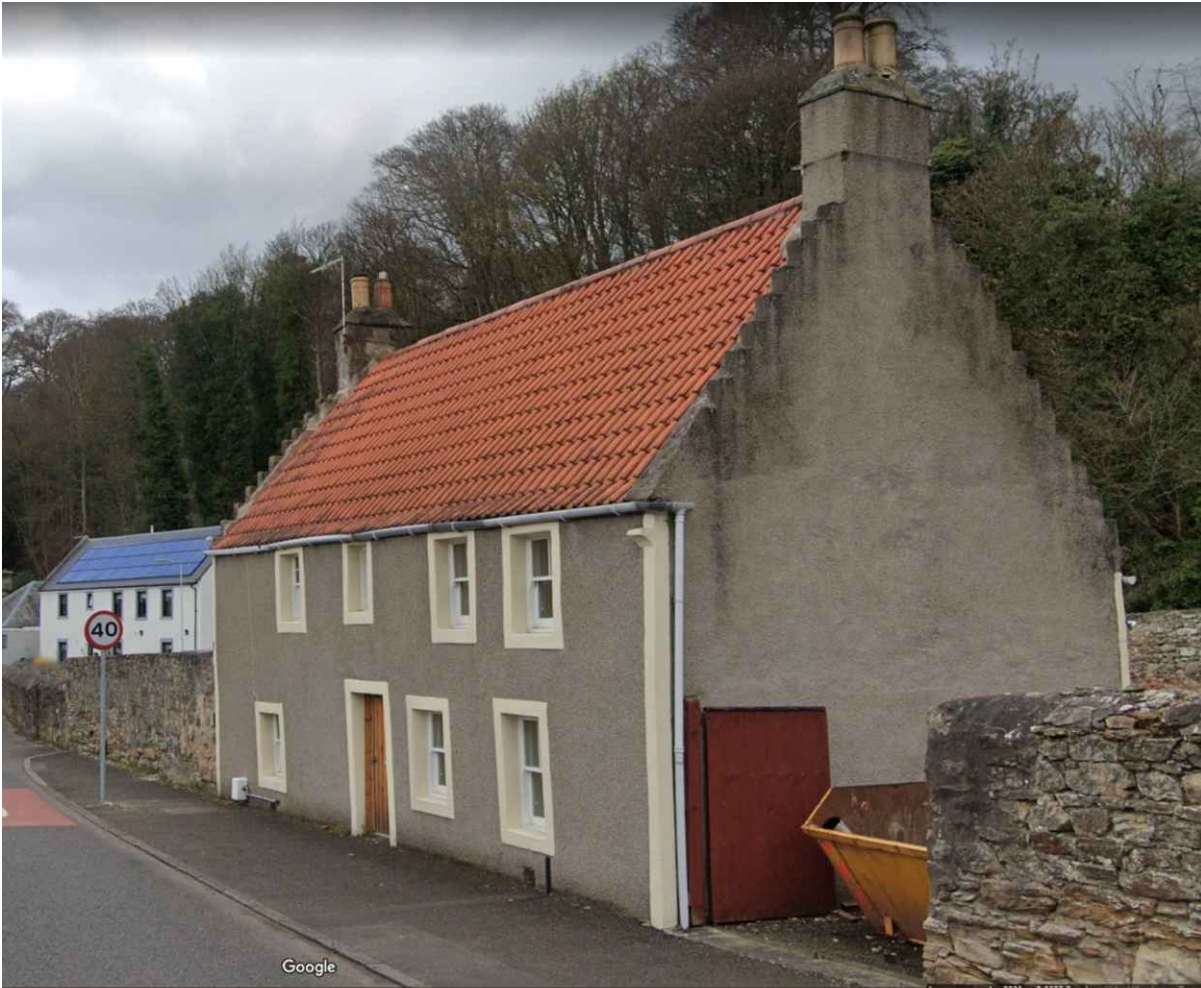
Image of 1 Main Street, 2023, Google Maps

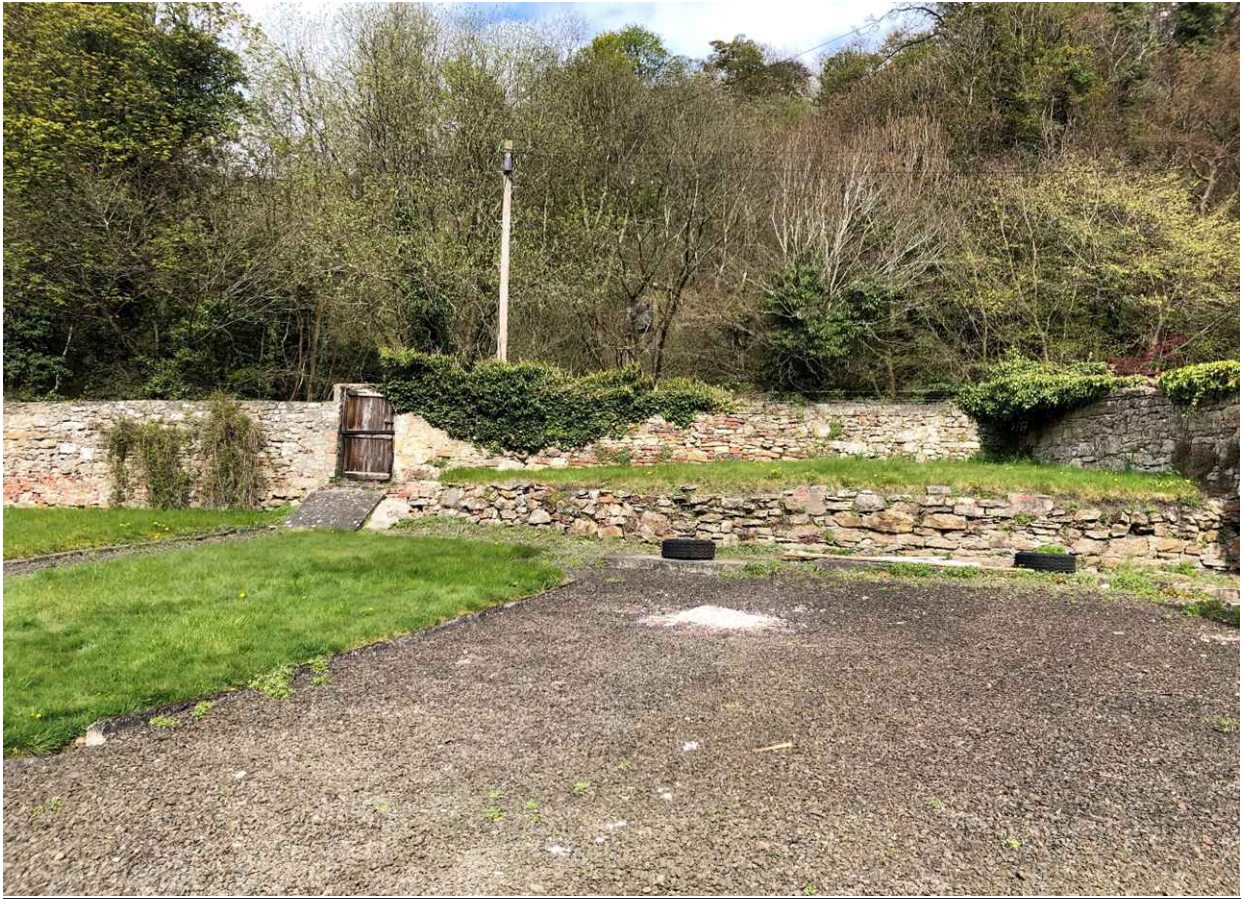
View of the property looking to the north boundary wall showing change in elevation of the property to the north boundary wall

As the site photographs show, the building is clearly visible from the west and the south, however the changing elevation of Low Causeway heading east on the north of the property, and the height of the north boundary wall being 2.2m high, obscure the building from the road and pavement. Therefore, even although there is heightened visibility of the listed building, the rear of the property holds enough privacy to enable a modest extension and allow for a conversion of the existing listed building. As the property is 0.27 Acres, and with the expansive garden area to the north and west of the cottage, there is ample space to develop this area without coming into conflict with Fife Council's policies on extensions and garden ground.

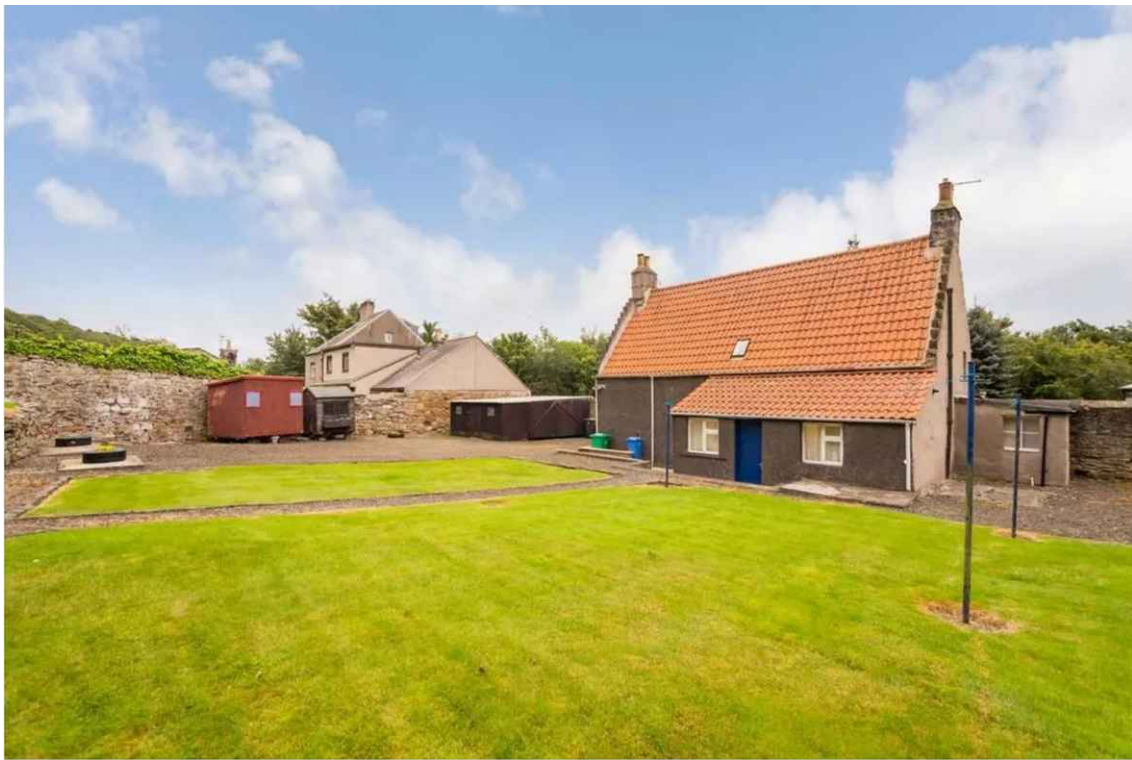
View of the north of Westend Cottage showing the location of the proposed extension

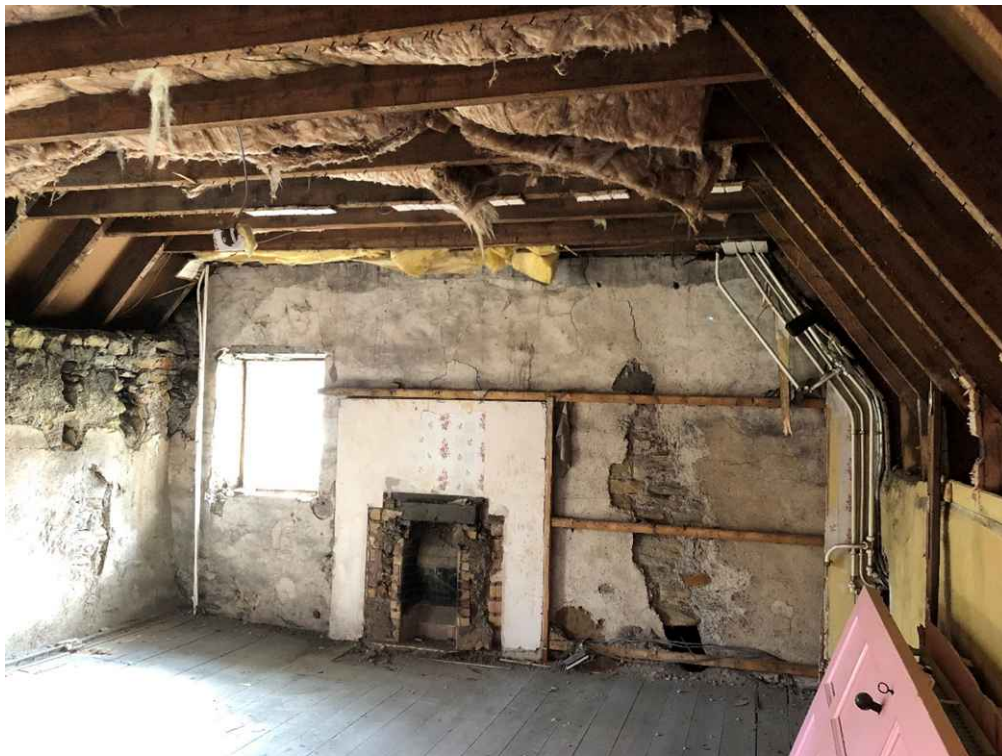
1st Floor west bedroom. Stripping back to original wall construction. Note holes in the wall on the south side and at floor level from the exposed ground floor flue.

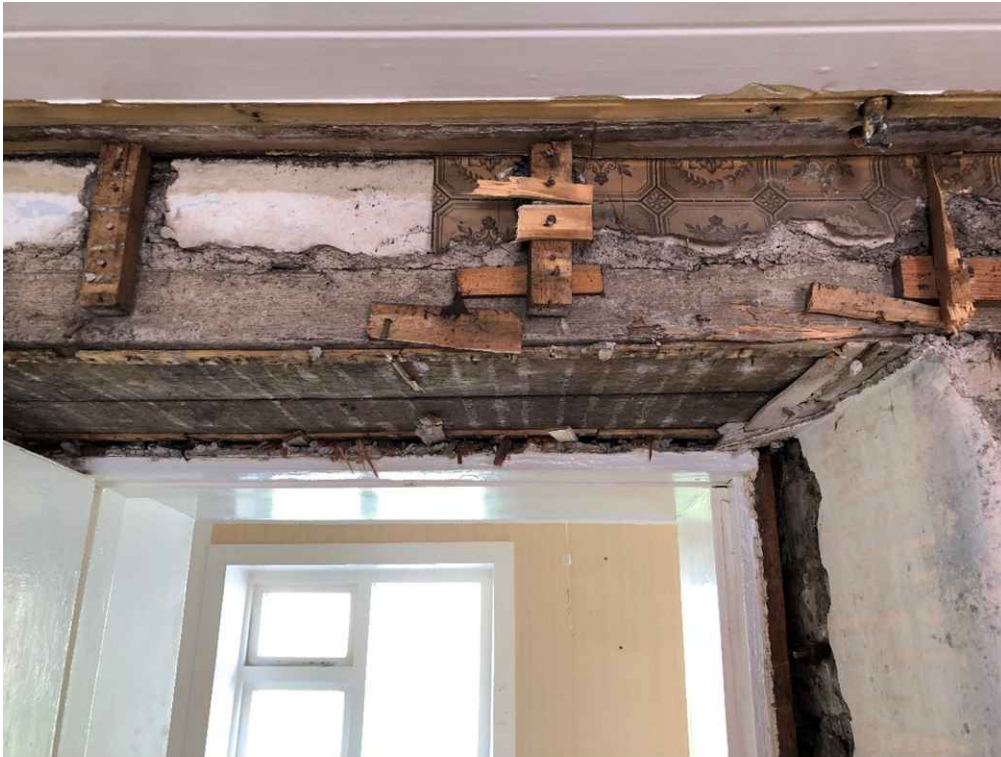
Doorway to kitchen showing timber lintel. This was not an original opening from the original cottage construction but was added in the Victorian period.

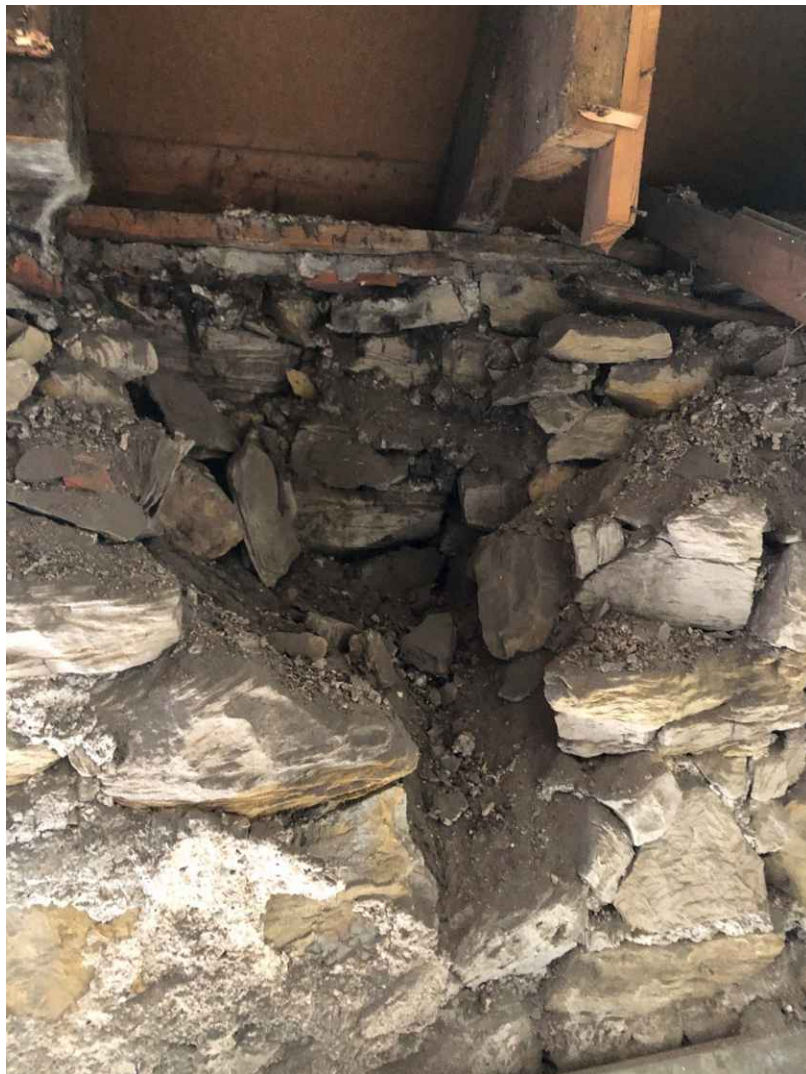
Huge hole in the first-floor south wall at the top of the wall head to the east of the front door. This area caused the roof to collapse during further renovation works. This was one of a number of voids discovered while work was ongoing.

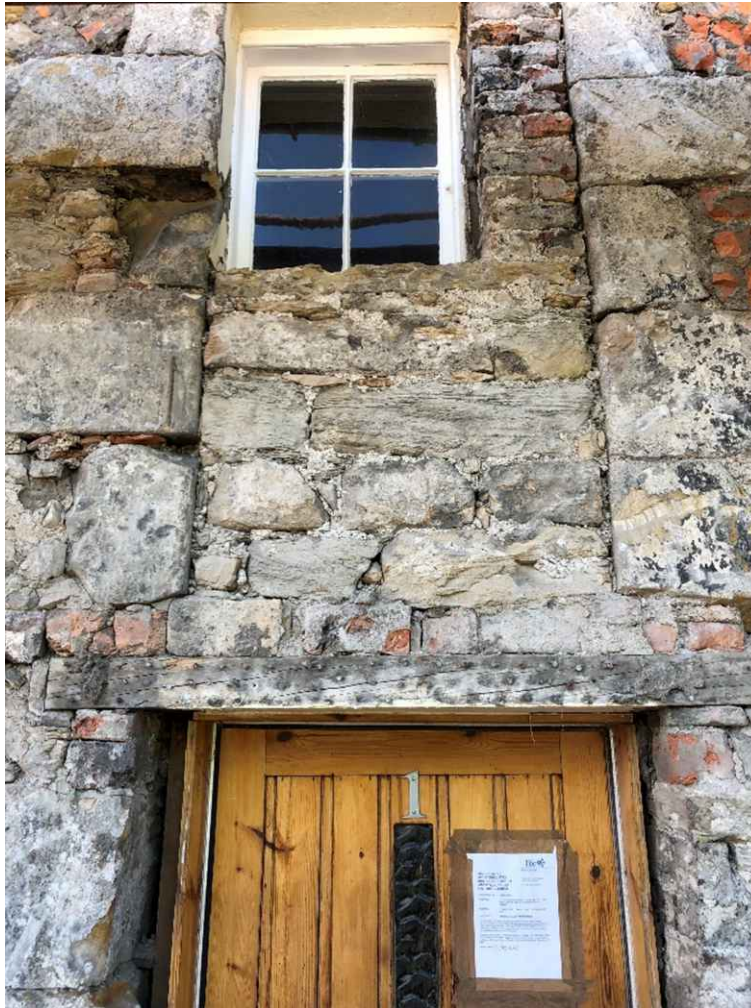
Quoined returns at the front door that show the building was once two distinct buildings. The quoins run down to grade

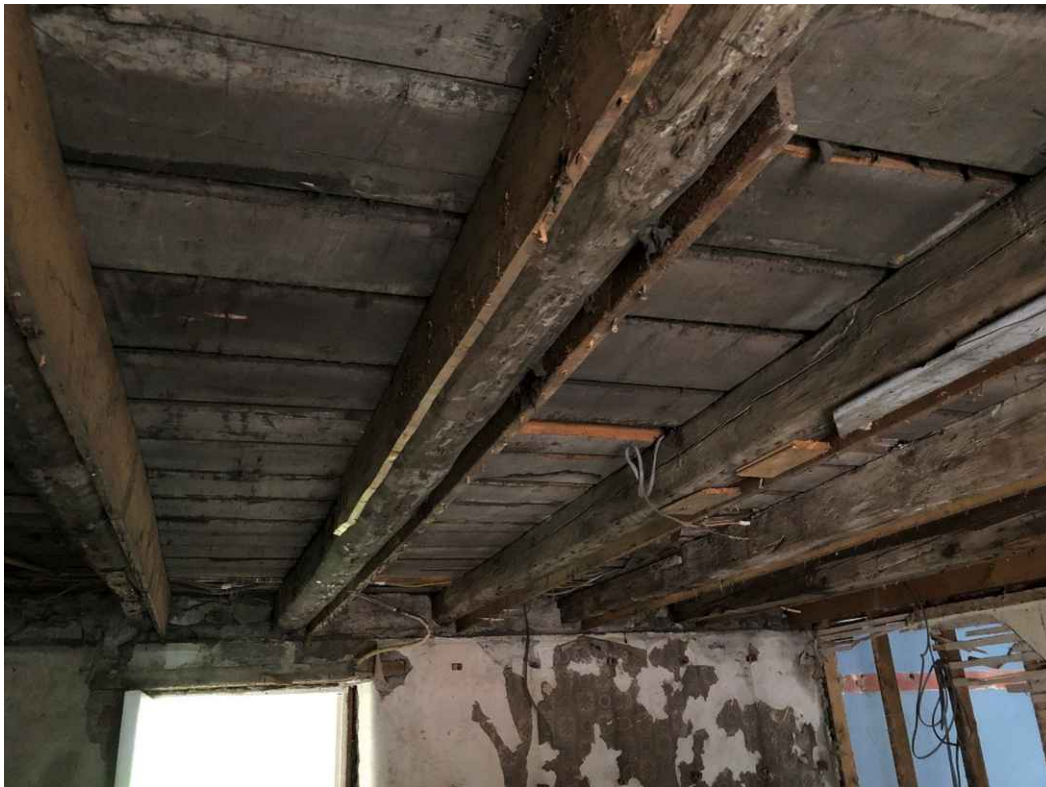
Sistered floor joists using 1" material. The floor joists were full of dry rot and had no load bearing capacity left. They had been sistered by timbers inadequate for their structural use and the resultant impact was a failure in structural integrity.

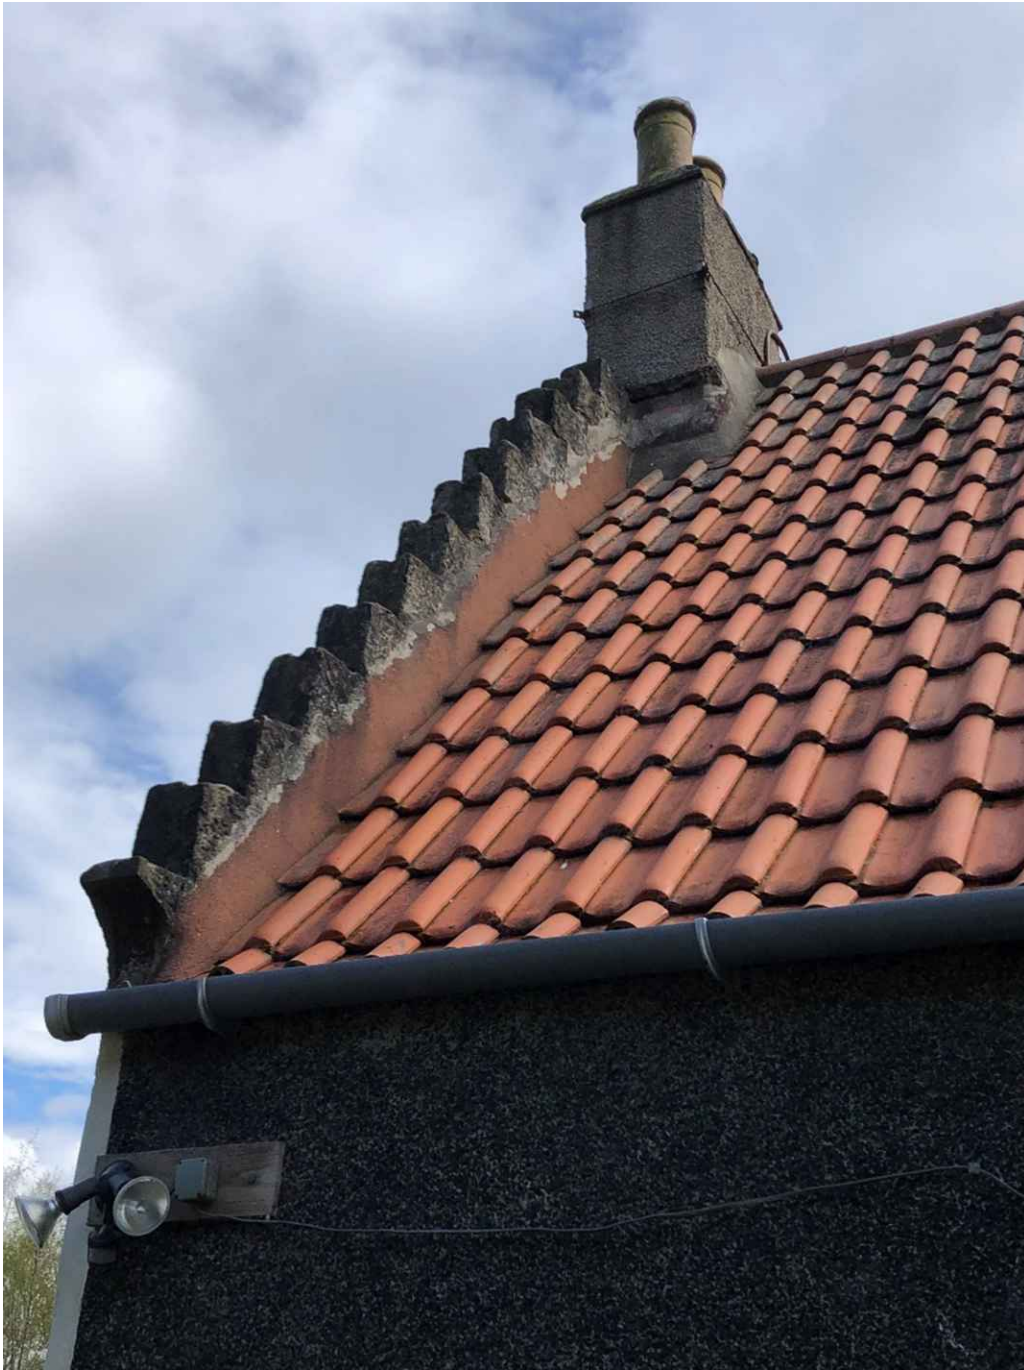
Change in roof line and pitch shown on north side at the east gable with cement flaring at the crowstep gable to make up the difference in the new roof line. This photo clearly shows the negative impact of the roof change in the 1980's without LBC and allowed water ingress into the roof space.

The change in roof form is also indicated clearly on the north and south rooflines at the gable and the intersection of the crowsteps. It is clear that the roof has been lowered on the north side and the pitch altered and raised on the south side.

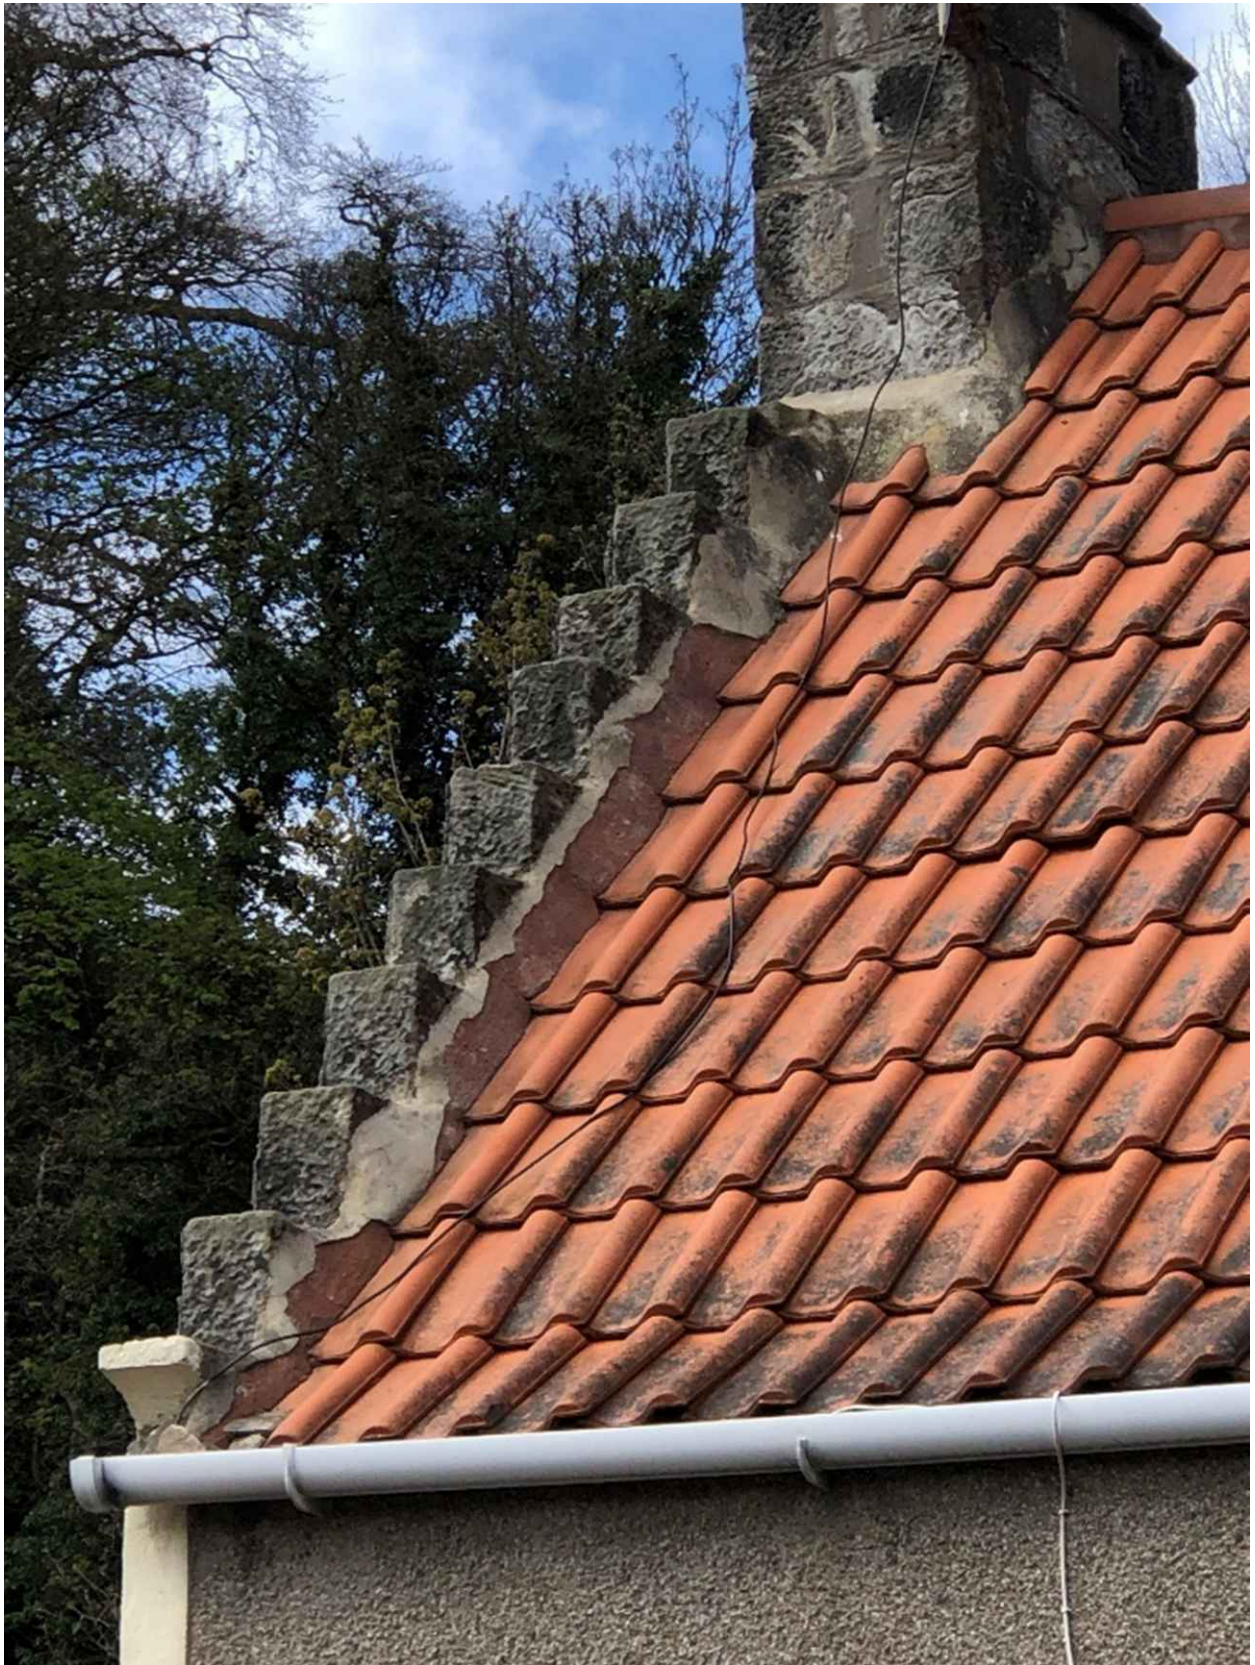
Change in roof line and pitch shown on south side at the west gable. The change of roof from the 1980's and poor workmanship at the crowstepped gable is clear.

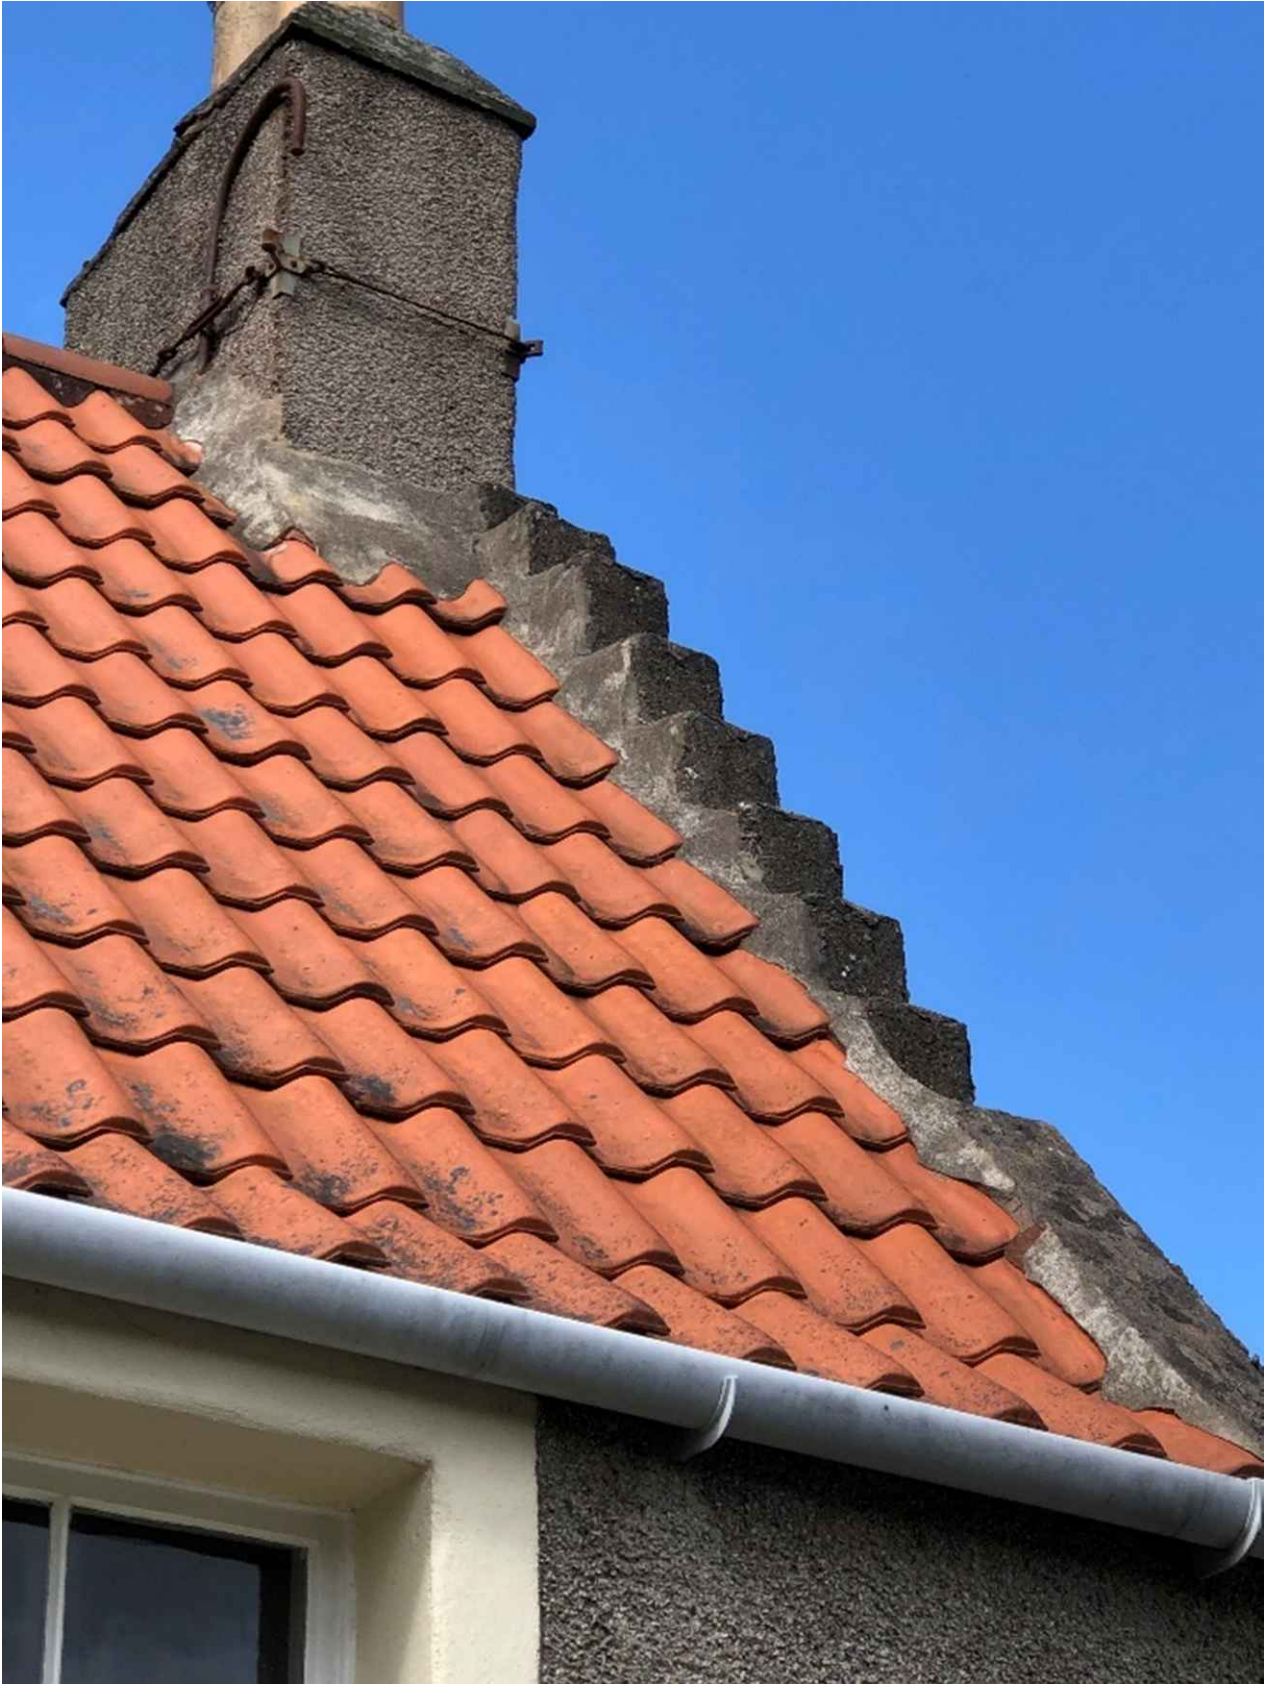
Change in roof line and pitch shown on south side at the east gable where the lower crowstepped stones have been covered in cement to smooth out the pitch

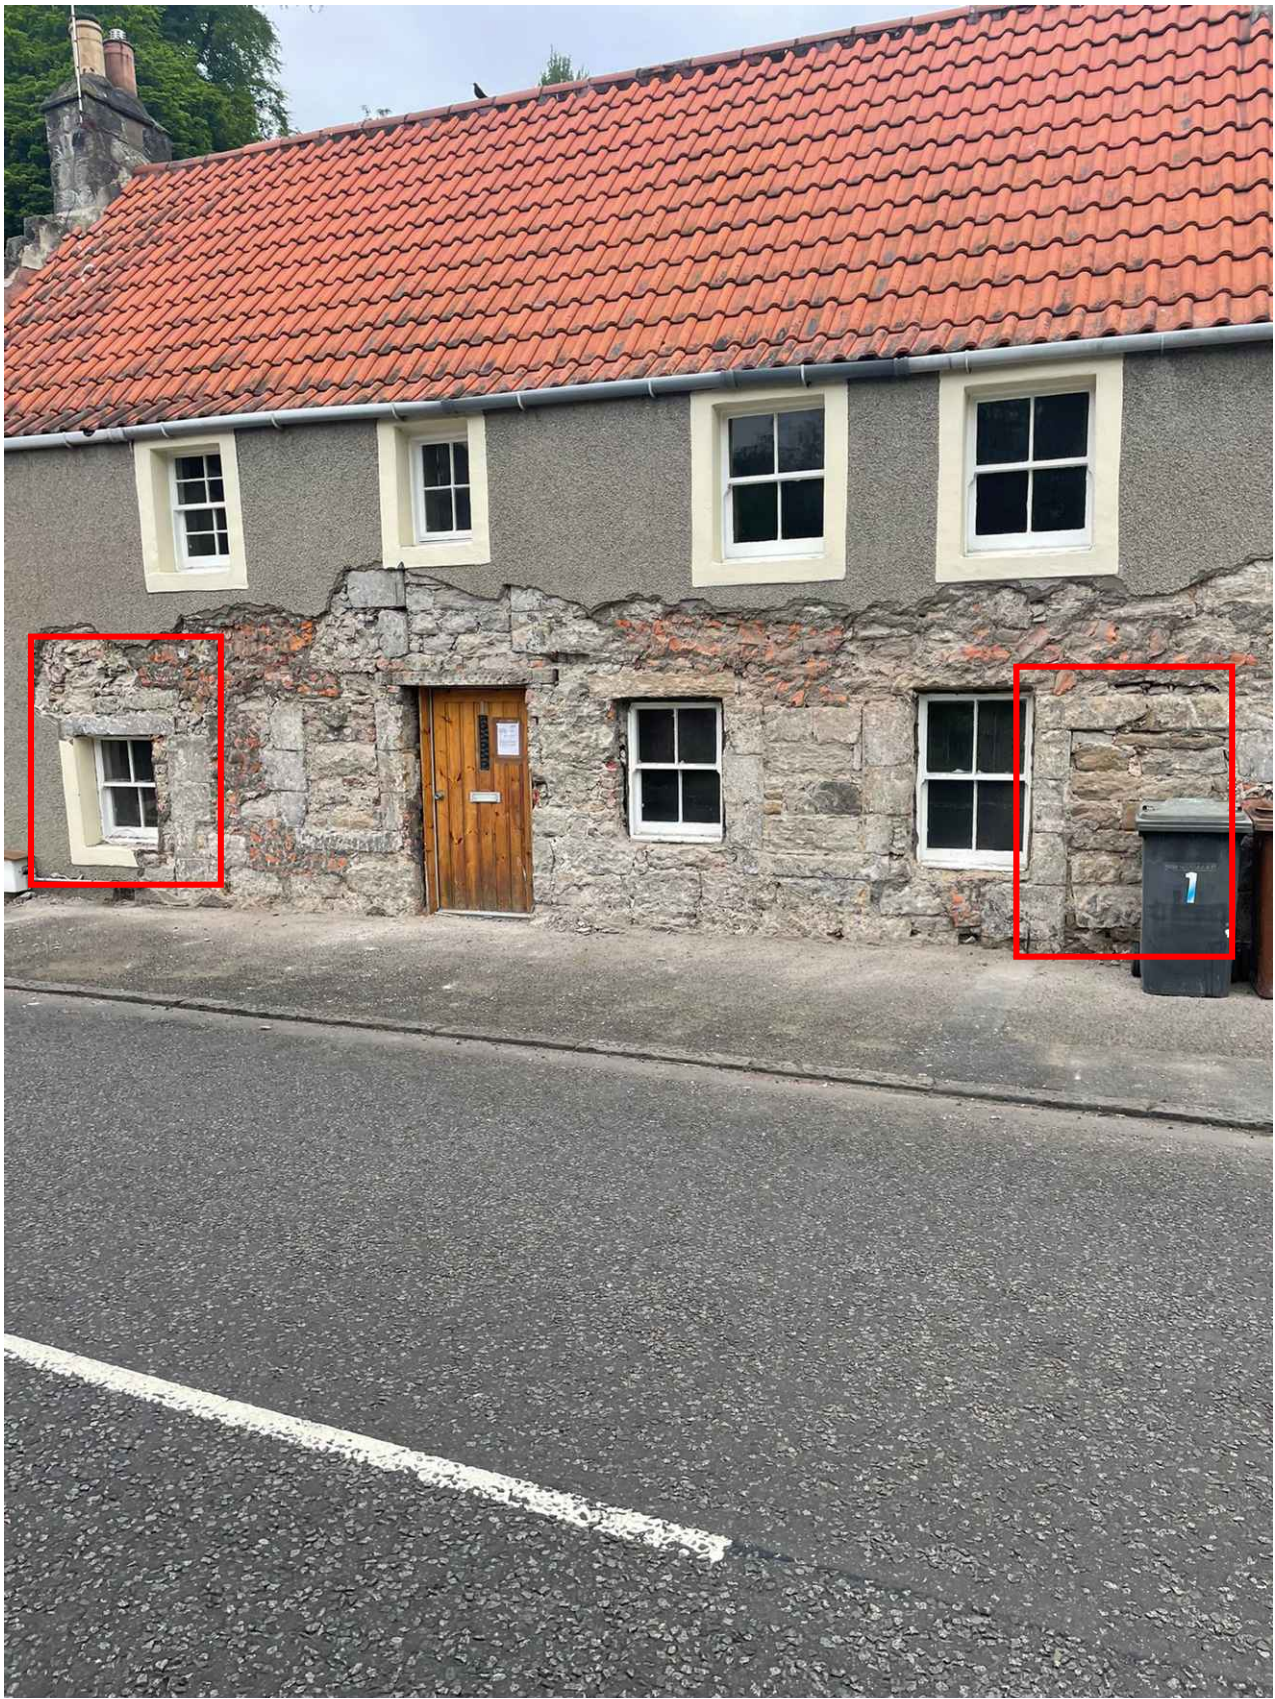
Lower render being removed from south elevation showing the original entrance on the east side and the original entrance shown on the west side of the south elevation

Upon removing the exterior cement render, which was in places 30-40mm thick, vernacular rubble sandstone construction was revealed with a large number of areas of the wall filled with the original pantiles, brick ends and cement. There were three original openings revealed that had been filled in and changed over the course of the building's history, that are delineated by quoined detailing and stone cills and lintels. There are also a number of new openings that have been created over time that have no stone detailing which also show a change over time of the property. On the ground floor, the two original doors were revealed, one to the east close to the east gable and one to the west mid-way between the existing entrance and the west gable.

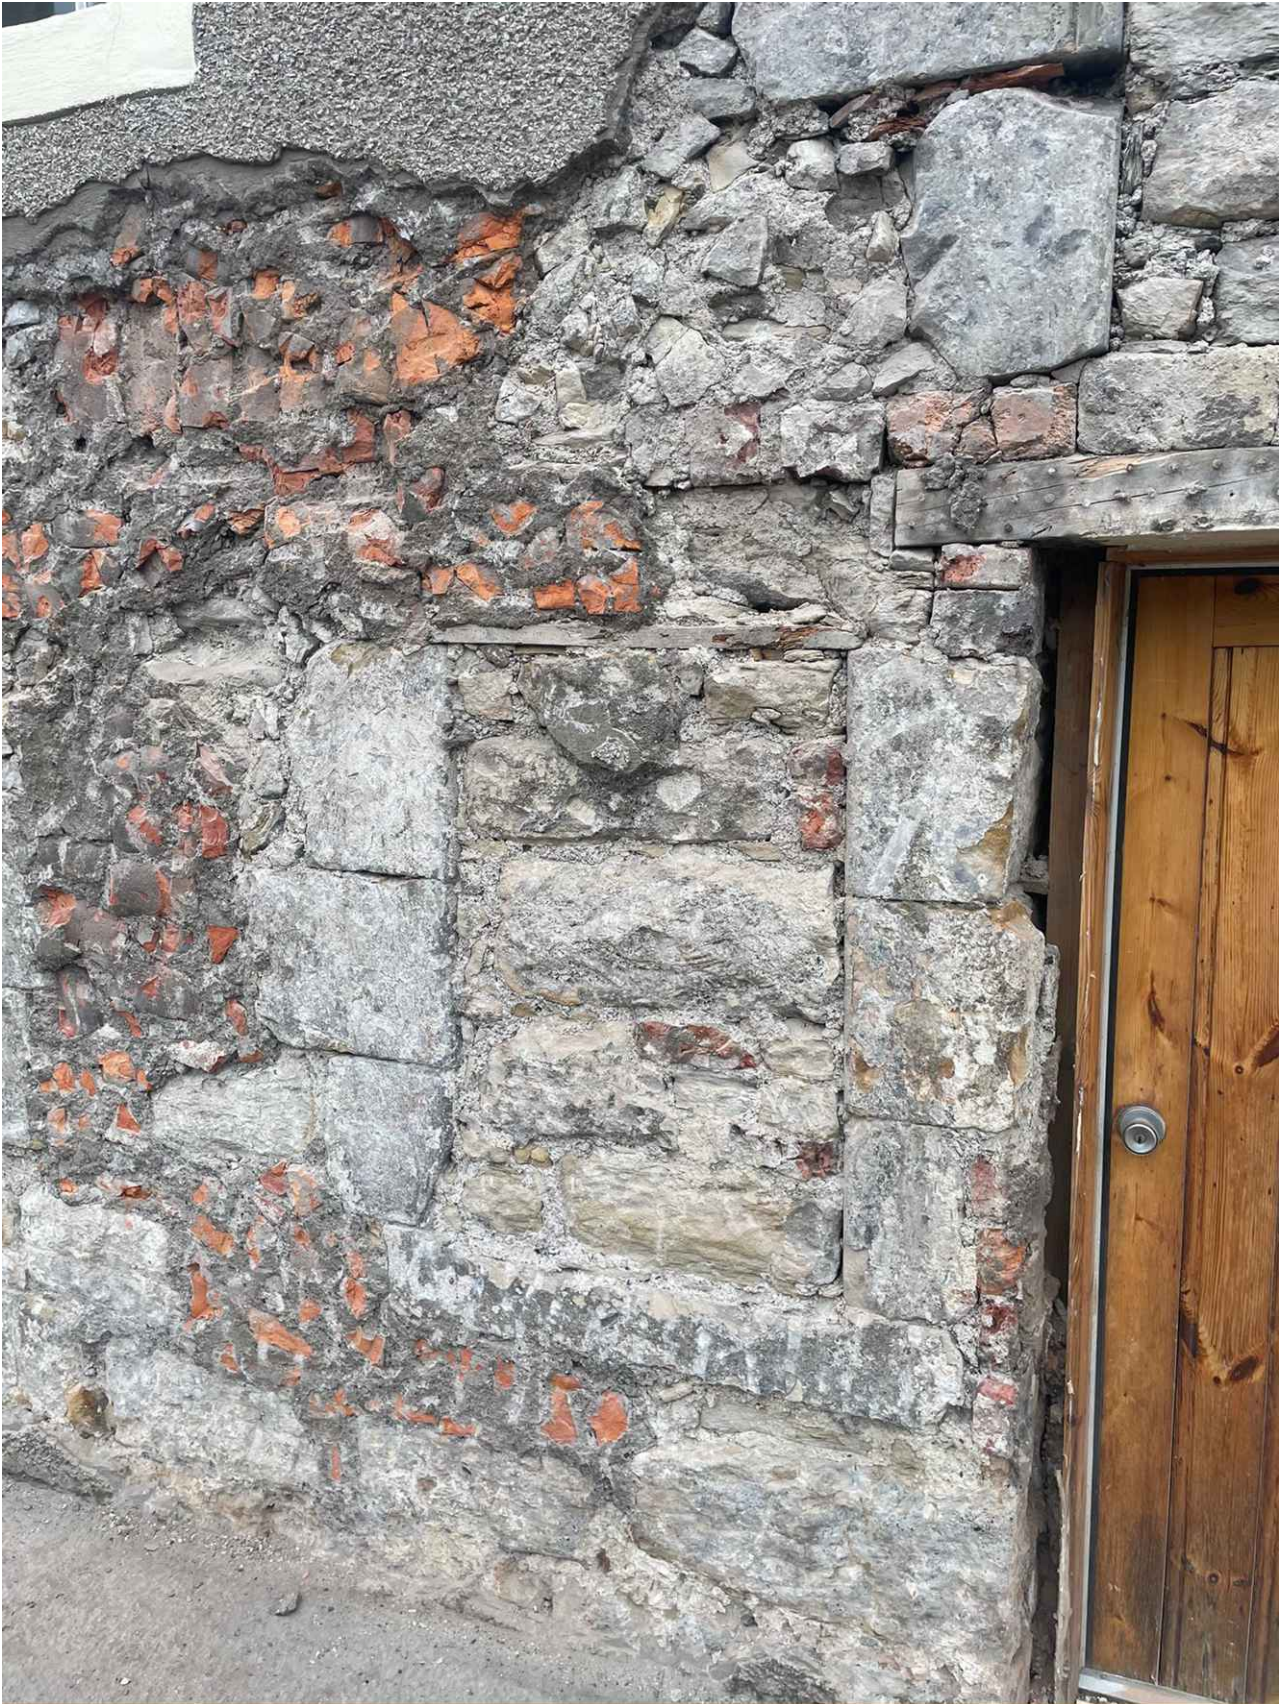
Original window filled in with sandstone to the west of the front door. Brick and cement infill to fill in gaps in the wall for the cement render applied in the 1960's.

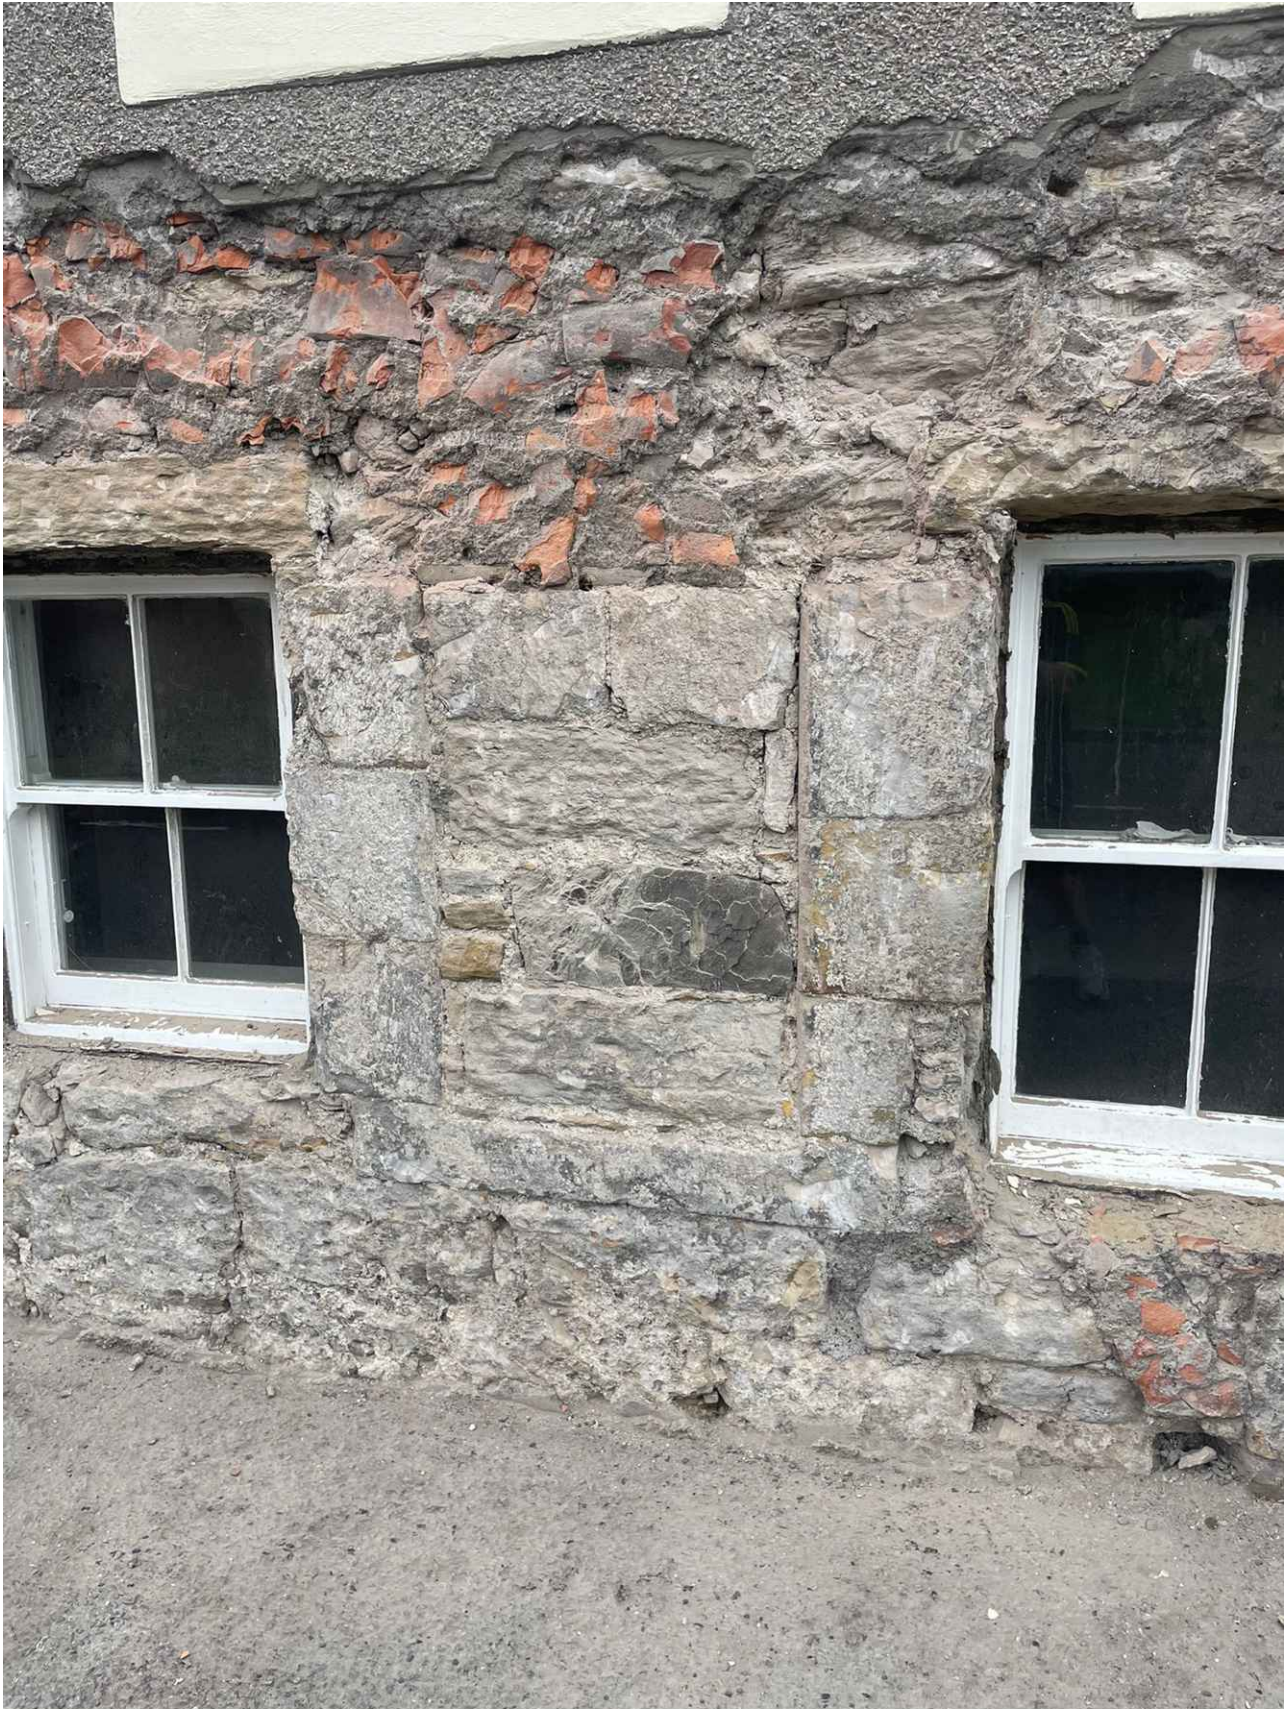
Original window on the west side of the south elevation filled in with sandstone. Brick and cement infill to fill in gaps in the wall for the cement render applied in the 1960's. The window opening adjacent to the original opening were added at a later date and the windows installed in the 1980's.
