UPDATED SUPPORTING STATEMENT FOR PLANNING APPLICATION SUBMISSION FOR WESTEND COTTAGE, 1 MAIN STREET, LOW VALLEYFIELD, KY12 8TF

Introduction

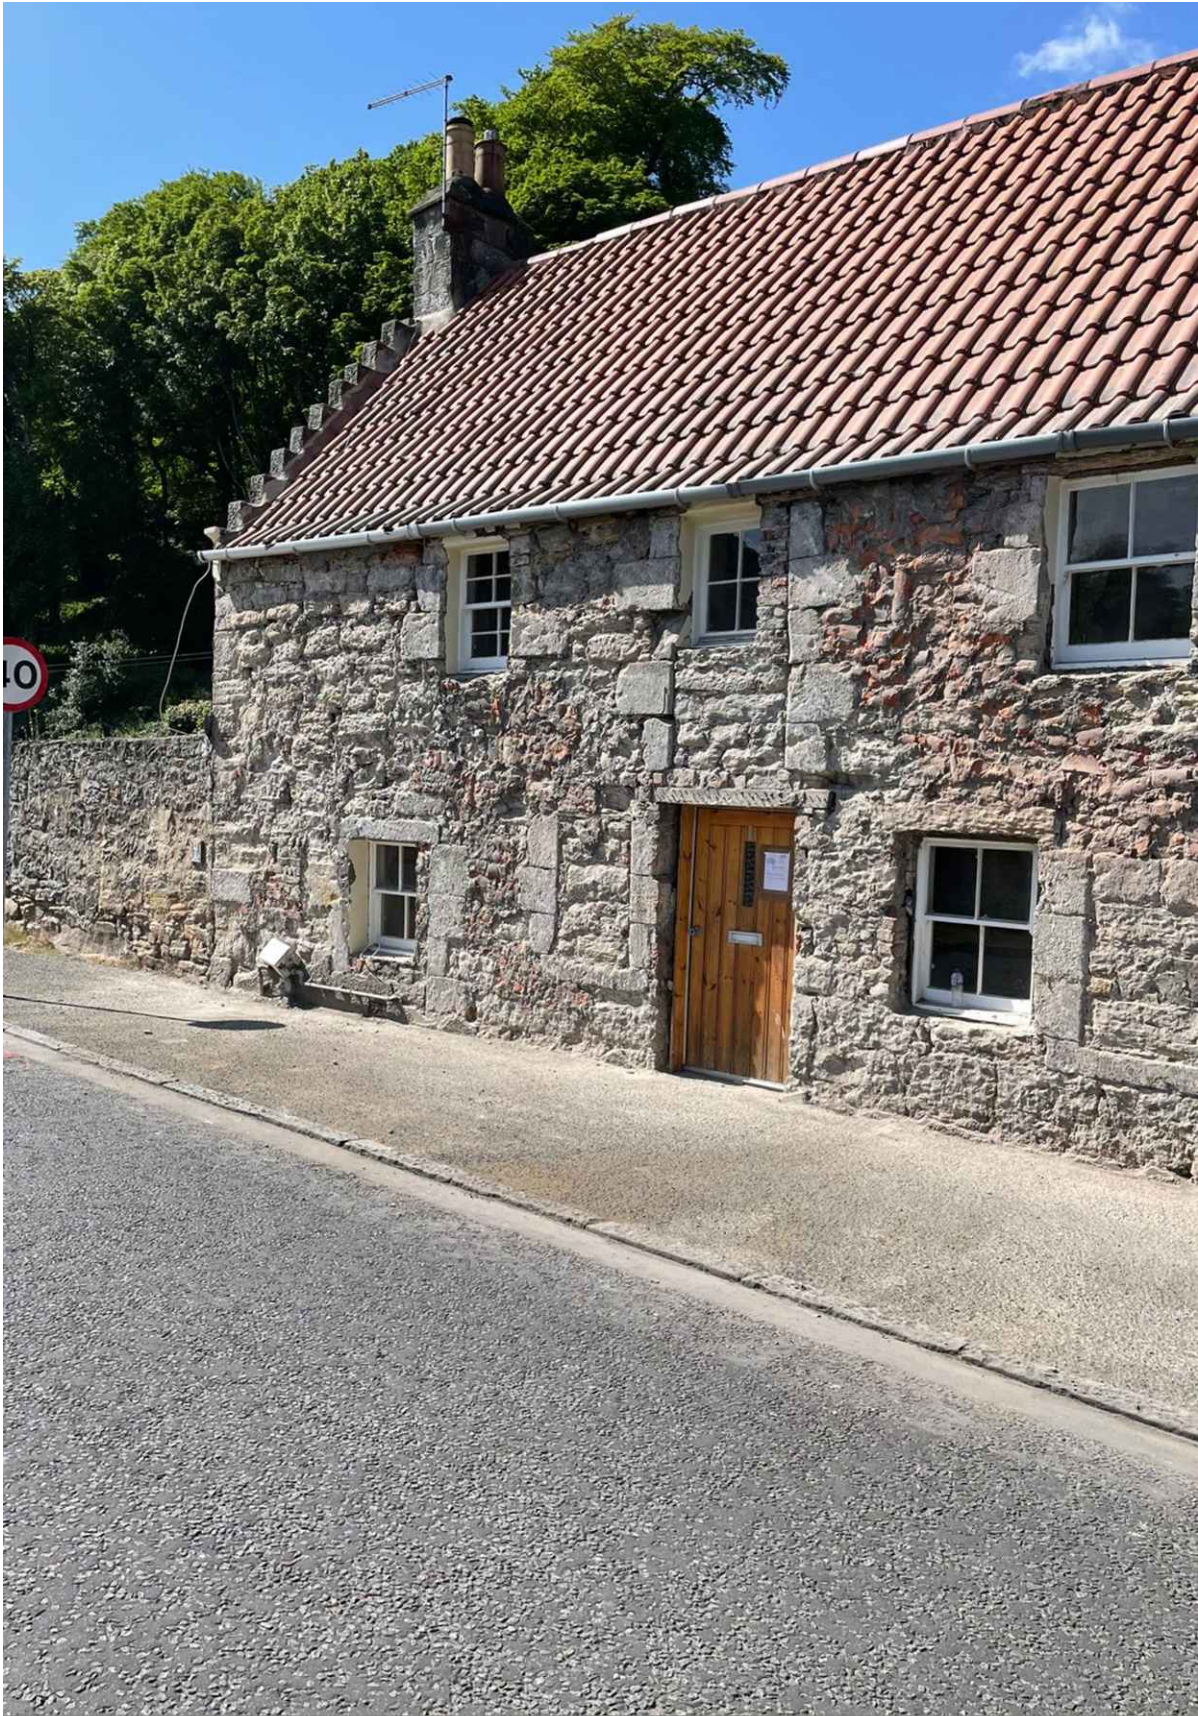
Original windows filled in with sandstone, either side of the front door. Quoins above the entry showing the infilled pend that once separated the two buildings. Brick and cement infill to fill in gaps in the wall for the cement render applied in the 1960's.

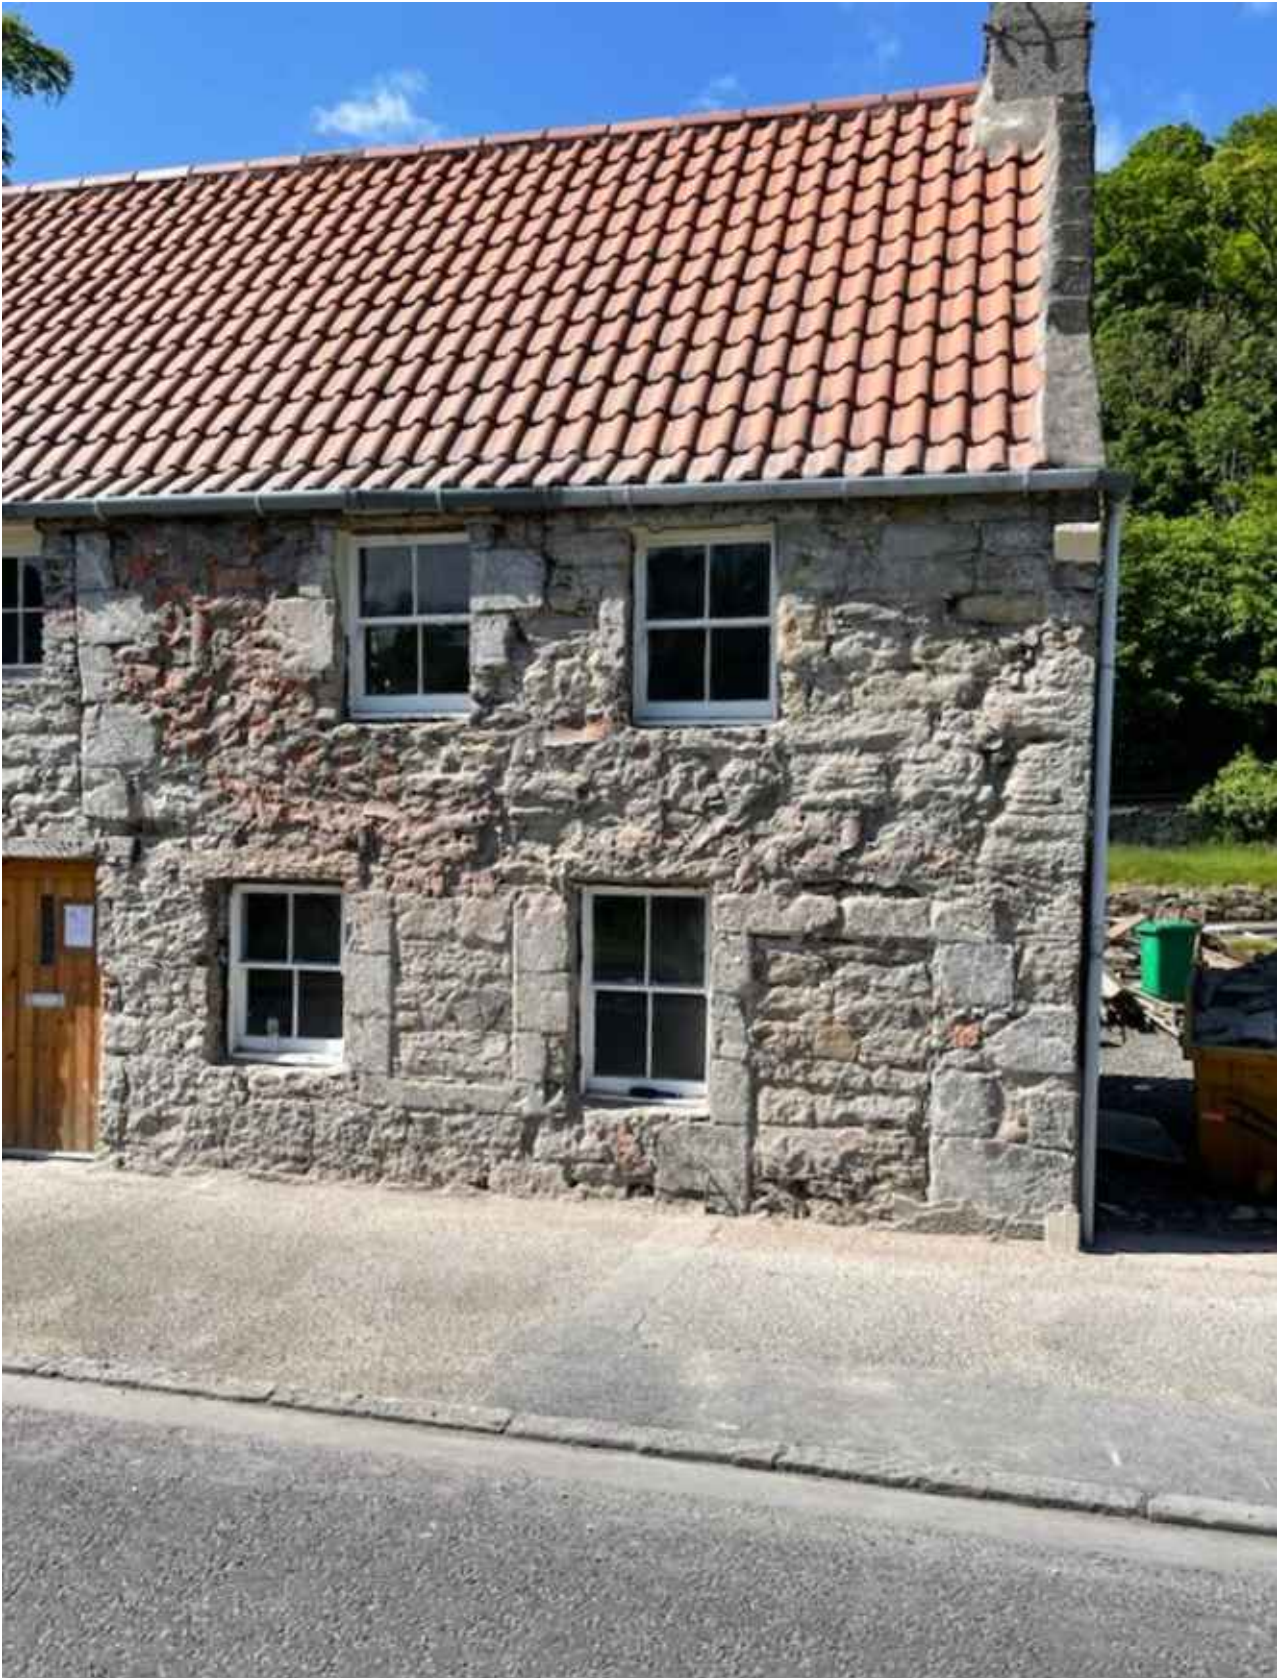
Original windows filled in with sandstone, either side of the front door. Quoins above the entry showing the infilled pend that once separated the two buildings. Brick and cement infill to fill in gaps in the wall for the cement render applied in the 1960's. The low skewput on the east side shows the change in the level of the wall for the new roof. There is also extensive damage to the sandstone from water and moisture impact.

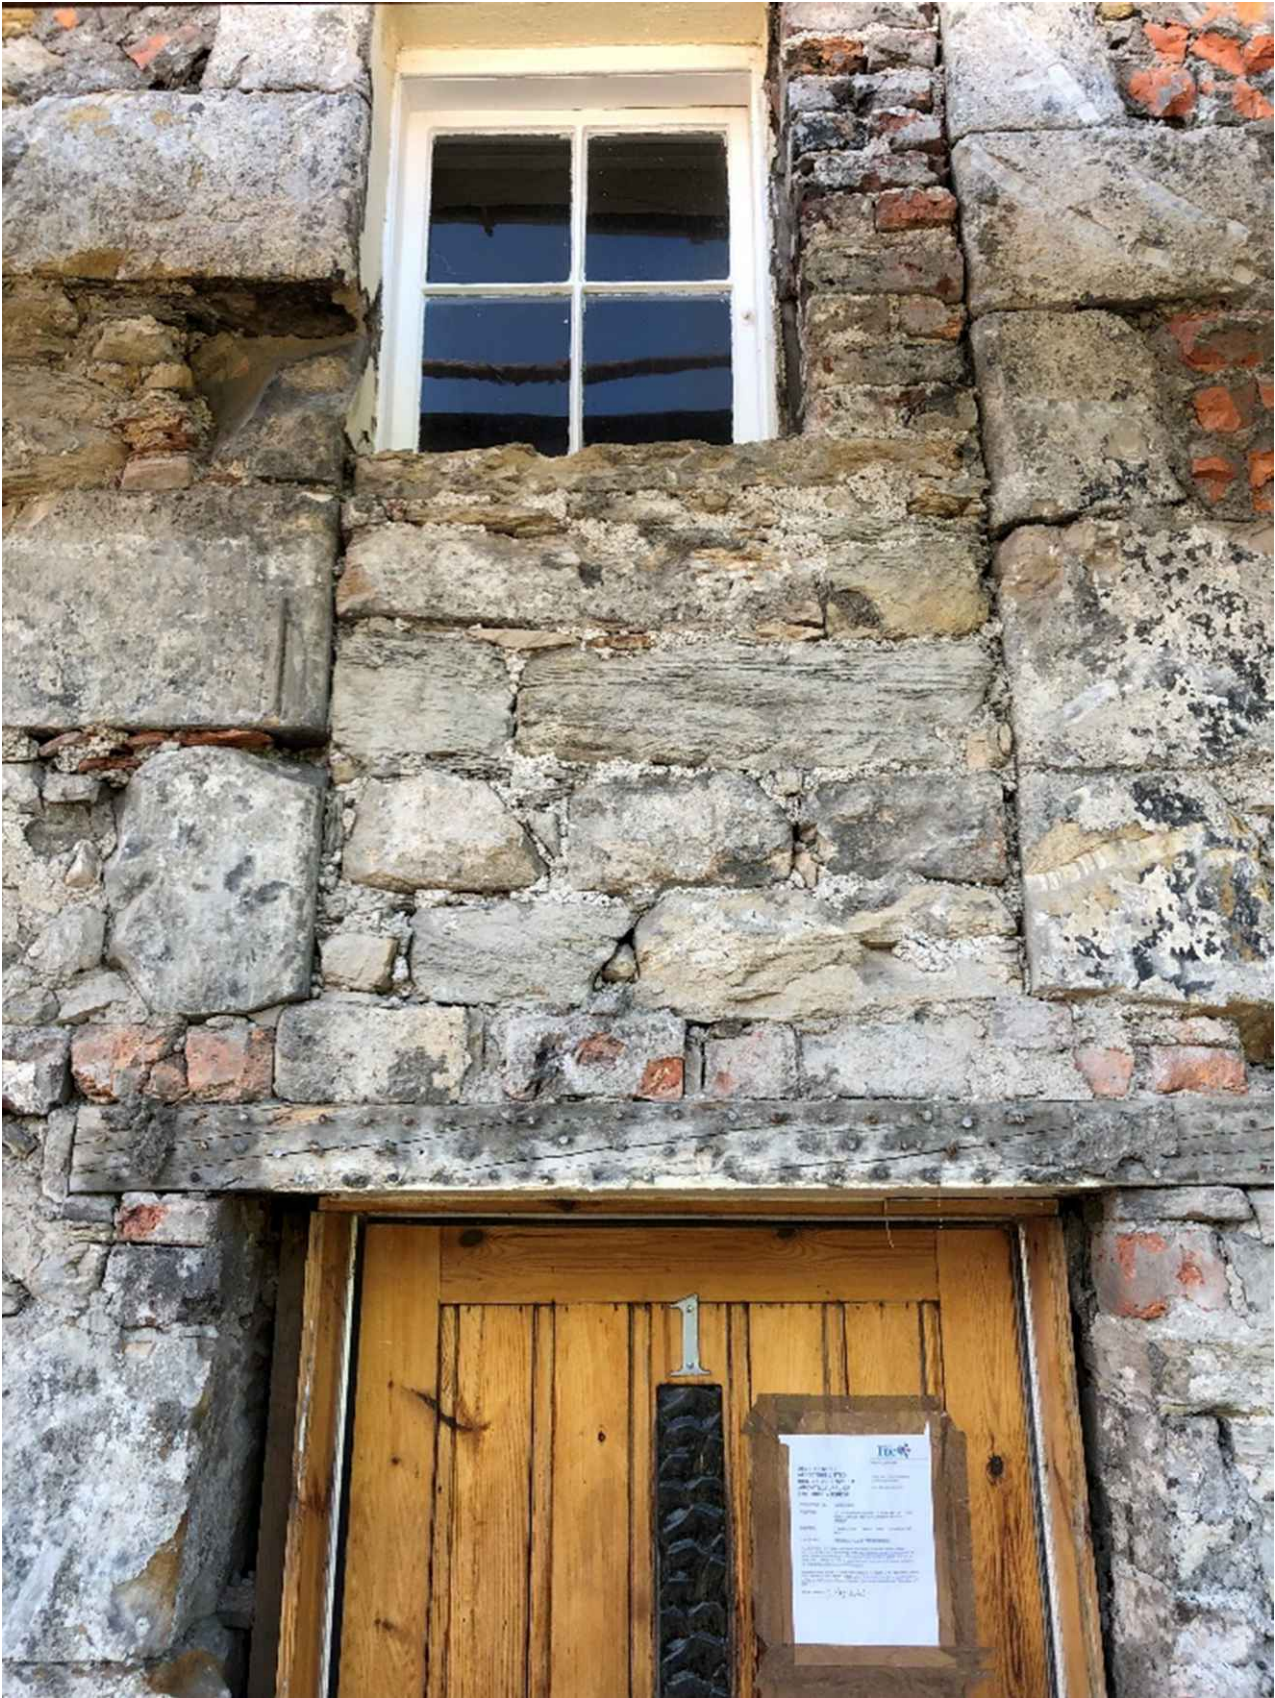
Figure 1: Quoined returns at the front door that show the building was once two distinct buildings. The quoins run down to grade

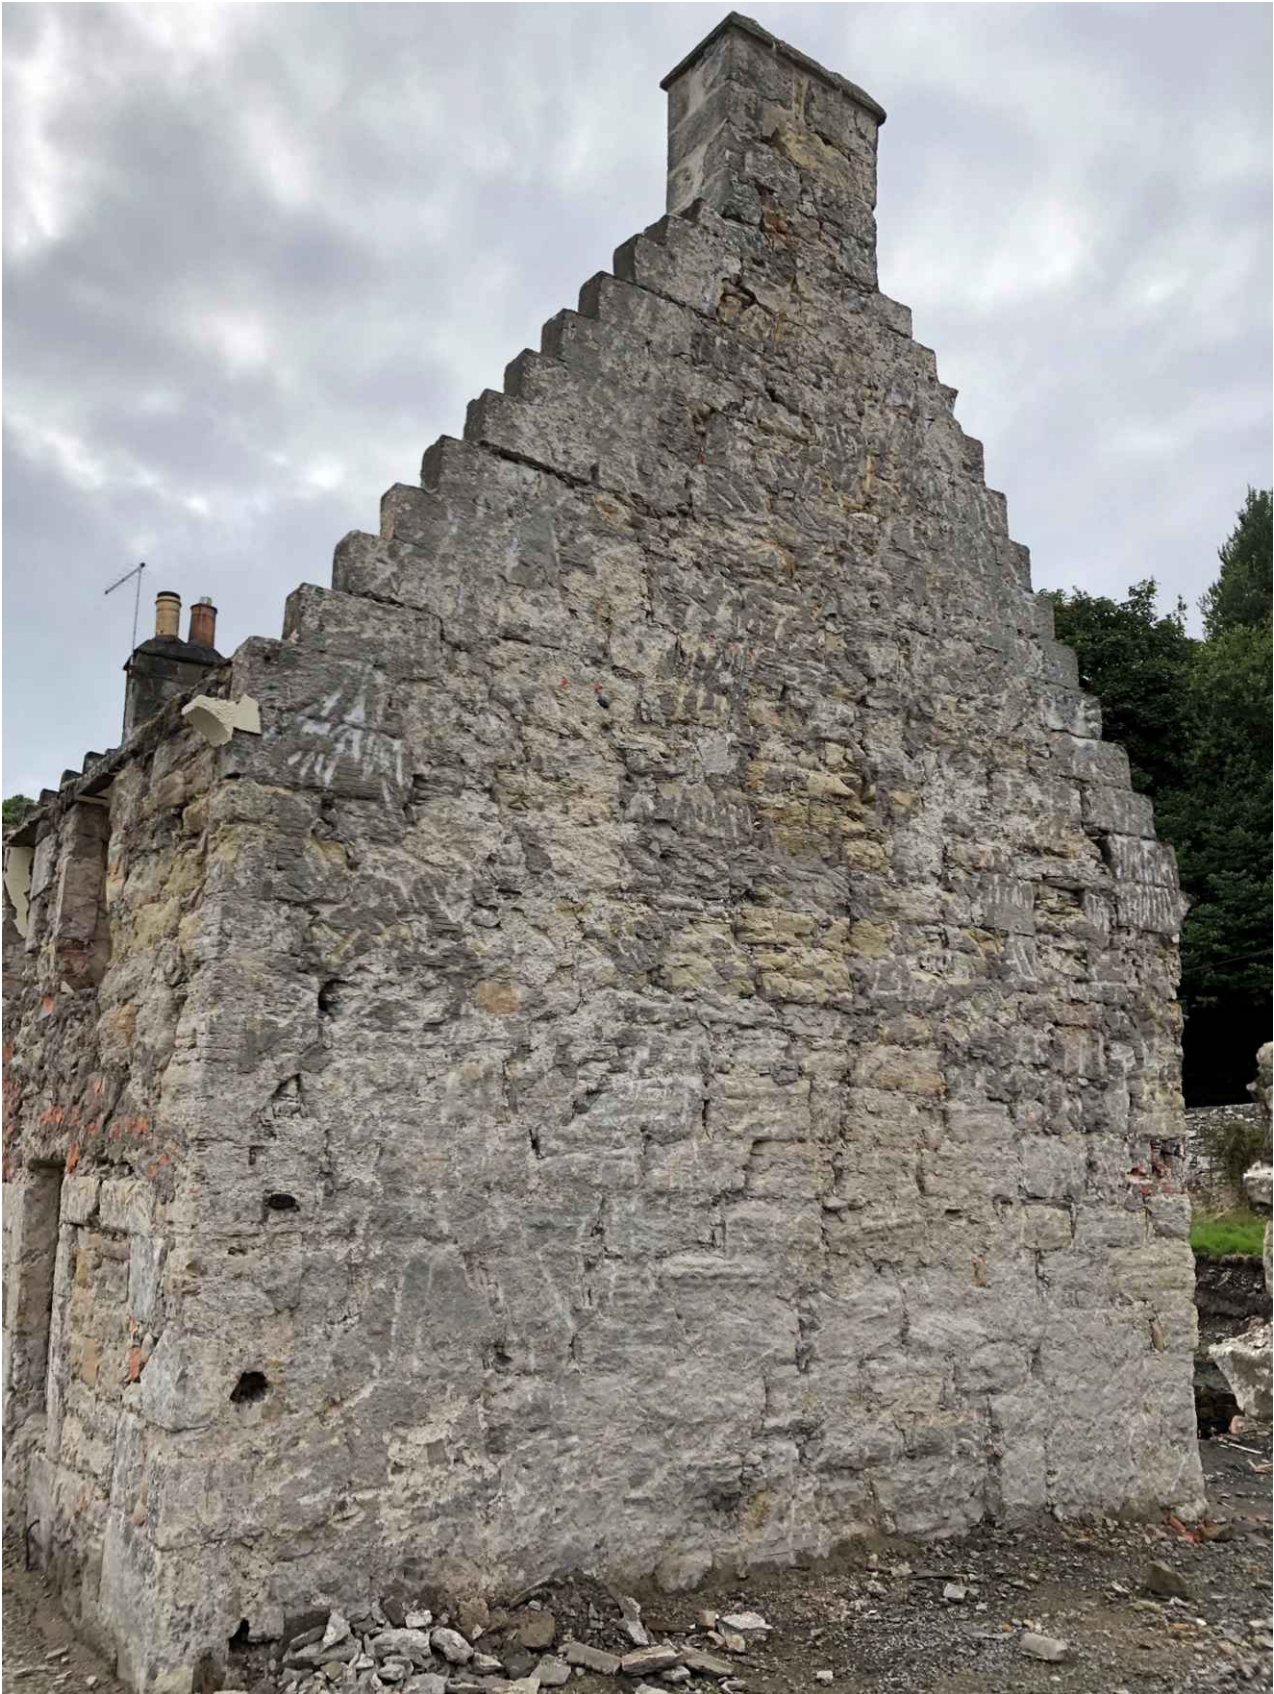
Figure 2: East gable showing original wall construction and skew puts at the same height indicating a typical symmetrical roof and building form. This gable also shows the impact of high moisture content within the walls.

The eastern building had a lower wall height, the roof was also lower and of an equal pitch each side, which is shown by the equal height of the skew puts on the eastern gable. The western building had a higher wall with an asymmetrical roof pitch which is clearly identified by the skew puts at the western gable being higher than those of the eastern gable and the southern skew put being higher than the northern one. The skew puts are in their original location as they are each individually carved from one piece of stone and the crow stepped gable begins with the skew put stone location.

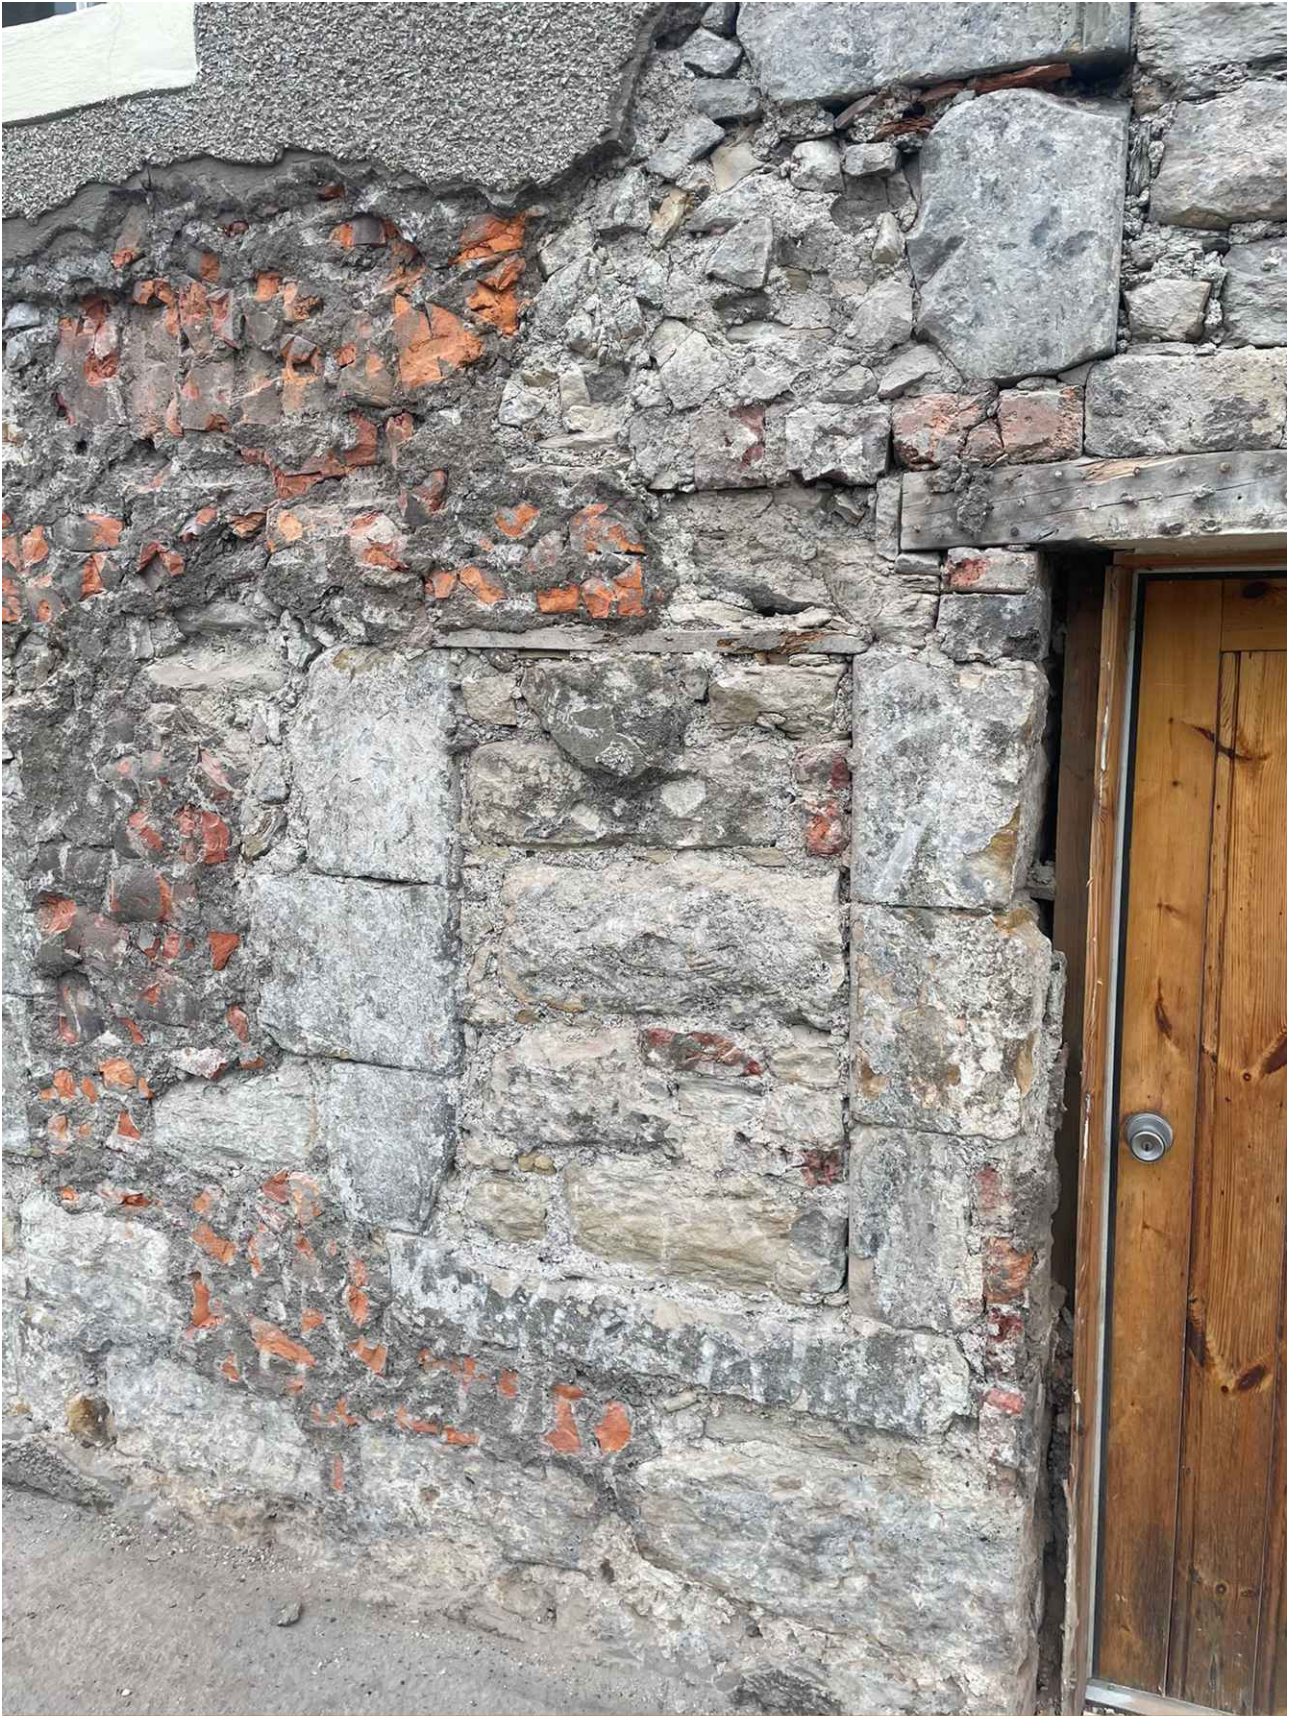
Figure 3: Original window filled in with sandstone to the west of the front door. Brick and cement infill to fill in gaps in the wall for the cement render applied in the 1960's

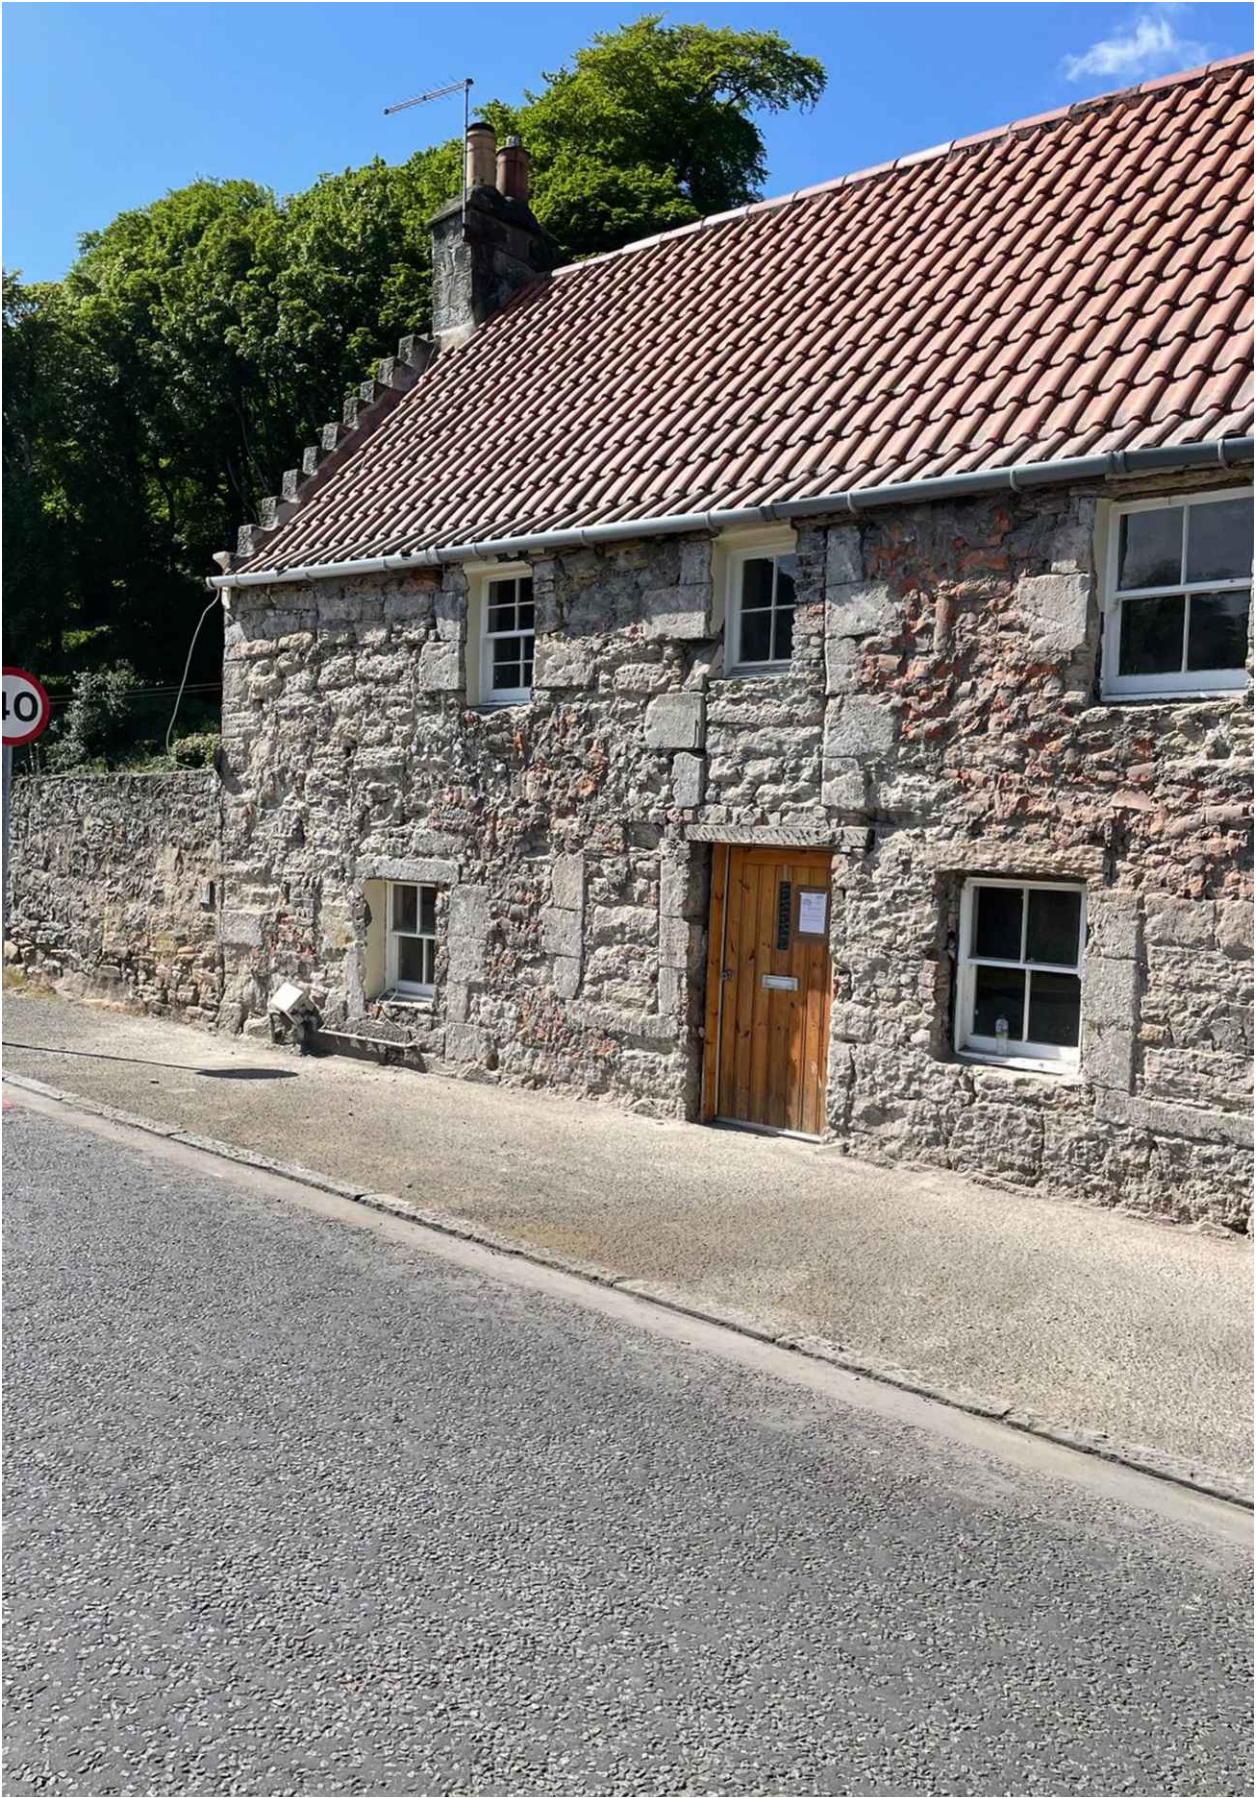
Figure 4: Original windows filled in with sandstone, either side of the front door. Quoins above the entry showing the infilled pend that once separated the two buildings. Brick and cement infill to fill in gaps in the wall for the cement render applied in the 1960's

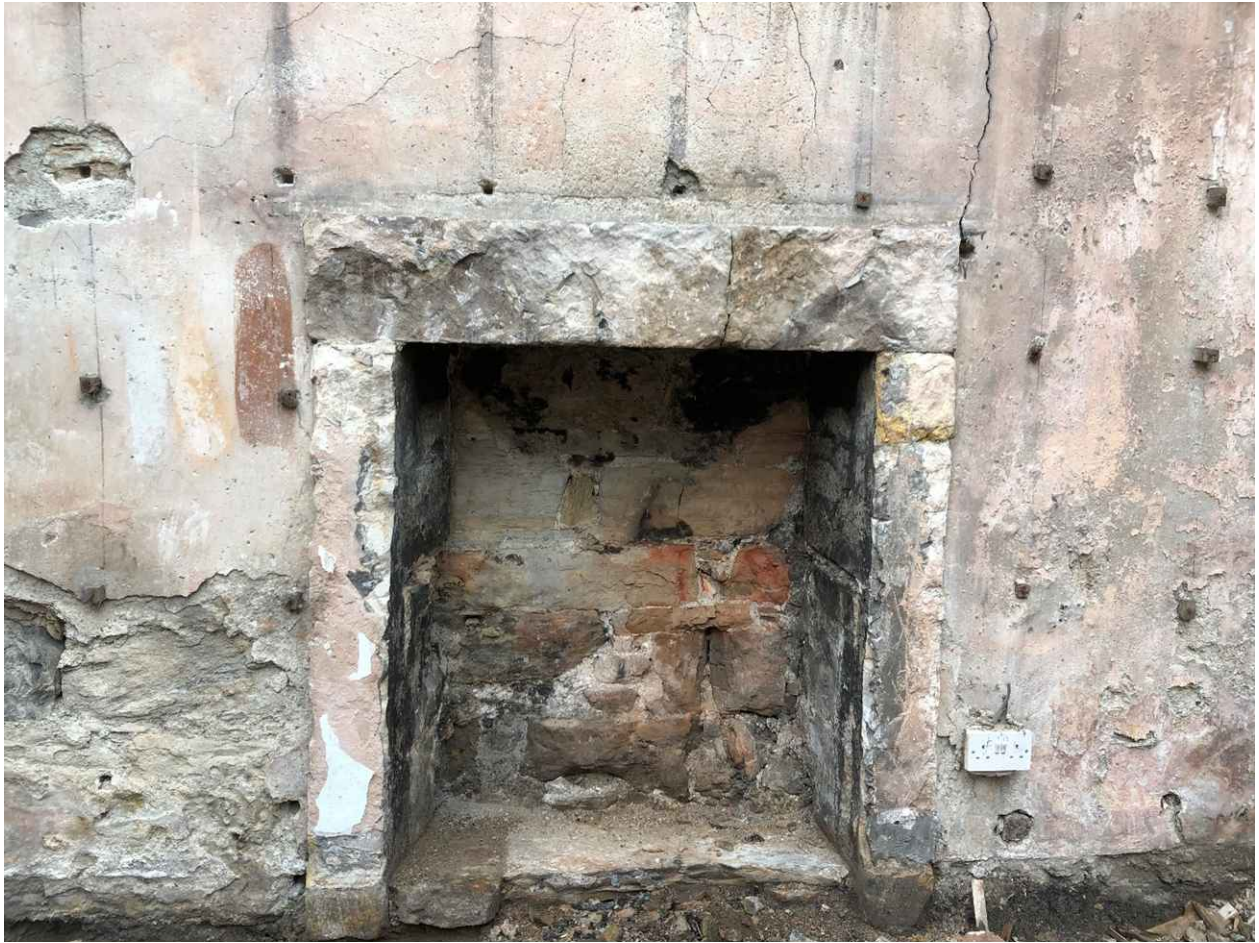
Original fireplace on the east gable exposed. Two stone columns and a stone lintel are clearly visible. These will be retained and be a feature of the renovated property.

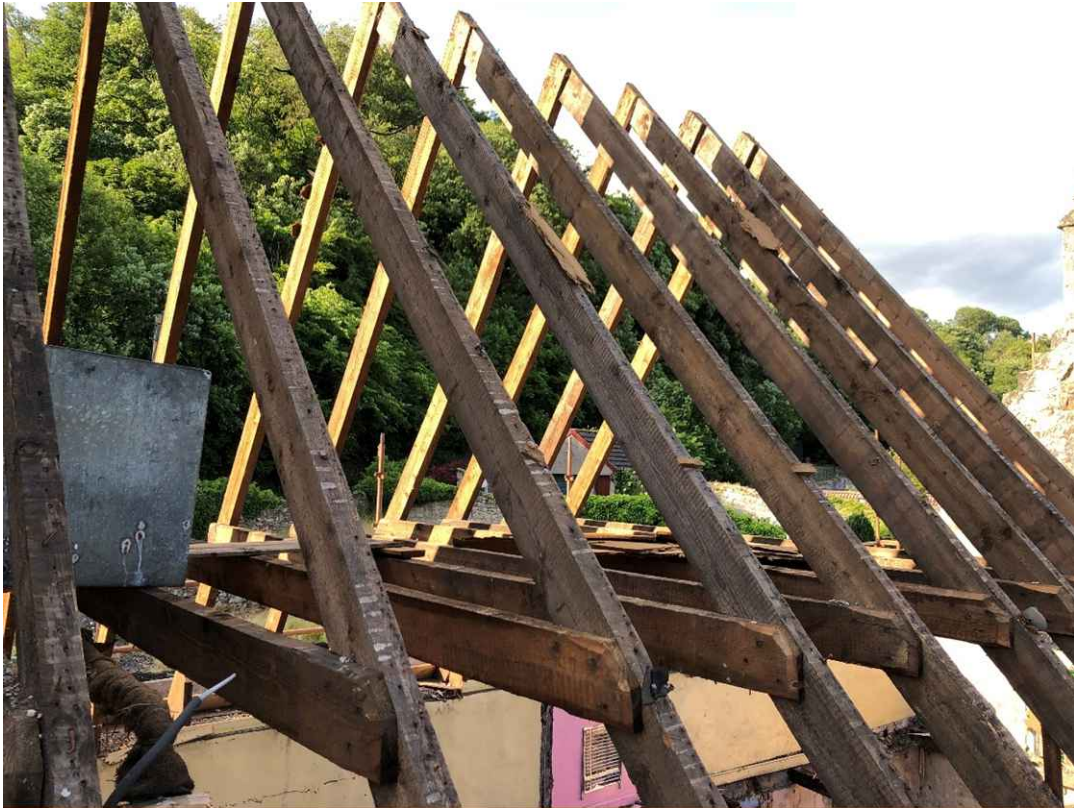
Exposed rafters after 1980's pantiles and substructure were removed post roof collapse. This was conducted outside LBC but was necessitated by health and safety concerns and the structural integrity of the exterior walls.

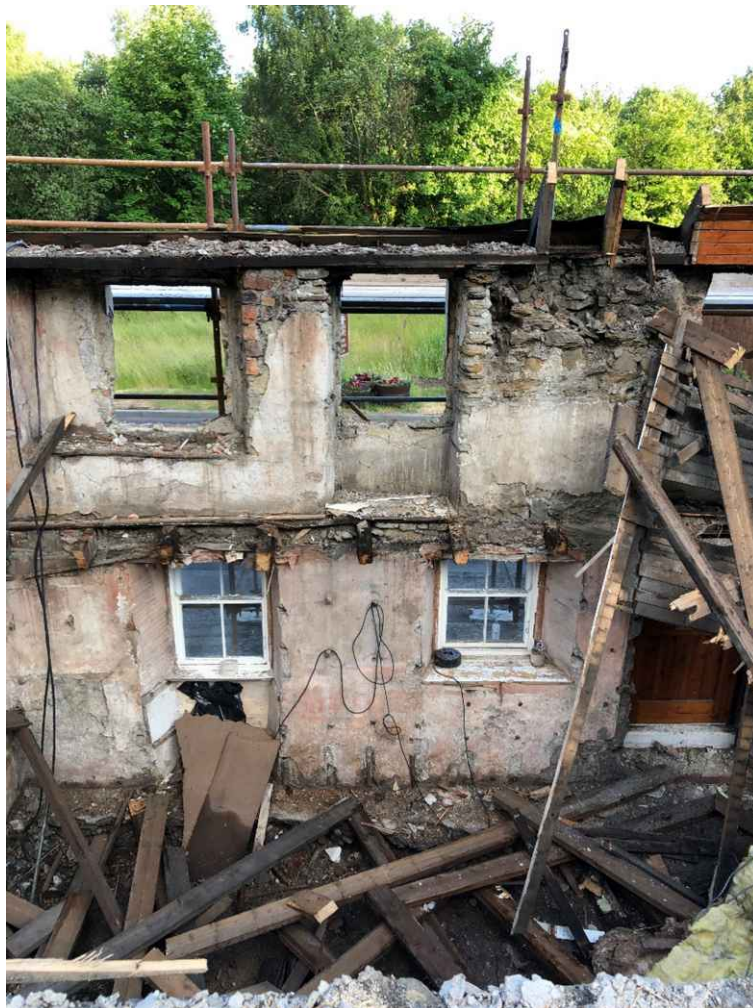
Image showing the top of the wall head that collapsed during interior works to the first-floor framing and exterior render removal. Pantiles had been removed at this point.

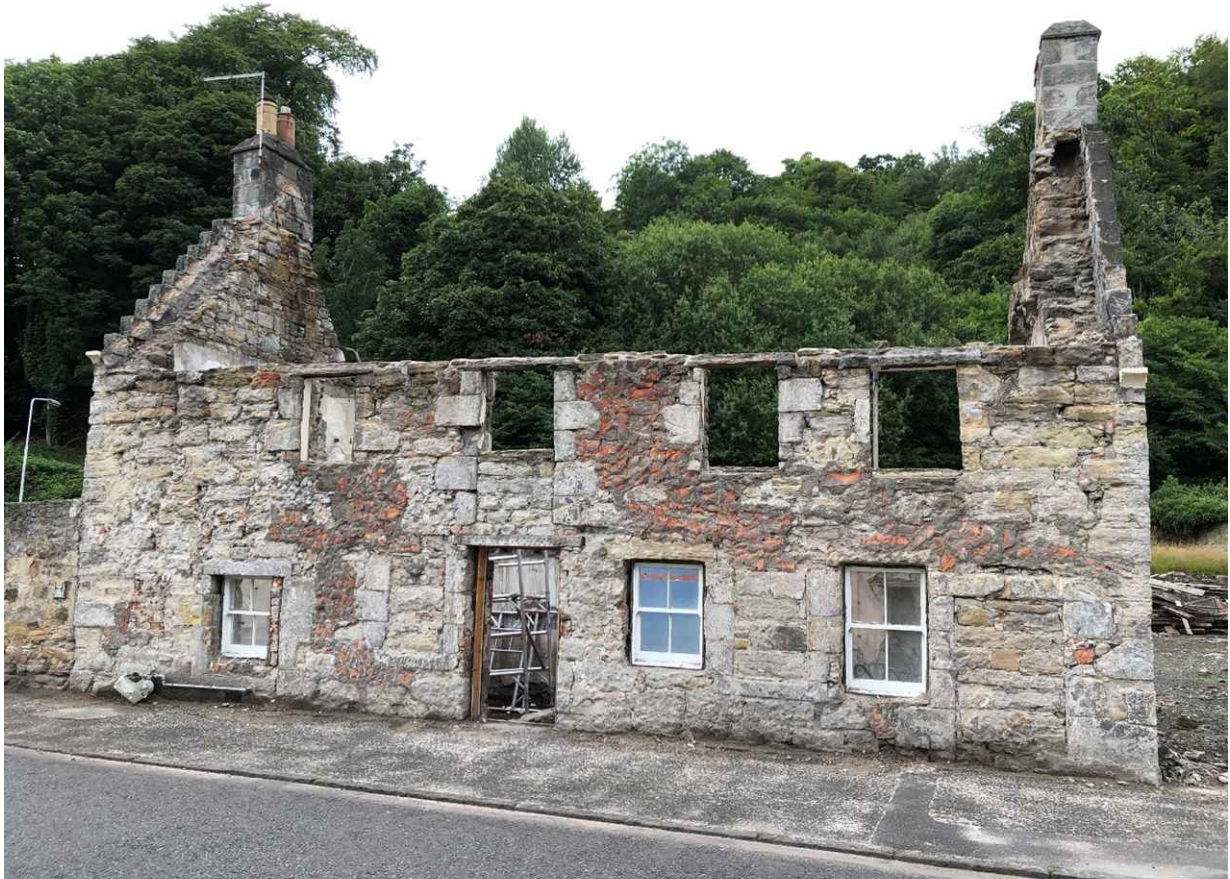
South elevation with roof removed. The west gable wall had shown signs of moving but this was deemed to be historical in nature.

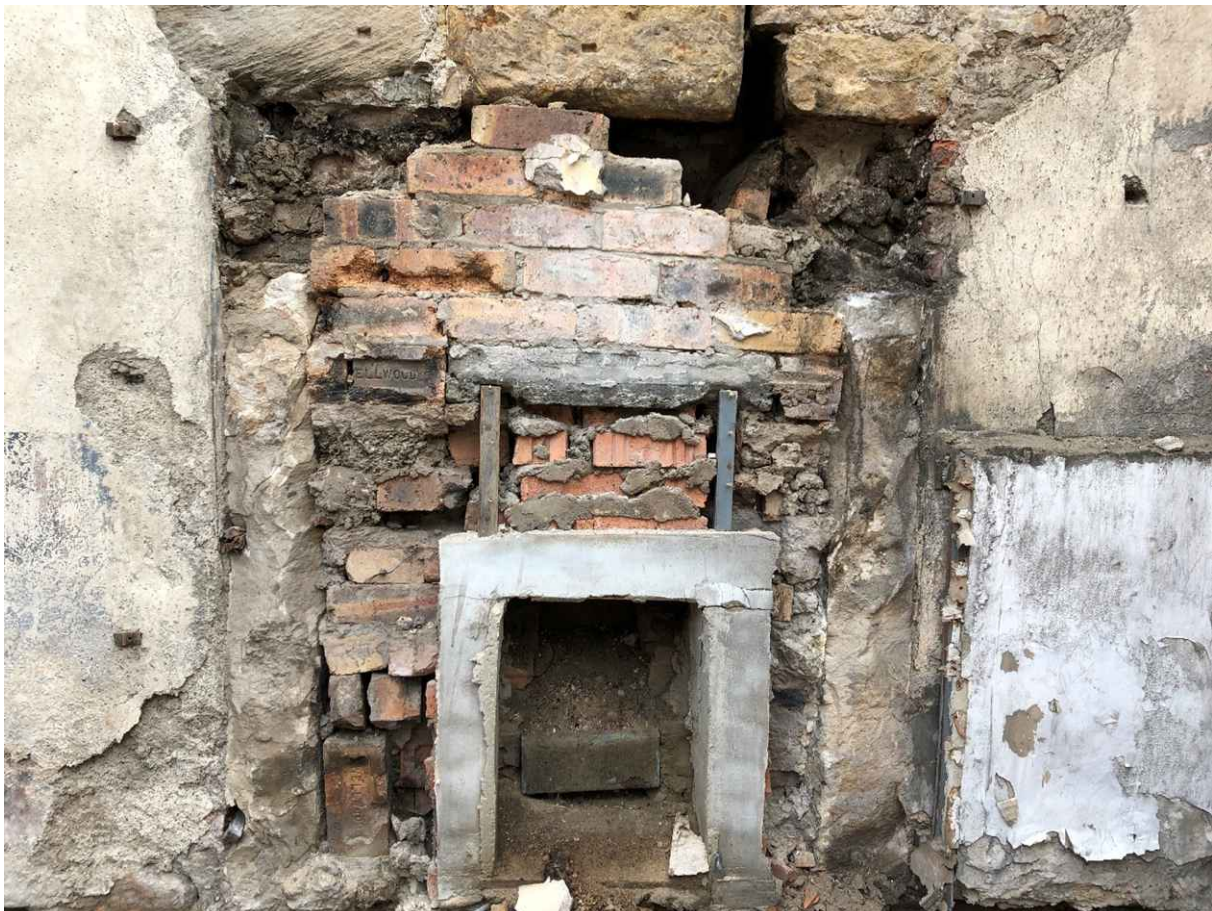
Original fireplace on the west gable exposed. The two stone columns are clearly visible, however, the stone lintel is missing. The stone lintel was replaced, and this fireplace will be retained and be a feature of the renovated property.

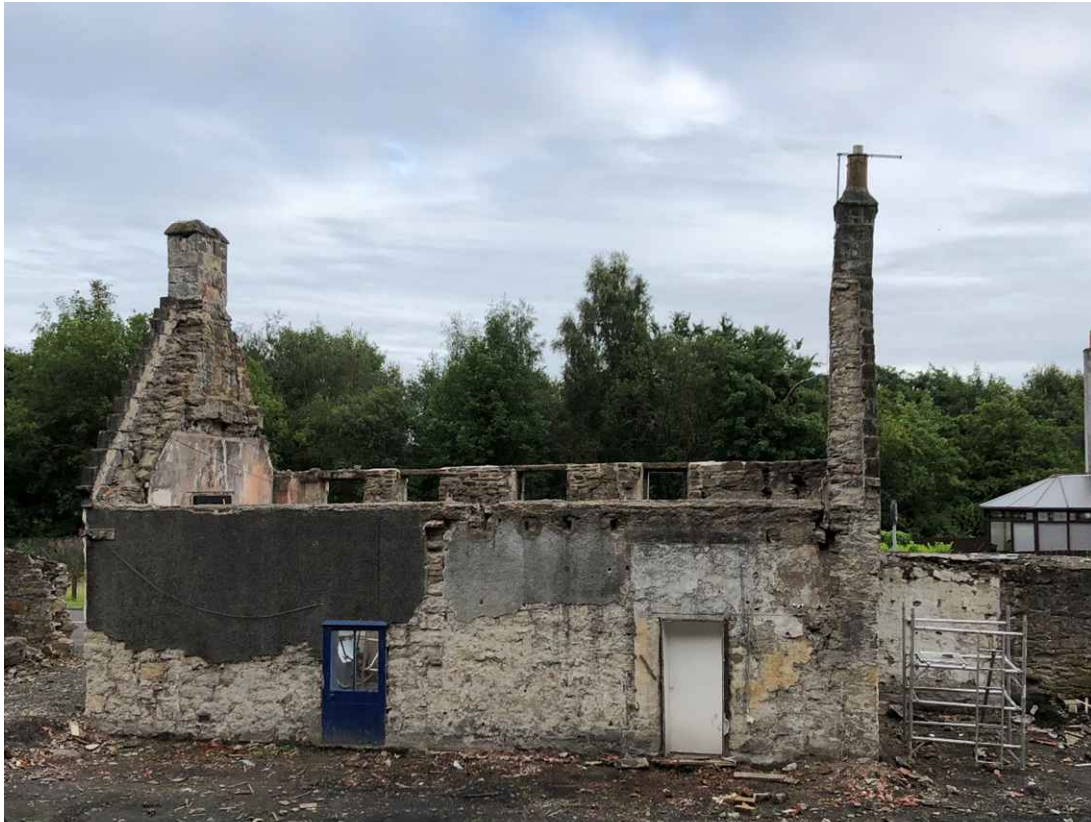
North elevation with roof removed. The west gable wall had shown signs of moving but this was deemed to be historical in nature. The wall head on the south wall has been repaired in three places with stone recovered from the site of the building. Both doors in this wall are not original to the house.

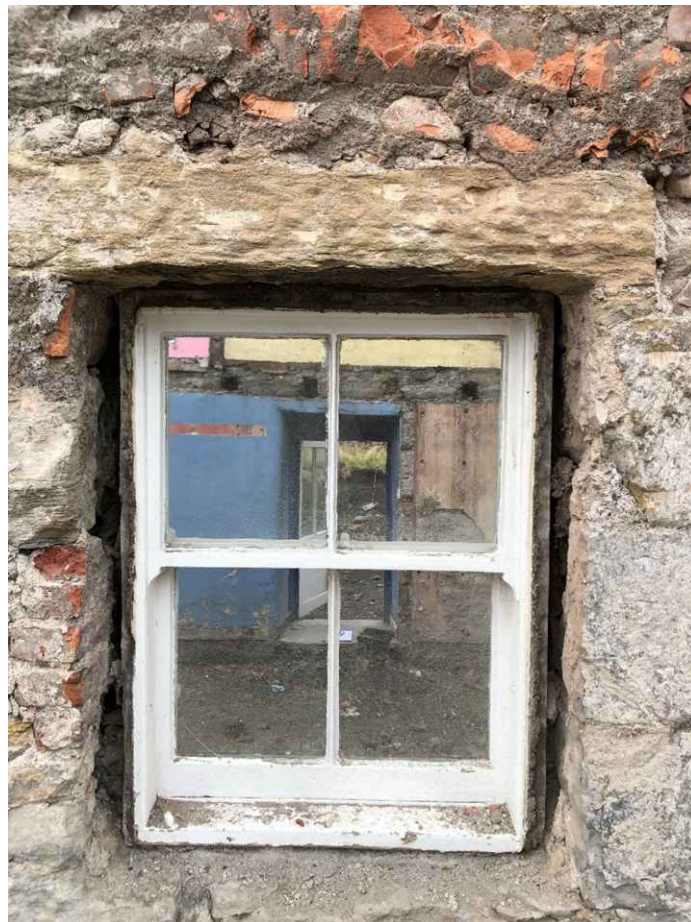
Once the render was removed from the wall, it is clear that the window was being held in place by the cement as the sash boxes were removed, therefore the window was sitting within the rough opening with no tieback. As the window was sealed closed and had no operating function, it served no function and is clearly not original to the building. This was deemed to be a health and safety concern as the window could easily fall out. These windows were retained in one of the rear sheds.

- Removal of windows due to health and safety after render removed from the exterior wall. The render was holding the windows in place and once removed it was highly likely that the windows would fall out. They have been kept in one of the outside sheds.
- Partial down taking of the south boundary wall at the entrance to the property due to access issues and accidental damage. Stone has been retained for reconstruction like for like once the project has been completed.
- Partial down taking of the north boundary wall to allow for site access. The section of wall removed is 3.5m wide and the stone has been retained for replacing like for like once the project is completed.

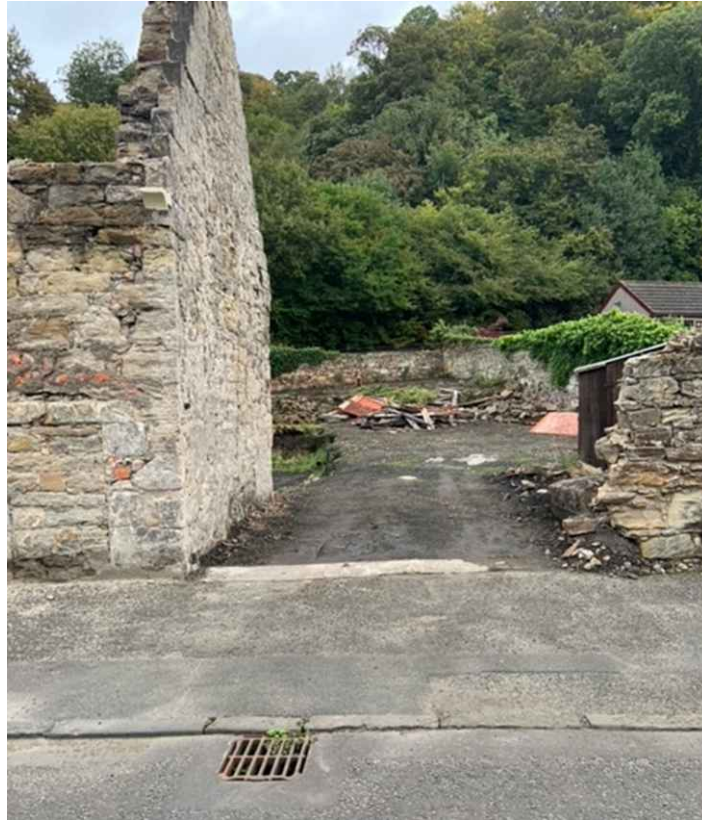
Unfortunately, during renovations, a small section of the south boundary wall was impacted by the skip. In order to prevent further damage to the wall, and to help improve access to the site, the opening was widened, and stone retained for rebuilding once the project has been completed. The gates had to be removed to access the gate hinges when the render was removed. These will also be reinstated once the project is completed.

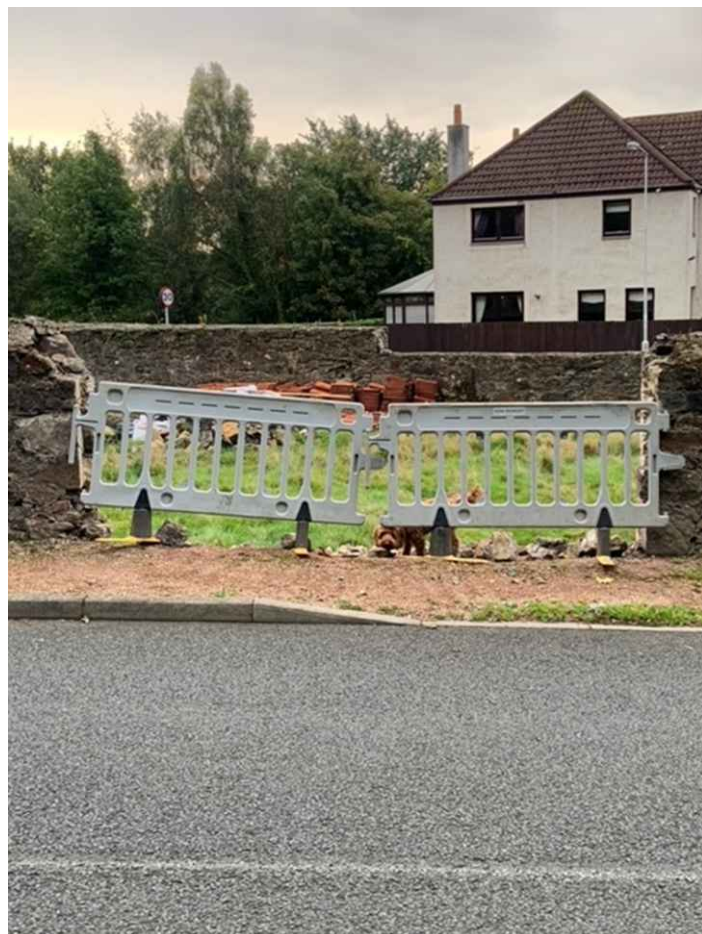
In order to provide better access to the northern part of the site for landscaping and continued renovations, a 3.5m wide section of wall was removed. The stone from the wall was retained for rebuilding once the project is completed.
