UPDATED SUPPORTING STATEMENT FOR PLANNING APPLICATION SUBMISSION FOR WESTEND COTTAGE, 1 MAIN STREET, LOW VALLEYFIELD, KY12 8TF

Introduction

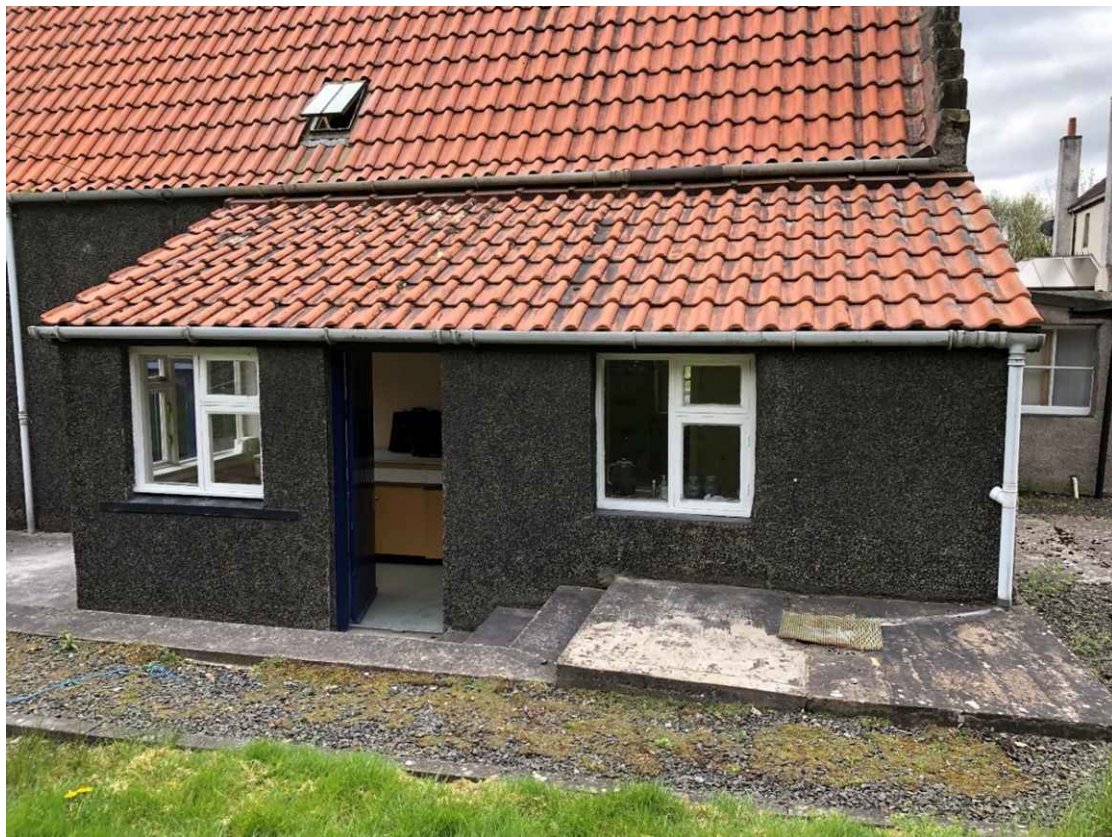
Victorian kitchen addition to the rear of the cottage with mono pitched roof tucked under the eave line. A conservation skylight is also visible on the cottage's roofline. It is clear that this extension also received a new roof in the 1980's when the dark grey cement render was applied.

The scale of development has already been established on the rear of the cottage as the Victorian kitchen had a mono pitched roof at the highest point sat just under the eave line of the cottages' north wall. Although the bathroom to the west was single storey and had a roof that sits contiguous with the top of the wall as a flat plane, the interior height of this room was very restrictive and functioned minimally as a bathroom.

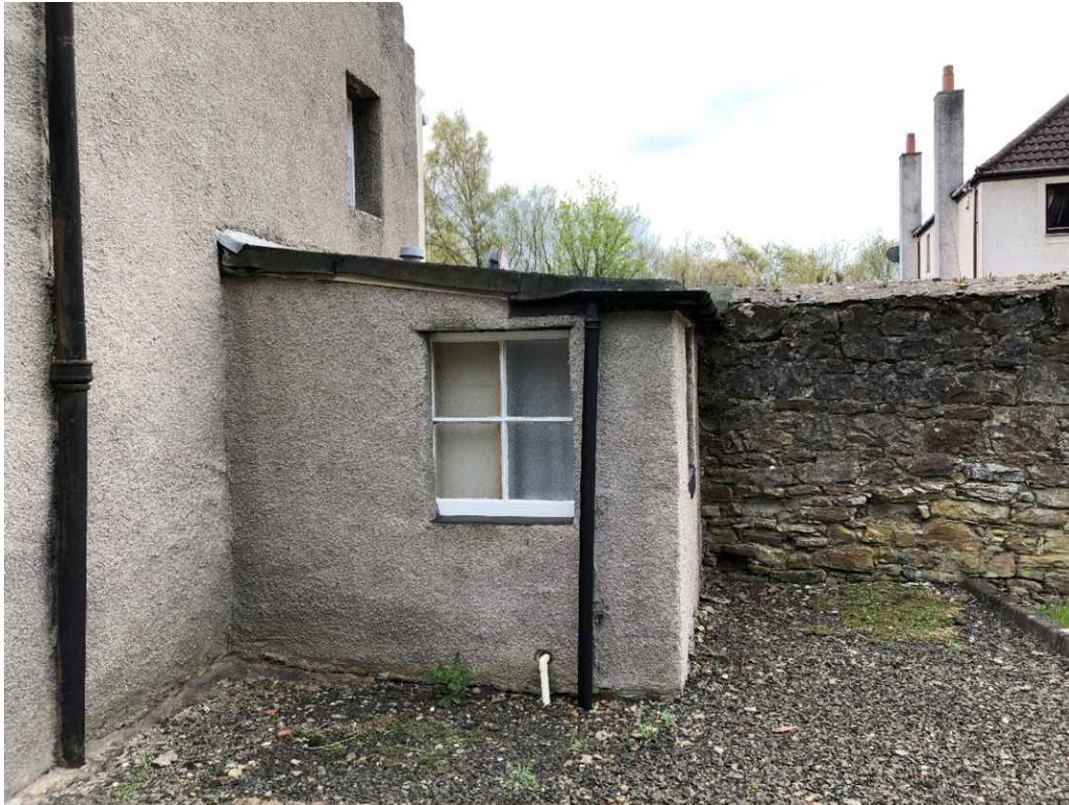
The bathroom extension to the west of the cottage is a poor example of development which has little relationship in architectural terms to the original cottage, emphasized by the tar flat roof and picture windows. This is in spite of the extension mass being limited to the top of the south boundary wall. Although the wall hides the extension from the south, it is clearly visible from the west and north. See below.

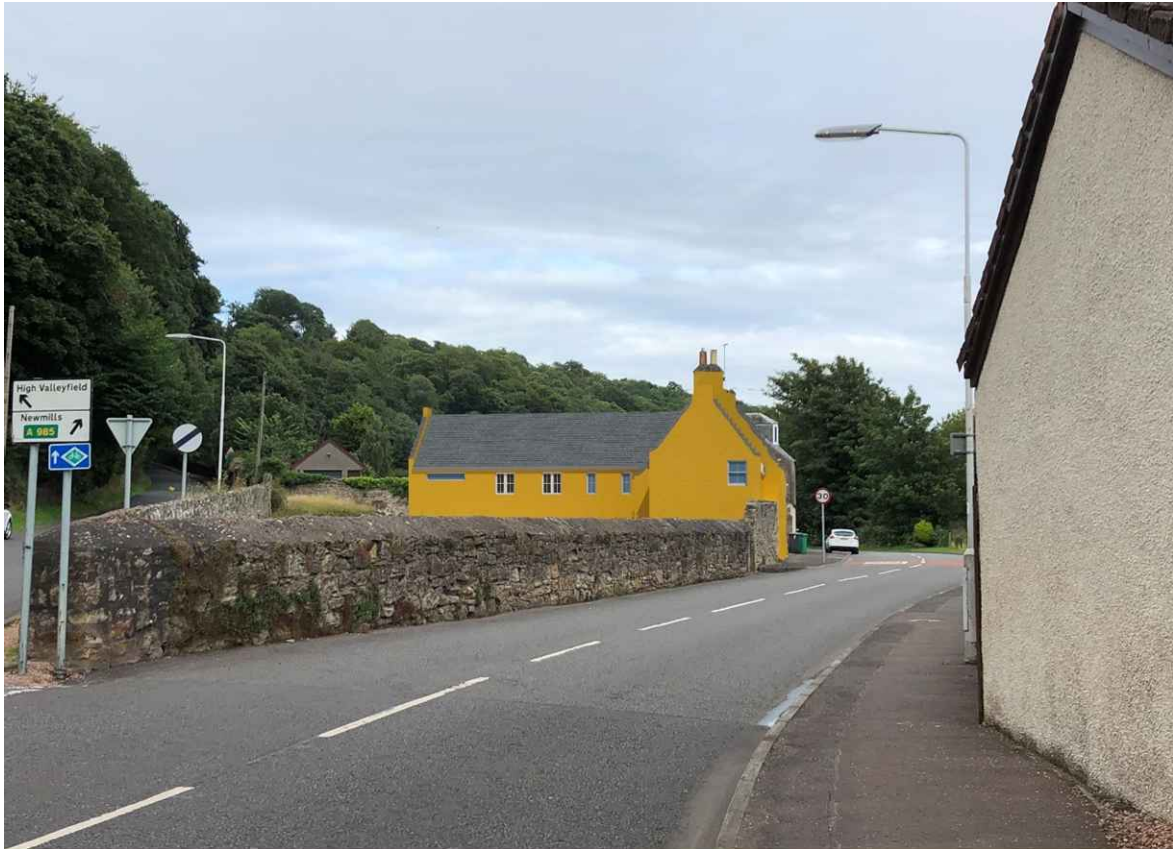
The CGI of the cottage in its surrounding shows how the extensions are hidden behind the north and west boundary wall. The upper window in the west extension is an exact copy of the existing Westend Cottage west gable window that is transposed directly to the same location on the west extension gable wall.

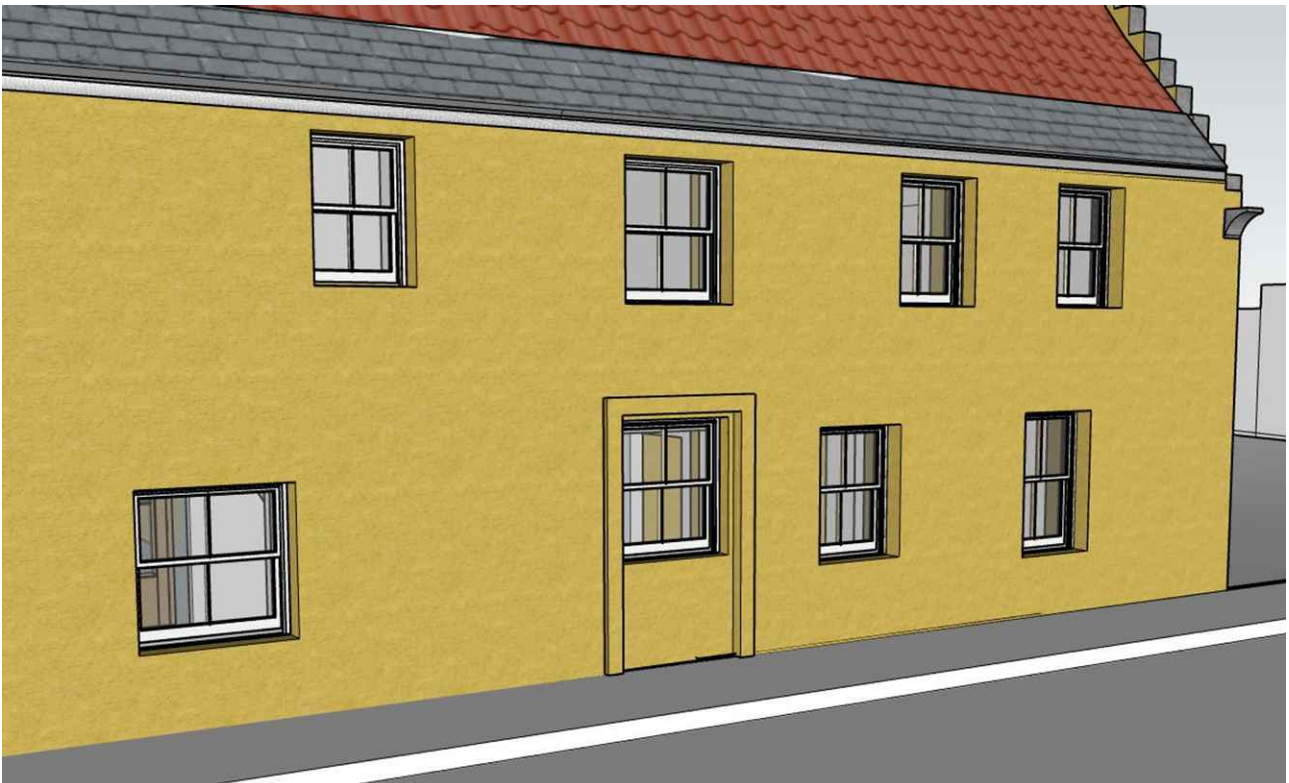
The new proposed detail on the south elevation of the existing cottage showing the new lime rendered door frame with the new proposed window set at the height of the existing door. This detail provides context to the location of the current door position even although it is not the original opening.

The proposed changes to the Westend Cottage involve the removal of the front door and two steps down into the cottage to allow the ground floor to return to its original level. The door will be replaced with a window and the first-floor window above will also be changed out to a window of the same size. The intention was to expose some of the quoins however the sparsity of good quality stones means the cottage and extension will be lime rendered completely. As the front door has been compromised in height due to extensive raising of the pavement and road, the entrance is no longer fit for purpose as an entry. However, in order to provide a context of the original door on the front façade a raised lime rendered door frame is proposed with the infill wall being composed of two 120mm SIP panels. This wall is recessed 50mm back from the existing wall and the rendered frame is 120mm wide and protrudes 50mm from the face of the existing wall. This gives the representational appearance that an entry to the property once existed in this spot.

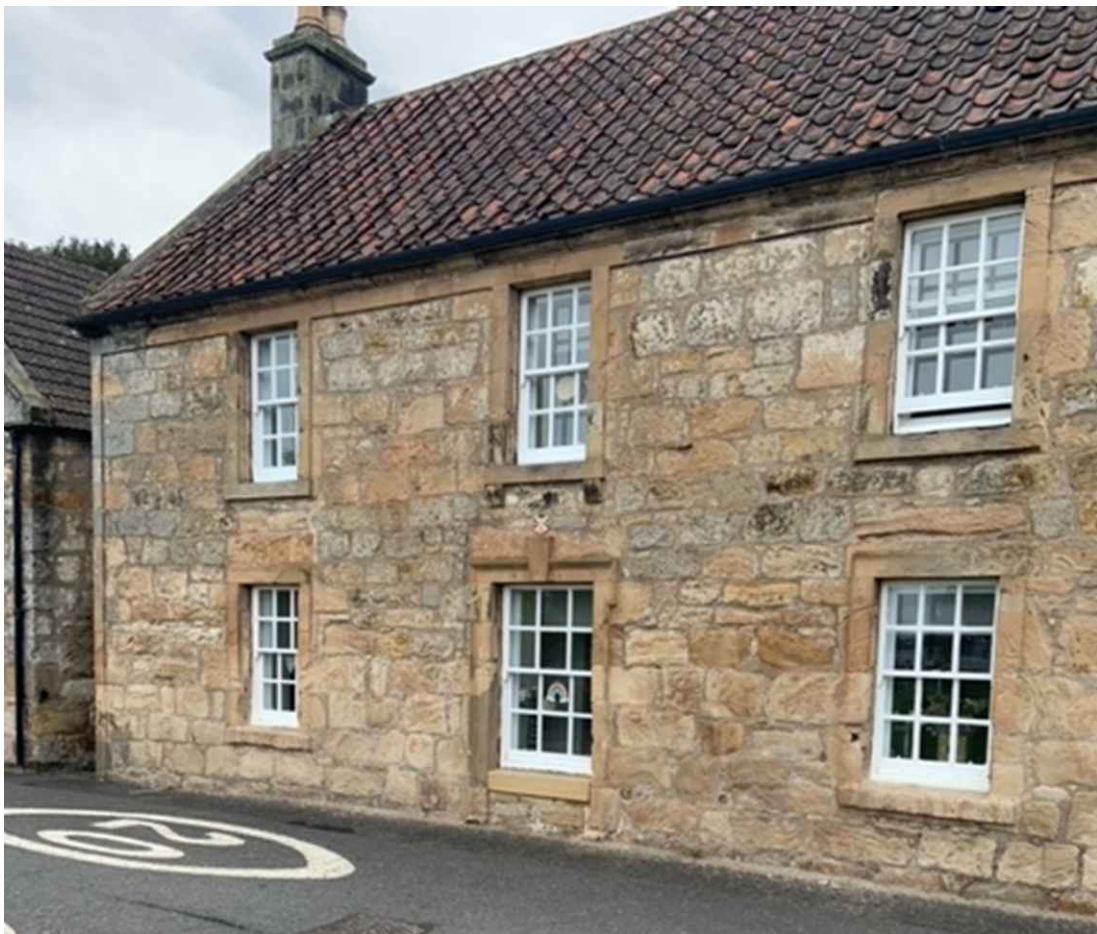
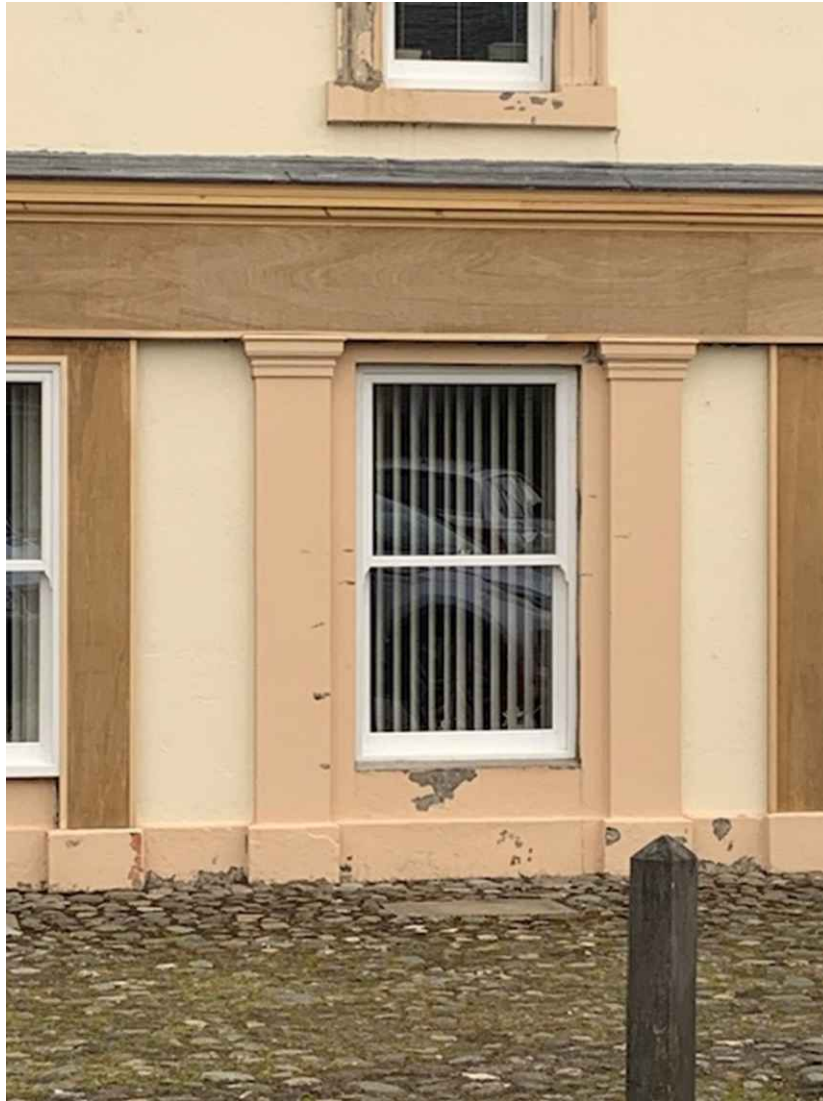
A similar detail has been developed on two listed buildings in Culross as shown below.
