THE HOWARD de WALDEN ESTATE

Title:
 Ground Floor Layout - PROPOSED

Drawing no: MA014/002/P	
Scale: 1:100@A3	Date: 06/07/20
File name: base.dwg	Revision:

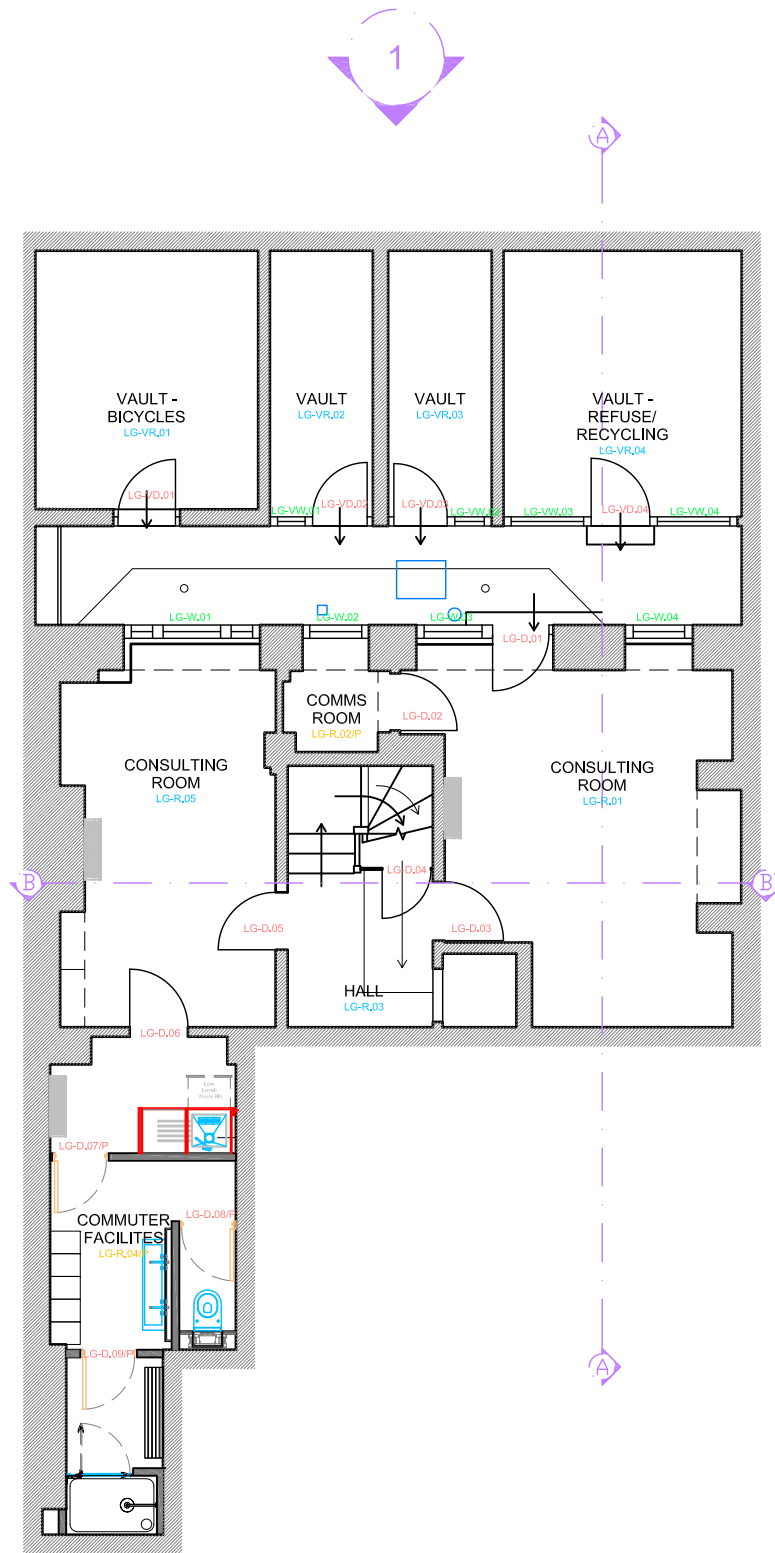
BASEMENT

1. Tea point, wc, shower and locker space formed in full height plasterboard partitioning with skirtings, architraves, door to match adjacent patterns/detailing. Existing plasterboard ceiling adapted or renewed to suit the proposed configuration.
2. Tiled wall finishes to be applied to shower enclosure and changing area walls
3. New carpet finish applied to timber staircase between ground and lower ground including contrasting nosings.
4. Staircase handrail to be stripped, made good where necessary and French polished. Balustrading to be painted.
5. Proposed new wall mounted air-conditioning units.
6. Mechanical extract for shower and wc to discharge via 100mm ductwork extending through accessible wc service void above.

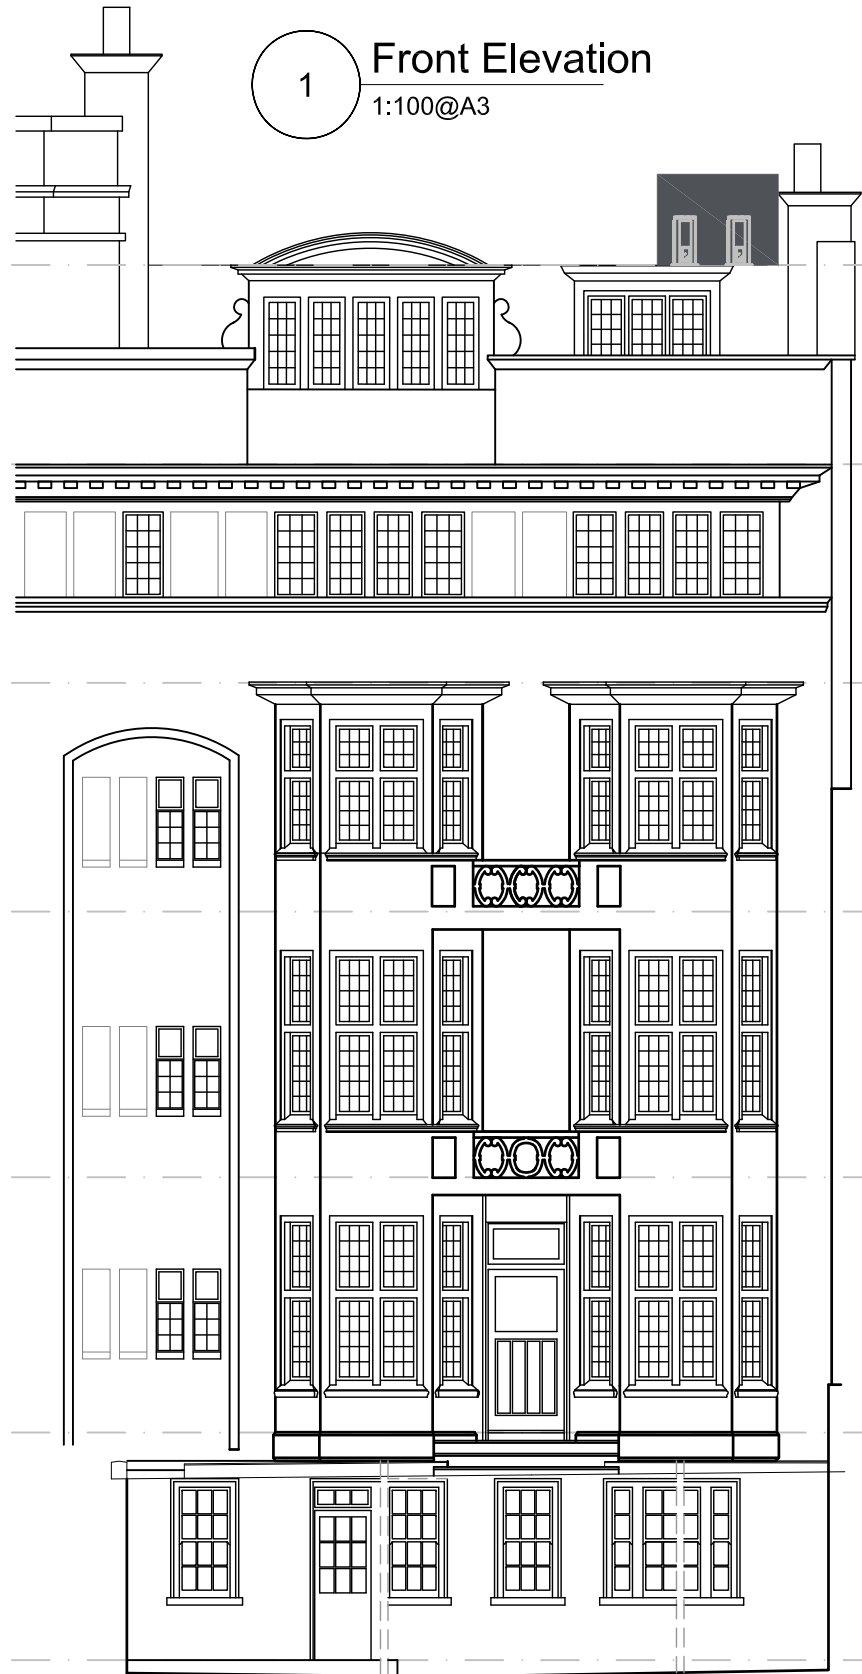
1 Front Elevation
1:100@A3

11. Existing gas meters and redundant pipework to be removed, brackets/fixings removed and glazed bricks made good.
12. Retained wall mounted pipework and cabling to be rationalised, reconfigured or removed where redundant. Redundant fixings to be removed and all glazed bricks made good.

13. Specialist clean and repair marble front entrance steps, path and glazed brick light
14. Prepare parapet copings, projecting stone cornice and bay roofs as necessary and apply lead capping in accordance with the LSA standard details.
