Abbey Fields, Kenilworth: Warwick Leisure Centre

Heritage Statement S73

Mace and Warwick District Council

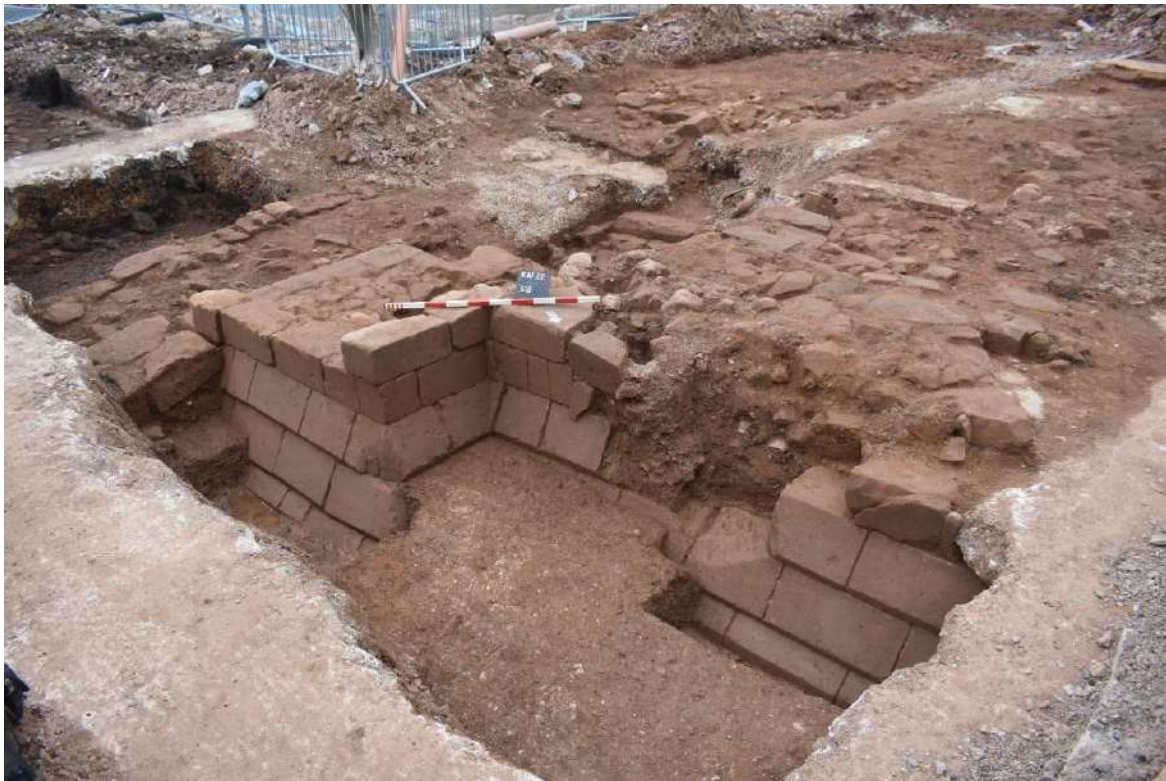
Photo 1: Stonework on the east elevation of the northern building

The exposed section of this building measures c.12m east-west and 8m north south, with its northern limit lying beyond the northern extent of the site. An exposed central buttress plinth suggests a possible north-south length for the building of *circa* 16m. It is stone-built with its east elevation being 1.5m wide and constructed from large, faced sandstone blocks including three courses of chamfered stonework towards its base (Photo 1). The wall, which had a square buttress forming the southeast corner of the building, also contained a small number of re-used blocks from an earlier building, including carved Norman stonework. A number of masons marks were recorded on the chamfered stones, some of which have previously been recorded in the existing barn and gatehouse buildings and were also recorded in the test pit for the new electricity sub-station (see below).

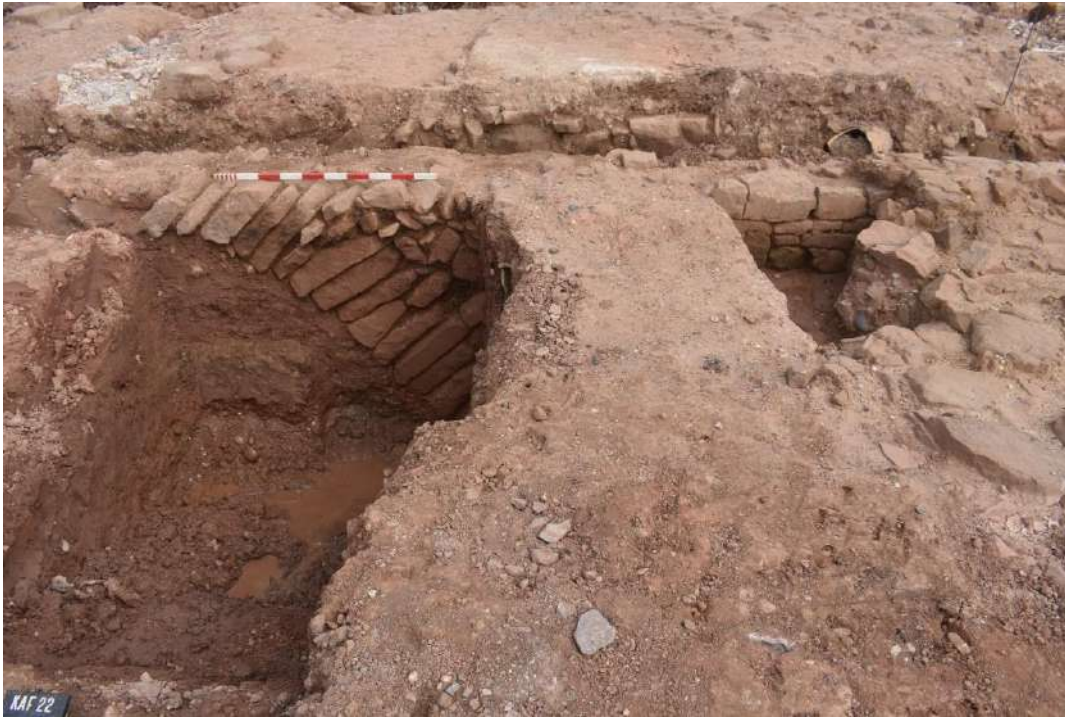
Photo 2 relieving arch in the south wall of the northern building

The southern wall was of similar width but was of very different construction. At its west end a surviving relieving arch (Photo 2) within the foundation was constructed from roughly shaped blocks. The significant difference between the two walls suggests that the east wall was the principal face of the building and it may have fronted onto the access route into the abbey from the south.

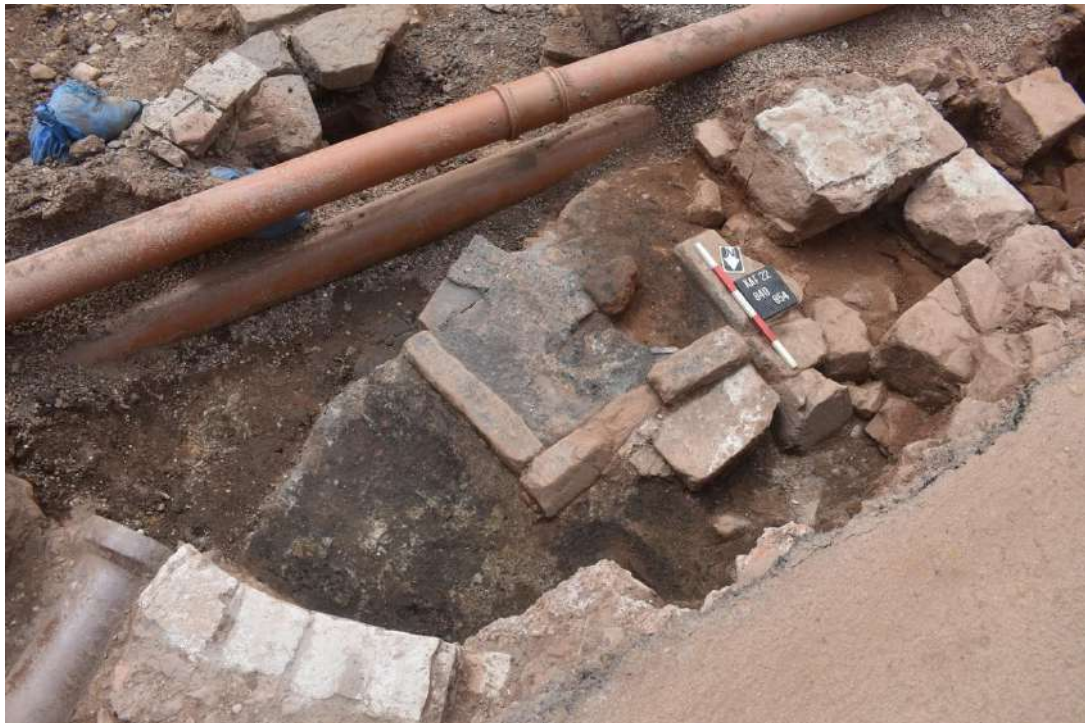
Photo 3 West wall (top right) of the possible extension to the Northern building with the later fireplace/oven and circular oven.

A later extension was built onto the west wall that extended beyond the eastern and northern edges of the excavation area and was constructed from sandstone blocks. Its west wall was constructed on and along the line of the reduced eastern wall of the northern building (Photos 3 and 9). The size and form of the building is not known but it was clearly a substantial construction with its south wall being at least 1m wide and extending approximately 8m to the east.

It contained a square stone lined fireplace/oven of possible 16th century date and slightly later circular oven constructed from tile (see Photo 3). The base of the earlier fireplace/oven was constructed from part of a flat slab inscribed with circles and lines, which had clearly been reused from elsewhere on the site (Photo 4).

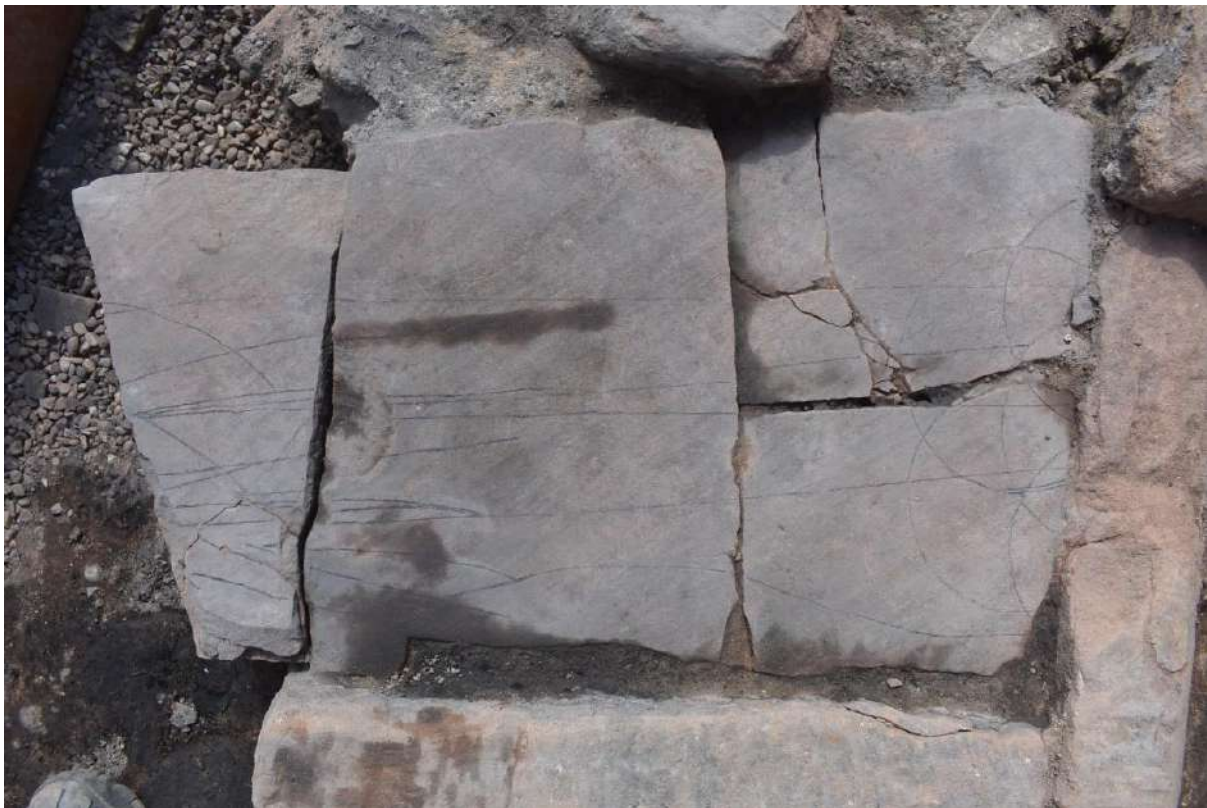
Photo 4 Inscribed stone used as the base of the fireplace in the extension to the northern building

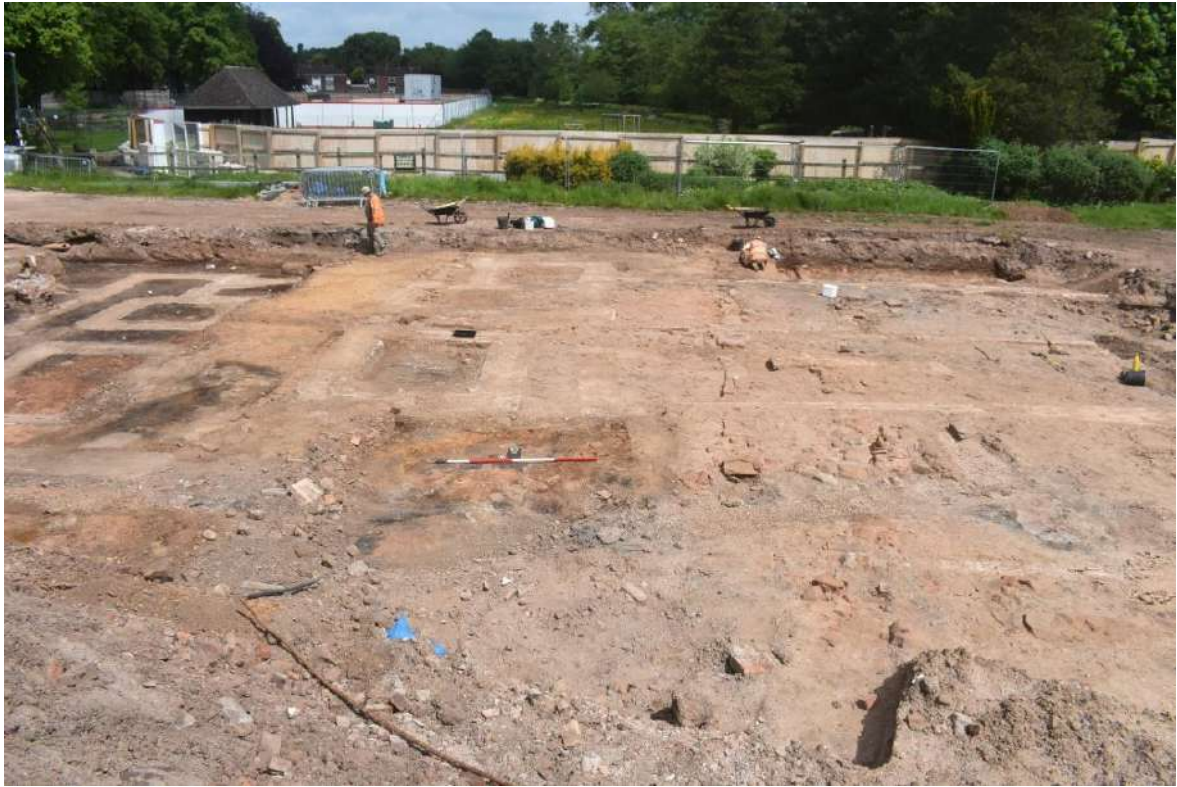
Photo 5 General view east across the southern buildings during cleaning showing the stone foundations running across the site and cut by the later pool foundations

They consisted of narrow foundations constructed from sandstone blocks with large sandstones pads on the corners, suggesting they were timber-framed (Photo 5). The northern building was divided into two rooms, with one containing a large fireplace/oven constructed from roof tiles set on edge, which showed signs of burning (Photo 6).

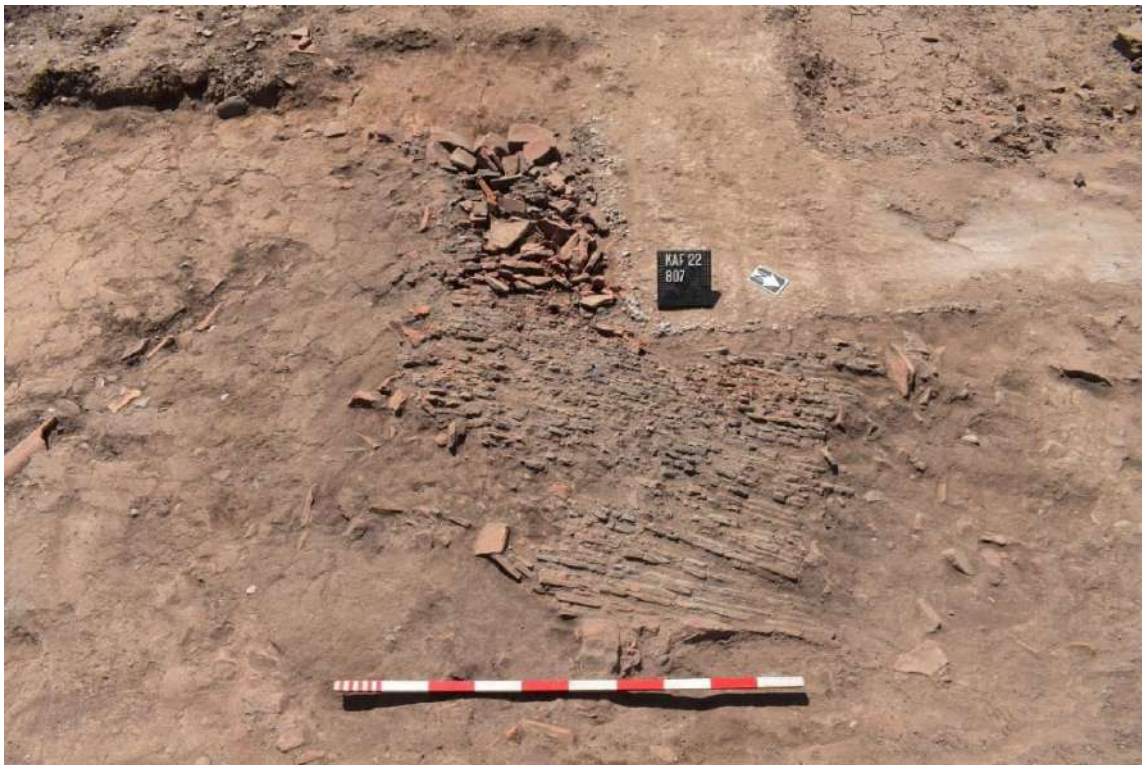
Photo 6 Hearth/oven constructed from tiles one edge in the middle of one of the southern buildings

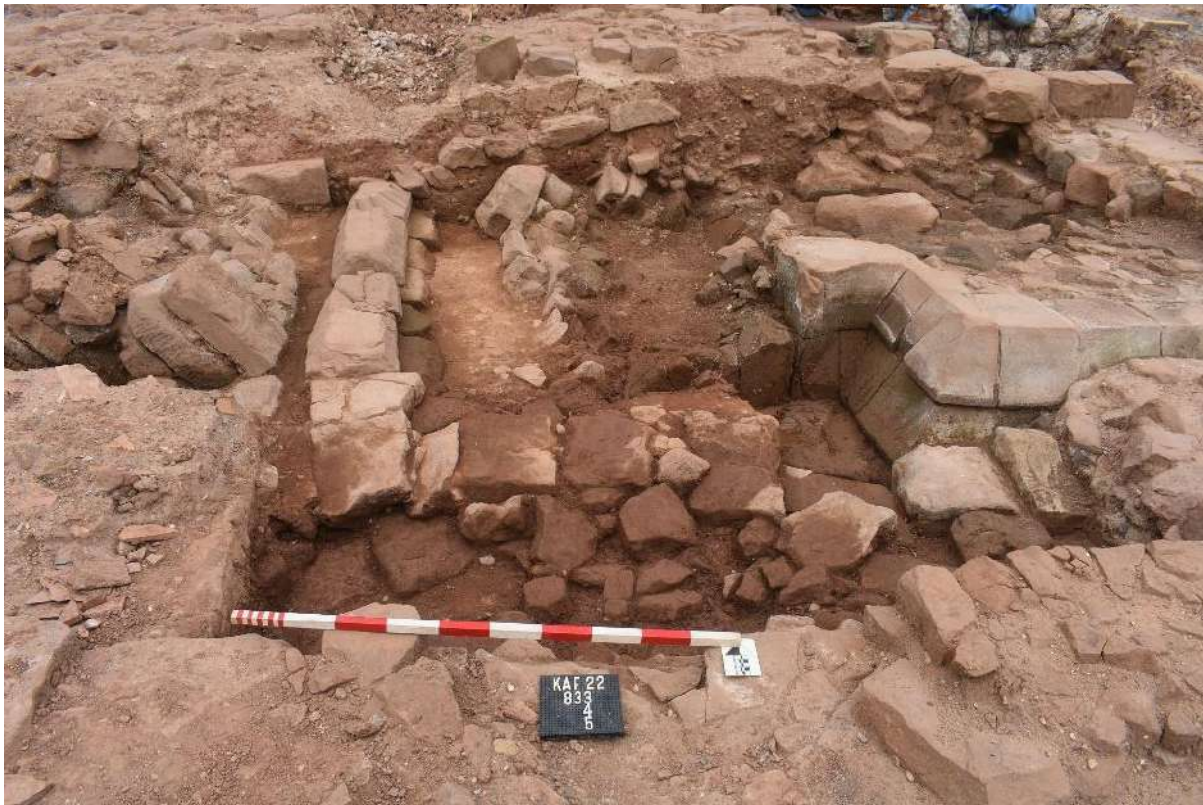
Photo 7 Stone capped drain running north-south through an arch below the floor of the northern building (note reused decorative stone block at far end)

Parts of five stone lined drains have been recorded across the site, with three in the main pool complex area and possibly two in the electricity sub-station test pit. All are of very similar design with stone lining capped by sandstone blocks, or in one case sandstone roof tiles (Photos 7 and 8).

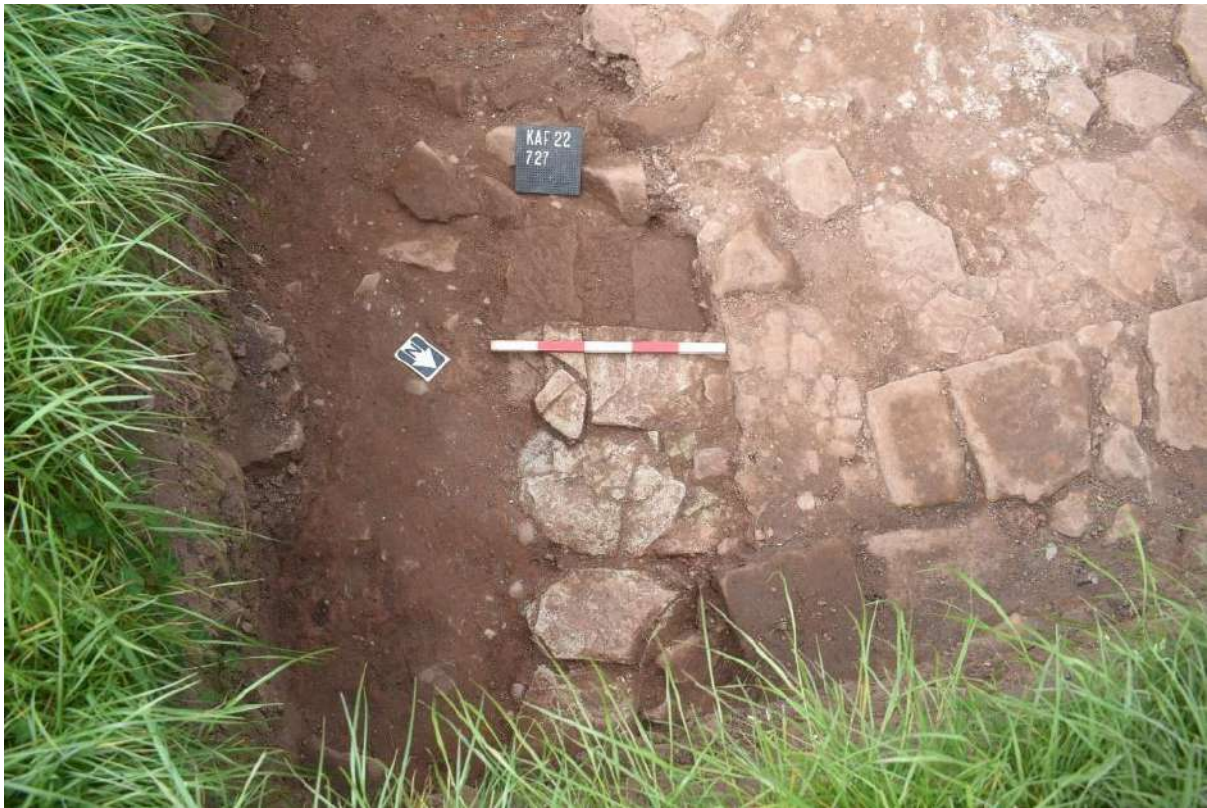
Photo 8 Stone drain capped with sandstone roof tiles in the sub-station test pit

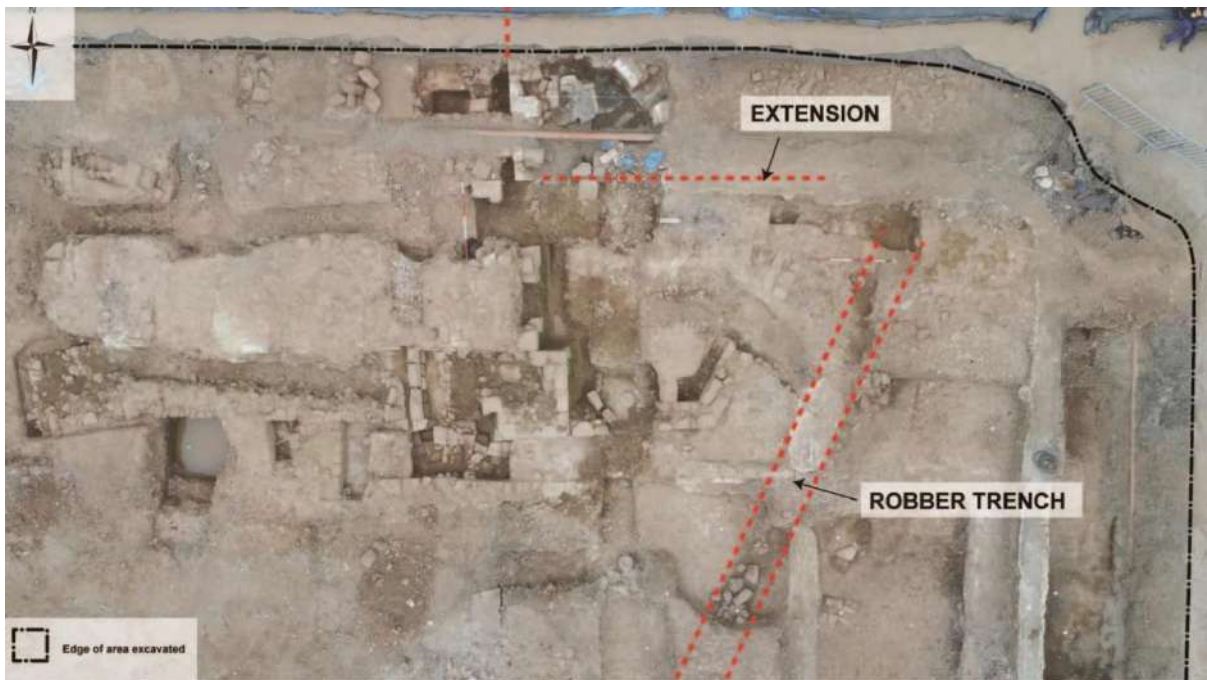
Photo 9 Drone shot of the northern building showing the possible pathway (indicated by the ranging rod) formed by the later angled wall butting the east wall and the robber trench. Note the later extension at the top of the photo

A possible northeast-southwest pathway across the site is indicated by a length of surviving wall (Photo 9) and the line of rough wall/rubble filled robber trench. The surviving wall butts against the east face of the buttress on the southeast corner of the northern building and extends east for a short distance before turning northeast and possibly butting the south wall of the extension.

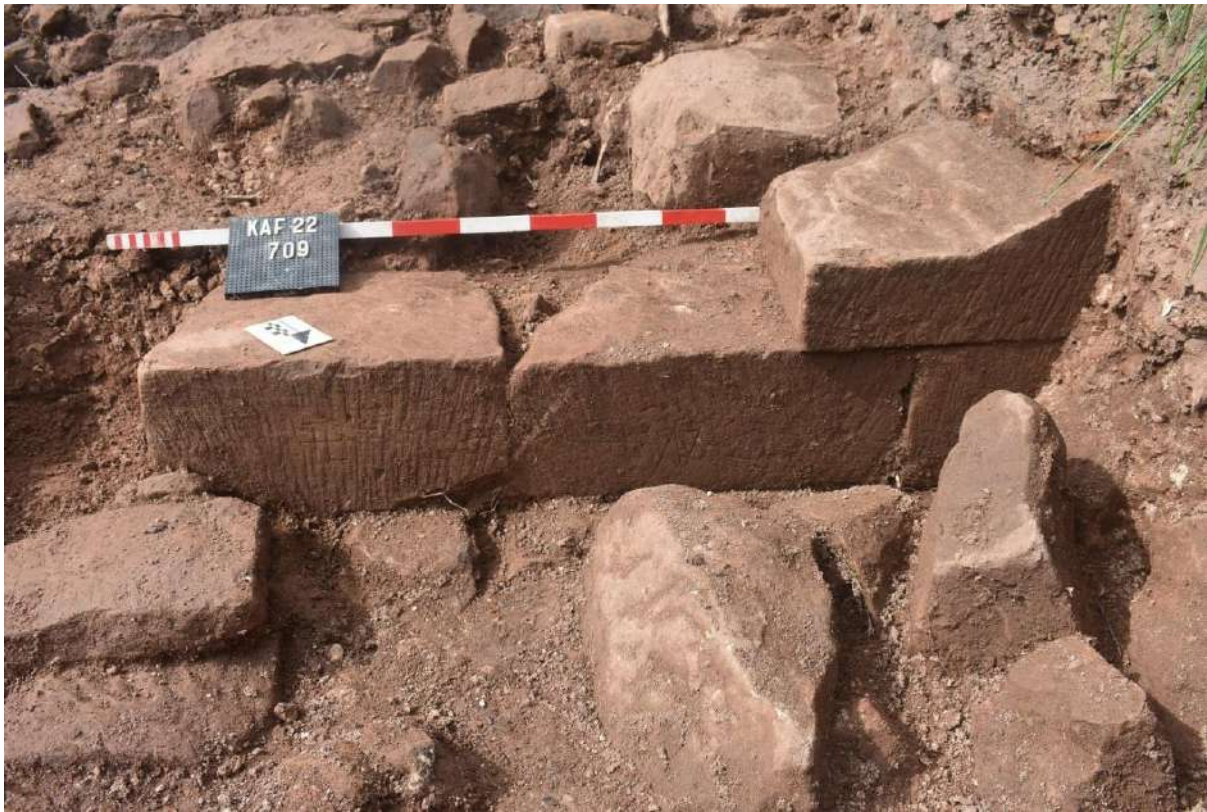
Photo 10 Worked and faced stones of the wall in the sub-station test pit

Investigations within the proposed locations for the electricity sub-station have revealed a substantial stone wall within a mound of rubble at the southwest end of the pit. The wall included a number of large worked and faced stones on the north end (Photo 10). The faced stones, which had been removed in the southern half of the test pit were set of a line of more rounded sandstones, which appeared to form a foundation. The wall was overlain by rubble, presumably from the demolition of the former structure, but there was no evidence for its former use. Its location is thought to be on or close to the former line of the mill pond bank, but the impressive nature of the wall suggests it may have been part of a building rather than the pond bank.

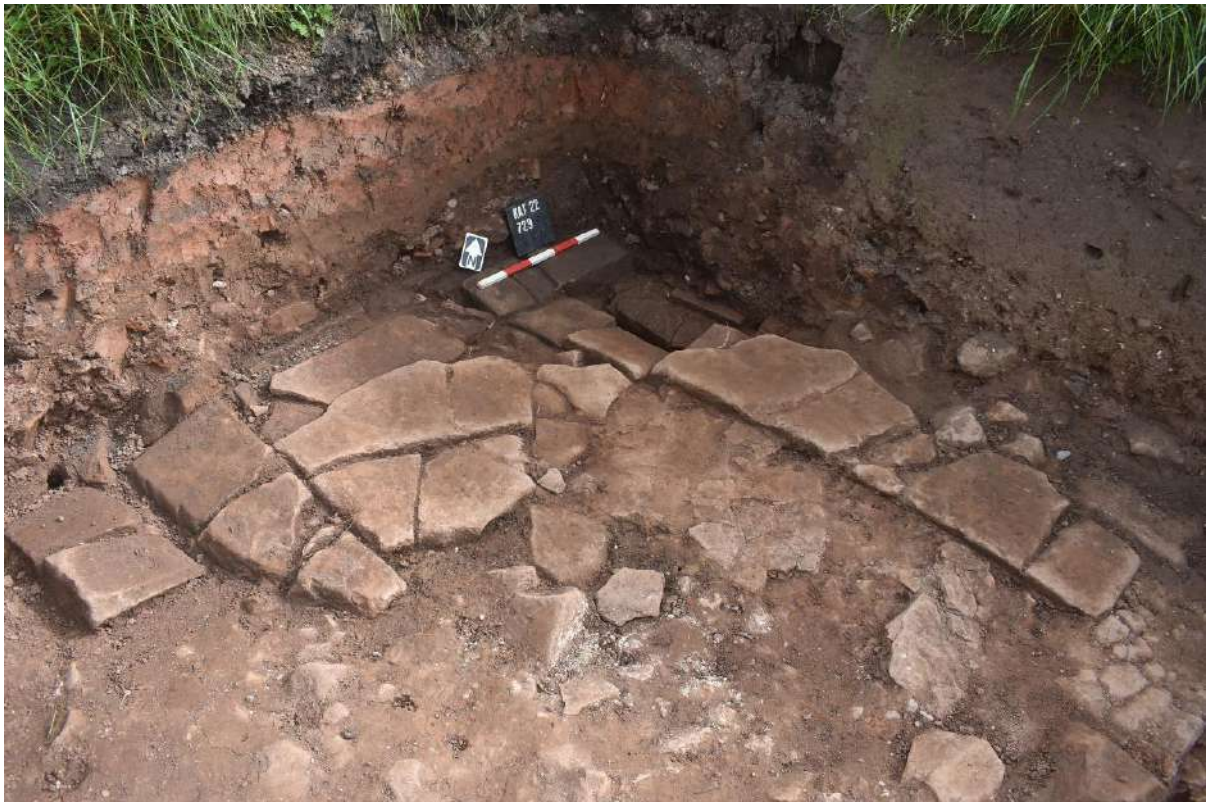
Photo 11 Stone surface in sub-station test pit with possible drain below

A layer of flat sandstone blocks, thought to have been part of a wall or floor at the northeast end of the test pit were investigated following the removal of a 1930s park structure and they were part of a surface with a possible stone lined drain below (Photo 11).

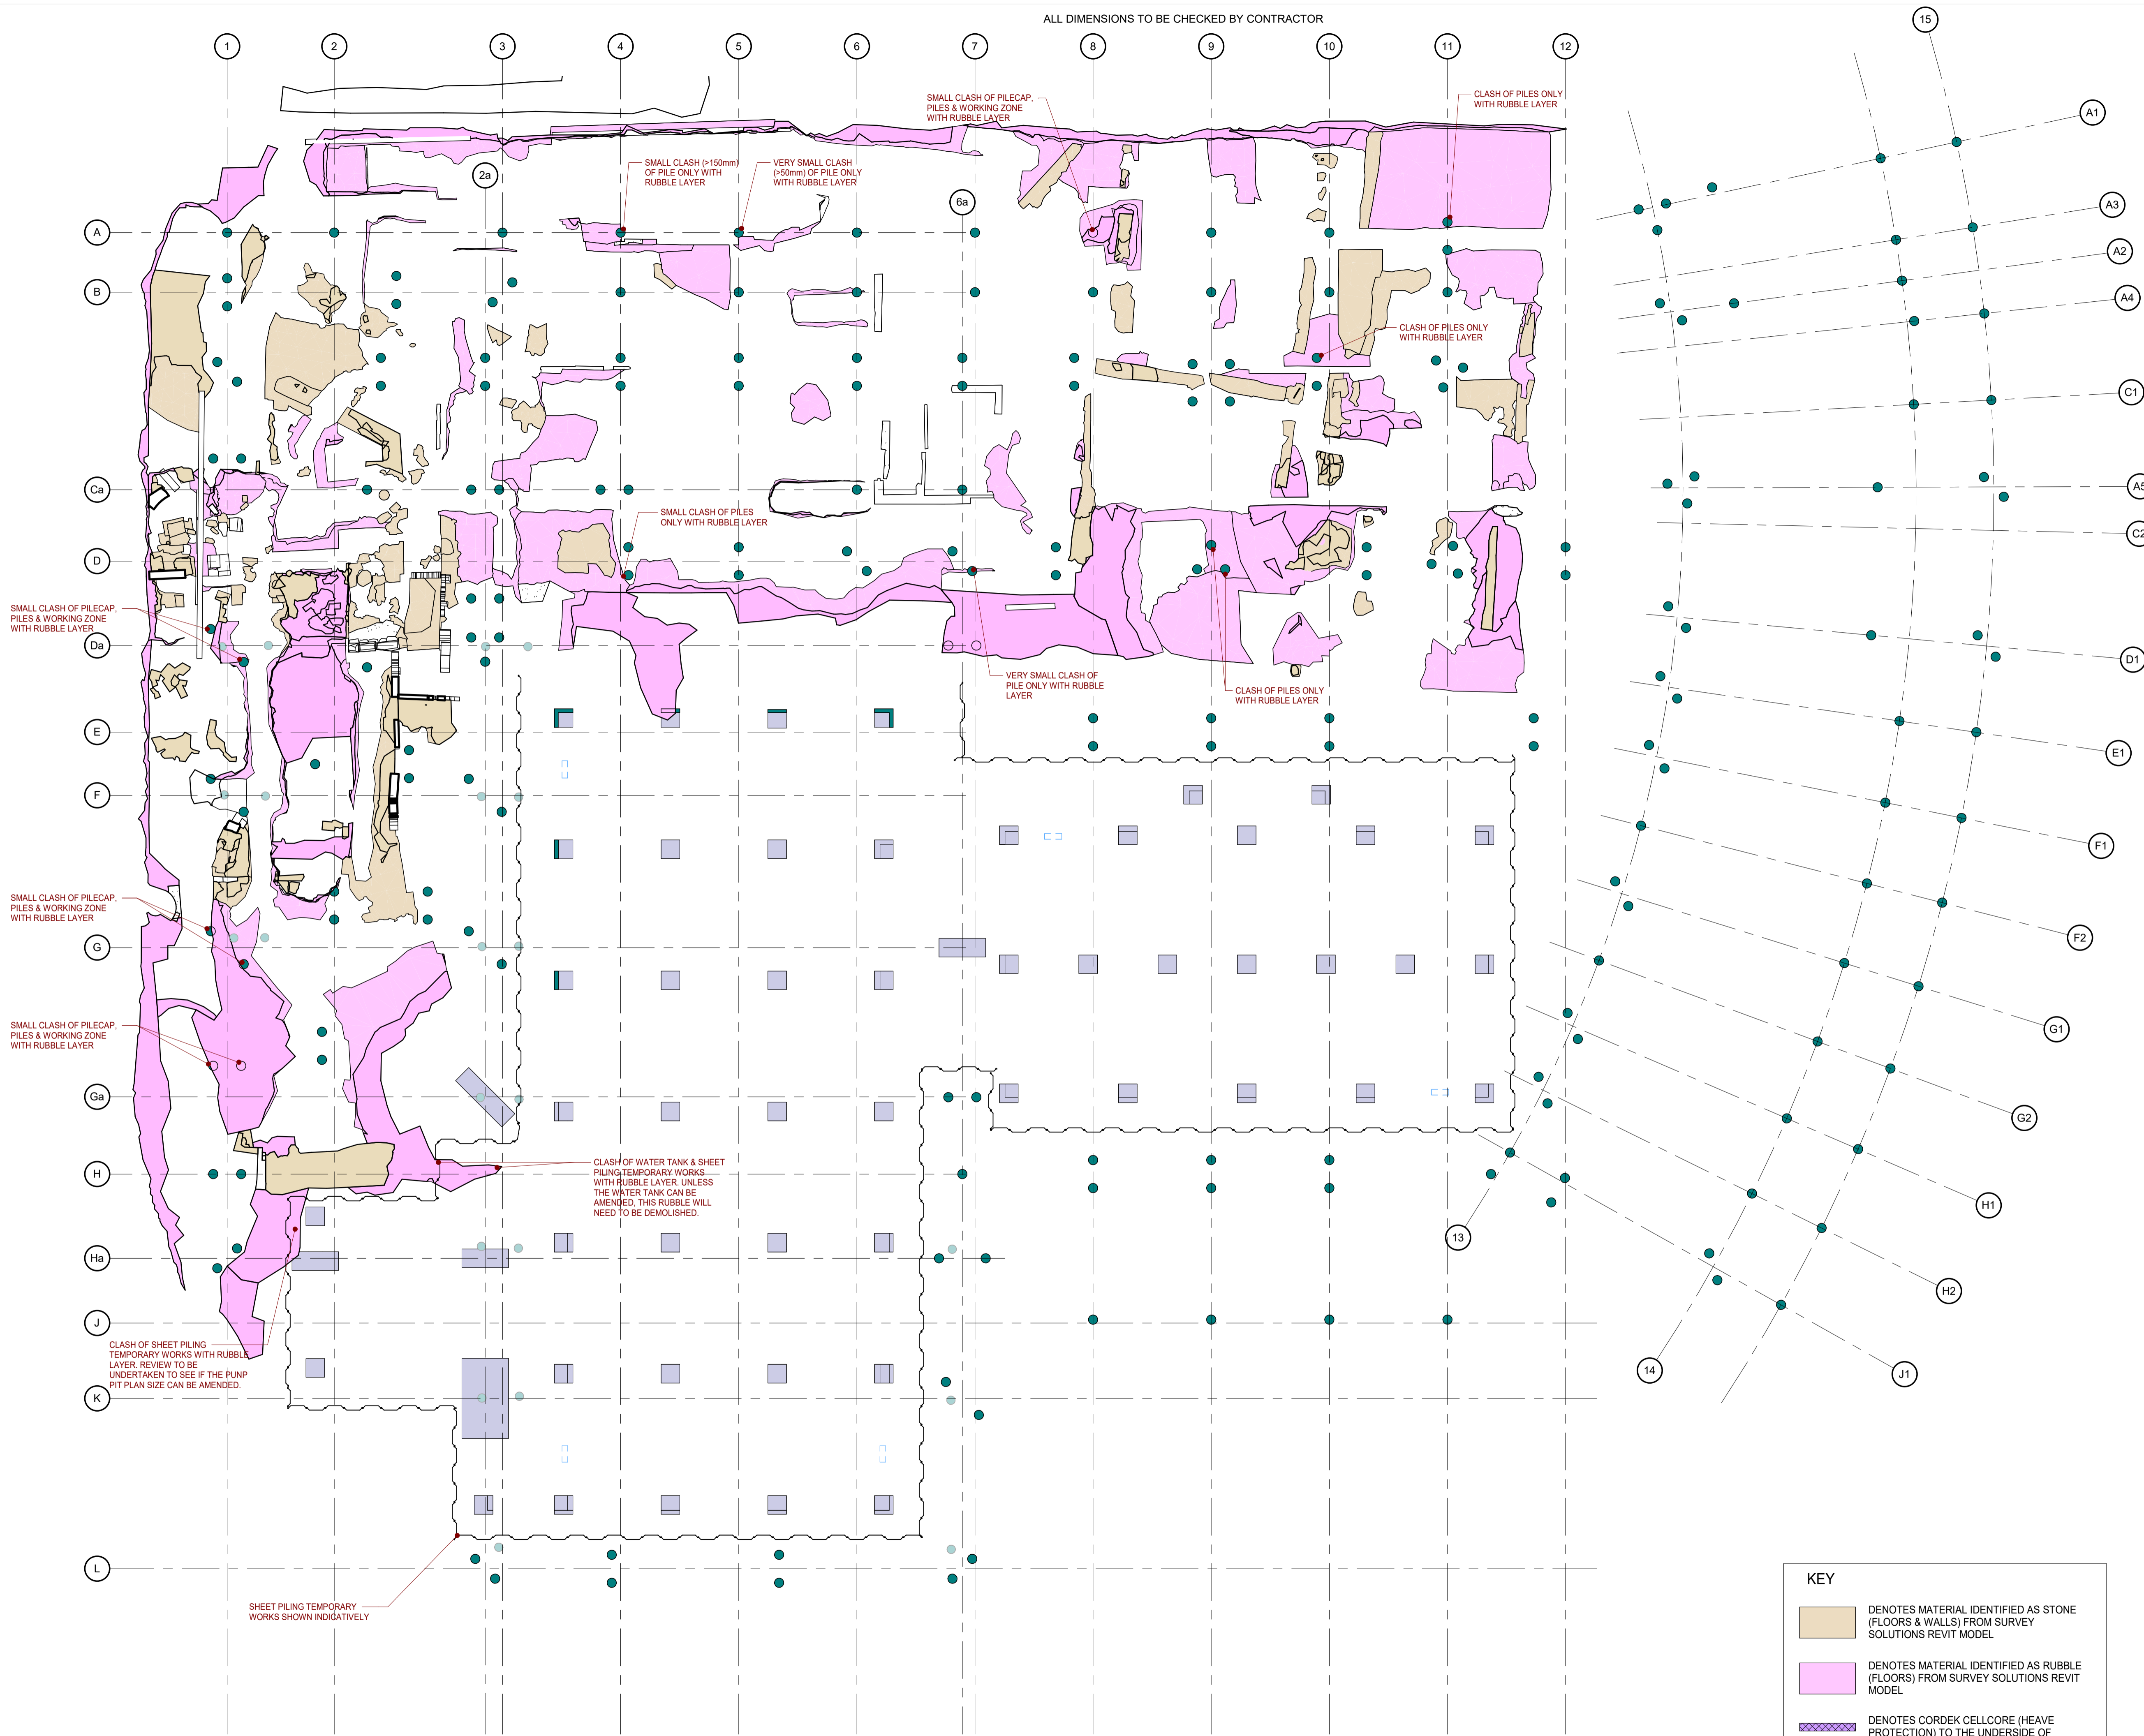
DENOTES MATERIAL IDENTIFIED AS STONE (FLOORS & WALLS) FROM SURVEY SOLUTIONS REVIT MODEL
	DENOTES MATERIAL IDENTIFIED AS RUBBLE (FLOORS) FROM SURVEY SOLUTIONS REVIT MODEL
	DENOTES CORDEK CELLCORE (HEAVE PROTECTION) TO THE UNDERSIDE OF GROUND BEAMS & PILECAPS
