## The Heights Academy, Solihull Verification Report Rev A

Project No.	2021-323	
Checked by:		Pages: 2
Date:	September 2023	
Issued to:	Tilbury Douglas Construction Ltd	
Issued by:	MH

## **Verification Report**

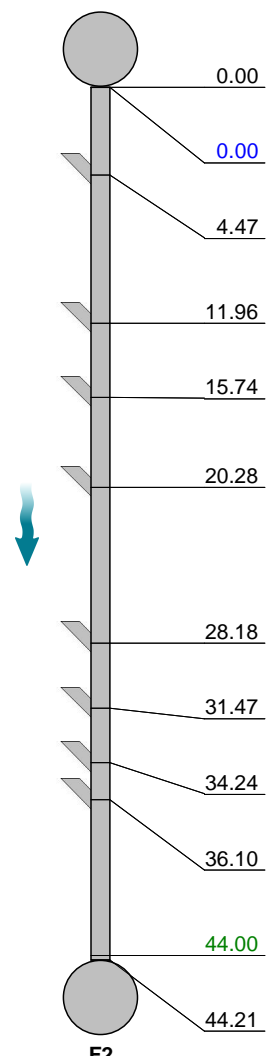
Town or Village: Solihull	Inspection Direction: Downstream	Upstream Node: F1
Road: Auckland Drive	Inspected Length: 44.21 m	Upstream Pipe Depth: 0.850 m
Location:	Total Length: 44.21 m	Downstream Node: F2
Surface Type:	Joint Length:	Downstream Pipe Depth:
Use: Foul	Pipe Shape: Circular	
Type of Pipe: Gravity drain/sewer	Dia/Height: 100 mm	
Flow Control: No flow control	Material: Polyethylene	
Year Constructed: Not Specified	Lining Type: No Lining	
Inspection Purpose: Post completion condition survey	Lining Material: No Lining

<table><tr> <td style="text-align: right;">0.00</td> <td>MH</td> <td>Start node, manhole, reference: F1</td> <td style="text-align: right;">00:00:00</td> </tr></table>

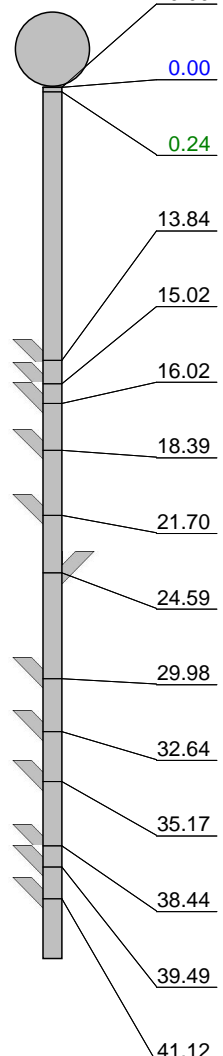
Town or Village: Solihull	Inspection Direction: Downstream	Upstream Node: F2
Road: Auckland Drive	Inspected Length: 52.07 m	Upstream Pipe Depth: 1.490 m
Location:	Total Length: 52.07 m	Downstream Node: F3
Surface Type:	Joint Length:	Downstream Pipe Depth:
Use: Foul	Pipe Shape: Circular	
Type of Pipe: Gravity drain/sewer	Dia/Height: 100 mm	
Flow Control: No flow control	Material: Polyethylene	
Year Constructed: Not Specified	Lining Type: No Lining	
Inspection Purpose: Post completion condition survey	Lining Material: No Lining

<table><tr> <td style="text-align: right;">0.00</td> <td>MH</td> <td>Start node, manhole, reference: F2</td> <td style="text-align: right;">00:00:00</td> </tr></table>

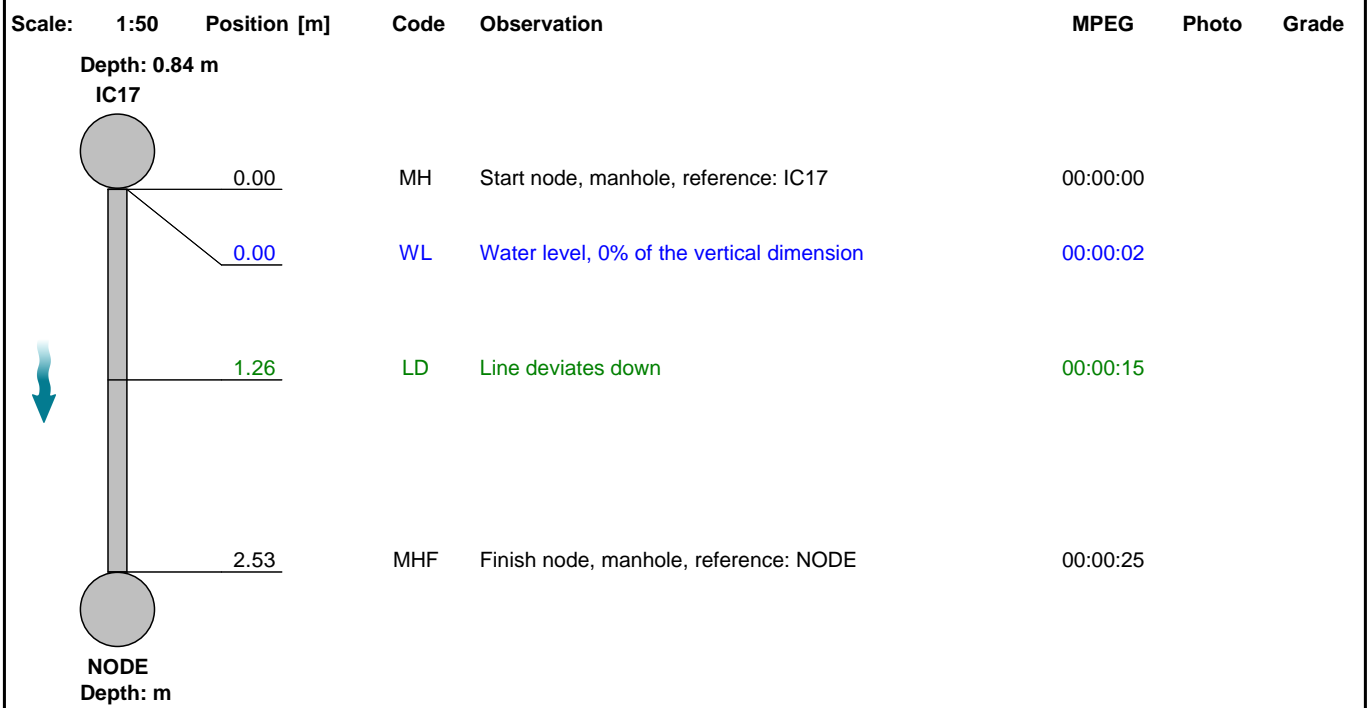
**Section Inspection - 25/08/2023 - IC17X**

Town or Village: Solihull	Inspection Direction: Downstream	Upstream Node: IC17
Road: Auckland Drive	Inspected Length: 2.53 m	Upstream Pipe Depth: 0.840 m
Location:	Total Length: 2.53 m	Downstream Node: NODE
Surface Type:	Joint Length:	Downstream Pipe Depth:
Use: Foul	Pipe Shape: Circular	
Type of Pipe: Gravity drain/sewer	Dia/Height: 100 mm	
Flow Control: No flow control	Material: Polyethylene	
Year Constructed: Not Specified	Lining Type: No Lining	
Inspection Purpose: Post completion condition survey	Lining Material: No Lining

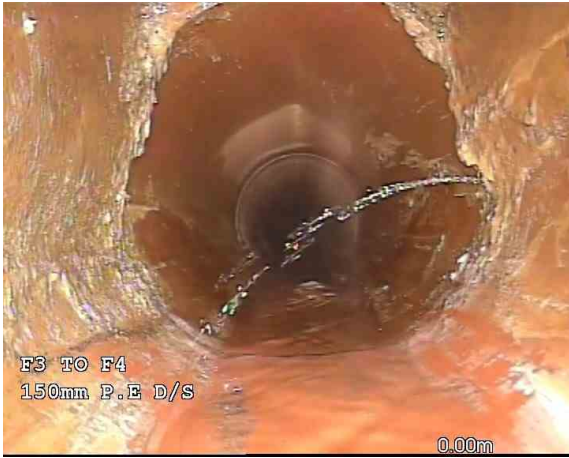
F3X\_eaa49116-6e70-43e8-9044-8524c720c29c\_20230907\_1  
15657\_277.jpg, 00:00:05, 0.00 m  
Infiltration, running at joint at 3 o'clock, IN MH

Scale: 1:294	Position [m]	Code	Observation	MPEG	Photo	Grade
	0.00	MH	Start node, manhole, reference: F3	00:00:00		
	0.00	WL	Water level, 10% of the vertical dimension	00:00:05		
	0.00	IRJ	Infiltration, running at joint at 3 o'clock: IN MH	00:00:05	F3X_eaa4 9116-6e70 -43e8-904	
	33.64	IRJ	Infiltration, running at joint at 9 o'clock: IN MH	00:02:18	F3X_dfe36 d74-ff05-4 c8a-81e5-	
	33.91	MHF	Finish node, manhole, reference: F4	00:02:27

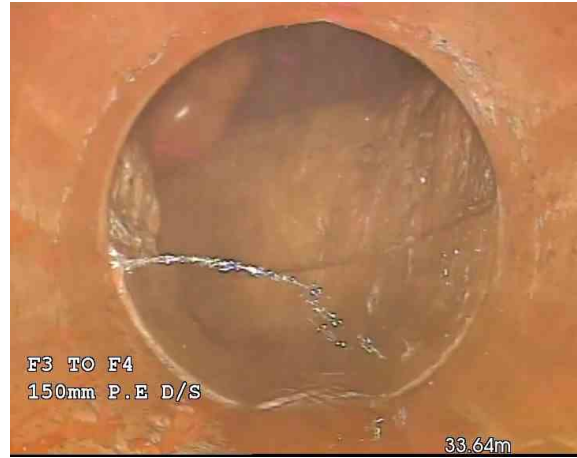
F3X\_dfe36d74-ff05-4c8a-81e5-2ba0df47674a\_20230907\_115  
940\_407.jpg, 00:02:18, 33.64 m  
Infiltration, running at joint at 9 o'clock, IN MH
