East Elevation

PROPOSED EAST ELEVATION LINE

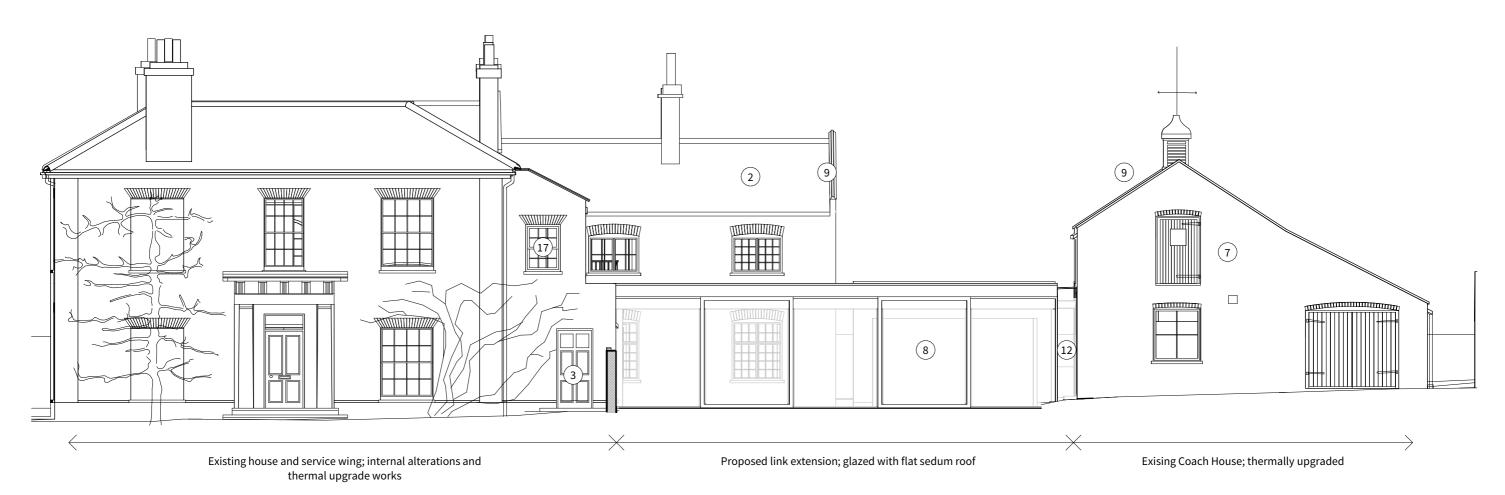
- Proposed red brick in Flemish bond.

Glazed black pantiles; tiles and ridge tiles to be carefully removed and reinstated following insulation and struc
- Proposed painted timber door.
- Proposed painted lime render.
- Stable partitions; existing retained and refurbished.

Brickwork repair; brickwork to be repaired in matching brick and mortar.

Proposed glazing and sliding doors; hardwood frame internally and hardwood capping externally
- Parapet capping to be removed and reinstated following re-roofing and flashing works.
- 10. Photovoltaic panels (shown indicatively, sizing TBC).
- Link roof; single ply membrane with sedum blanket.
 Frameless glass "slot".
- 13. Conservation rooflight.
- 14. Glazed black pantiles.
- 15. Vertical timber cladding and matching garage doors.
 16. Air source heat pump (indicative; size and specification TBC).
 17. Proposed painted hardwood sash window

18. Proposed hardwood window behind existing timber door NOTE: Existing windows to be thermally upgraded with either secondary glazing or slimline double glazed
