## **REMEDIATION METHOD STATEMENT**

**BARN AT DUCK END FARM  
GREEN ROAD  
LINDSELL  
DUNMOW  
CM6 3QH**

**Reference Number 3293/Rpt 2v1  
July 2023**

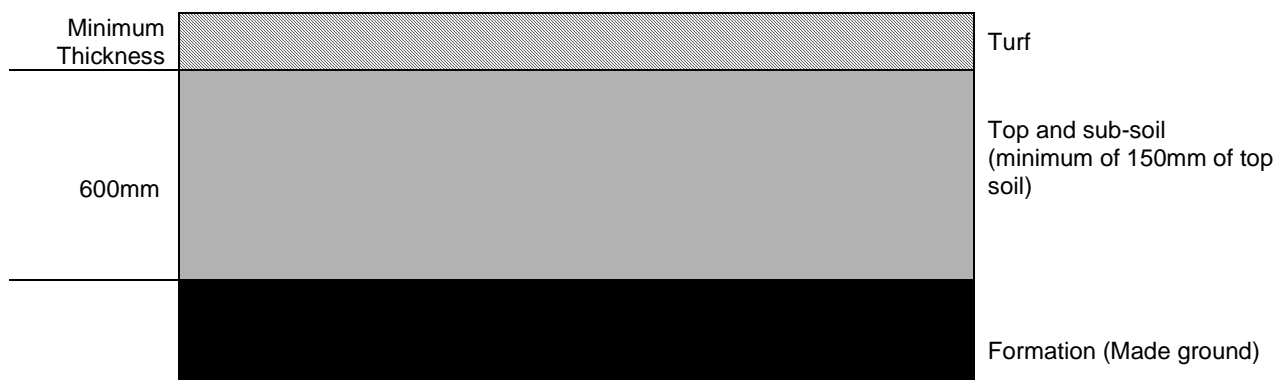
Following the verification should any contaminated made ground still be present in the base of the excavated area a cover system will be placed. If all contaminated made ground has been removed, a cover system will not be required. Details of the cover system are presented below:

The soils imported to make up the capping layer should be of a standard suitable for a residential end use. The soils must be physically suitable for the intended use and be free from deleterious materials such as glass, plastic, wood, paper etc. It is recommended that topsoil should generally comply with the requirements of the specification for multigrade topsoil as given in BS 3882: 2015 or to the satisfaction of the landscape architect. All top and sub-soil that is used for the capping layer must conform to the chemical specification detailed in Appendix II.
