REMEDIATION METHOD STATEMENT

**OAK HILL FARM
COXES FARM ROAD
BILLERICAY
CM11 2UA**

**Reference Number 3015/Rpt 3v1
March 2023**

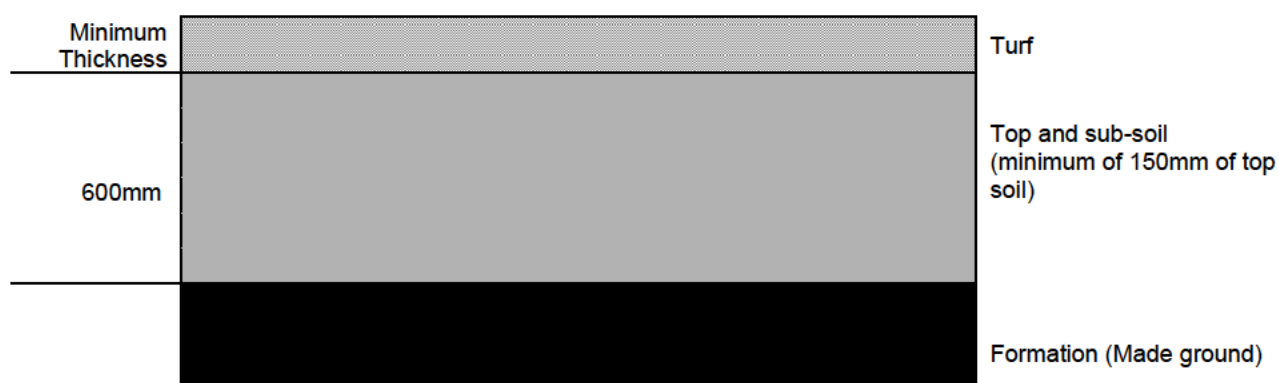
Private Gardens

If all the made ground has been removed and confirmation is provided by verification sampling, the area will be reinstated back to the required finished garden level using clean suitable top and sub soil. If contaminated made ground is still present, following the completion of the excavation, a cover system will be placed. Details of the cover system are presented below:

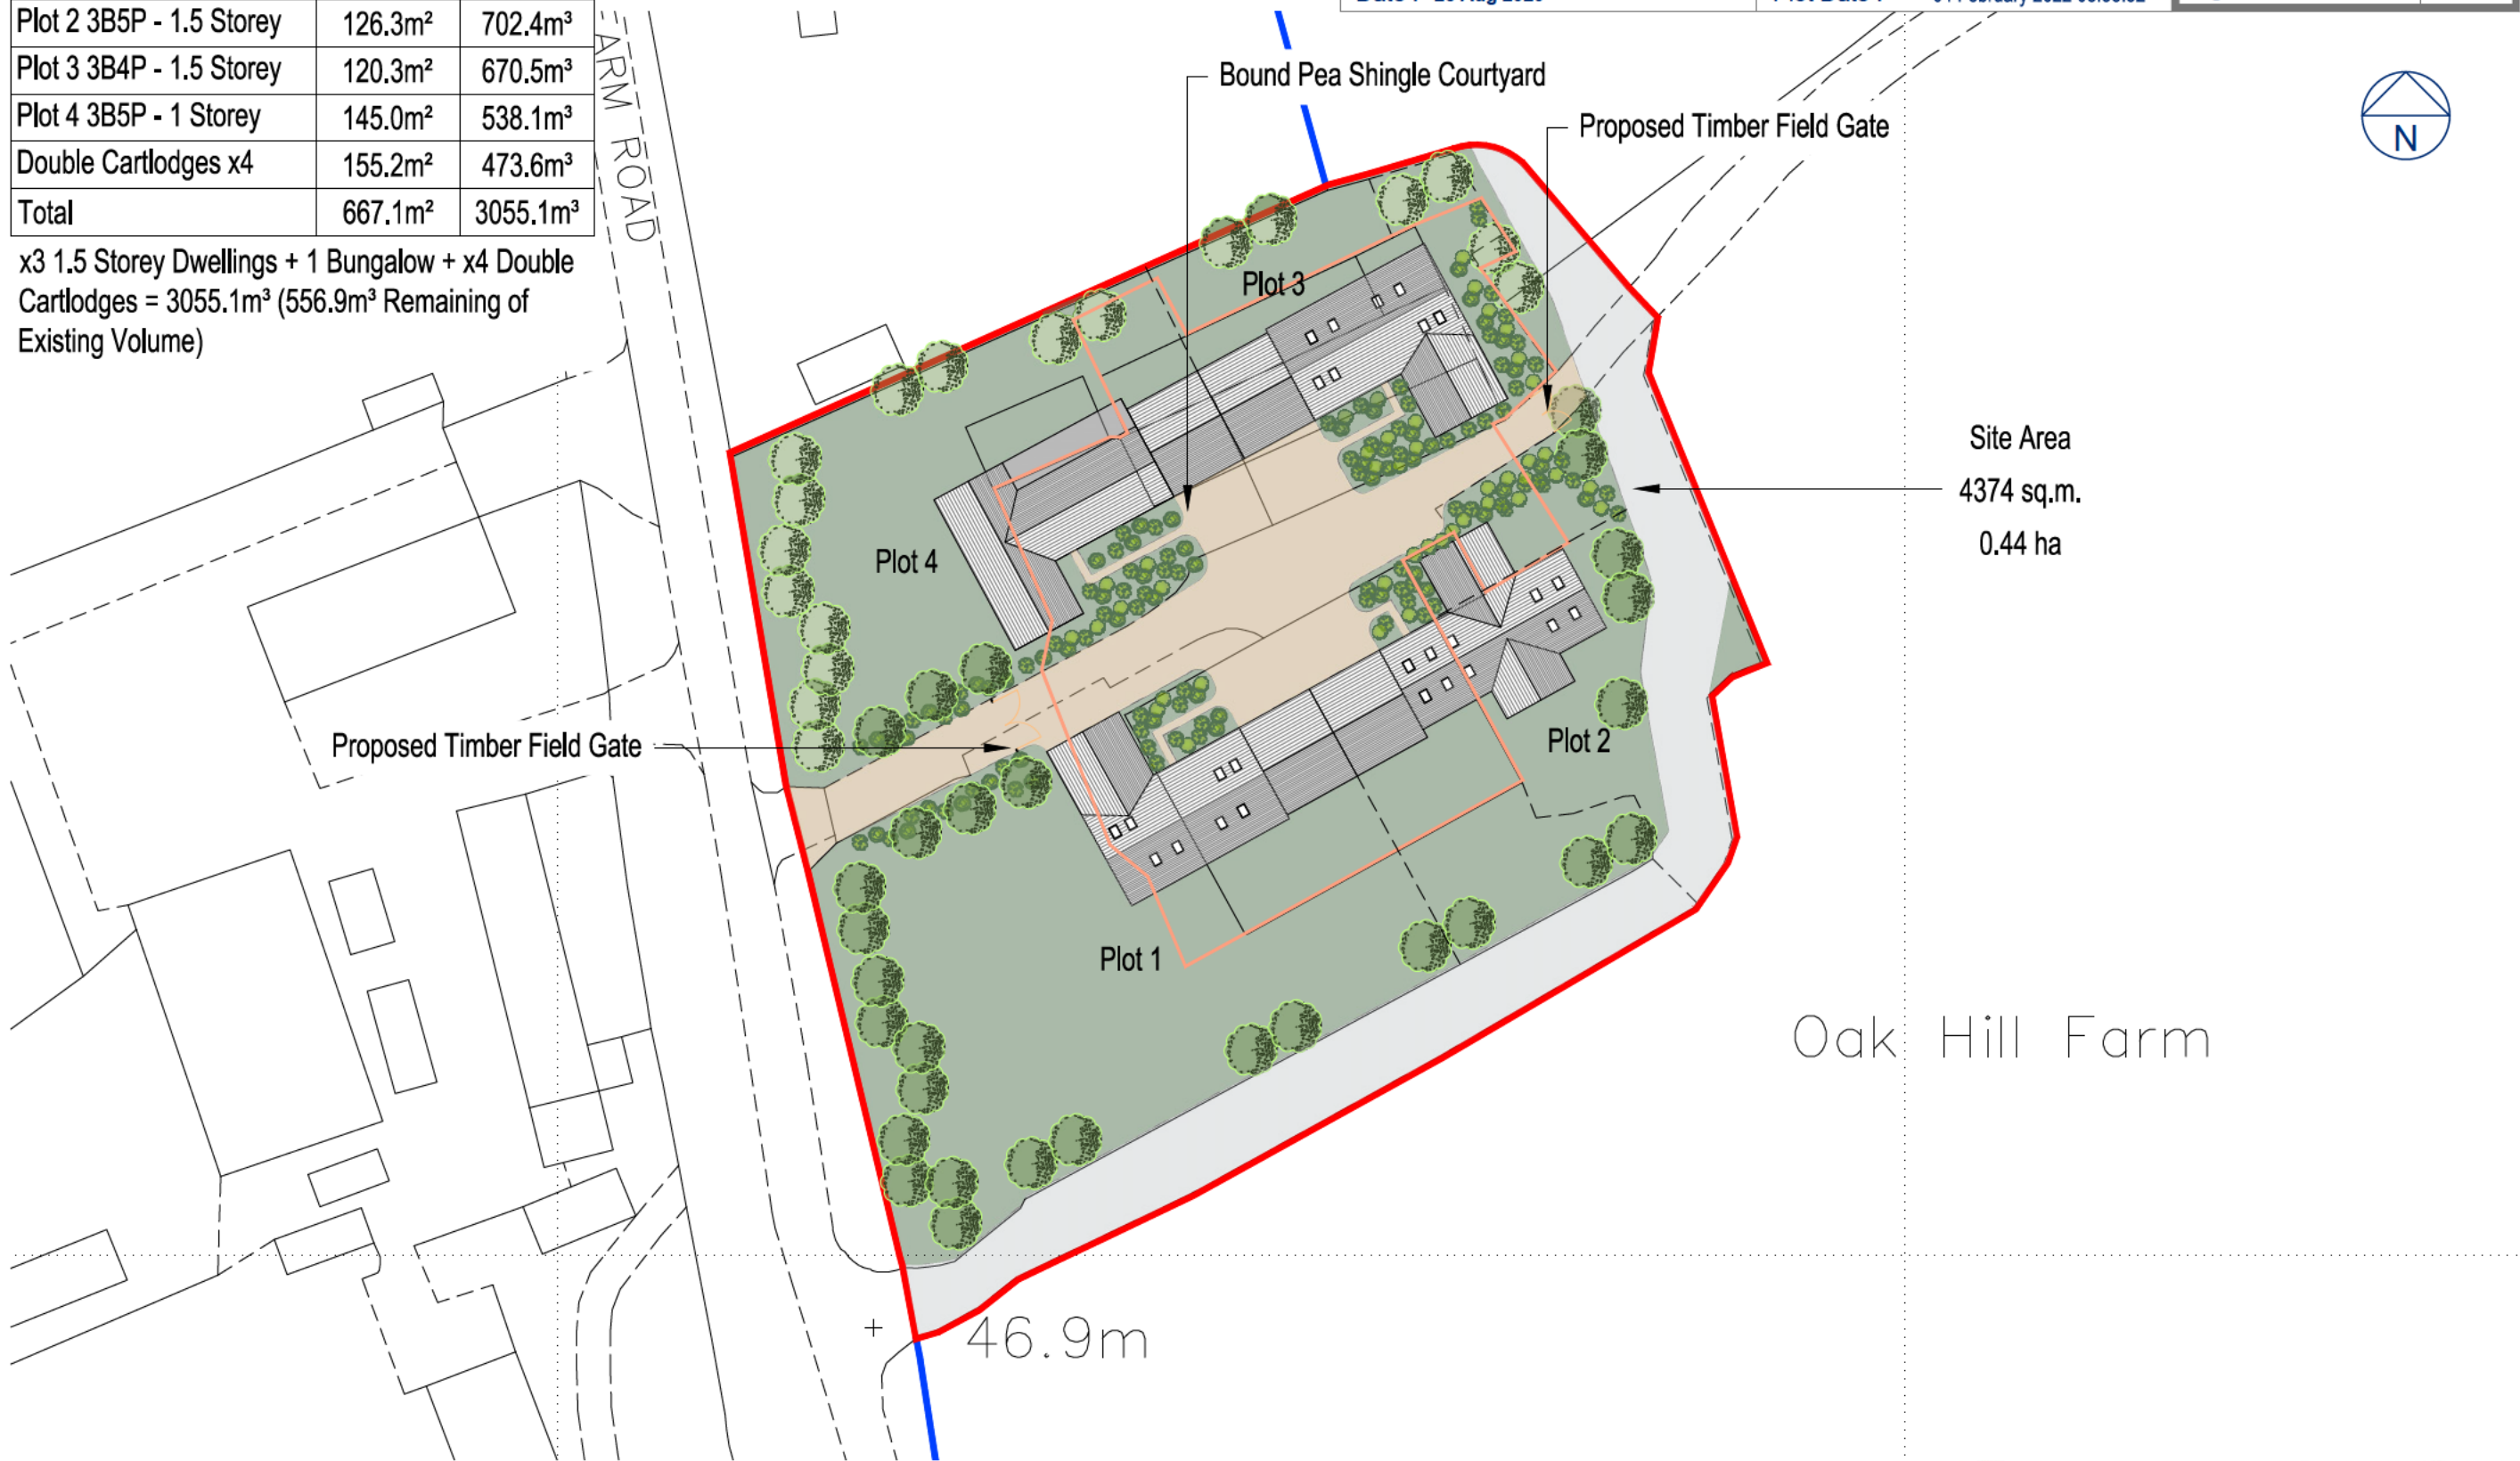
Client Name : Mr J Keeling			
Project Title : Oak Hill Farm, Coxes Farm Road, Billericay, Essex, CM11 2UA			
Drawing Name : Proposed Site Plan			
Scale : 1:500 @ A3	Drawn/Checked: MK/HW	Status : Application	Rev: A
Date : 25 Aug 2020	Plot Date : 04 February 2022 08:58:52	Dwg No : 20.7268/P201

x3 1.5 Storey Dwellings + 1 Bungalow + x4 Double Cartlodges = 3055.1m³ (556.9m³ Remaining of Existing Volume)

Appendix I	Proposed Development Layout
Appendix II	Chemical Specification of Top and Subsoil
