Pavilion Gardens Gazetteer of Historical Landscape
Elements – Lamp posts, Boundary Cast Stone Wall,
Water Features, Gates and Railings for Allen Scott Ltd

P1154 Pavilion Gardens

Gazetteer of Historical Landscape Elements – Lampposts, Boundary Cast Stone Wall, Water Features, Gates and Railings.

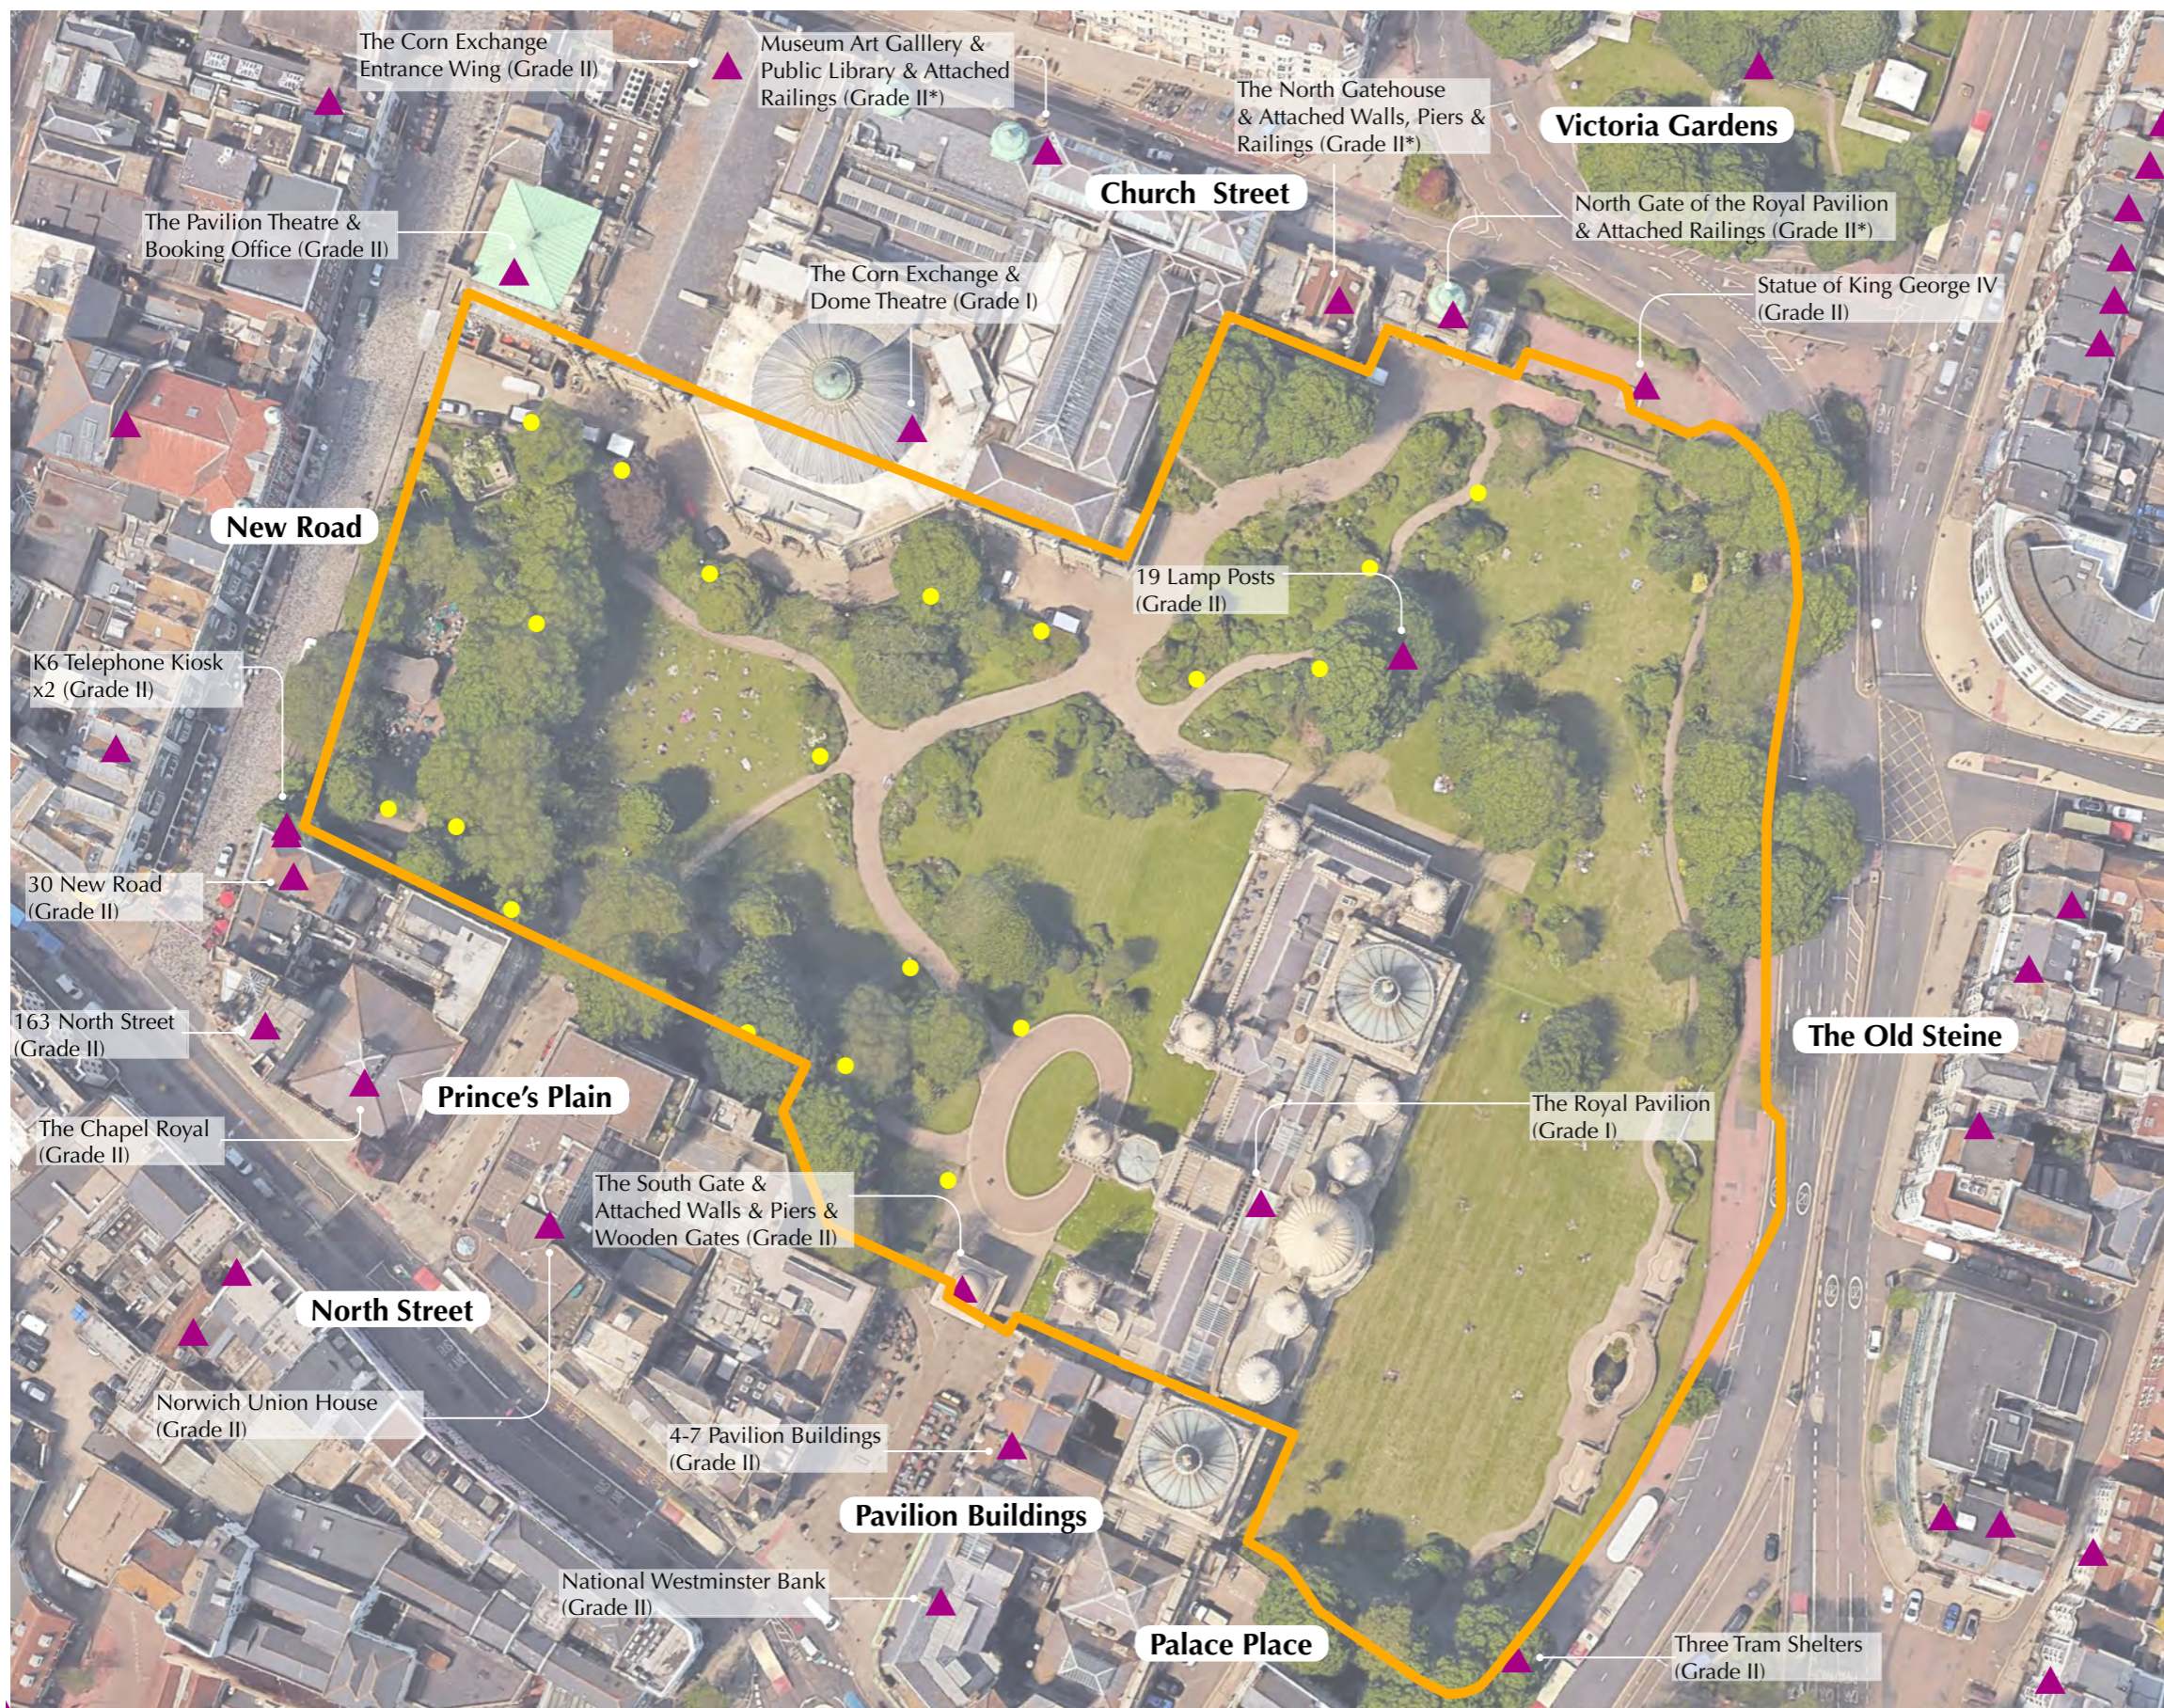
CBA Conservation Plans

- Key
- Royal Pavilion Garden, Brighton - Registered Park and Garden
 - ▲ Listed Buildings
 - Listed Lampposts

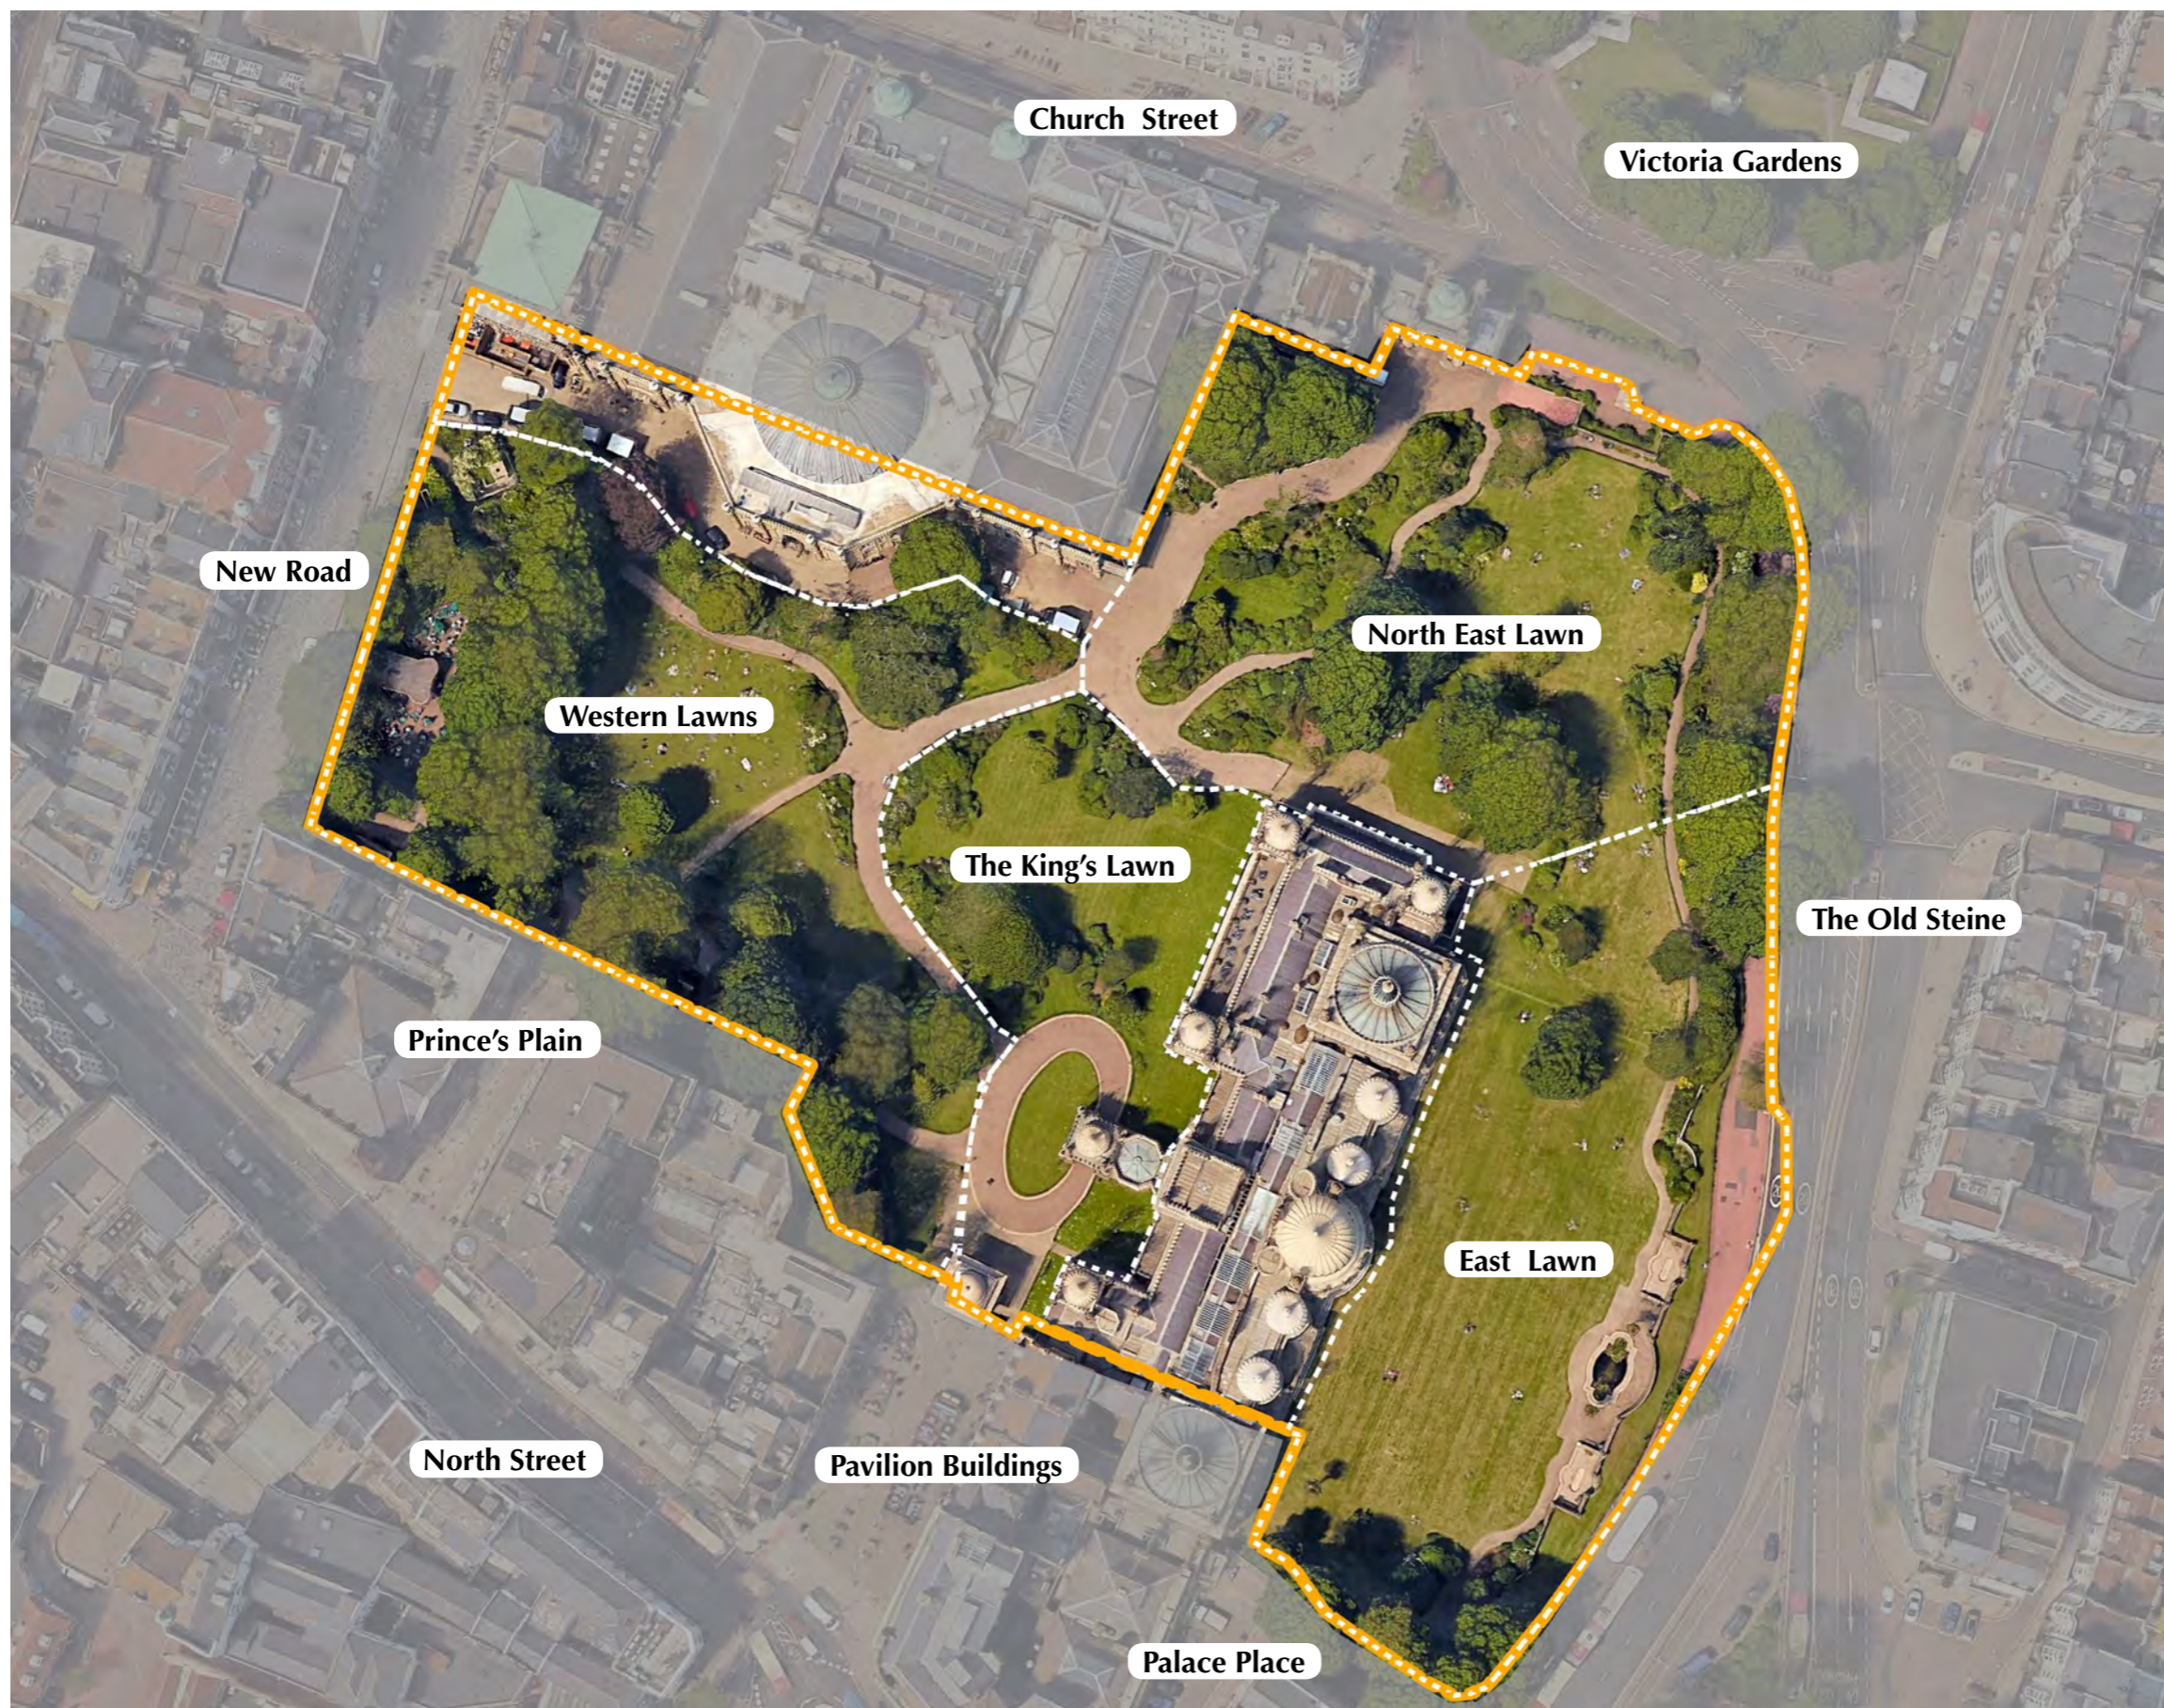
- Key
- Royal Pavilion Garden, Brighton - Registered Park and Garden
 - Compartment Boundary

Compartment Uses

- East Lawn**
- * Occasional sitting/relaxing
 - * Casual strolling/walking
 - * Photography
 - * Annual ice rink
 - * Misuse and inappropriate behaviour
- North East Lawn**
- * Casual sitting/relaxing
 - * Strolling space for public visitors
 - * A through-route for pedestrians
- Western Lawns**
- * Use of cafe
 - * Lunch breaks
 - * Relaxing
 - * Casual strolling/sitting
 - * Entertainment
 - * A through-route for pedestrians
 - * Enjoyment of historic trees
 - * Focus of anti-social behaviour
- The King's Lawn**
- * 'Private' atmosphere with minimal public use - discouraged by railings/notices
 - * Biodiversity focus - focus on butterflies and birds
 - * Occasionally used for wedding photographs and photo-shoots/filming
