# Optera Structural Solutions

## SOW 7581 Root barrier quotation on behalf of GHG Solutions Ltd.

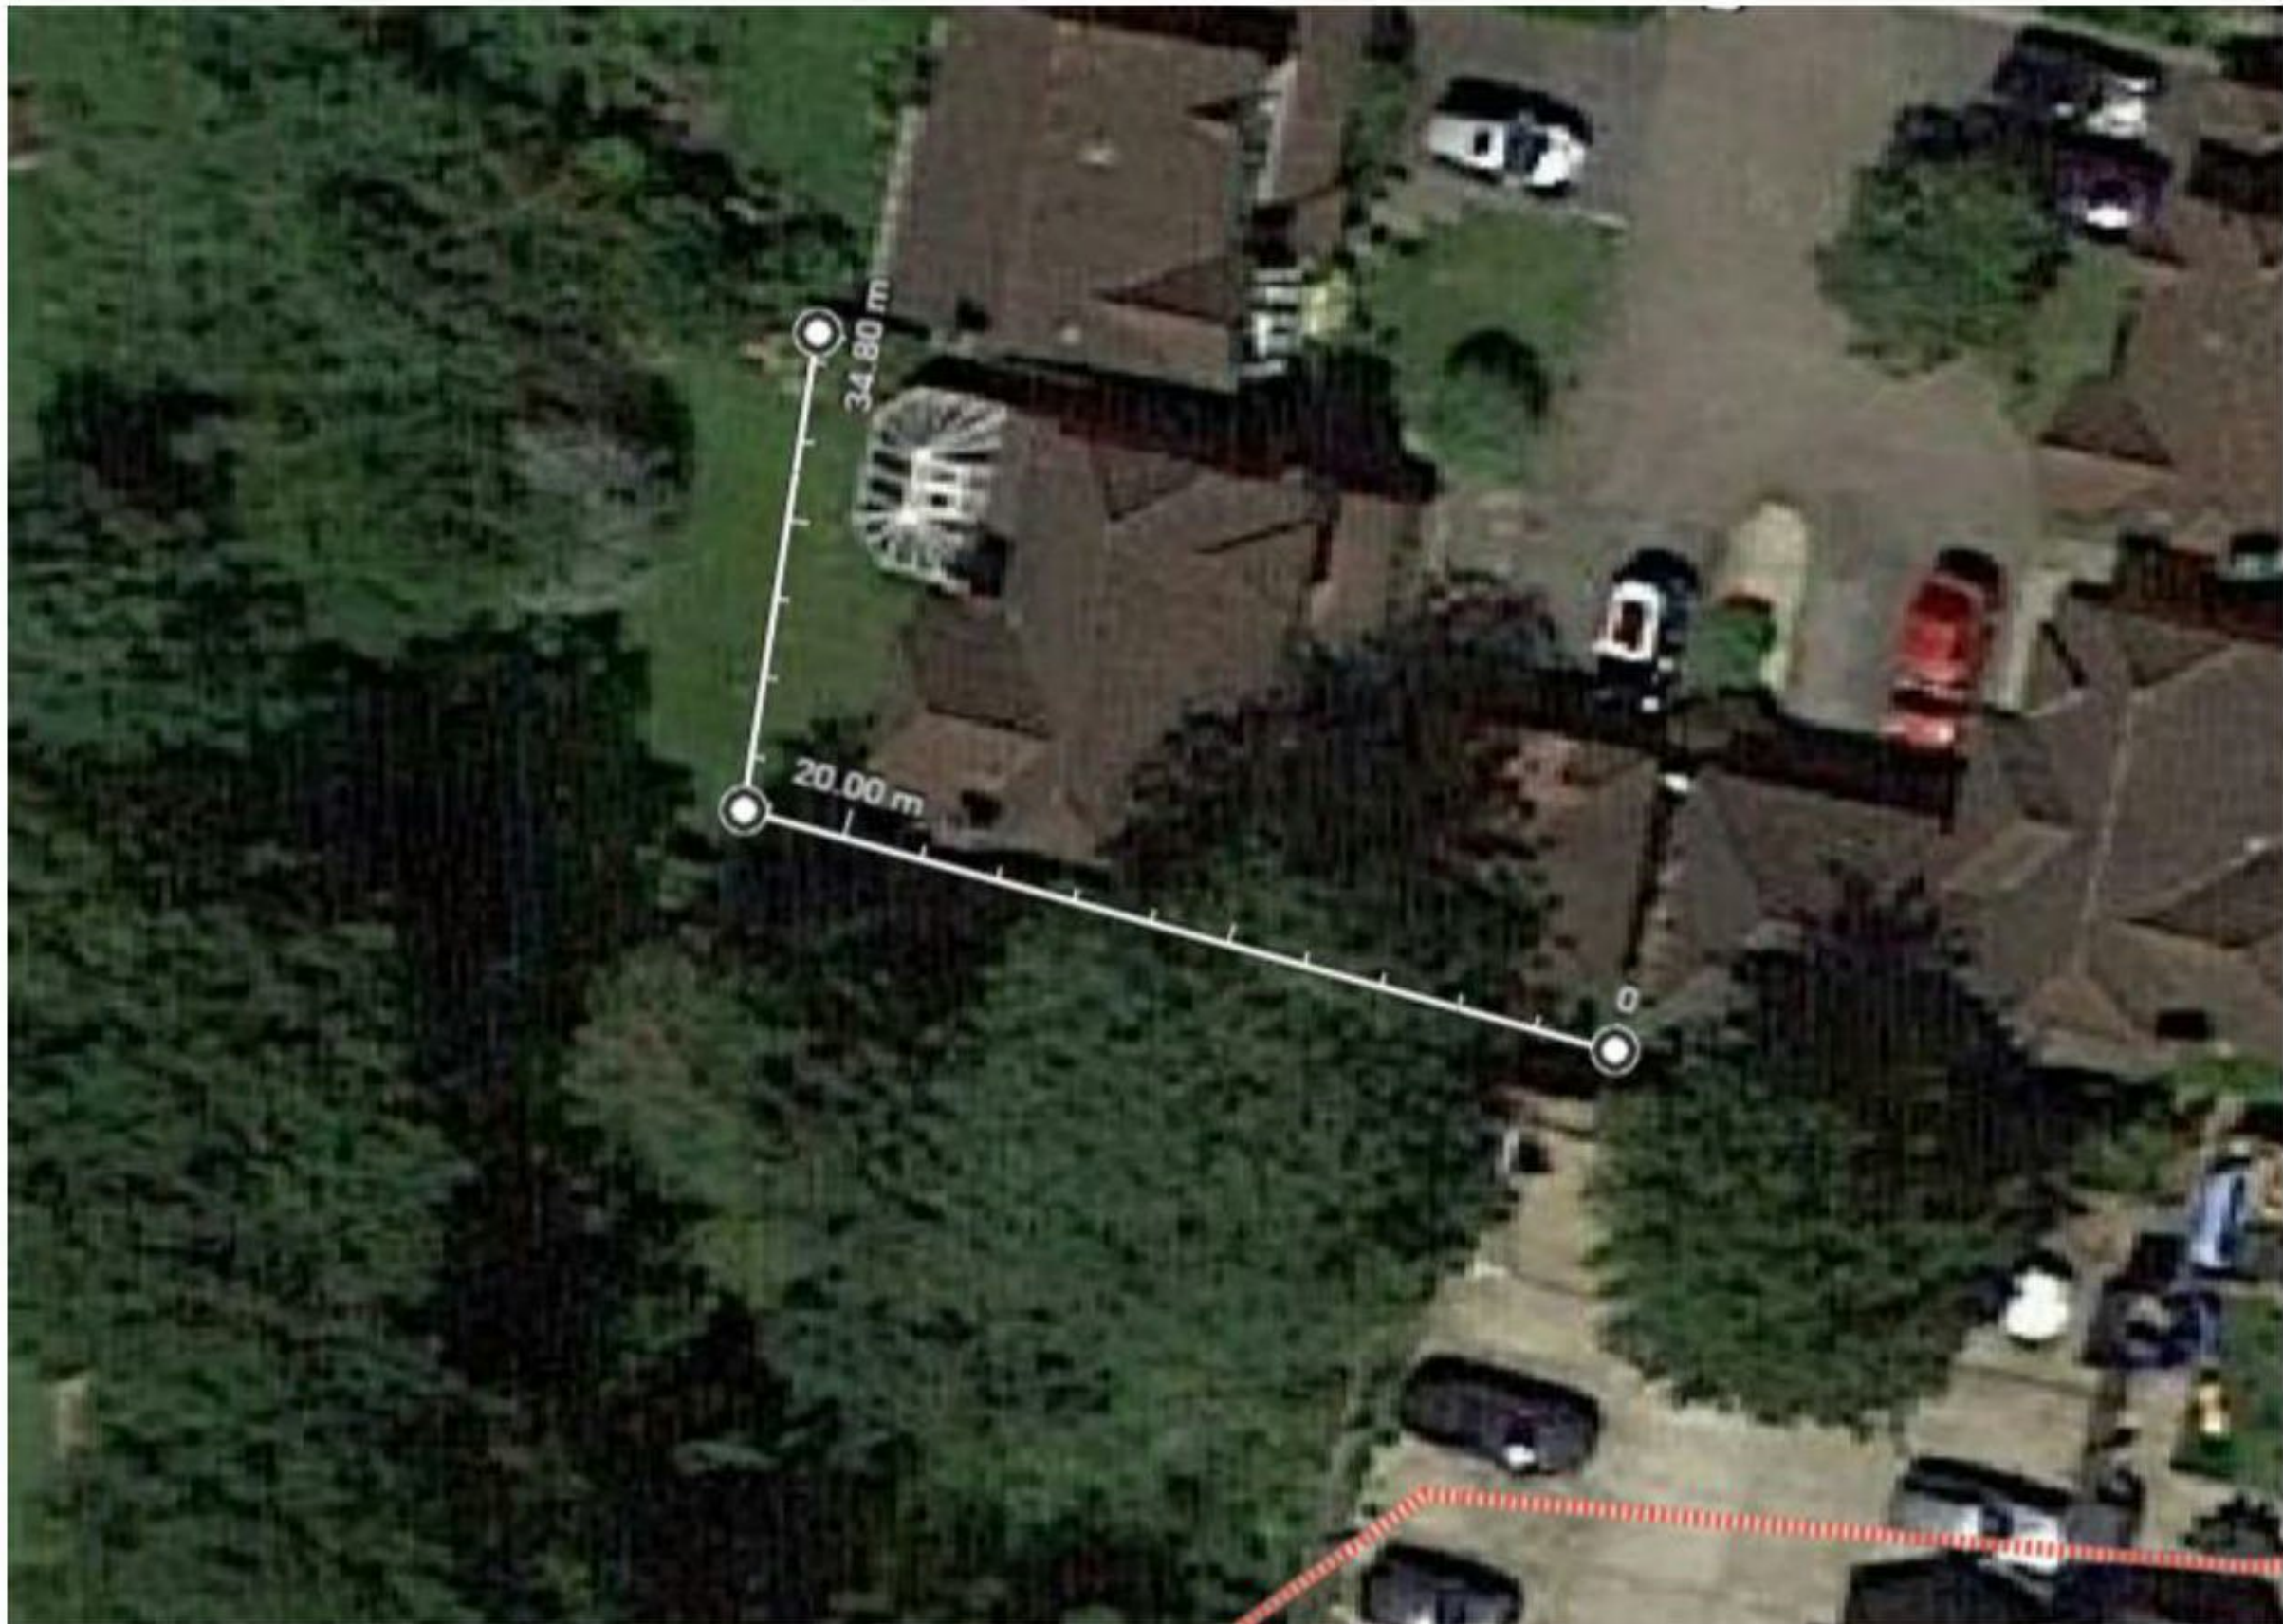
**Aerial plan of proposed 35m barrier option to the rear of the risk address.**

Specifications of Barrier					
Barrier Type	Length (m)	Max Root Depth from SI (m)	Minimum depth to be achieved with barrier (m)	Shortest distance between vegetation and barrier (m)	Shortest distance between barrier and foundation (m)
Copper	35	3.3	3.7	4	1

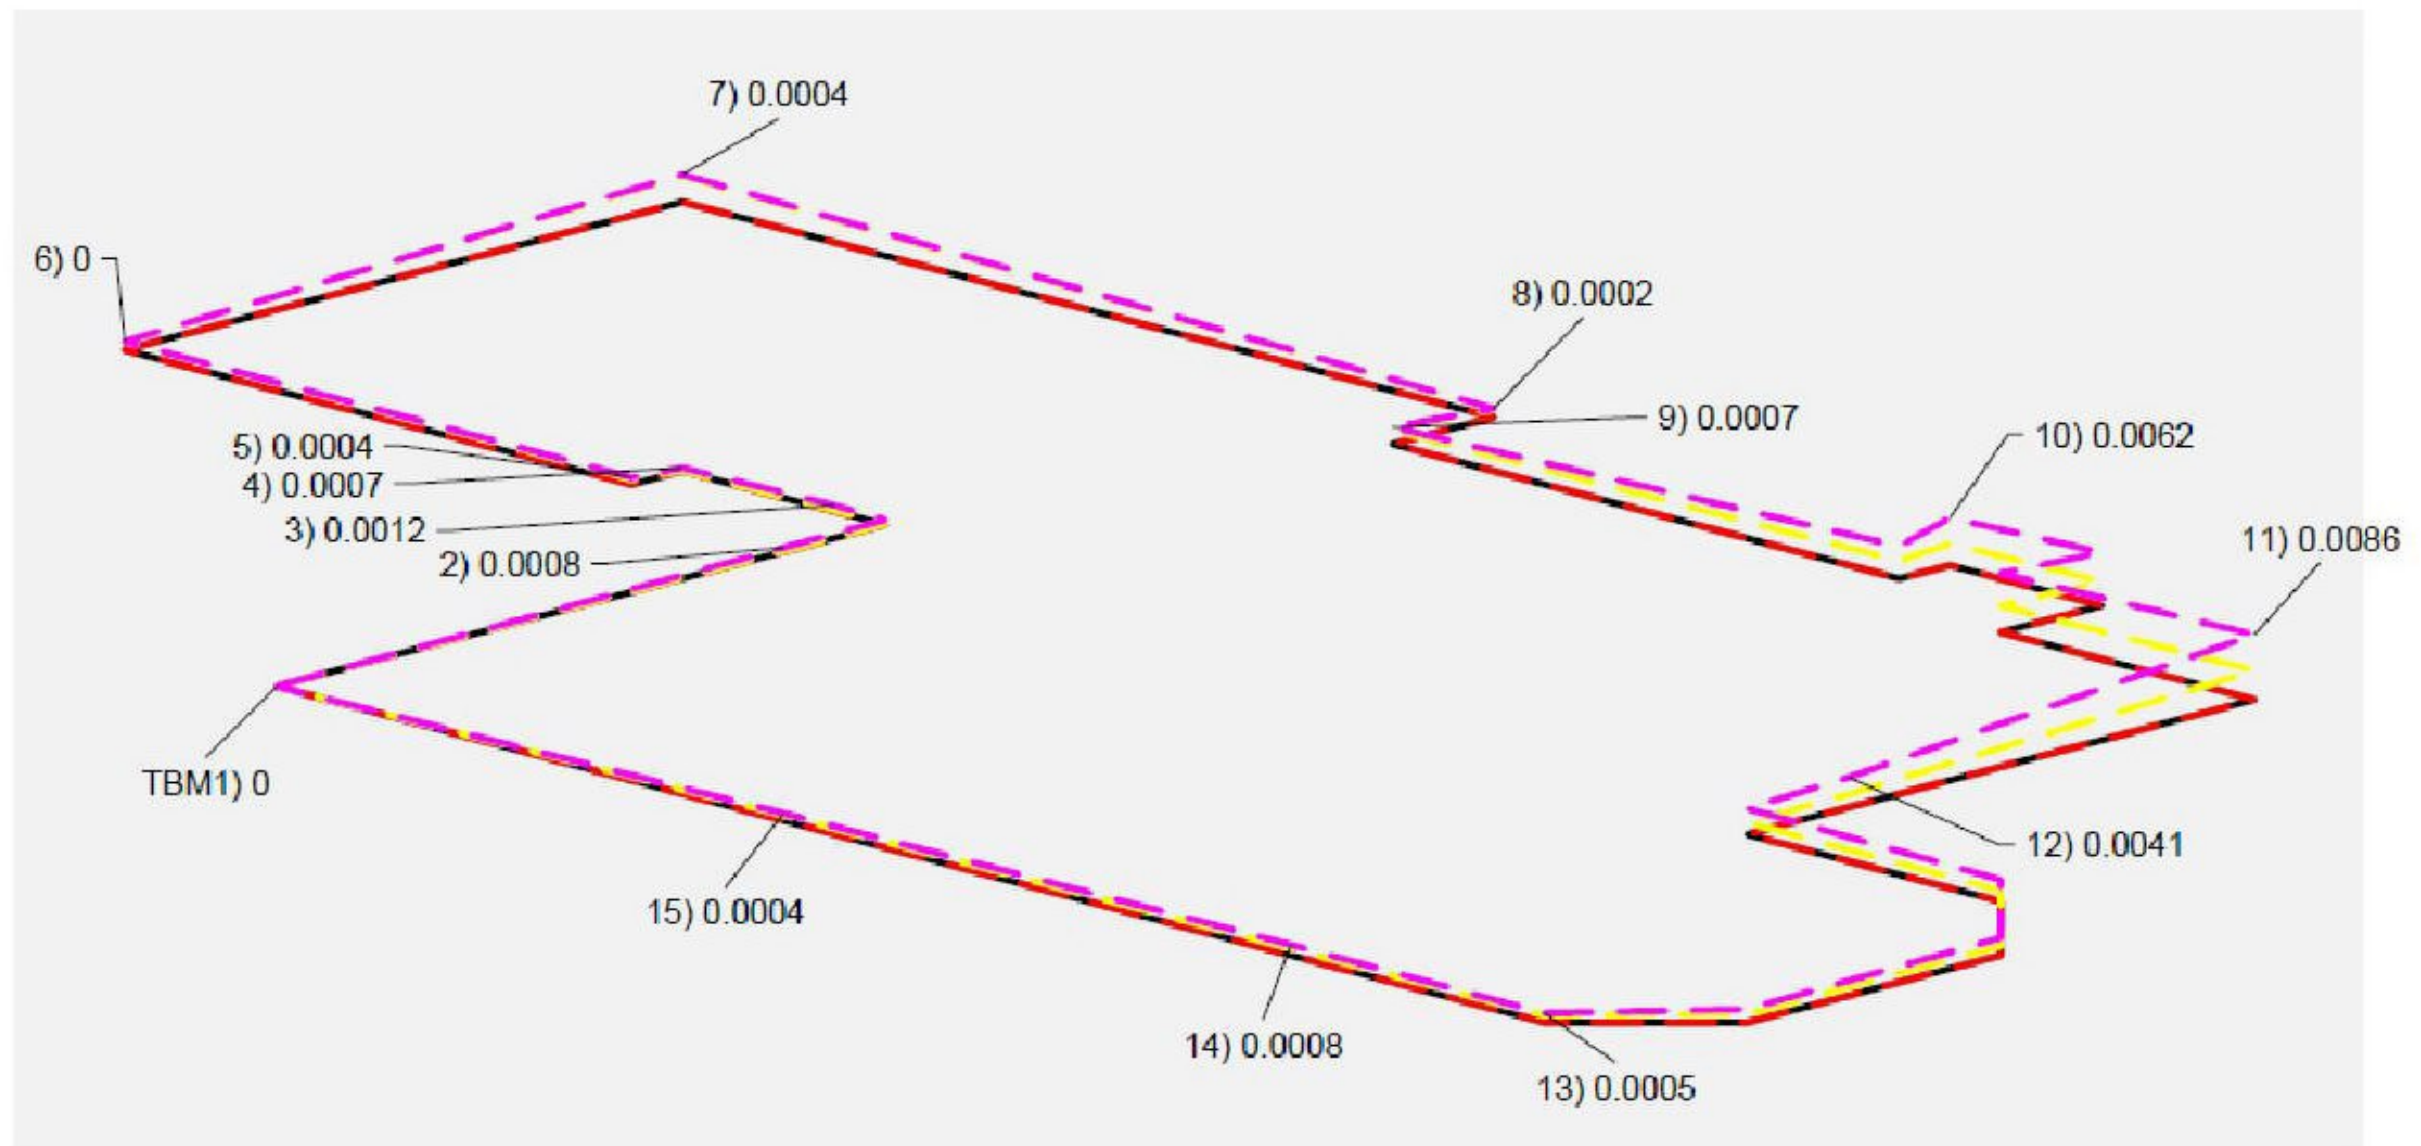
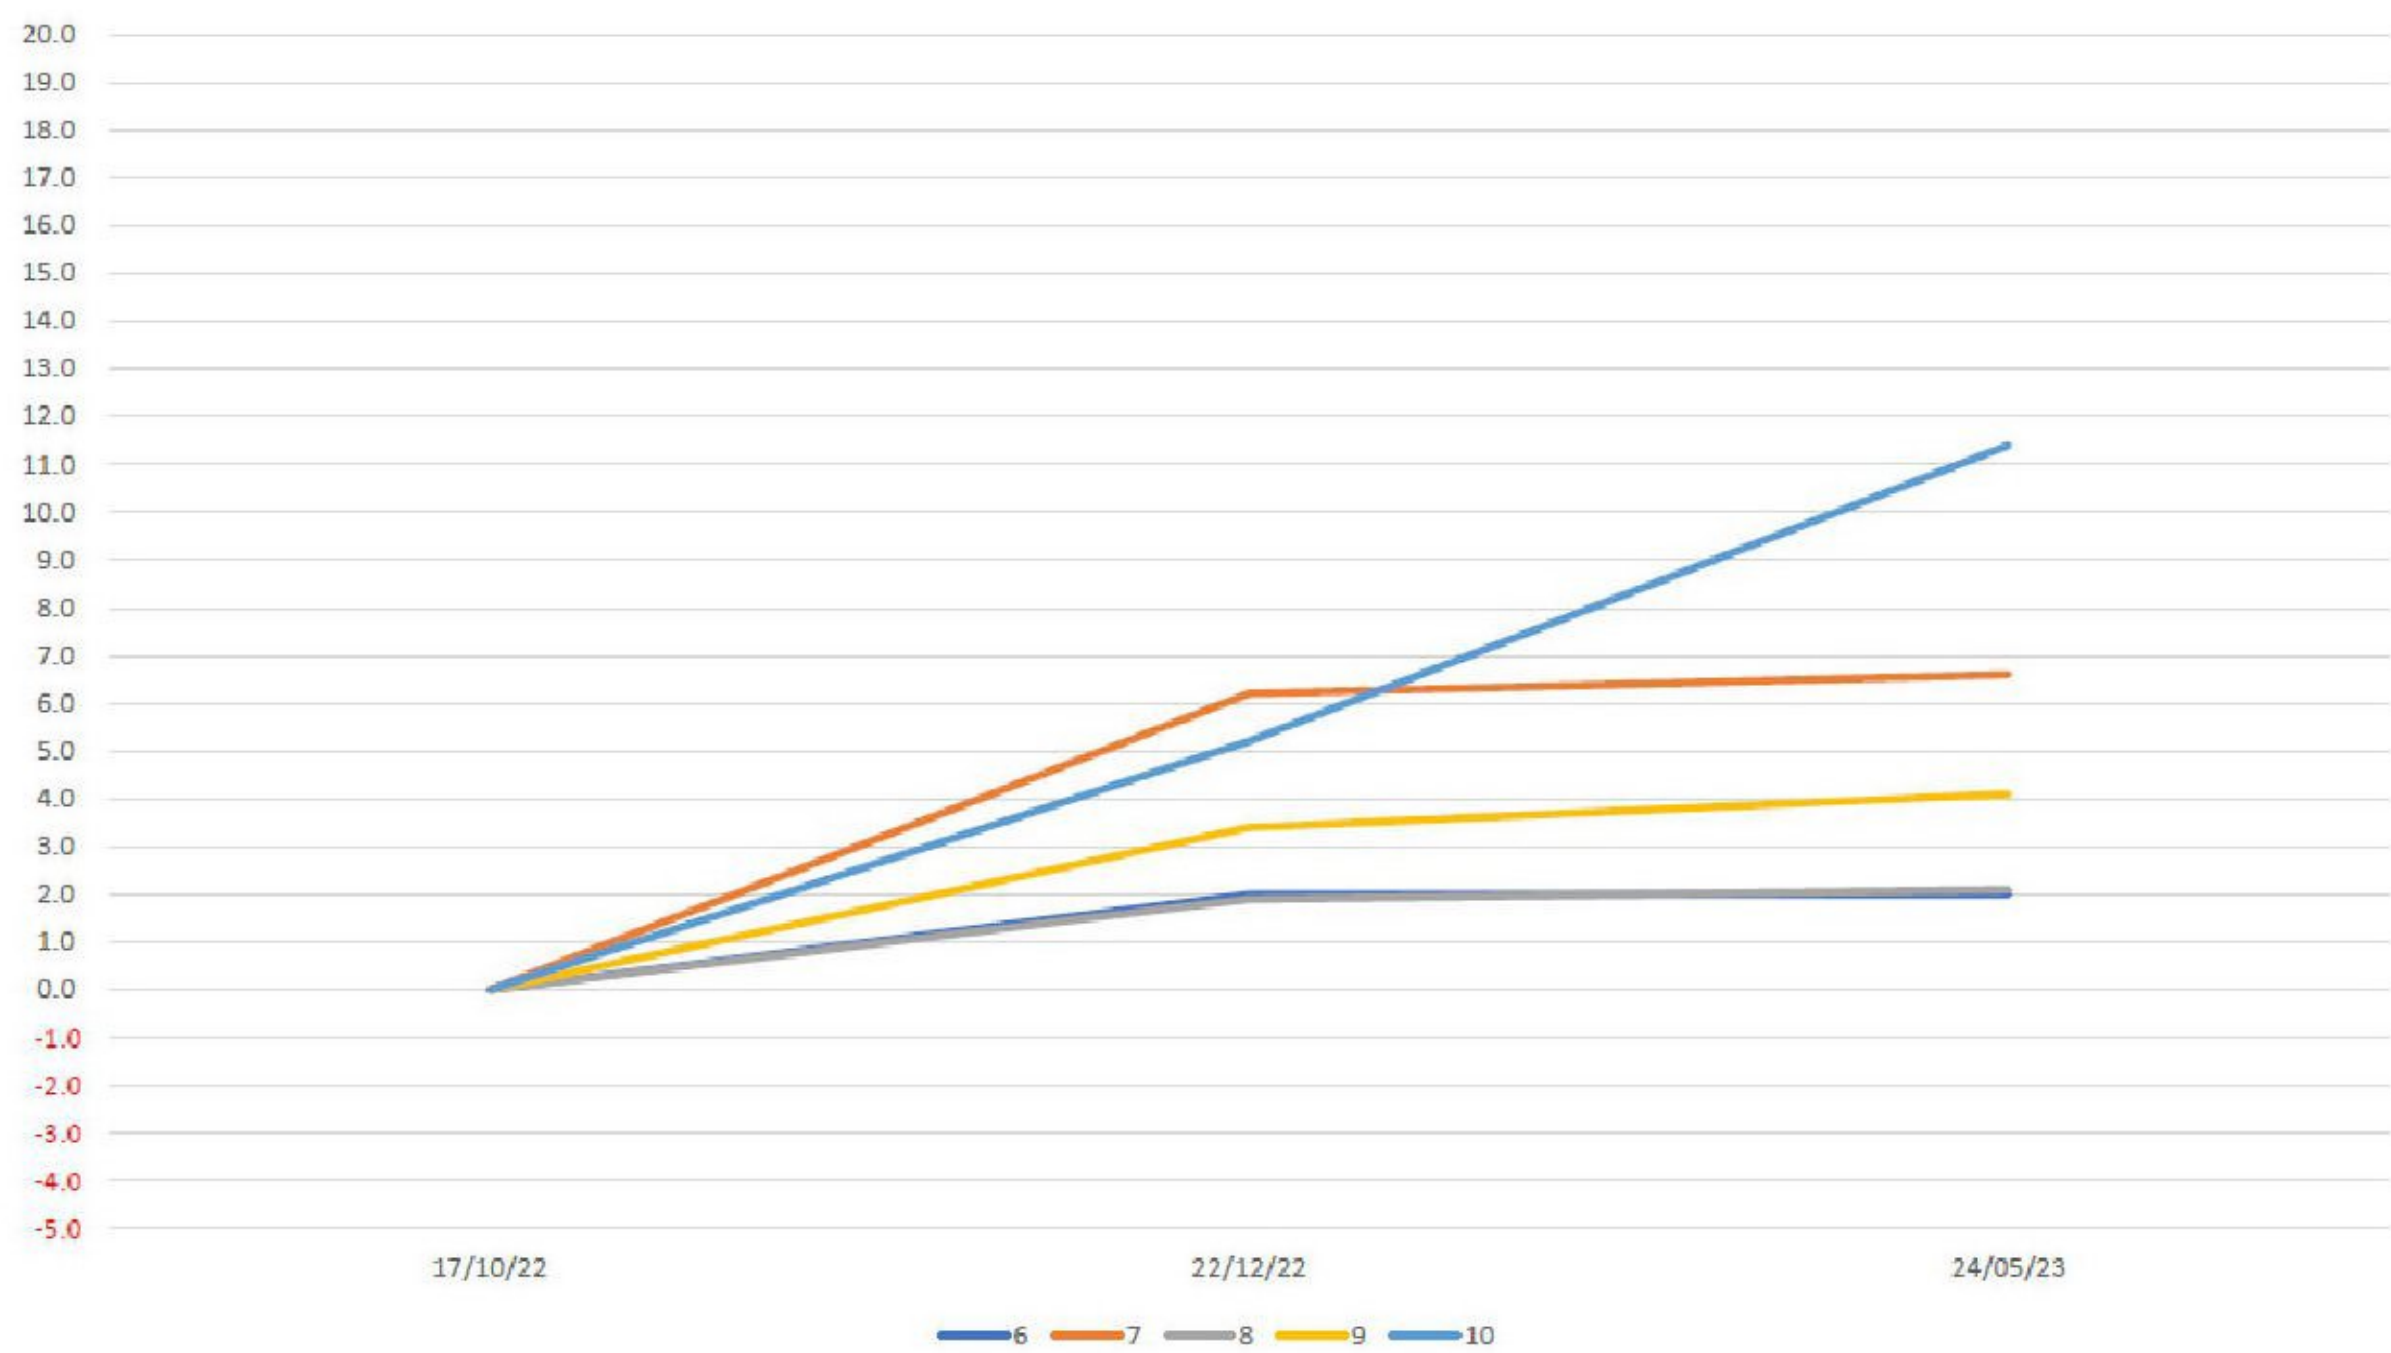
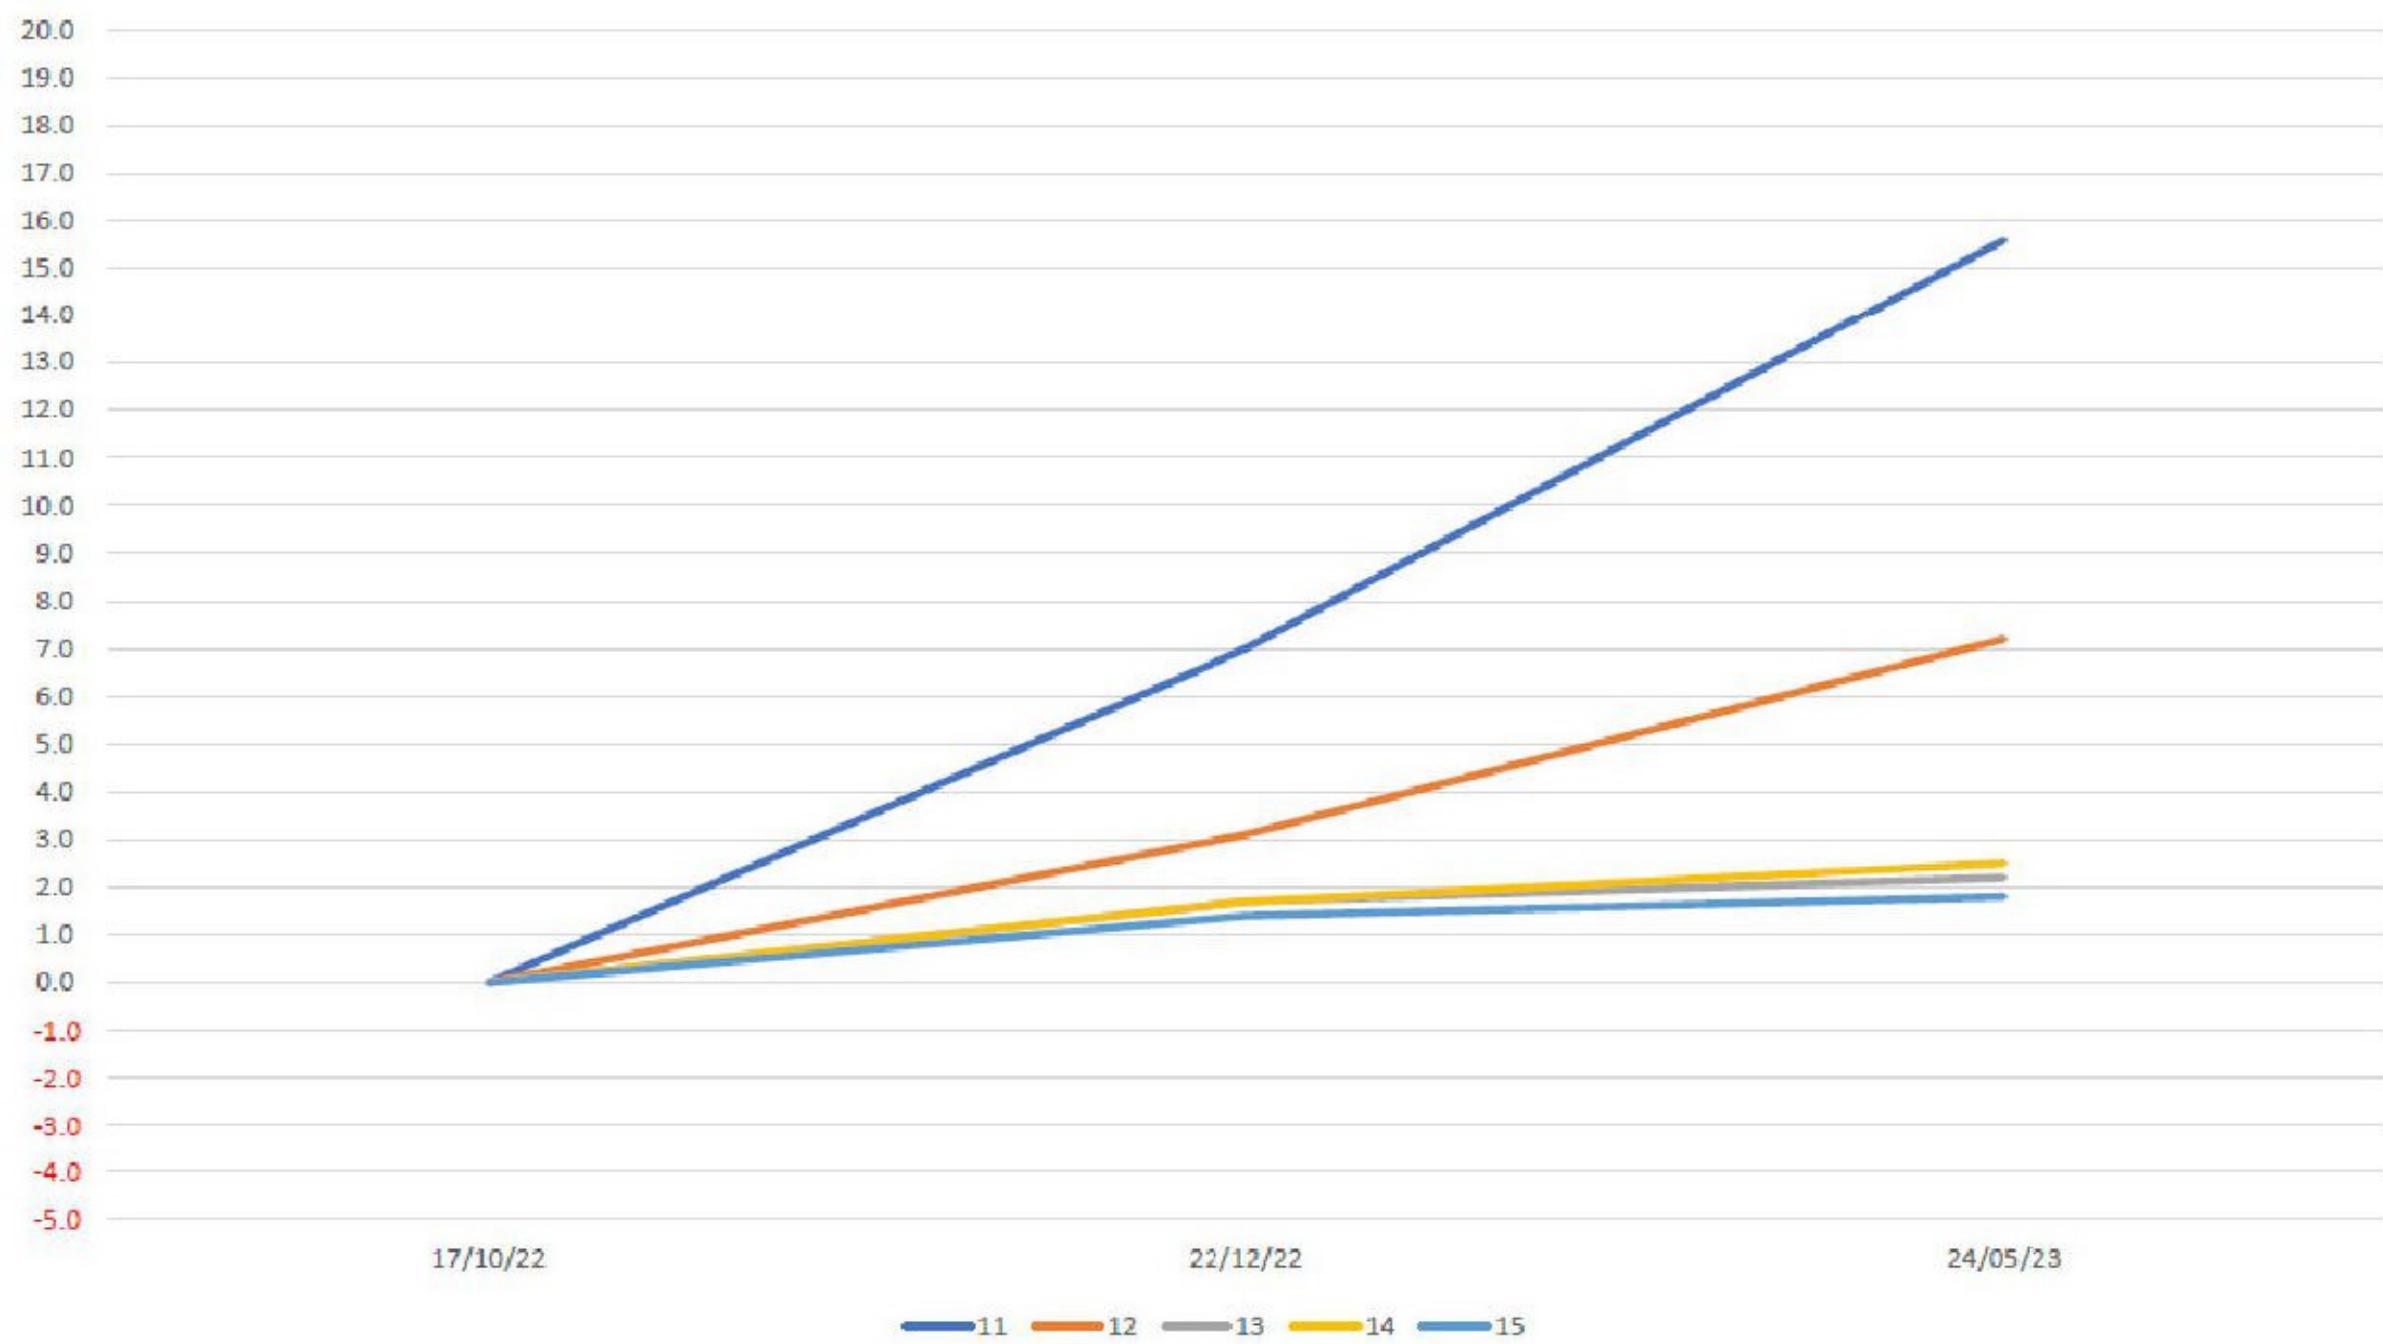
Level monitoring has been ongoing since October 2022 when the most recent movement was noted, following the previous repairs. This shows a marked upward movement, particularly focused around points 10 and 11. The upward movement is only relevant in terms of the timing of the readings. The monitoring was initiated too late in the year to detect downward movement and the upward recovery is assumed to correlate with the areas which experienced the most downward during the preceding summer period.

Upward movement is only witnessed in clay soils and is confirmatory of the cause as root induced clay shrinkage.

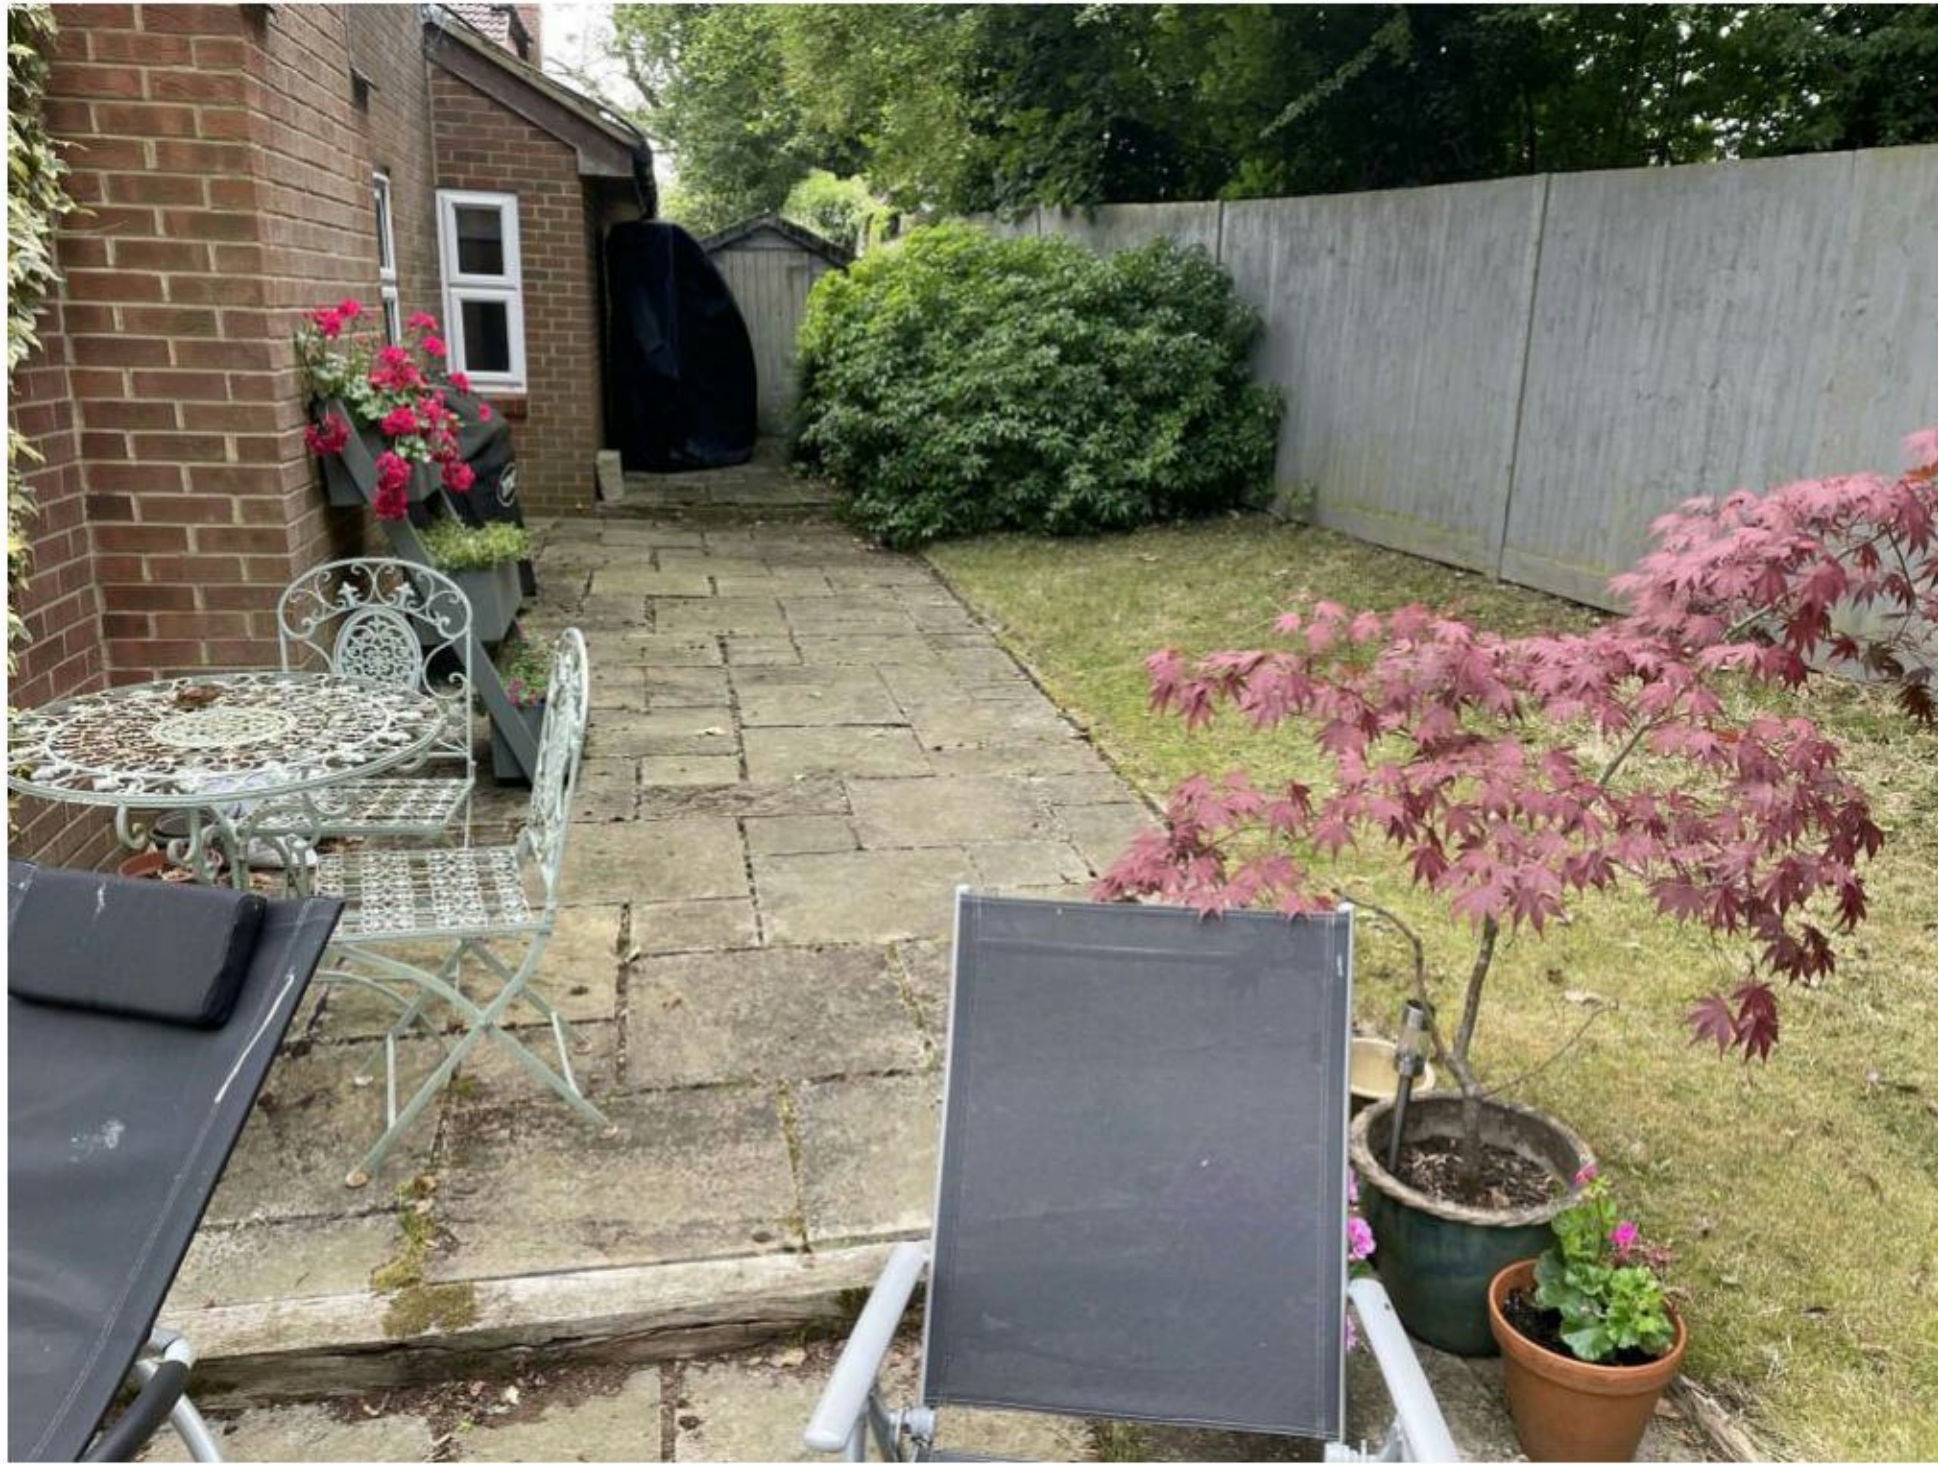
**Photo shows the paving down the left hand side of the house which will need to be lifted and relaid.**

The process is then repeated until all 35m of the barrier has been dug and installed. Any residual spoil will be loaded into tracked barrow and conveyed to the front of the property where it will be sotred on boards and periodiclaly collected by grab lorry. The trench will be topped up across the patio area with compacted type 1 MOT stone to formation level and across the lawn with compacted topsoil. The trecnh will be seeded with grass seed across the lawn and the slabbed area will be relaid with a full mortar bed. The slabs will be pointed with a resin pointing compound.

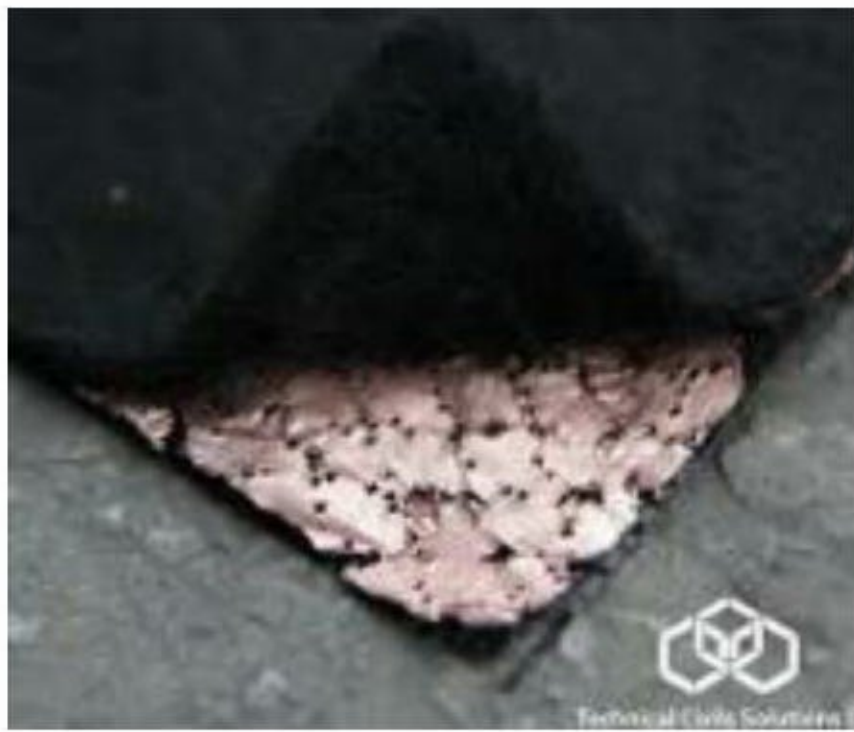
The Copper signal barrier details a copper foil securely bonded between porous geotextile, releasing copper ions and forming copper carbonate (verdigris) that signals an adverse reaction to roots deflecting them away from the barrier. The presence of copper does not constitute an eco-system burden or impact on groundwater

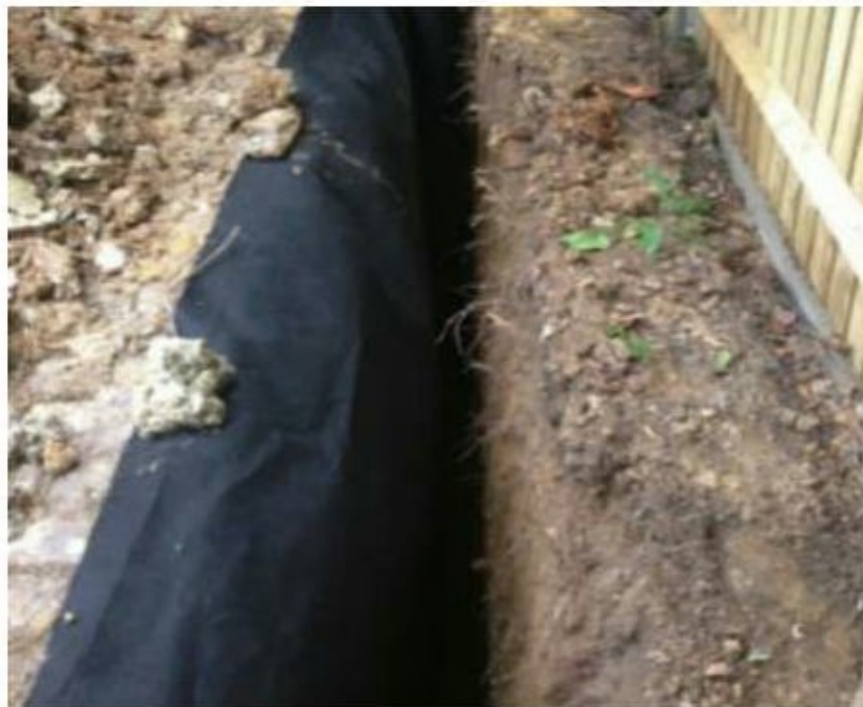
This solution is multipurpose and ideally suited to the current application. Traditional impervious barriers divert rather than stop roots and may block moisture movement. Also, roots getting under such barriers can grow back to the surface. Therefore, the use of this permeable barrier stops roots either by engaging and constricting them or by chemically inhibiting them.

The benefits of such a shield are its dual protection both physical and biological. The multi layered sheets can be welded together whilst retaining its flexible qualities, i.e. can be cut and effectively resealed to fit round services and foundations, inert with a 60 year service life expectancy. Equally the solution inhibits root growth on the barrier face which is often problematic with conventional barriers where increased moisture levels can cause root growth to become more prolific on the face of a traditional barrier. Research has shown that the use of the recommended style of copper based screening has greatly reduced the effects of root growth when compared to other traditional physical barrier installations

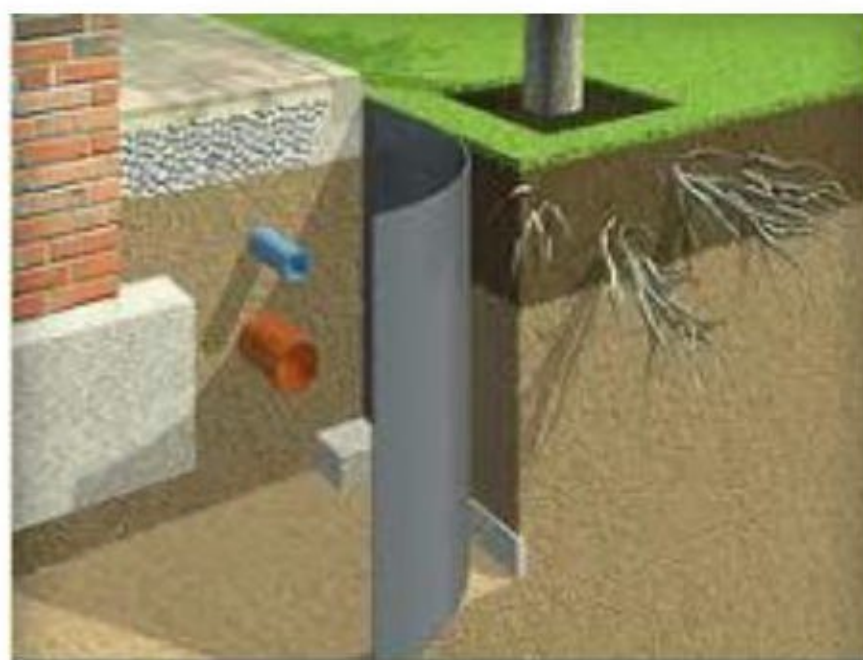
Following the installation of the shield the trench will be backfilled and compacted mechanically with 20mm single sized stone. Alternatively, dependent upon site conditions backfill using lean mix concrete will be utilised on the structure side of the shield. On occasions some natural settlement is anticipated following completion. In all instances the project envisages a return visit to the property to affect any required maintenance of the surface of the reinstatement routinely programmed within 6 months following completion of the installation.
