Schedule of repairs and improvements to the main house:

Proposed Works at Cookham Dene

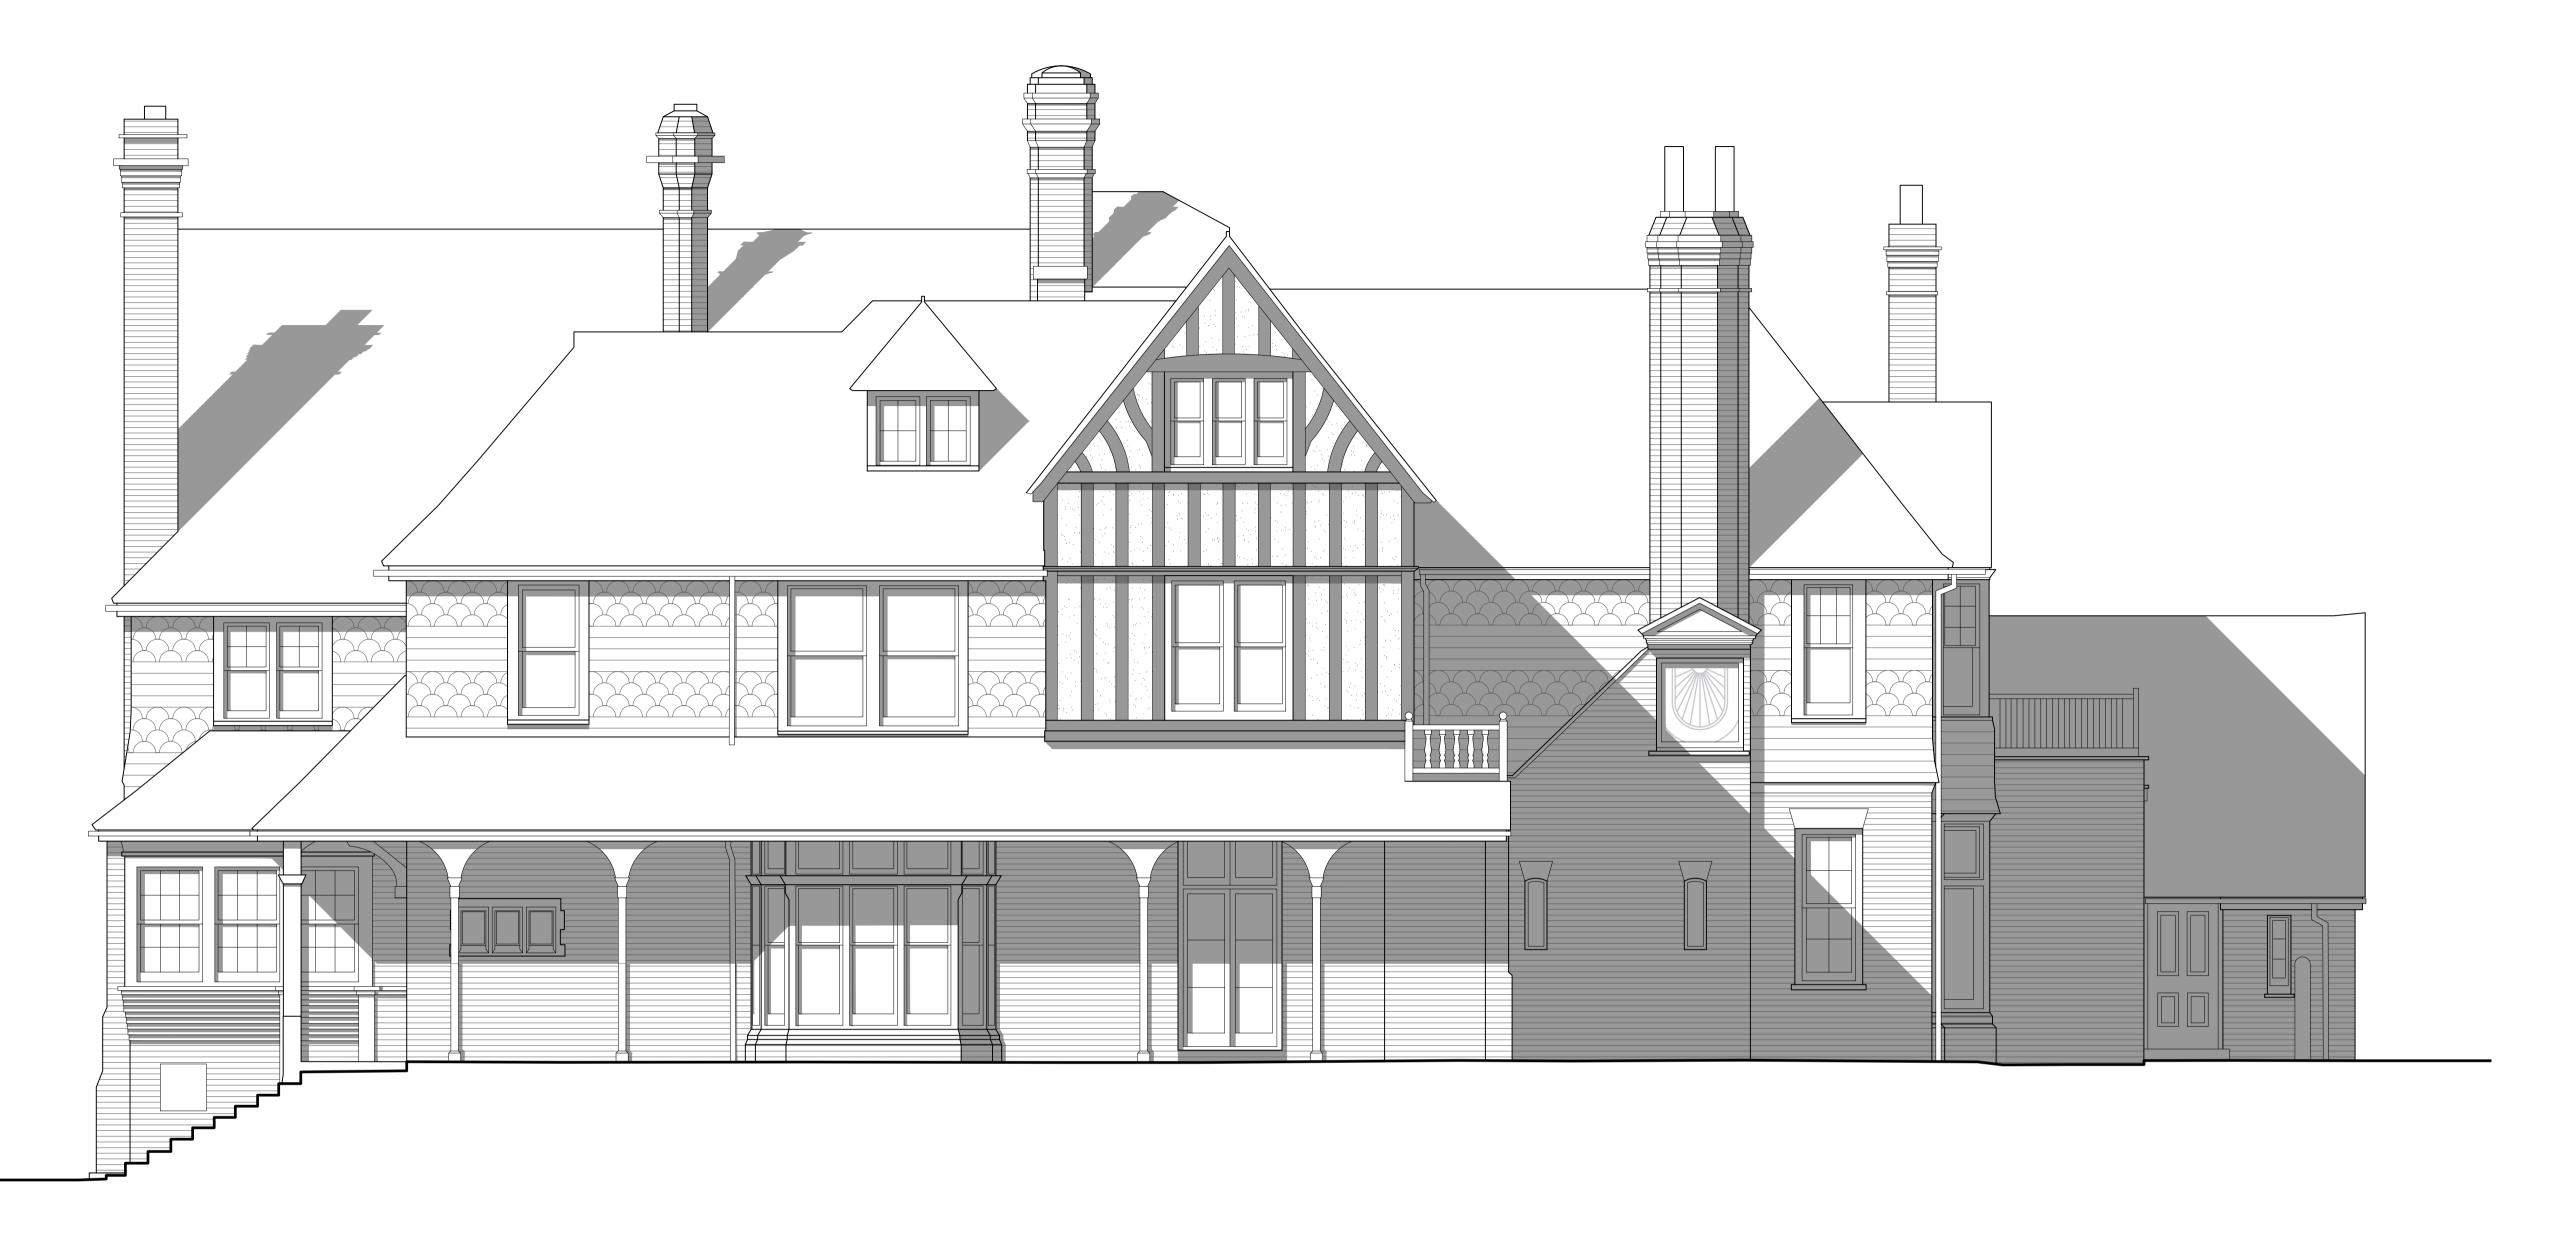
- Existing roof finishes to be carefully removed and retained. Existing timber battens to be removed where rotten and replaced with new treated timber battens
- New sheeps wool or hemp fibre insulation to be installed between the existing rafters. Roof tiles to be reinstated. New clay tiles to match existing to be used to replace broken tiles
- Existing lead flashings and weatherings to be removed and replaced with new lead flashings and
- weatherings Existing concrete haunching weatherings to be removed and replaced with new lead flasings
 Existing timber fascias and soffits to be removed and replaced with new painted timber facias and soffits
- Existing Velux windows to be removed and replaced with conservation style rooflights Existing Cast Iron and Upvc gutters to be removed and replaced with new metal gutters to match the

- Existing lead and substrate to be removed
- Sheeps wool or Hemp fibre insulation to be installed between the existing joists New tongue and groove boarding and lead roof finish to be installed
- Top 1200mm of all chimneys to be carefully dismantled and rebuilt using existing bricks and pots Lightning conductors to be removed and replaced
 Cracked chimney pots to be replaced with new clay pots to match the existing

Existing pointing to be raked out and replaced with new lime mortar pointing

- Existing clay tiles to be carefully removed. Existing timber battens to be removed and replaced with new
- Tiles to be reinstated with new clay tiles to replace any broken tiles. New tiles to match the existing New lead flashings to be installed

Damaged areas of render to be removed and new lime render to be installed

- Existing sash windows to be eased, repaired and made operable. All existing windows that have been converted to Sprung sash windows to have sash chords, pulleys and weights reinstated
- Existing casement windows to be repaired
- All timber casement windows and sash windows to have existing glazing replaced with slim-line double glazing in existing timber frames. All windows with leaded glass and stained glass to remain as existing.
