# Barn Range at Old Burfa

## Heritage Impact Statement

### NIDUS ARCHITECTS

2019: Barn Range at Old Burfa, Evenjobb, Powys  
*16 February 2022*

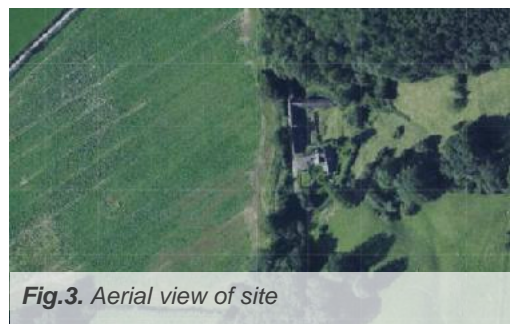
**Fig.3. Aerial view of site**

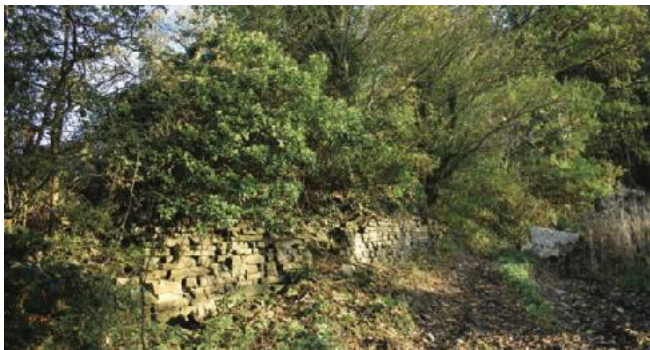
**Fig.6.** *The remains of the demolished stone barn to the south of Old Burfa*

- e) Unfortunately, the detailed research concentrated on the house and little has been published regarding the barn range. Although, throughout the archives and records there is mention of a Medieval barn immediately to the south of Old Burfa, which contained re-used cruck blades, this has been demolished along with another barn a little to the south east of this, of which only low stone walls and heaps of rubble survive.

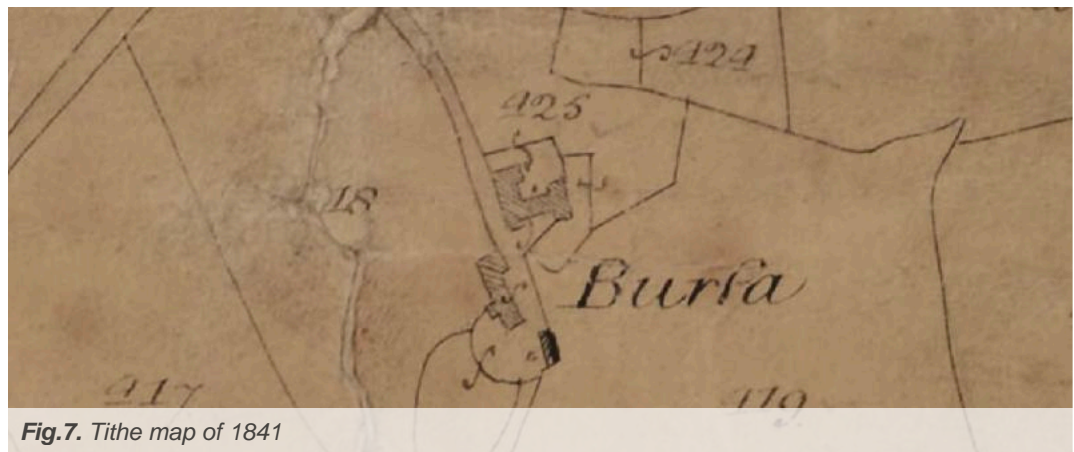
Fig.7. Tithe map of 1841

- a) There are a number of historic maps which show the development of the barns at Old Burfa and are useful for analysing dating. The earliest map of detail is the 1841 tithe map. The tithe apportionments show that Burfa belonged to Sir Harford Jones Bridges (or Brydges) and that it was tenanted by Robert Lawrence and that Sir Bridges owned a vast acreage of land within Radnorshire. The *Oxford Dictionary of National Biography* states he was a British diplomat and author and that his seat was at Boultonbrook, Presteigne. The family had been of importance in the county since the C16th. Sir Bridges was known as an orientalist and served as High Sheriff of Radnorshire in 1816. From 1832 he was a privy councillor and in 1841 was appointed deputy-lieutenant of the county of Hereford. He died in 1847. Lawrence is recorded in the 1841 census as a farmer, living with his wife Margaret, two daughters and a son and two agricultural labourers.

- b) Confusingly the tithe map shows a different configuration of barns, which appear to be attached to the west end of the main house and barns 5, 6 and 7 are not shown at all. The 1840s tithe map is generally considered to be fairly accurate and therefore it seems likely that only barn 4 is shown here and the other ranges were probably built later.

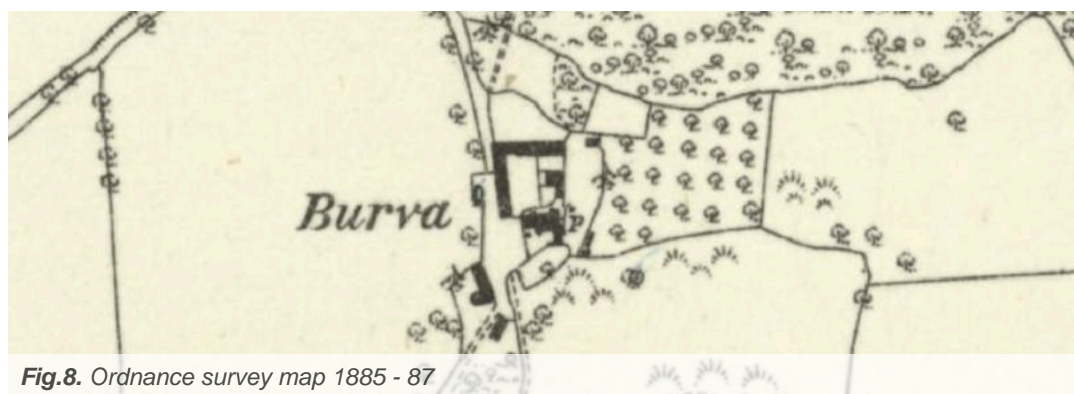
Fig.8. Ordnance survey map 1885 - 87

- c) The late 1880s OS map shows a configuration much closer to that of today's barn range. Again there is no barn 7 but barns 1 to 3 and barns 5 and 6 are now in situ. Another structure is shown at the east side of the courtyard but this has not survived. The courtyard is divided north-south. Lawrence and his family were still at Burfa at the time of the 1851 census. There are no records for 1861 and 1871 census. By 1881 Burfa is occupied by Peter Gravenor (farmer) and his wife, Sarah, with one domestic servant.

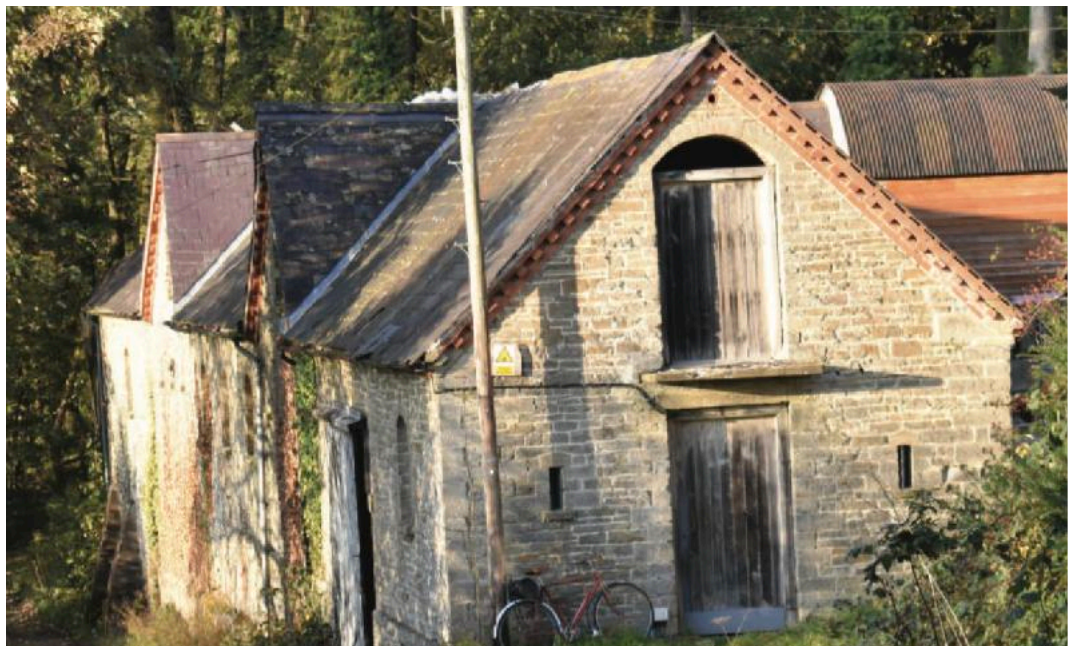
*Fig.12. South facing elevation of Barn 1 and part of the west facing elevations of barns 1, 2 and 3*

- b) Barn 1 is one and a half stories with a gable end south facing elevation. It is constructed from rubble block walls, with dressed quoins, a slate roof, red brick dentil detailing to the eaves and a stone plinth to the west elevation. At the corners of the eaves are stones carved to resemble the brick dentils. The entrance to the ground floor is from the south through an unpretentious ledged plank door with cast iron hinges. The doorway has a flat stone lintel and dressed stone quoins with a large flat stone slab above supported by cast iron rods. Above the stone slab is another timber panel door providing an entrance to the hay loft. This doorway has a segmental stone arch with decorative brick detailing to the arch interior. Two high quality ventilation slits are located on the ground floor on the south facing elevation. These have dressed stone heads with arched tops and stone cills. Another ventilation hole provided by a red clay pipe is above the upper doorway. Opposite each other in the west and east facing elevations are small window openings at ground floor level with segmental curved stone arches, stone cills and modern timber framed windows.

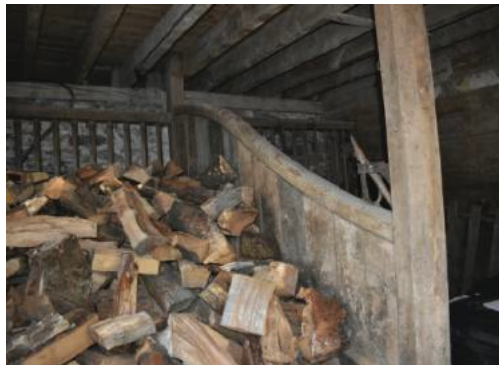
**Fig.13.** The ground floor interior of Barn 1 with pony stalls and hay racks

- c) Internally this area is divided into two sections on the ground floor by a north to south timber wall, it has a stone cobbled floor with drainage channels. The larger western side contains two pony stalls with timber hay racks (area now used for log storage). The eastern side is a narrow storage room, with fixtures for saddles, it was presumably used for storing horse tack. The floor in this area is concrete. The upper room appears to have originally been the granary but is now empty and unused. It has timber floorboards and a modern roof light (unauthorised work proposed for removal).

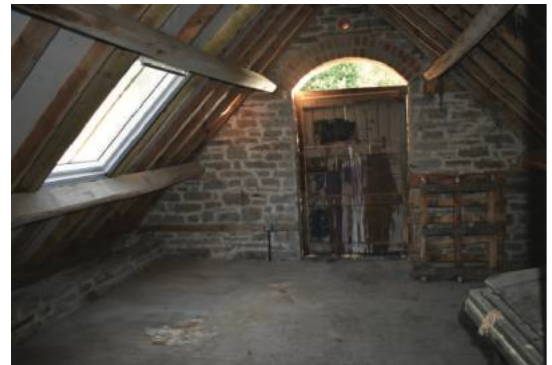
**Fig.14.** The upper floor of Barn 1, previously the granary

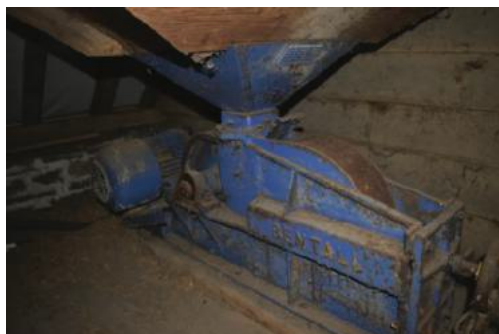
**Fig.15.** Surviving machinery relating to the use of the first floor barn 1 as a granary

- d) The surviving machinery is an electric powered corn / grain grinder produced by the famous agricultural machinery company E H Bentall & Co Ltd, based in Essex. It is likely to post date 1946 when Bentall & Co became a public company.

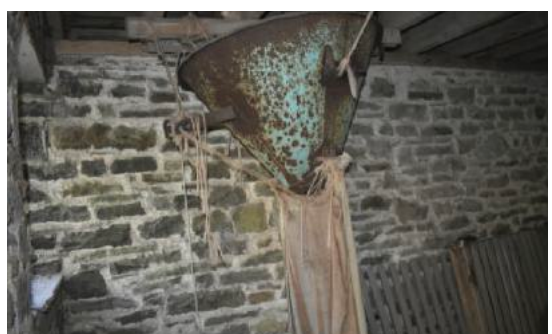
**Fig.16.** Grain shoot from granary (barn 1) into trap house area (barn 2)

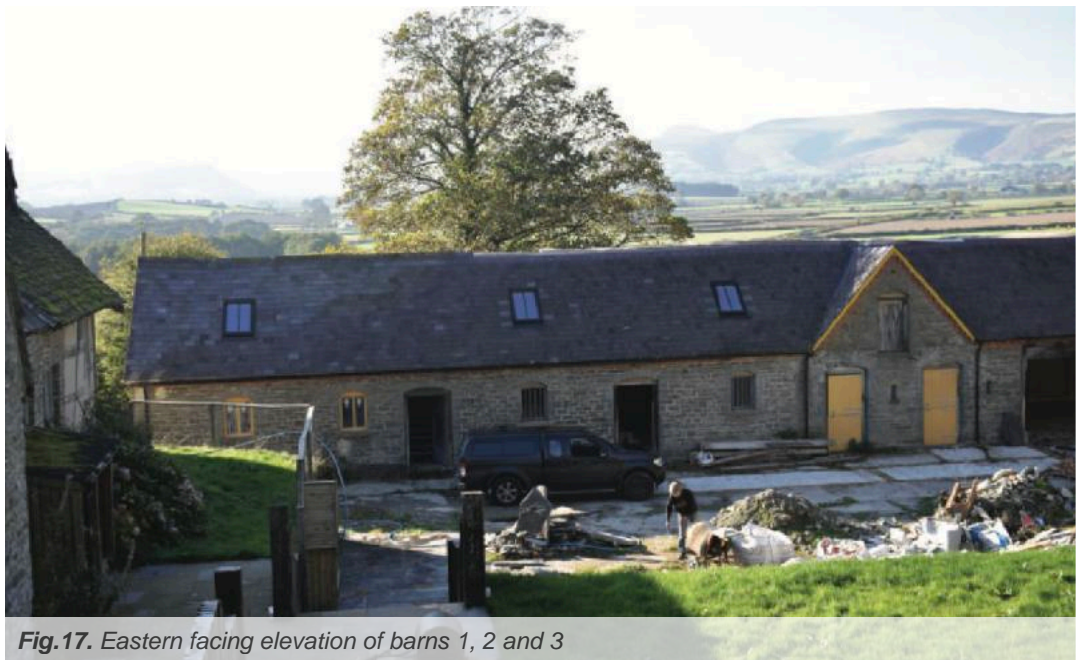
*Fig.17. Eastern facing elevation of barns 1, 2 and 3*

- a) Barn 2 is a modest one and half storey building which appears to have been constructed in conjunction with Barn 1 and 3 and shares the same external architectural detailing and materials (see above) and also appearing to date from the late C19th. The structure differs in that it has a gable on the west facing elevation and is of four bays. The gable provides space for a window (of the same design as on barn 1) which provides some light for the upper storey but otherwise would seem to be an architectural pretence. The gable also has evidence of three ventilation slits as on barn 1 but these have been infilled. The eastern facing elevation has two doorways, one to the trap house and one to the ground floor barn, both with unpretentious ledged panel doors and chamfered stone arches. Of the three regularly spaced windows on this elevation, two of them had surviving sliding slatted windows, which have been retained and repaired.

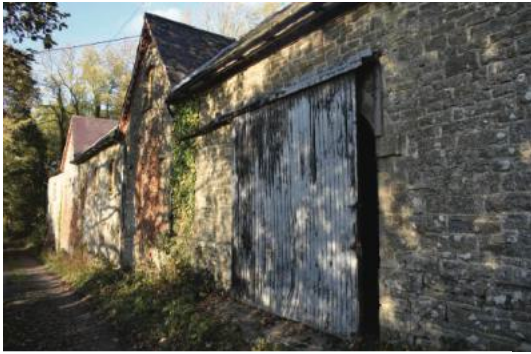
**Fig.18.** Western elevation of barns 2 and 3 with trap house arched doorway

- b) The southern bay has a partially submerged floor level with steps down from the farmyard level but allowing level entry from the west. It was previously the trap house. It is separated from the northern end by a timber panel wall. The former trap house has a fine chamfered arched entry in the west elevation, now closed by means of a large corrugated iron sliding door. This area also houses a very steep vernacular ladder timber staircase providing the only access to the first floor for barns 1 and 2. The northern part of the ground floor is an undivided area of three bays with a later inserted concrete feeding trough and two small windows along the western wall. It would seem that this was the area identified in the listing description as a working horse stable.

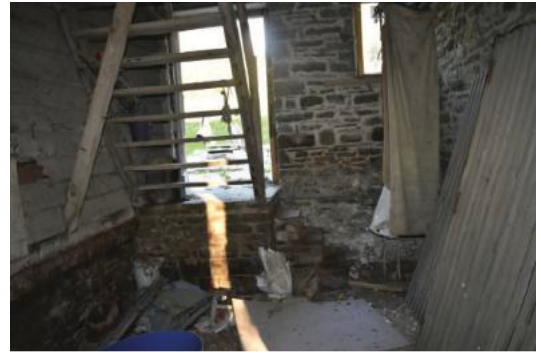
**Fig.19.** Interior of trap house with partially submerged floor and steep timber ladder stair

- a) The southern bay/trap house currently houses the existing staircase. This staircase is very steep, partially rotten and as such it is noted that access to the upper levels for maintenance is limited. Whilst it is considered that the stair has limited heritage value this requires further analysis.

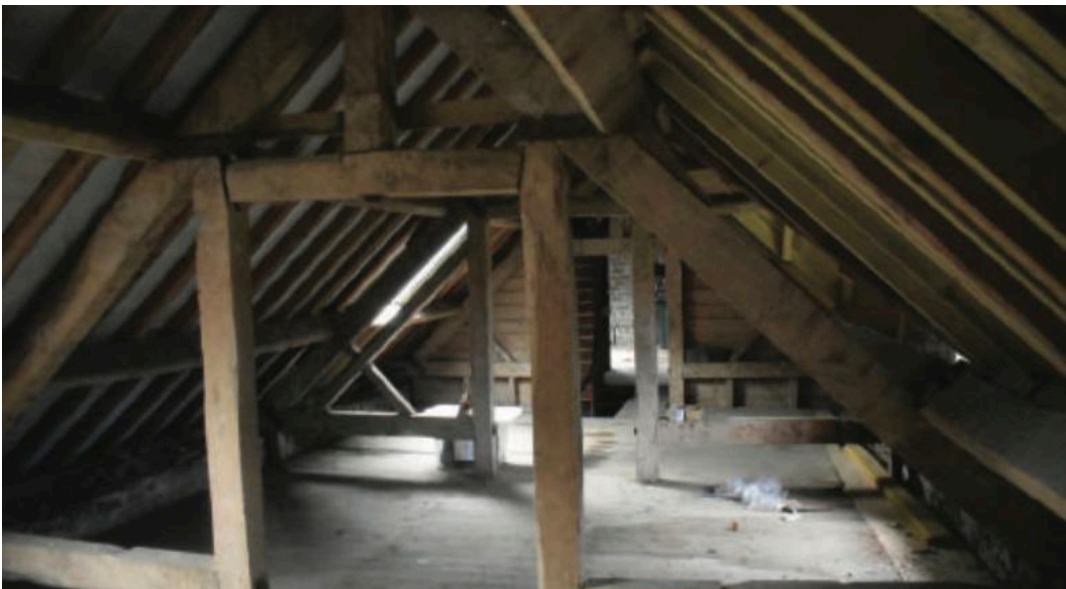
**Fig.20.** View of upper floor barn 2

- c) The upper floor is again of three bays, with timber floorboards and open to the rafters with limited head height at the eaves. Trusses provide some limited division of space. Two modern roof lights have been inserted on the eastern facing roof elevation (as above, unauthorised work proposed for removal). It is currently unused.

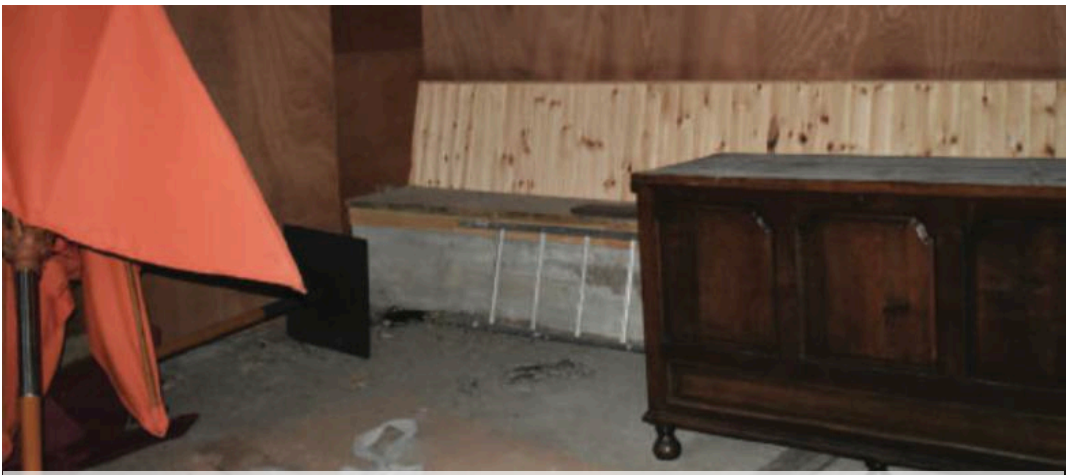
**Fig.21.** Interior (southern end) of barn 2 showing concrete trough, now converted to seating

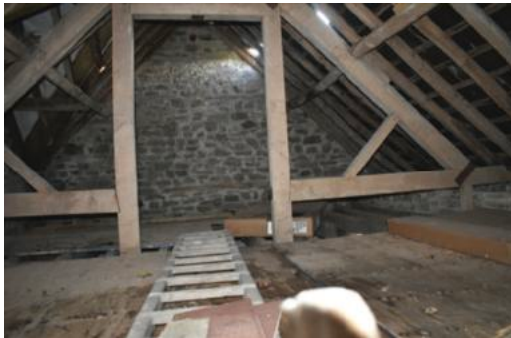
**Fig.22.** Upper floor of barn 3, looking south from doorway to barn 4

- a) Barn 3 is the northern end of the stable block range and to the eastern elevation has a more refined character with a gable containing an upper doorway over two stable doors each of which has another fine ventilation slit of the same design as previously described to its north. The western elevation of this part of the range blends seamlessly into barn 2 and contains another small window of the same design. The materials and architectural features are the same as barns 1 and 2. The ground floor of barn 3 contains two loose boxes, separated by timber stud walls and with a cement corner water trough in the northern stable. Access to the first floor is currently by ladder from barn 4 and through a first floor doorway. This area was presumably used for hay perhaps for both the horses below and the cattle in barn 4. Floor joists remain but no floorboards.

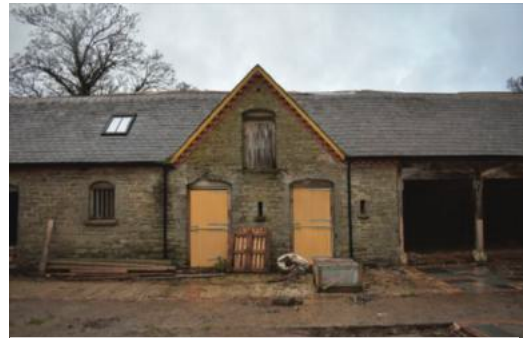
**Fig.23.** East elevation of barn 3

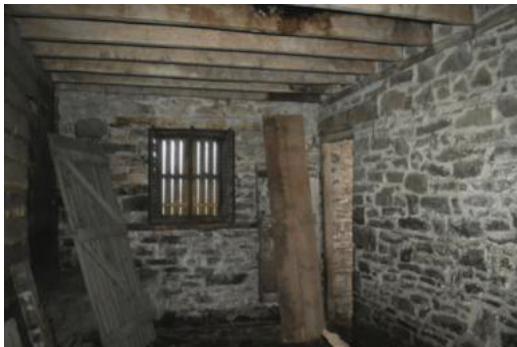
**Fig.24.** Interior of one of the loose boxes with concrete corner feature

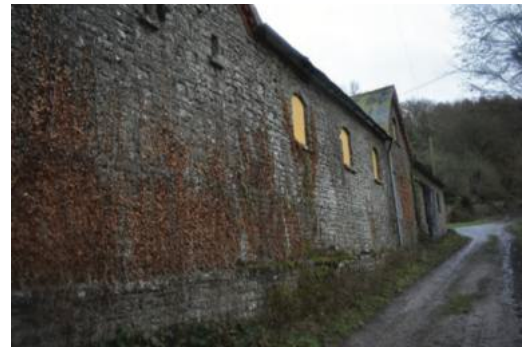
**Fig.25.** West facing elevation of barn 3

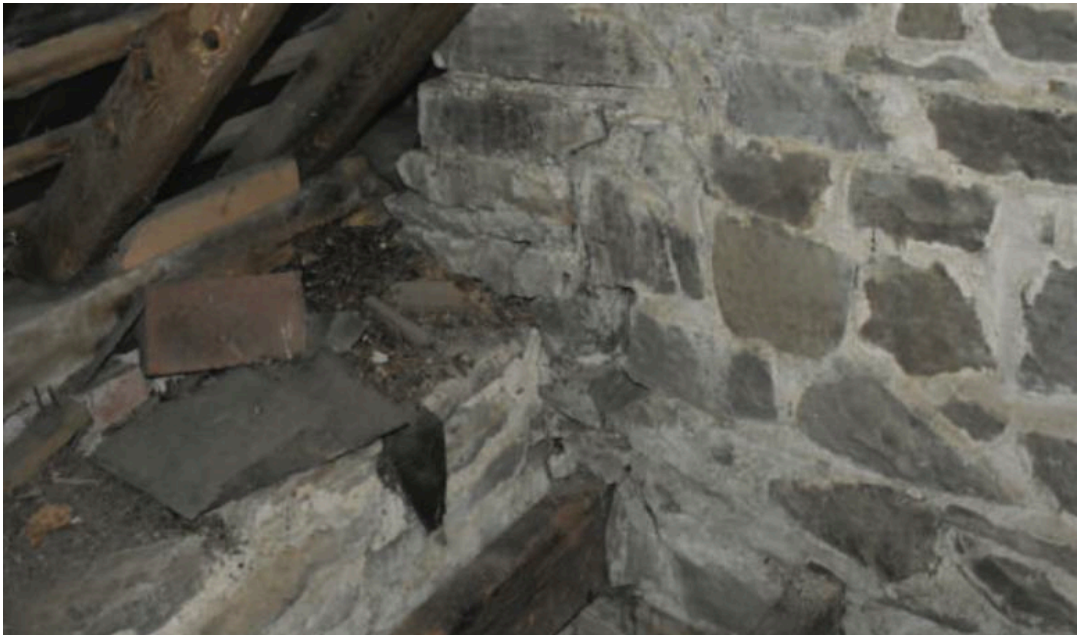
**Fig.27.** Internal first floor wall (between barns 3 and 4) butting up against western elevation of barn 4 at eaves level.

- a) Barn 4 seems to have been much altered. It is built in an L shape of rubble stone and although physically tied into barn 3 on the western elevation there are signs that parts of it may be an earlier build. Whilst also constructed of rubble stone, the coursing and cut of the stones are more rough than in barns 1, 2 and 3. The stone plinth on the western side does not extend the whole length of barn 4 but cuts off at a tall buttress. The West facing elevation shows evidence that it has been increased in height or rebuilt above a certain level. The west facing elevation also contains two ventilation slits and three windows in the same style as those on barns 1 to 3 (probably later and contemporary with the building of barns 1 to 3).

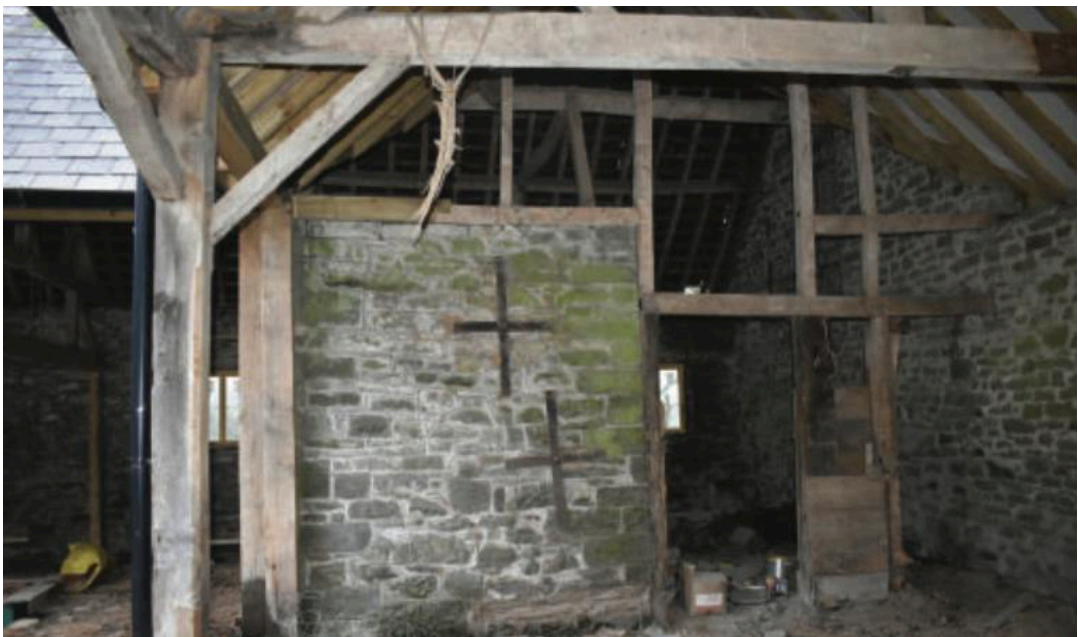
**Fig.28.** Free standing wall in barn 4, on possible line of earlier configuration and showing good, possibly later, quoins but poor original wall construction

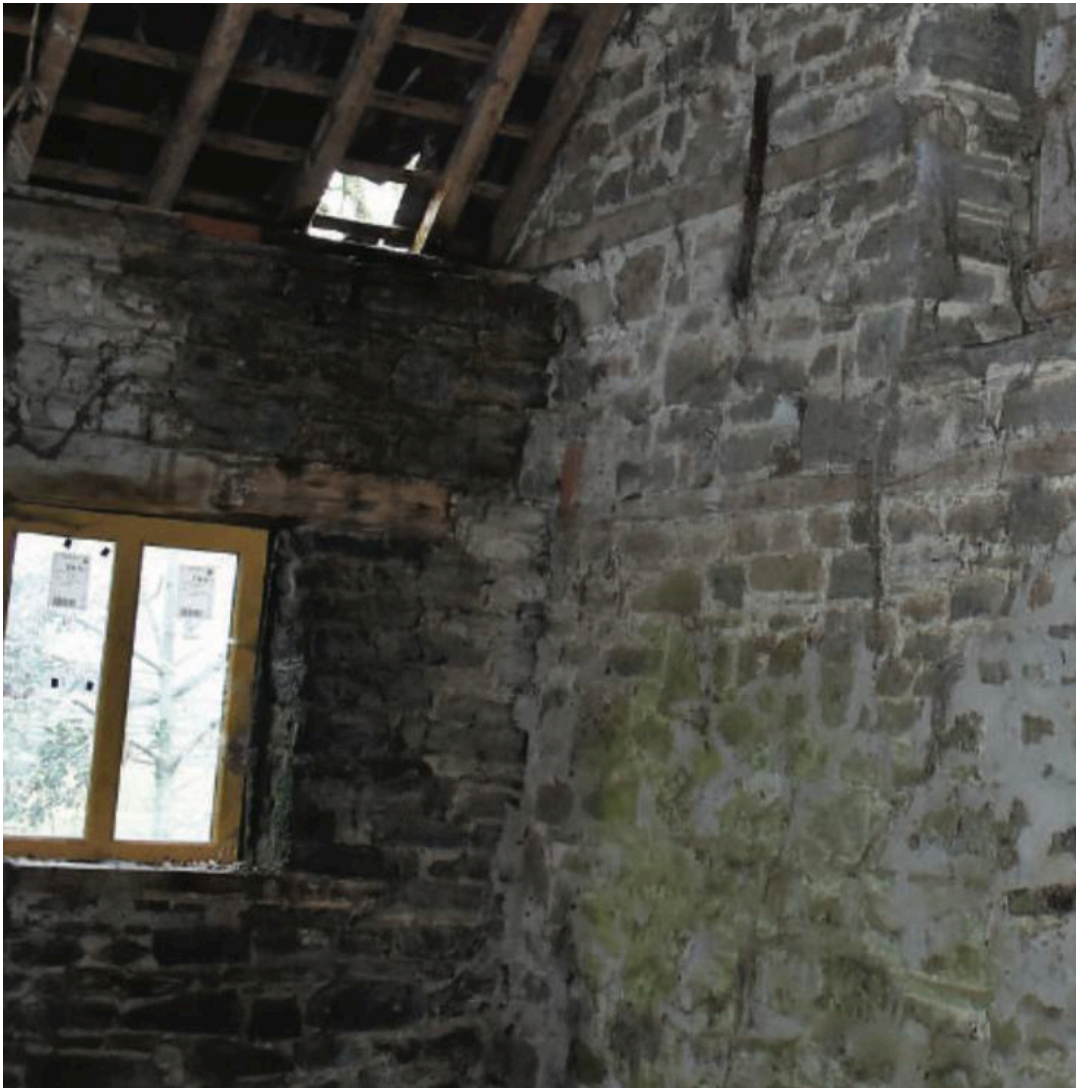
*Fig.29. Interior of north west corner of barn 4 showing the north wall as a later build.*

- b) The brick dentil detailing to the eaves continues along the west facing elevation and on the north facing gable end. The north facing elevation has a first floor doorway to the west and a ground floor doorway to the east end. The ground floor doorway is of good quality and all the stone and architectural style of the openings and corner quoins show the same characteristics as in barns 1 to 3. The internal first floor wall between barns 3 and 4 is clearly a later insert and butts up against the western exterior wall. There is a free standing wall at the internal corner of the L shape (Wall A on Fig. 6 above) orientated north south. This is possibly the remains of an earlier configuration of the eastern side of the barn but has also been altered with the addition of good stone quoins. The northern wall butts up against the western wall indicating that this is also a later build. All this evidence may imply that barn 4 was substantially rebuilt and altered at the same period as barns 1 to 3 were built and that the eastern part of the 'L' may have been an addition at this time. The western wall is being supported by two modern buttresses and also internally by metal rods, these were installed without LBC by the previous owner.

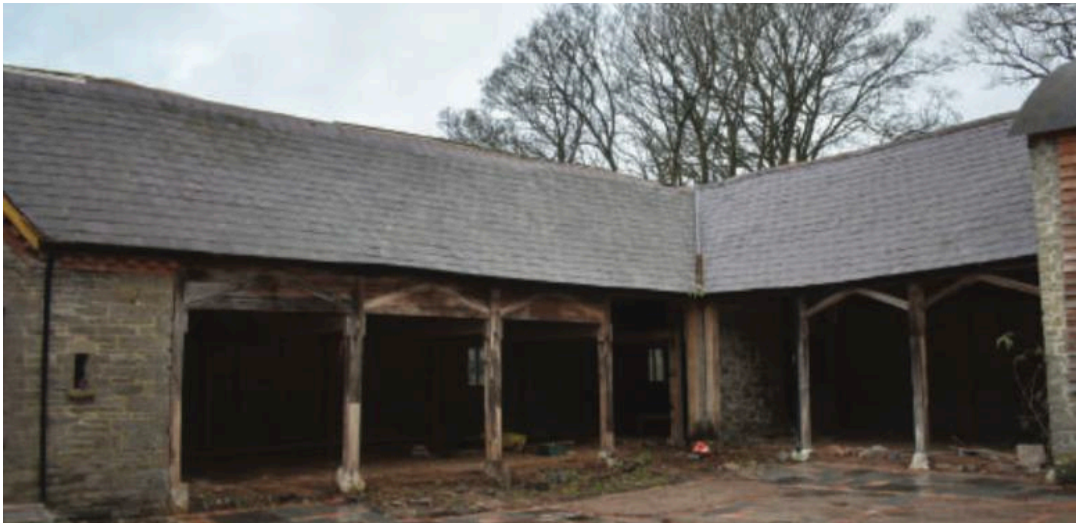
*Fig.30. Courtyard elevation of barn 4*

- c) The courtyard elevations of barn 4 have a later open fronted 7 bay format with chamfered timber posts on stone pads. Some of these bays retain the timber cladding at the top with diagonal timber supports between the bays. Internally there is evidence that it was lime washed. The flooring is a mixture of cobbles, earth and brick. Evidence of a former internal, dividing wall running north to south survives at ground level.

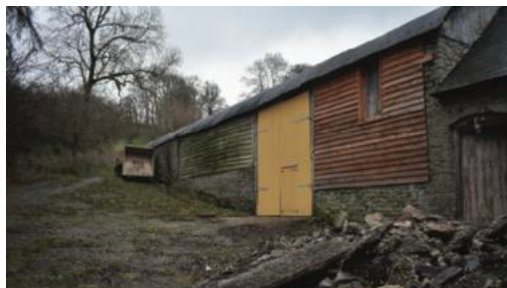
*Fig.31. North elevation of barns 5 and 6*

- a) Barn 5 is orientated east to west and encloses the northern end of the courtyard. It is constructed with high rubble plinth walls (north and south) with end walls and weatherboarding on timber frame. The curved roof and parts of the end walls are of corrugated iron. Timber tie beams with metal rods support the roof. Some of the timber framing in the upper walls demonstrate a vernacular tradition but do not appear to be of C18th date. In the north and south walls are large full height openings with double doors opposite each other, reminiscent of a threshing barn. Internally the western end is separated by a low modern brick wall surmounted by timber frame partitions. The barn has a concrete floor and a concrete feeding trough along part of the southern wall.

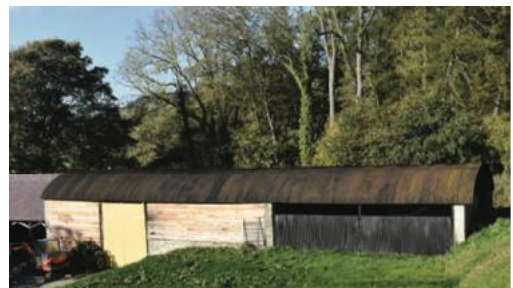
*Fig.32. South elevation of barns 5 and 6*

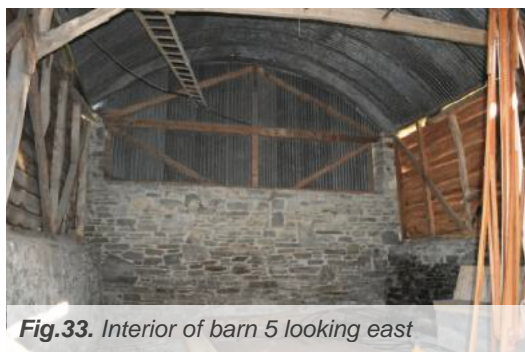
*Fig.33. Interior of barn 5 looking east*

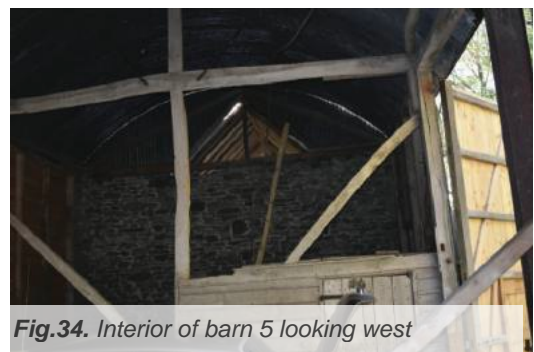
*Fig.34. Interior of barn 5 looking west*

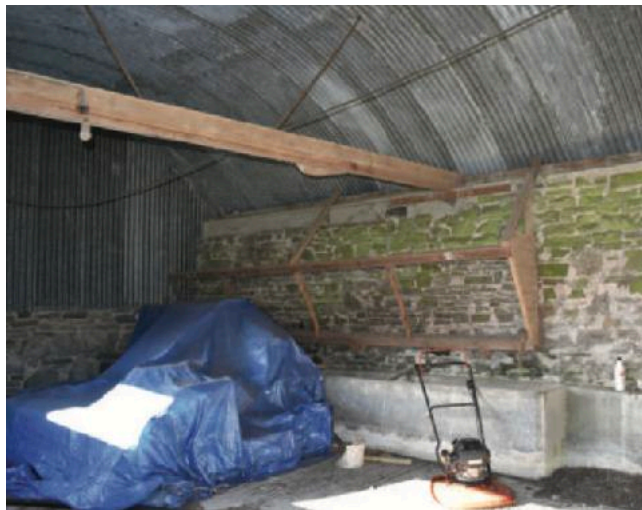
**Fig.35.** North elevation of barn 6

- a) To the east of barn 5 and on the same building line is a separate barn with building joints indicating it is a different build, possibly earlier. The northern wall is of rubble stone, the western wall has a high rubble stone plinth with corrugated iron above, the southern wall is open with large modern metal double gates and the eastern wall is of concrete block. The roof is as for barn 5. Internally there is little of interest, with another concrete stone trough against the northern wall and a modern hay rack.

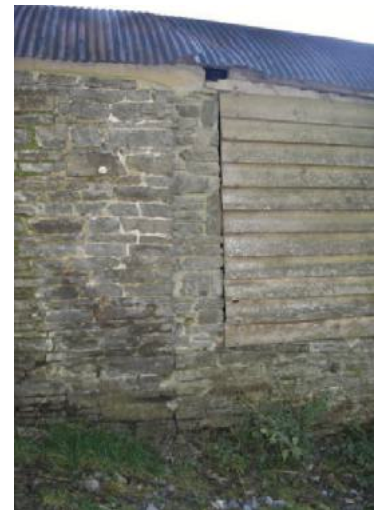
**Fig.36.** Straight joint between barns 5 and 6 on the north wall

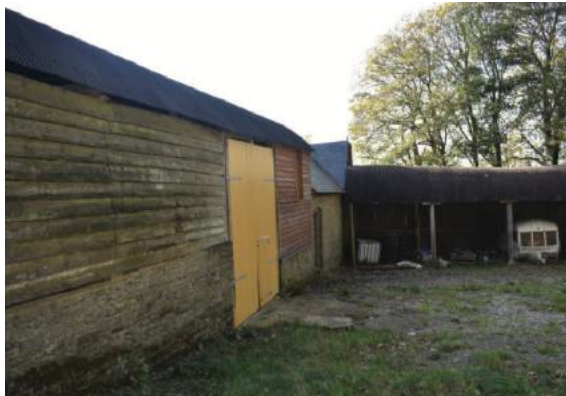
*Fig.37. Eastern elevation of barn 7*

- a) Barn 7 would appear to be of relatively modern construction, using old telegraph / electricity poles and corrugated iron. One of the poles retains its signage with two dating plaques, one from 1964 and one from 1973. Around the exterior are the overgrown remains of a low rubble wall. The earliest evidence for a barn in this location is the OS map of 1902. It is therefore possible that this is the remains of an earlier barn. On the 1975 OS map the building on this site is shown with dotted lines which may indicate the lightweight nature of this structure. Using the dating plaques we can therefore presume that the current structure was built between 1973 and 1975. It can therefore not be considered to be curtilage listed.

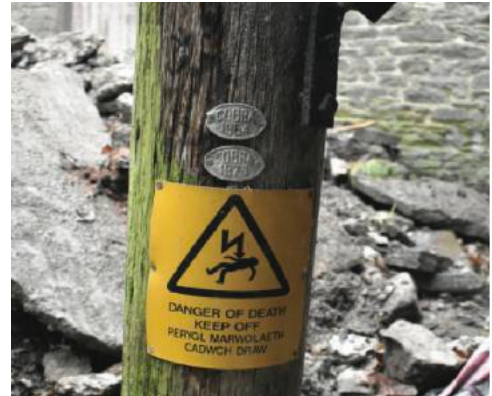
*Fig.38. Dating plaques on re-used service poles*

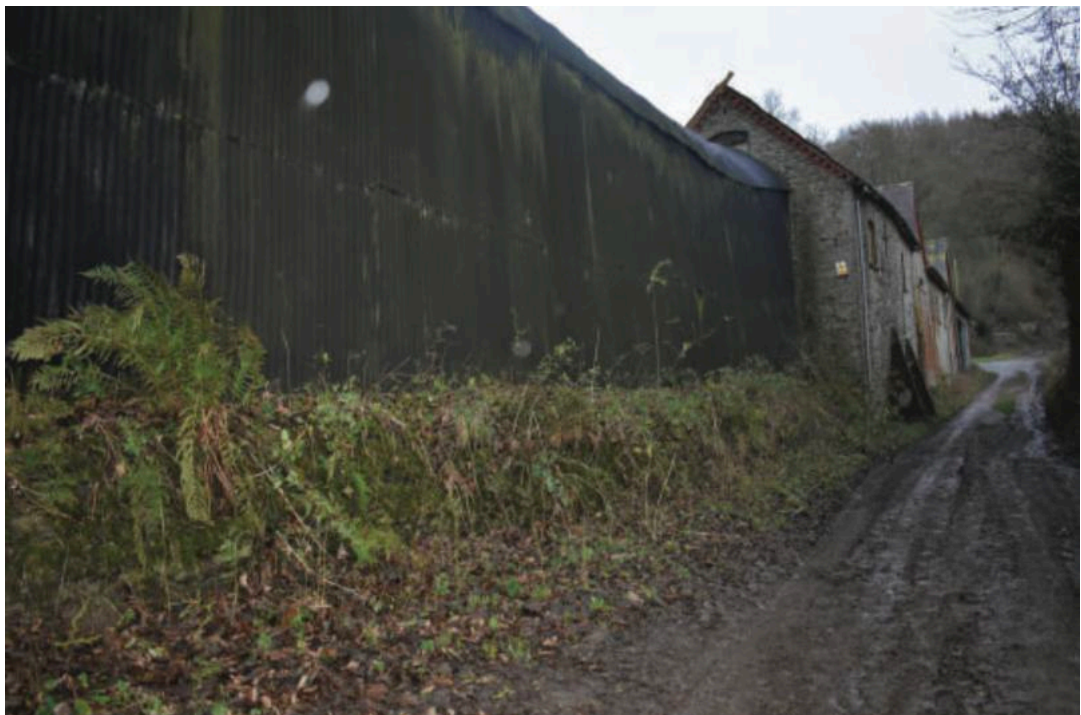
*Fig.39. Possible low wall or the remains of an earlier barn?*

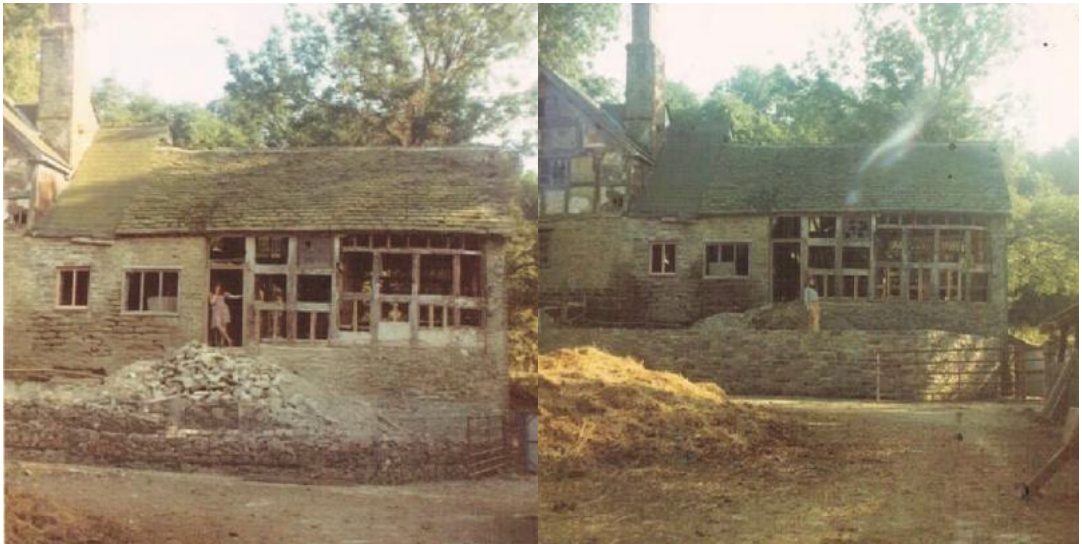
**Fig.40.** Scans of photographs from 1972 showing the construction of the wall at the south end of the courtyard in progress.

- a) The earliest evidence of an enclosed courtyard is the 1902 OS map. The current courtyard is a large open space bordered on two sides by the barns and on the southern side by the house and on the eastern side by a grass bank. The surface is a mixture of concrete, cobbles and brick. The courtyard is always shown on the historic maps as being divided. Early photographs show there was a timber wall across the courtyard retaining a slurry pit behind. The timber wall was removed in the early 1970s and not surprisingly the slurry pit has been infilled but the division across the yard has been retained by the limits of the grass bank. To the south of the courtyard is a retaining rubble wall, which, according to (dated) photographs, was constructed in September 1972. There are also stone steps bordered by railway sleepers leading up to the north elevation of the house which were constructed more recently by the present owner.
