Barn Range at Old Burfa

Design Statement

NIDUS ARCHITECTS

2019: Barn Range at Old Burfa, Evenjobb, Powys
18 October 2023

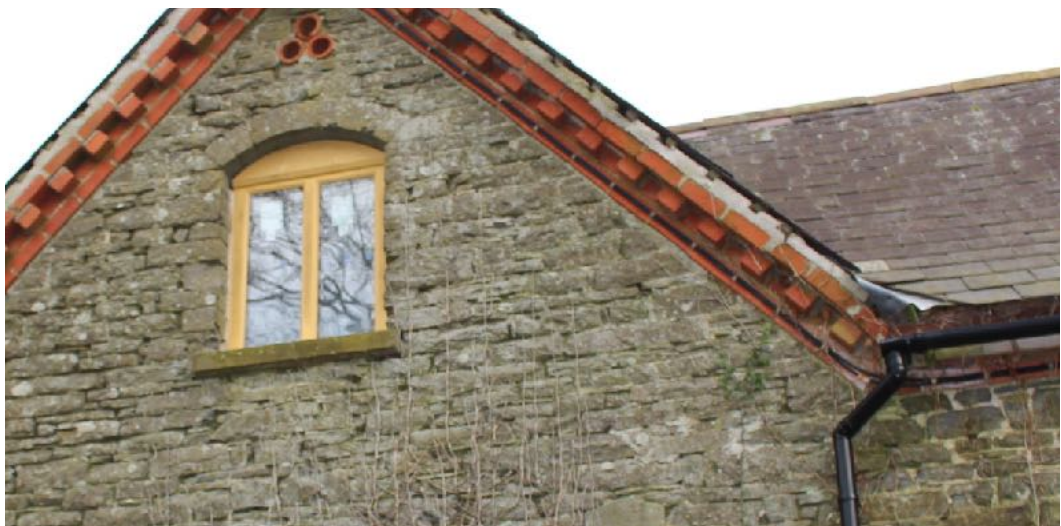
Fig.2. Window installed without LBC on western elevation of barn 3

- a) Drawing EX.31 describes the work previously undertaken to the windows, doors and roof light without LBC in 2017. The reason for removal was reportedly due to the timber frames being rotten. New windows installed are a modern timber frame design fitted with double glazing as shown in Fig 2. and on EX.31.

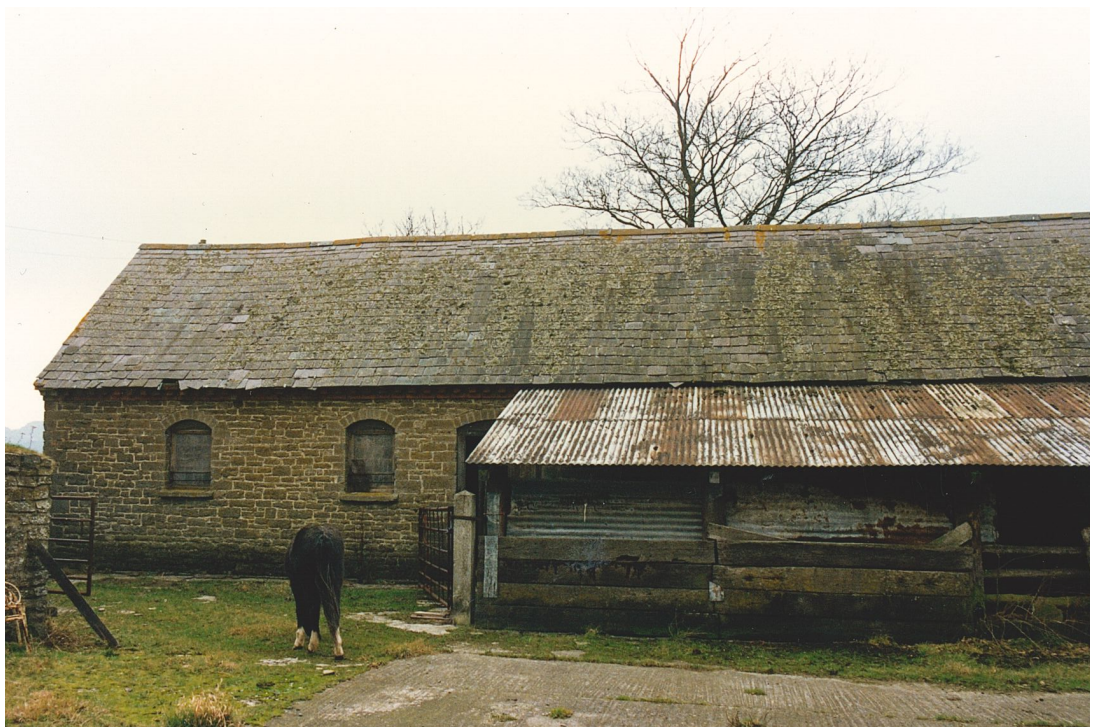
Fig.3. Cadw photo from 1992 Listing showing metal frame windows and now demolished outshut.

- b) From the above, limited photographic evidence has been found. Photographs from Cadw's 1992 Listing visit show windows EX-W-04 and 05 in-situ. As a starting point this verifies that these were the windows removed by Mr Michaels.

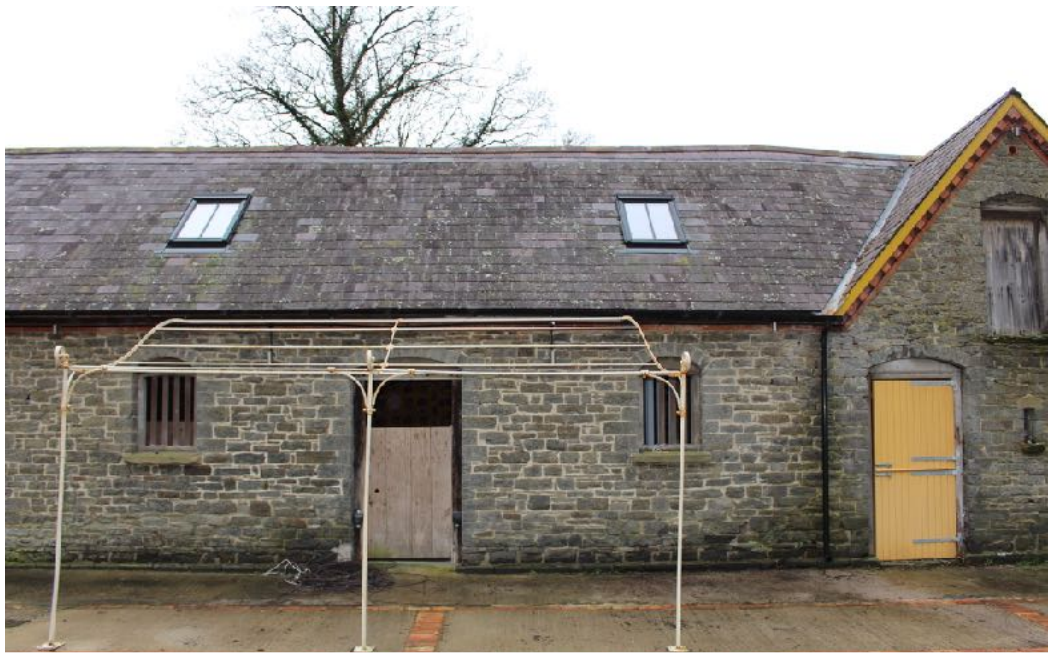
Fig.4. Yard side elevation showing timber louvred windows of barn 2

- c) The testimony of Counsellor Michael Jones also records that the windows were in situ when he occupied the house. This means that the windows can be dated back to the 1950's. Beyond this their history is uncertain.
- d) With this in mind it is noted that the windows are unusually ornate for an agricultural building. And that louvred timber windows might more conventionally be expected. It is also noted that two existing openings (on the yard side elevation of Barn 2) are louvred.

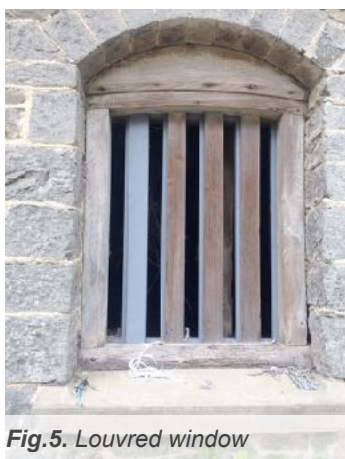
Fig.5. Louvred window

- e) Inspection of the louvred windows reveals that the frames, made of oak, are considerably older than the vertical louvres which are made of softwood (larch) and far less weathered. It is possible that the louvres were replaced at some point. It is also noted that when the metal windows are positioned against the timber louvred frames they form a perfect fit to the outer oak frame.

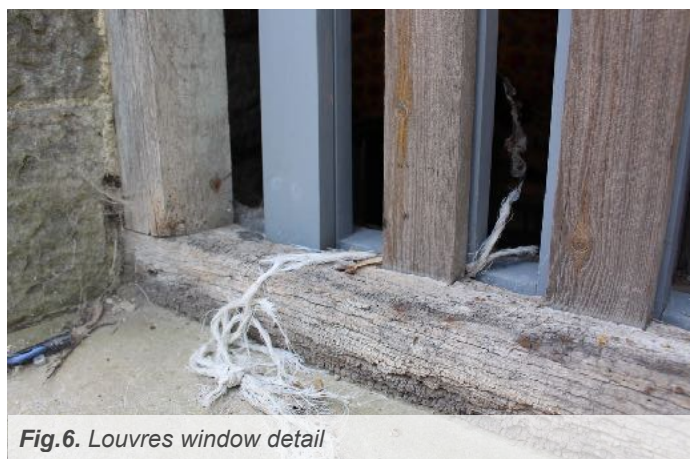
Fig.6. Louvres window detail

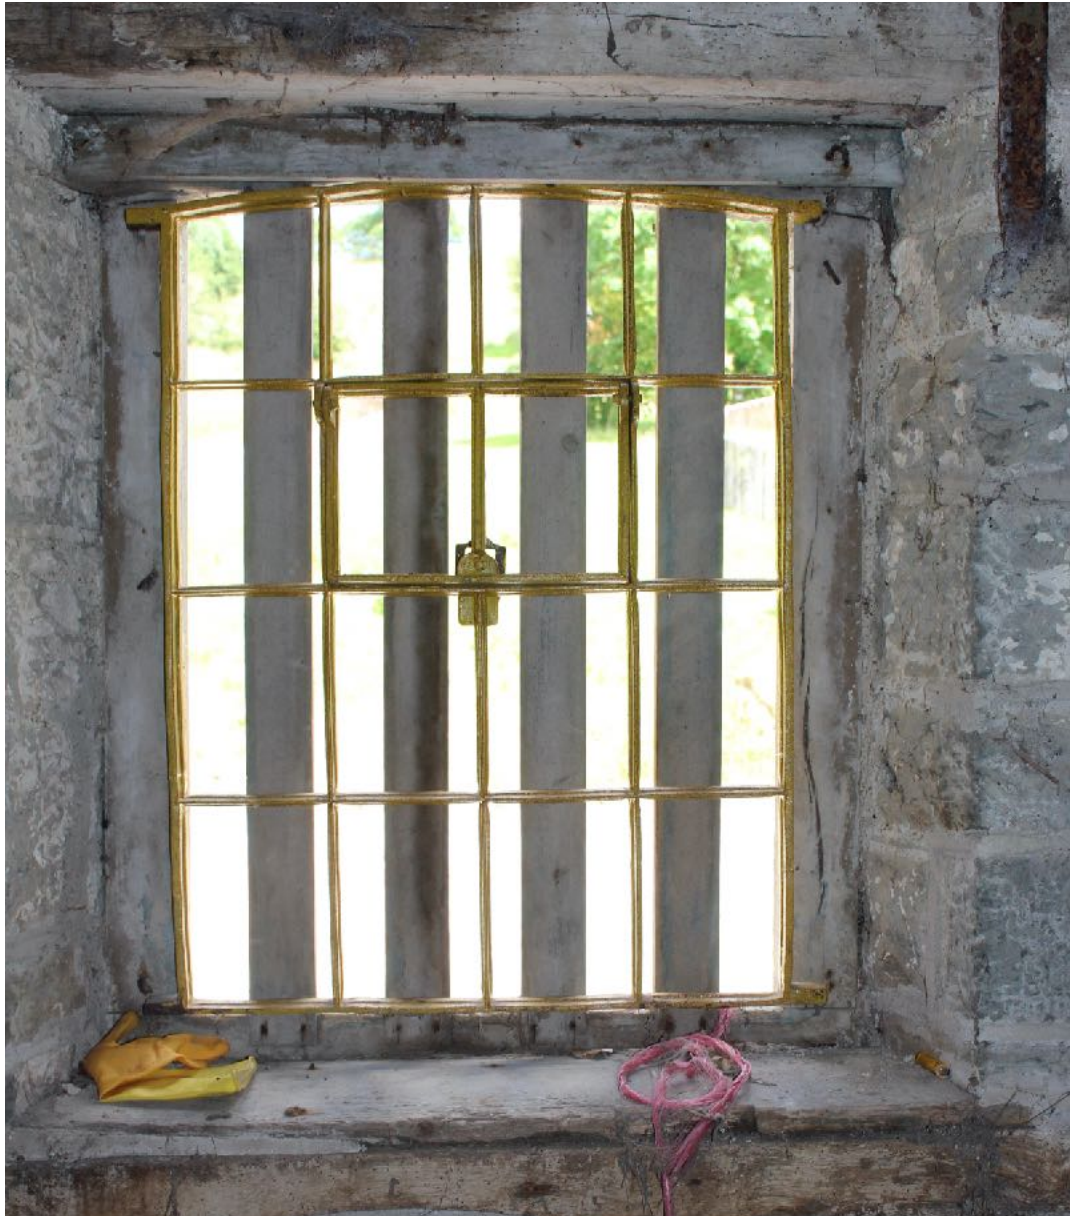
Fig.7. Barn 2 timber louvred window from inside with metal frame placed over.

- f) The Oak frame sizes also match the openings of EW-W-01 - 05, which according to Peter Michaels had matching (rotten) oak frames. It therefore seems highly likely that the metal frames were constructed specifically to fit into these frames and based on the detailing of the windows most likely installed during the late C19th. If so they can be considered an important part of the buildings historical narrative.

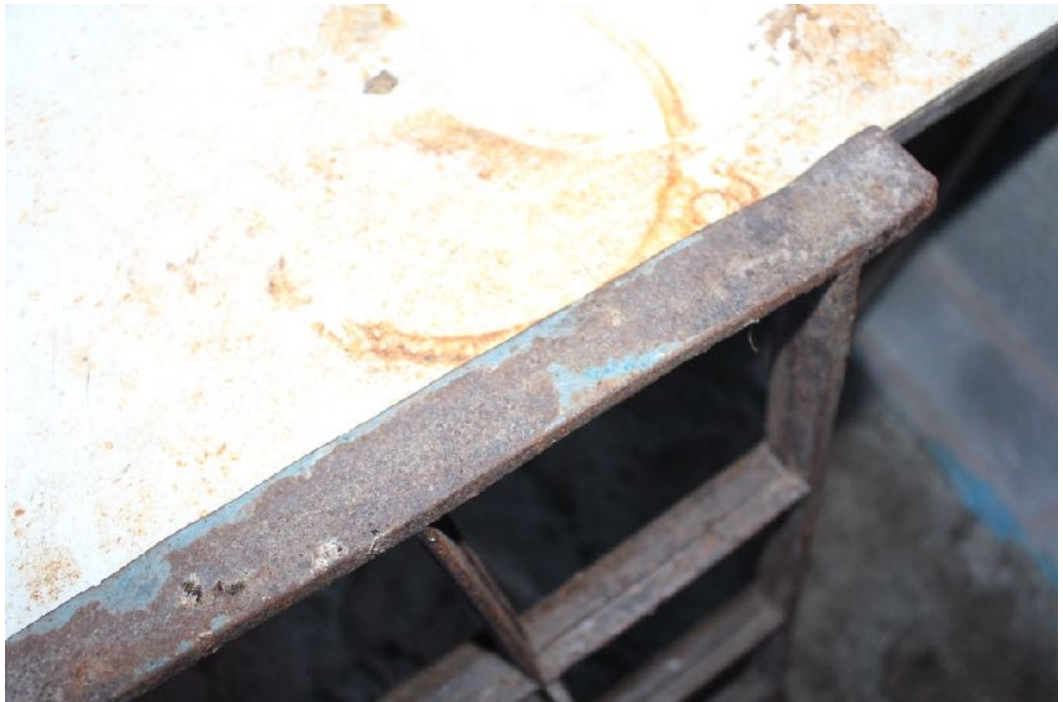
Fig.10 Close up of surveying paint flecks on metal frames.

- a) The proposal is to remove the existing windows as indicated on Fig.1 and replace with windows as shown on drawings DT.70.
- b) The colour chosen is based upon paint flecks found on the unpainted frames. Fig. 10 shows the paint flecks used for reference.

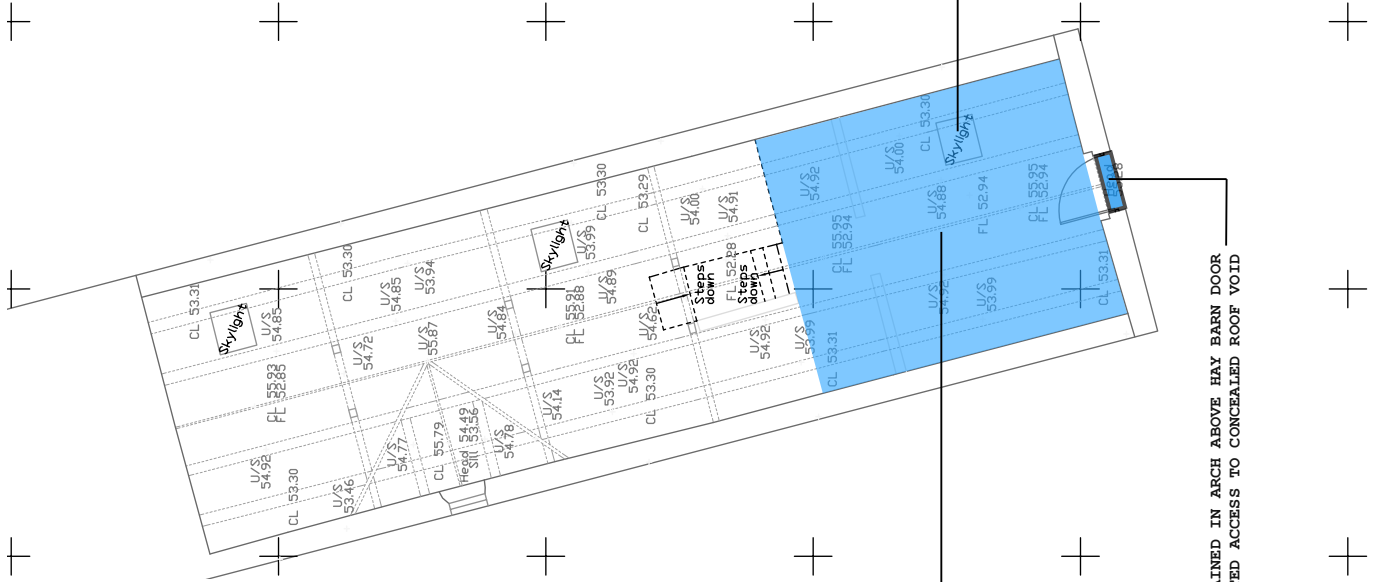
RETAINING A DEDICATED ROOF VOID (AS SHADED BLUE) FOR LESSER HORSESHOE BAT AND BROWN LONG-EARED BAT IS CONSIDERED APPROPRIATE TO MAINTAIN AND ENSURE LONG-TERM ENHANCEMENT FOR THE POPULATIONS. ANY REPAIR WORK WHICH WOULD RESULT IN THE LOSS OF EXTERNAL ROOSTING SITES FOR CREVICE-DWELLING BAT SPECIES WOULD BE REPLACED THROUGH BUILDING-IN BAT BOXES/TUBES

EXISTING SKYLIGHT TO BE REMOVED

CONCEALED ROOF VOID (SHADED BLUE) AT FIRST FLOOR TO RETAIN ROOSTING OPPORTUNITIES FOR LESSER HORSESHOE BAT AND BROWN LONG-EARED BAT. VOID TO MEASURE APPROXIMATELY 5M(W) X 6M(L). NORTHERN ELEVATION OF VOID TO BE PARTITIONED OFF FROM ADJACENT HABITABLE SPACE. EXISTING TIMBER ROOF STRUCTURE AND BITUMASTIC ROOF FELT PROVIDE GOOD ROOSTING OPPORTUNITIES WITH NO MODIFICATIONS CONSIDERED NECESSARY

BAT ACCESS POINT MAINTAINED IN ARCH ABOVE HAY BARN DOOR AND TO PROVIDE UNINTERRUPTED ACCESS TO CONCEALED ROOF VOID
