LISTED BUILDING CONSENT

Client:
Salvation Army

Property:
Ayr Corps, 59 John Street
Ayr, KA8 0BS

Title:
Elevations 1

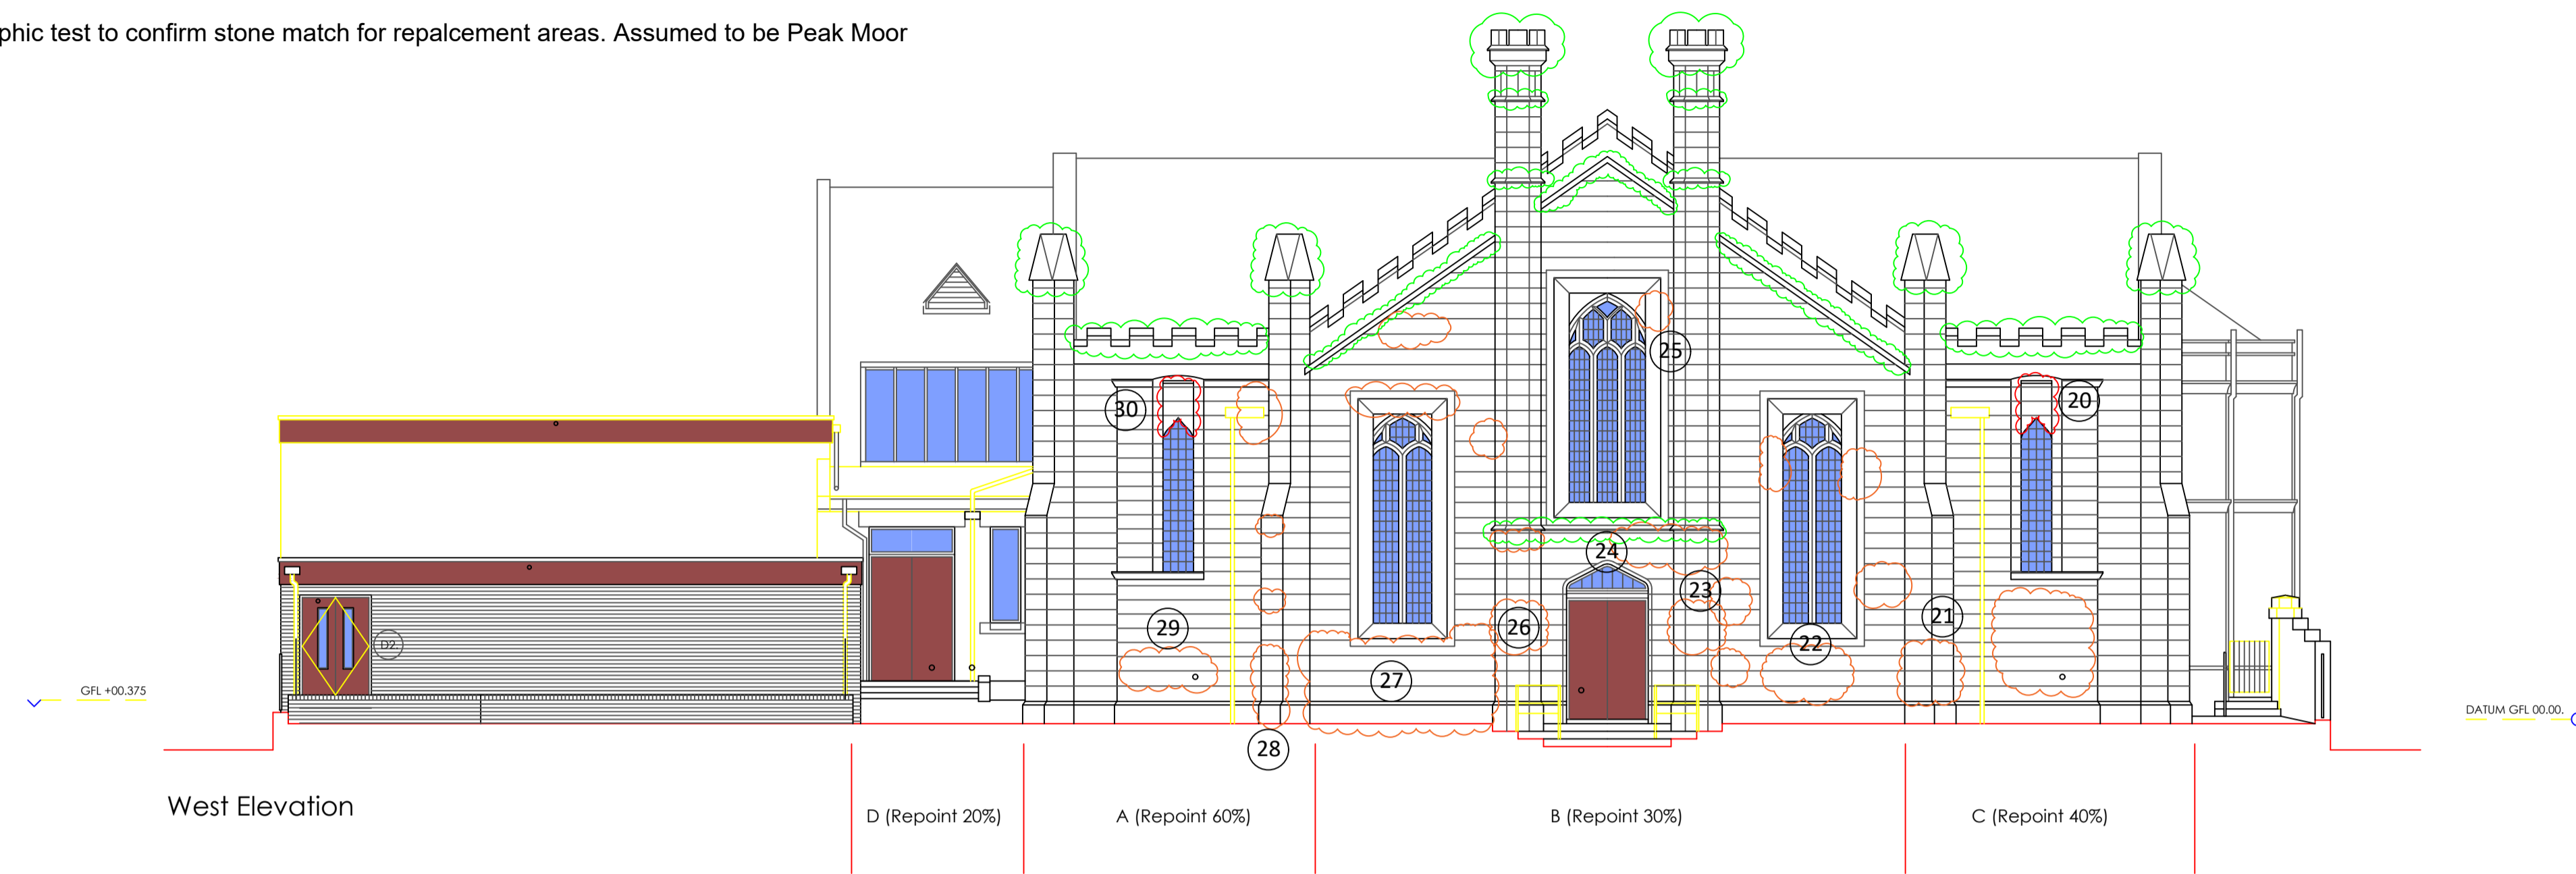
West Elevation

Remove all vegetation, moss etc from stonework with Doff cleaning. Rake out and re-point mortar joints in lime pointing. Refer to drawings and MS Stone Report for percentage areas and details of lime repair. Numbers noted on drawings correlate with photo numbers in MS Stone Report

Petrographic test to confirm stone match for replacement areas. Assumed to be Peak Moor
