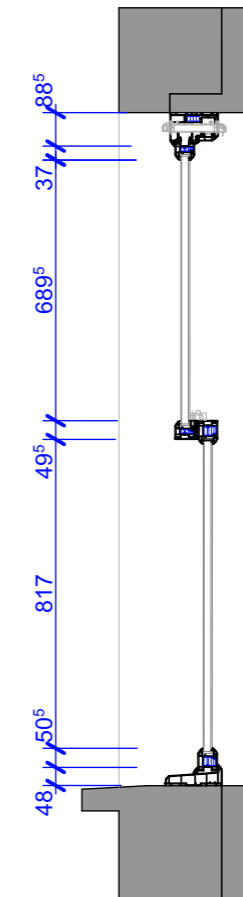
Proposed Elevation 1:20

Existing timber frame window dotted and damage beyond repair.

New uPVC sash window with frame size to match original with trickle vent incorporated to aid ventilation.
