LISTED BUILDING CONSENT
APPLICATION
20 MURRAYFIELD AVENUE
NOVEMBER 2023

1.1 INTRODUCTION

This design and access document outlines the proposal for window alterations to 20 Murrayfield Avenue.

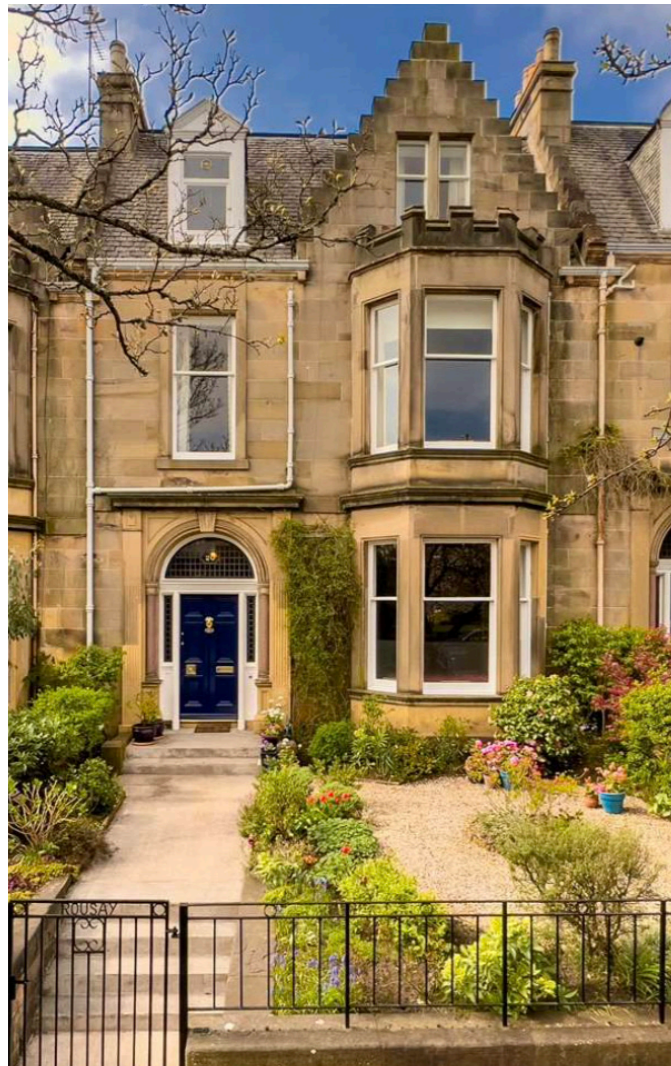
FRONT ELEVATION

The front elevation to no. 20 Murrayfield Avenue is the principal elevation and includes the entrance to the property and the bay-fronted windows to the dining room and sitting room.

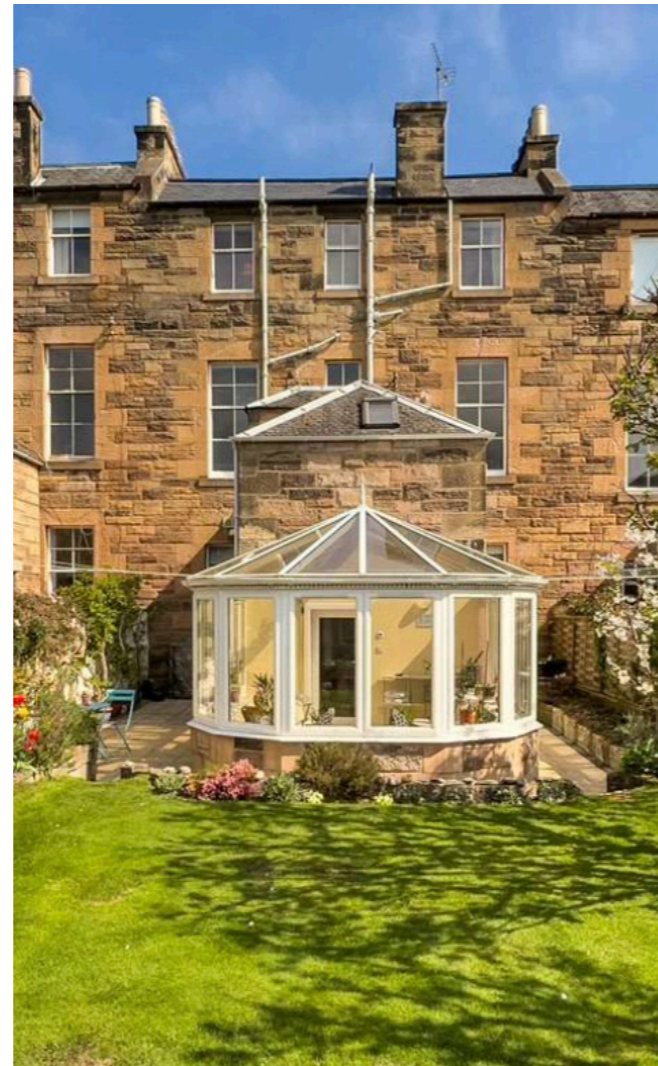
REAR ELEVATION

In contrast, the rear elevation (including the side and rear elevations of the outrigger) are secondary elevations with smaller windows and less considered compositions, sandstone of lower quality and some mixed sizes/colours.

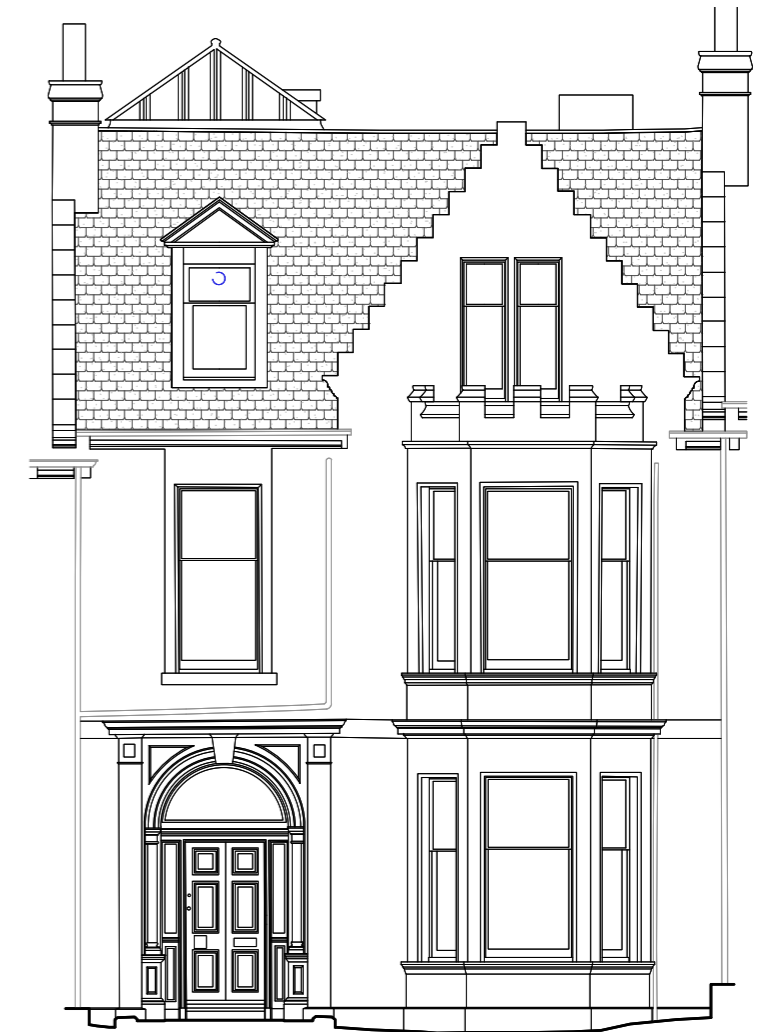
1.6 RECENT APPROVED ELEVATIONS

A recent listed building consent application (ref. 23/01013/LBC) was approved in April 2023 and concerned a range of internal and external alterations and refurbishment. Some of the approved external changes are noted here for clarity and completeness.

- 1 Double glazed metal sliding doors
- 2 Double glazed French doors and fanlight
- 3 New slimlite double glazed sash window

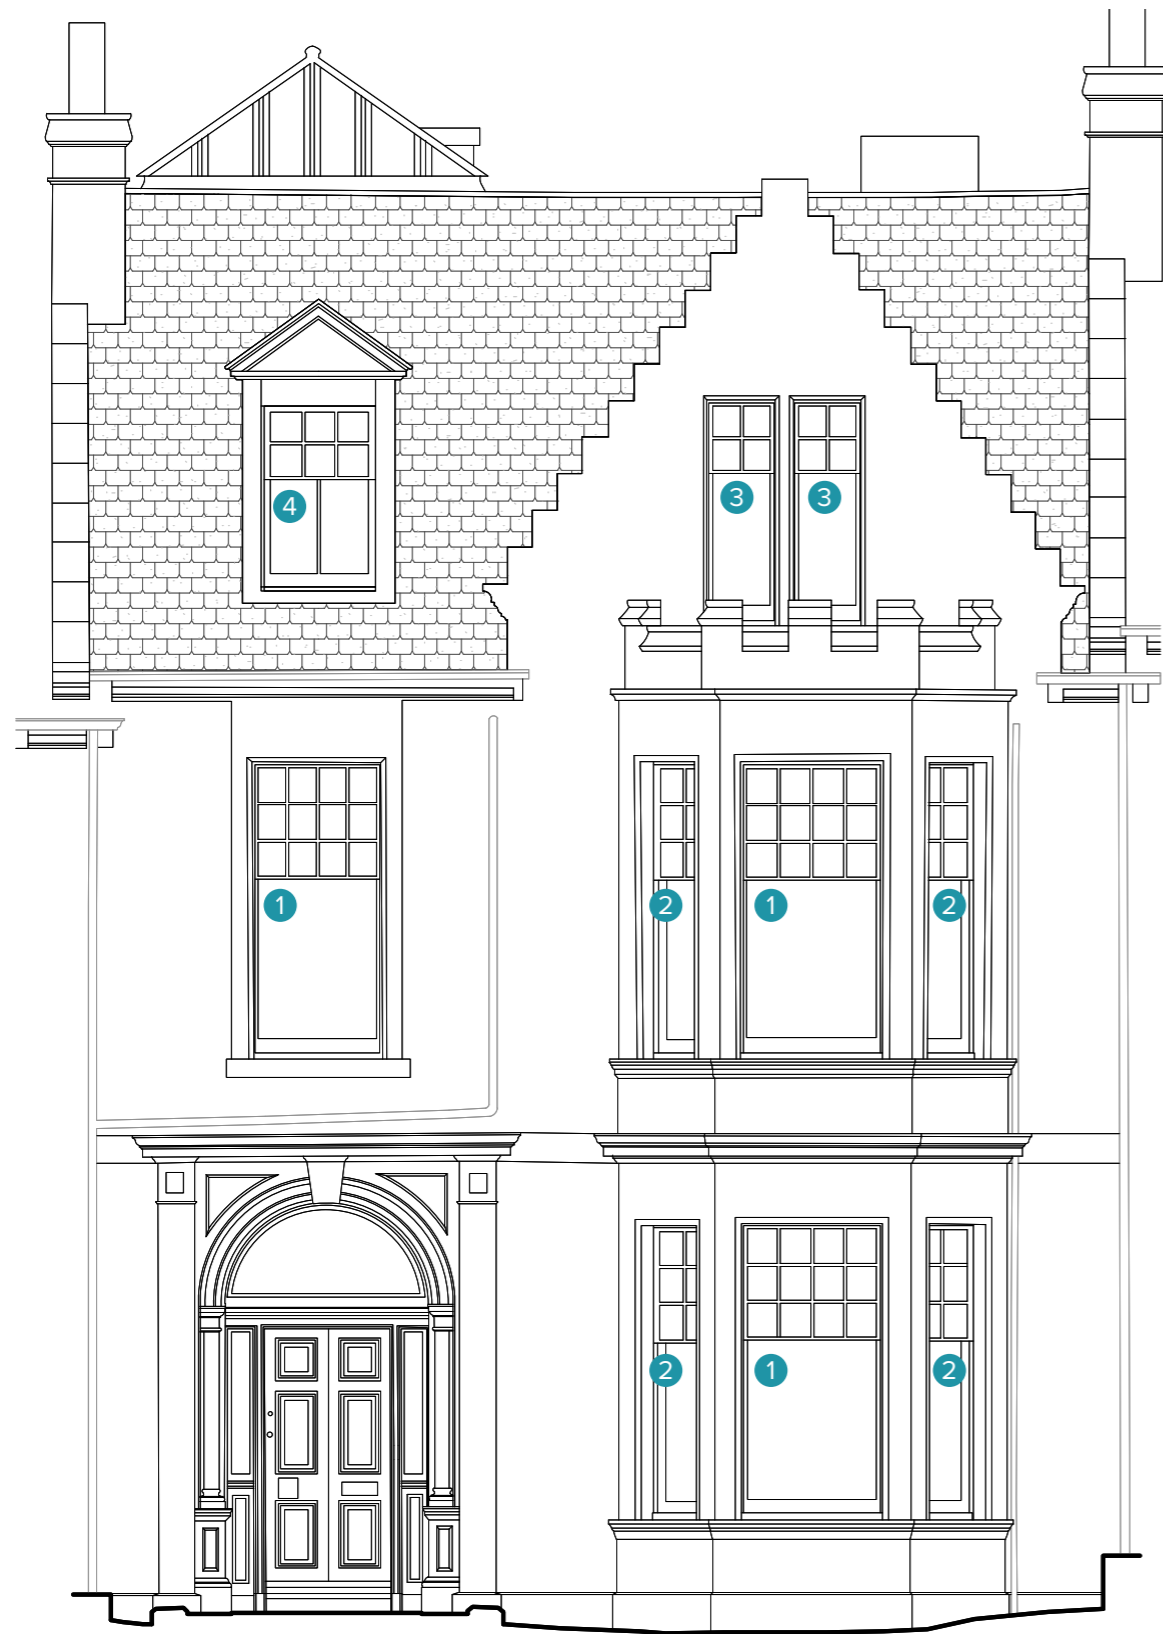
2.1 PROPOSED FRONT ELEVATION

- 1 Proposed new top sash with 12 over 1 astragal pattern and slimlite double glazing (to match other properties elsewhere in the street.) Slimlite double glazing to be installed within existing bottom sash. Bottom sash and cases to be retained and refurbished like for like as required.

- 2 Proposed new top sash with 6 over 1 astragal pattern and slimlite double glazing (to match other properties elsewhere in the street.) Slimlite double glazing to be installed within existing bottom sash. Bottom sash and cases to be retained and refurbished like for like as required.

- 3 Proposed new top sash with 4 over 1 astragal pattern and slimlite double glazing (to match other properties elsewhere in the street.) Slimlite double glazing to be installed within existing bottom sash. Bottom sash and cases to be retained and refurbished like for like as required.

- 4 Proposed new sash window with 6 over 2 astragal pattern and slimlite double glazing in keeping with the feedback by The Architectural Heritage Society of Scotland for the planning application to Flat 3, 17 Murrayfield Avenue: *"To the principal facade, the bipartite windows would have been four-over-one, and the single window would have been six-over-two. This can be seen on most properties along the street"* (ref. 22/03015/LBC)

In order to improve the longevity of the building and protect it for future generations, as well as make substantial improvements to thermal performance and energy use, we are proposing to replace the glazing of the existing sash windows with slimlite double glazing throughout. On the front elevation, we are also proposing to replace the top sashes with new sashes to match the original astragal pattern of some of the windows elsewhere on Murrayfield Avenue. Finally, we are proposing to replace the existing non-original dormer window on the front window, which is in extremely poor condition, with a new timber sash window with slimlite double glazing and detailing to match the existing.

The changes proposed to the front elevation will reinstate a lost window arrangement that is present on some other properties on Murrayfield Avenue and is therefore a heritage gain, whilst also preserving and enhancing the character of the Coltbridge and Wester Coates Conservation Area.

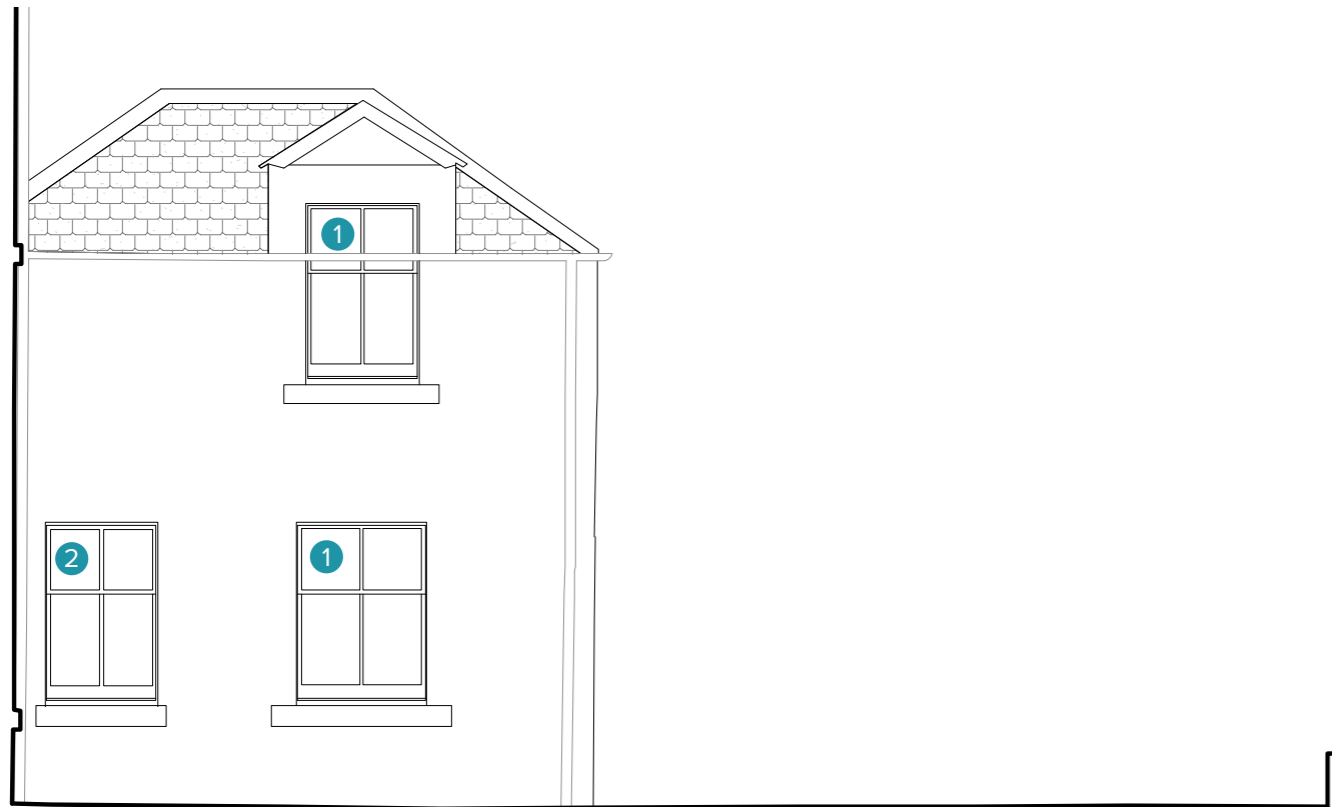
2.3 PROPOSED SIDE ELEVATIONS

- 1 Existing timber sash window to be retained and refurbished like for like as required. Slimlite double glazing to be installed within existing sashes.
- 2 New slimlite double glazed sash window, recently approved (application ref. 23/01013/LBC) (shown for completeness only)

PROPOSED OUTRIGGER SIDE ELEVATION
