# Ostrich Refurbishment

## Statement of Proposed Additional Works

18 November 2023 – Version 2

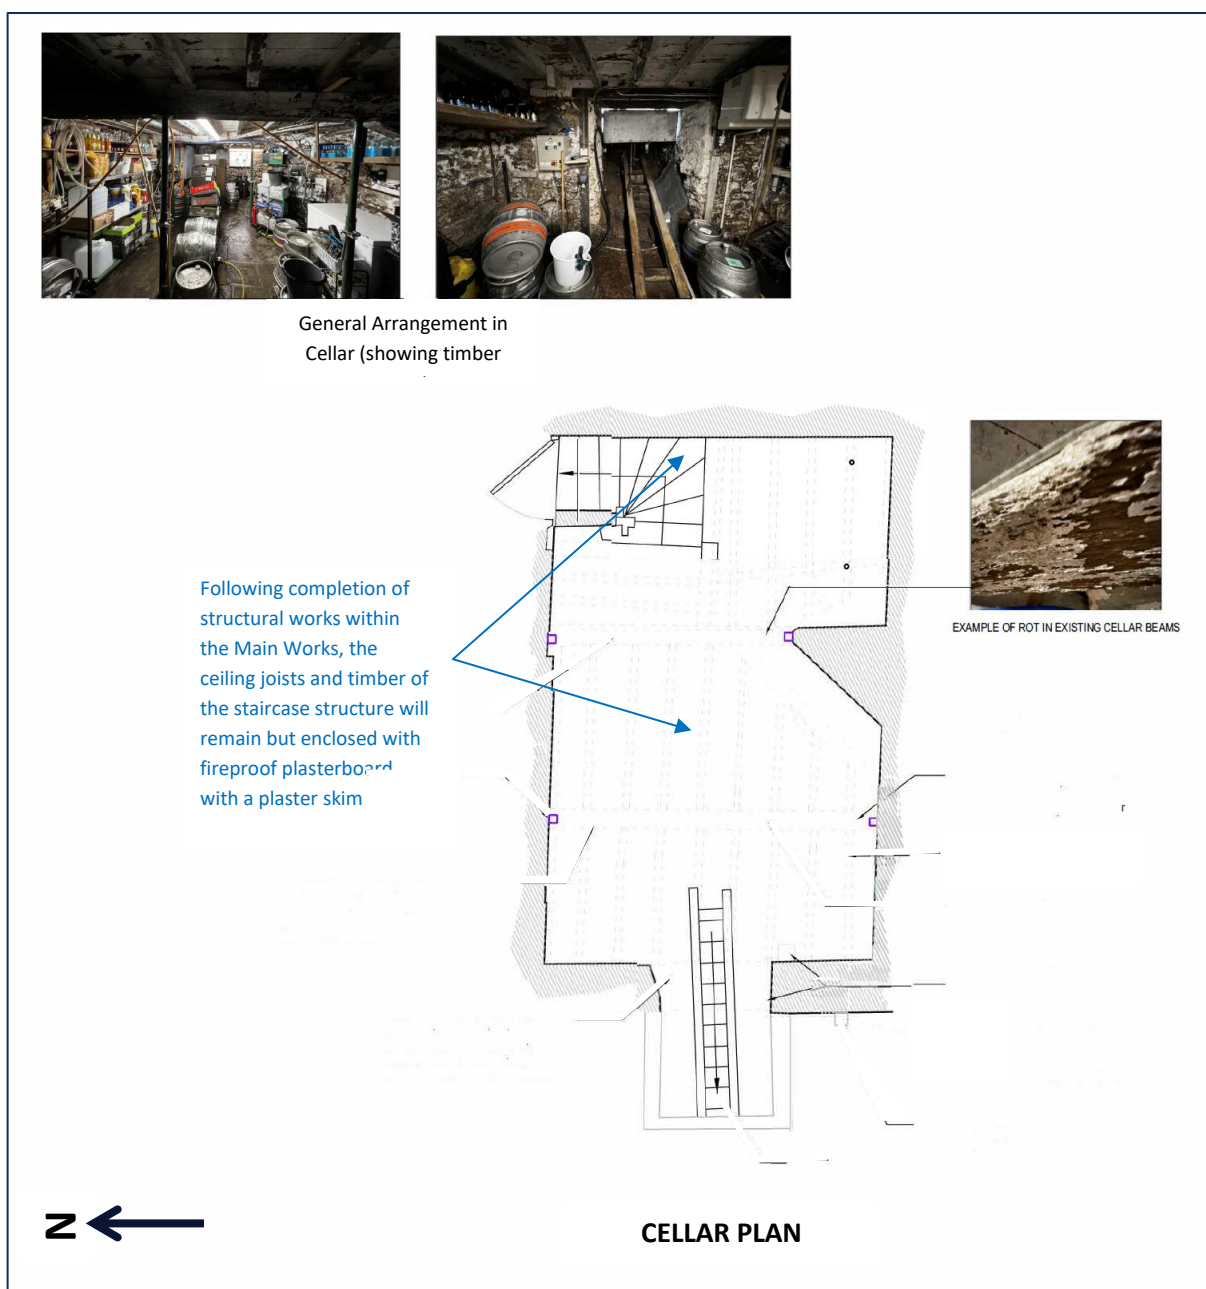
Figure 1: Cellar plan

- 2.3.1 line the cellar ceiling and under-stair lining (**Figure 1**) with fire-resistant plasterboard affixed to the underside of the ceiling, utilising timber battens where necessary for additional support of the plasterboard, and finished with a plaster skim. Edges and joints will be sealed with an appropriate intumescent seal/batt. Any resultant ceiling voids will be ventilated to the cellar using 55mm intumescent air transfer grilles to prevent moisture build up in the voids. All historic fabric will remain in-situ and, should it be required, the plasterboard and any battens can be removed in the future

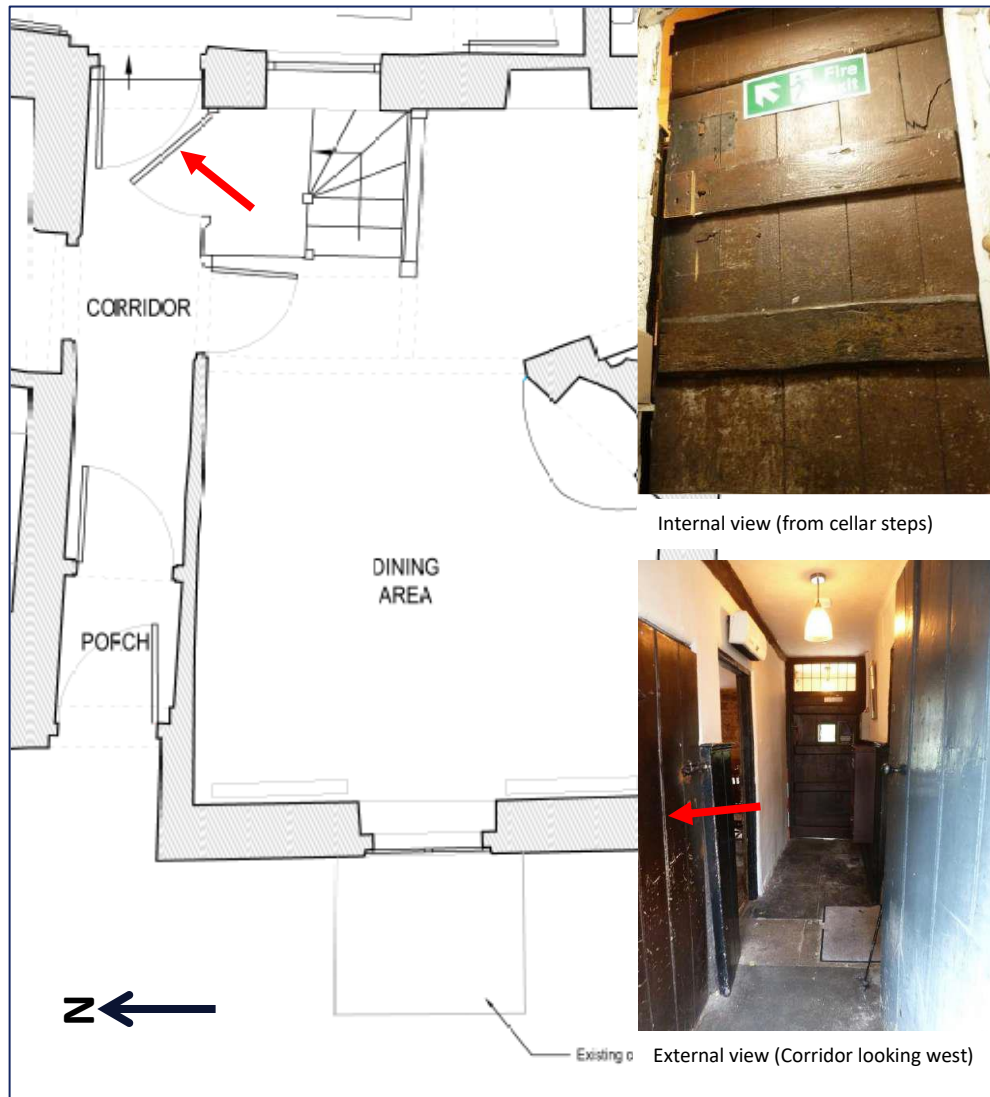
- 2.3.2 incorporate a 250mm square intumescent air transfer grille at low level within in the cellar door (see Figure 2) as part of its FD30 upgrade. The exterior of the transfer grille will be covered by a slotted plain metal grille painted to match the painted surface of the door.

**Figure 2:** Ground floor location of door to cellar being upgraded to FD30 as part of the Main Works (Red arrow)

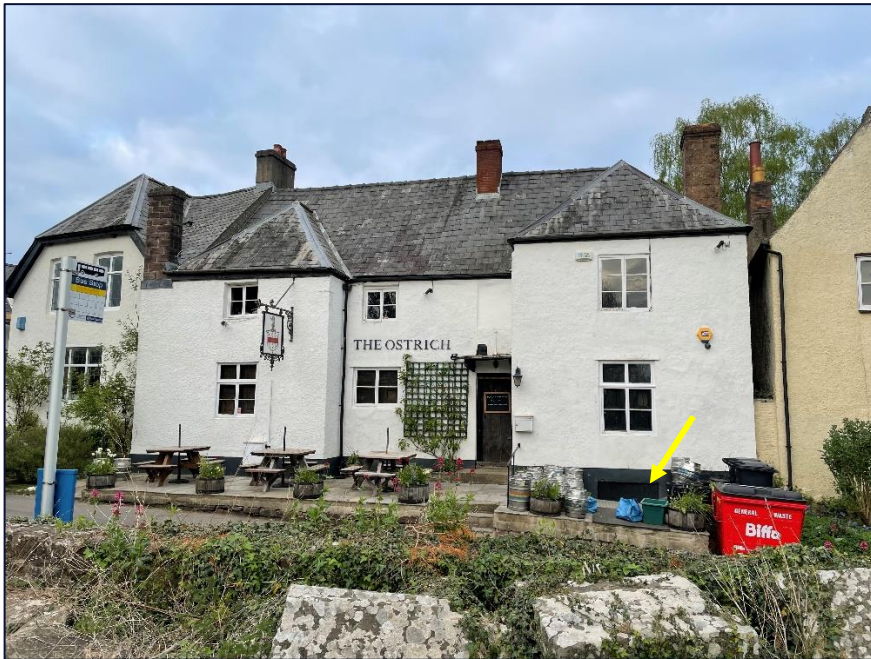
- 2.3.3 incorporate a 150mm square black external vent in the vertical plywood door that forms part of the beer drop to the cellar (Figure 3A and 3B).

**Figure 3A.** Context: location of vertical plywood door to beer drop to the cellar (yellow arrow)

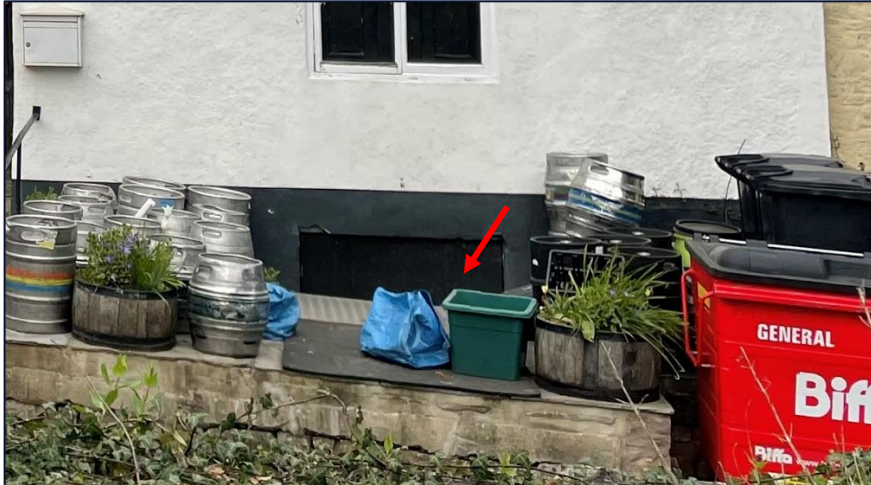
**Figure 3B.** Location of black 150mm black vent (red arrow)

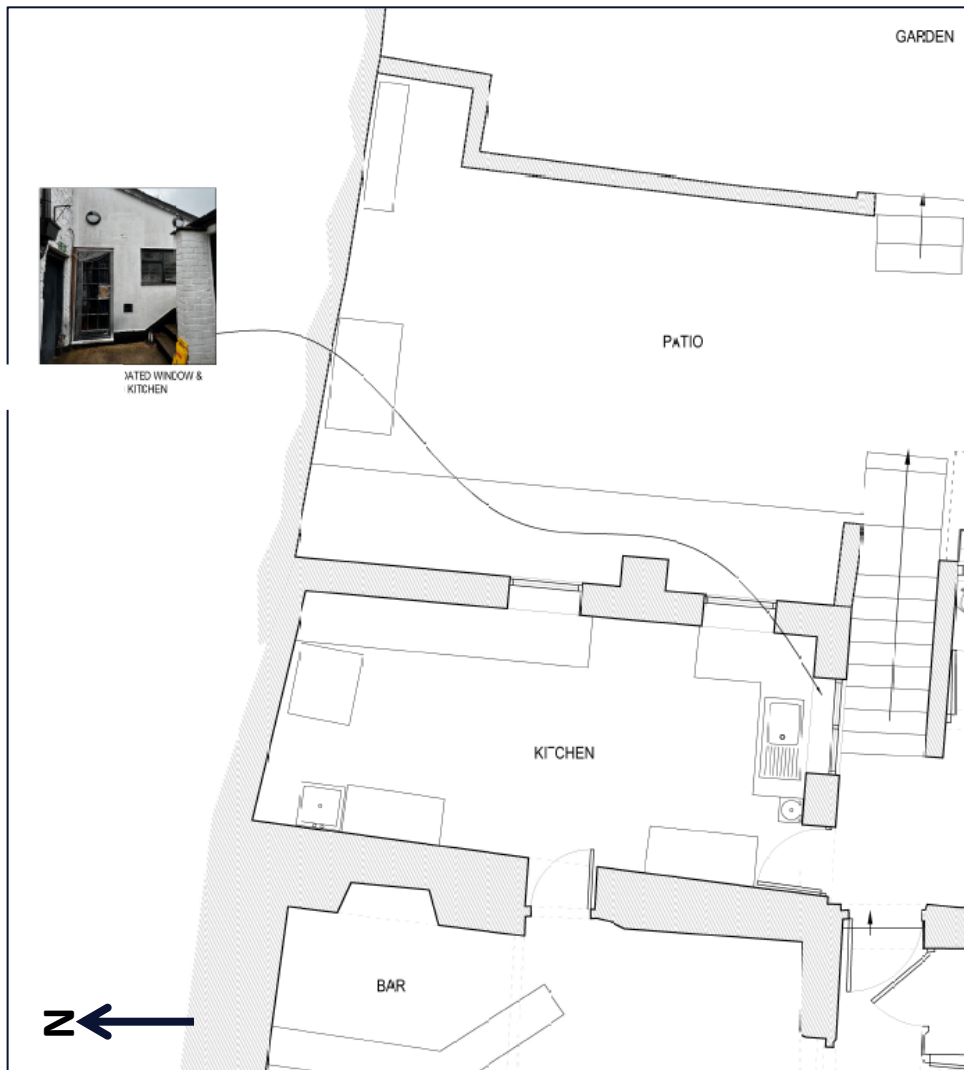
3.2.1 Install a 315mm external white aluminium air intake grille in the southern wall to the ground floor kitchen to distribute fresh air into the kitchen via ducts laid in the roof void and smaller grilles in the kitchen ceiling (Figure 4A and 4B).

Figure 4A: Location of ground floor kitchen south wall.

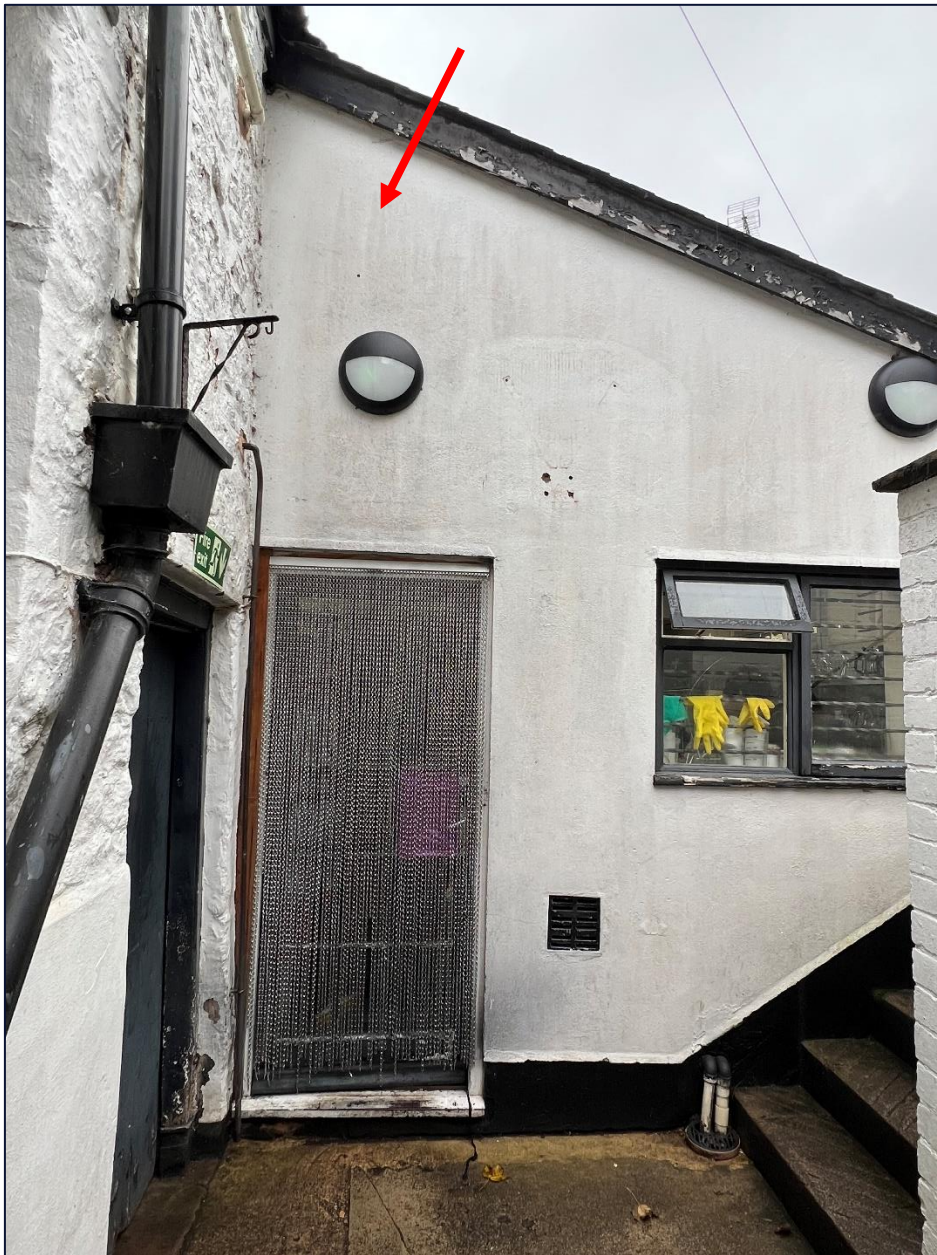
Typical grille detail – aluminium grille with insect screen

**Figure 4B:** Location (red arrow) and type of grille

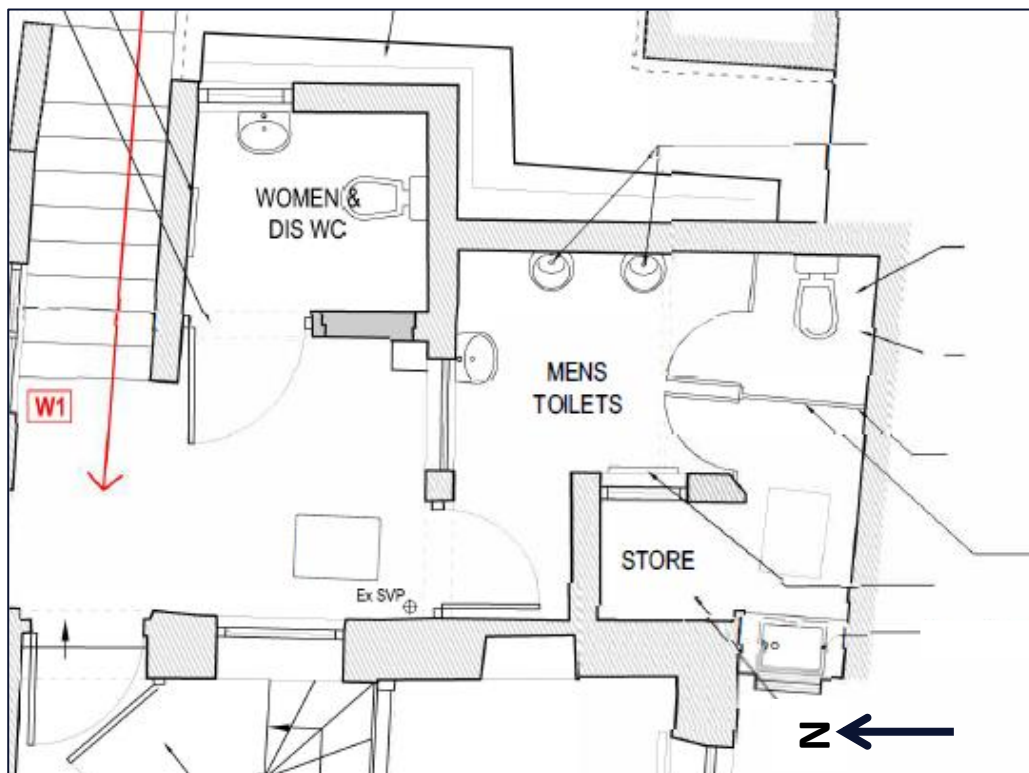
4.2.1 Create a new level ceiling in the Men's Toilet (Figure 5A) at approximately the level indicated in Figure 5B. The ceiling will be formed using timber joists and surfaced with plasterboard with a plaster skim finish. The upper side of the ceiling will be insulated with 200mm roll insulation. An access/inspection hatch will be incorporated in the ceiling.

Figure 5A. Location of Men's Toilet

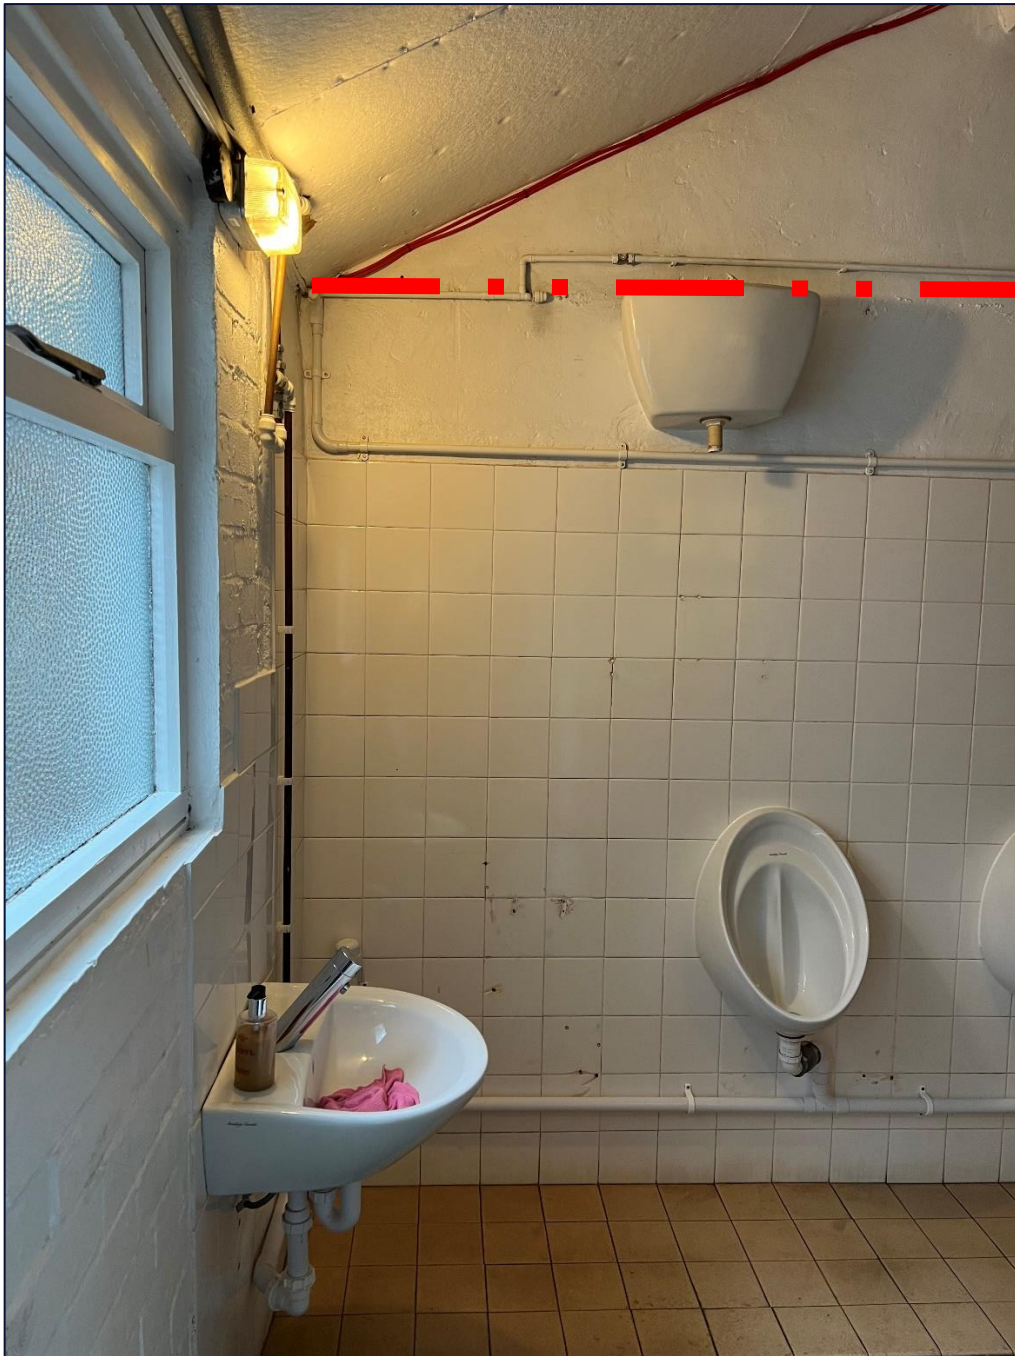
**Figure 5B.** Proposed ceiling level (red broken line). Note: photograph shows Men's Toilet as existing and prior to the Main Works.

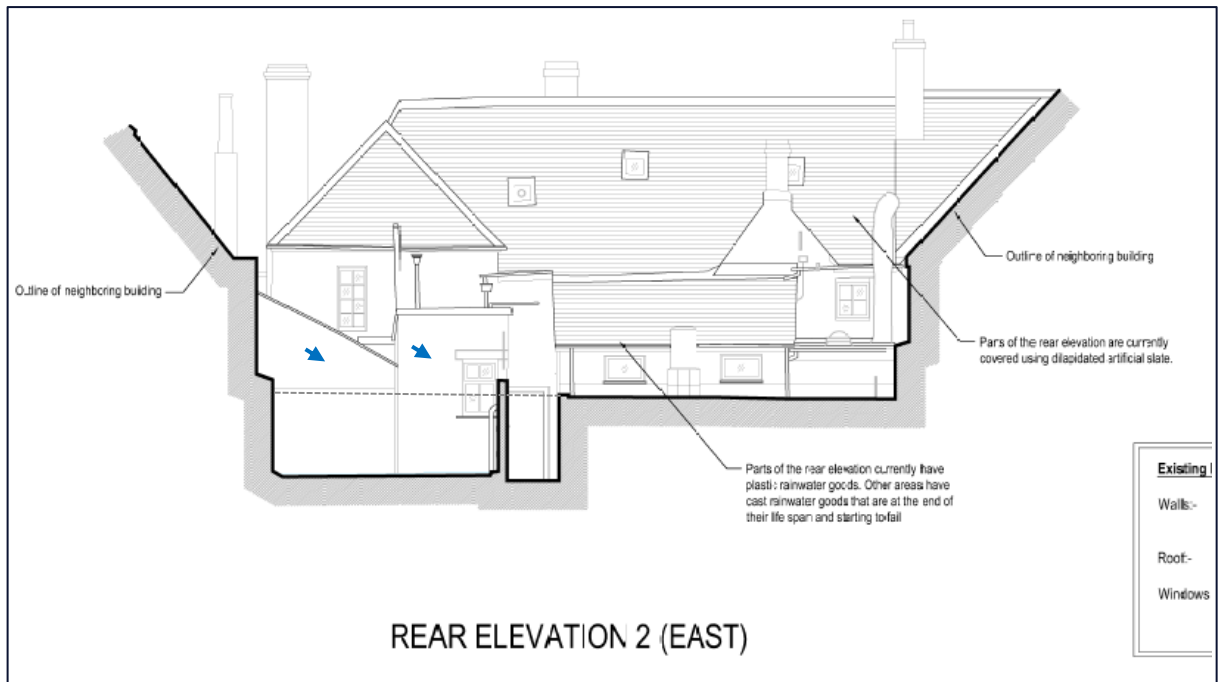
- 4.2.2 Install a 150mm extract fan to each toilet, vented to the rear wall and discharging into the gap between the toilets and the retaining wall for the patio, as indicated on Figure 5C with blue arrows

**Figure 5C.** Rear elevation. Extract locations indicated by blue arrows. Typical vent detail shown below.
