# **Factual Site Investigation**

## BOC Teesside CO2 Plant, North Tees BOC

S230624

### FACTUAL SITE INVESTIGATION REPORT

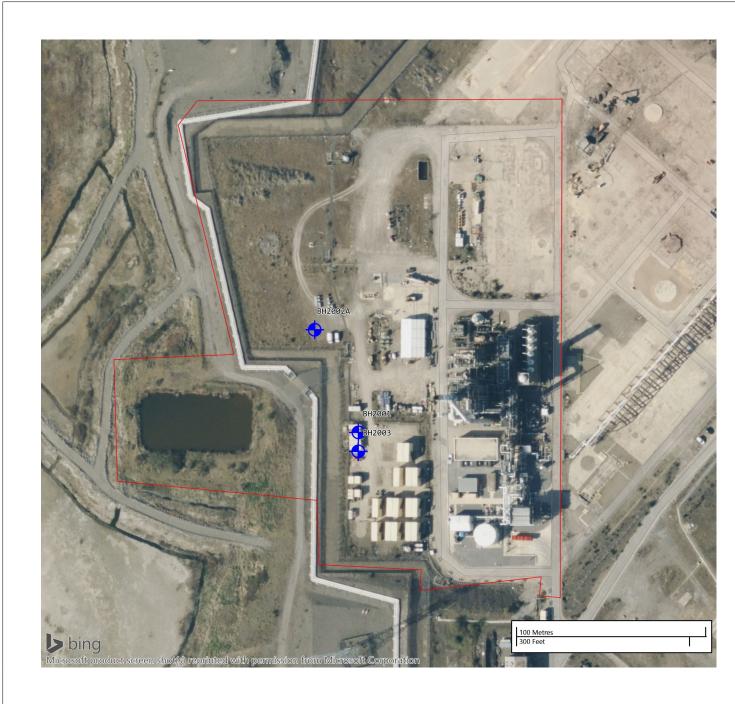
Descriptions of the strata encountered in the exploratory positions together with details of sampling and groundwater are presented in Appendix B of this report. A plan showing the location of all positions can be found in Appendix A (Figure 2).

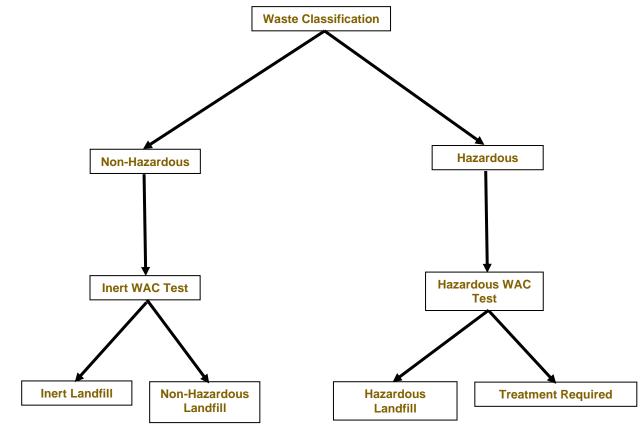
The below flow chart provides further information on the waste classification process.

If waste classification and/or WAC testing are not undertaken, material taken off site may be subject to WAC testing by the appropriate waste disposal company. The decision on whether or not to accept waste, or whether further testing is required, is at the discretion of the waste disposal company.
