## Heritage Statement

**Site:** Harpers, Shooters Hatch Road, High Easter, Chelmsford, CM3 1HU

**Proposal:** Single storey extension. Internal and external alterations.

**Date:** October 2023

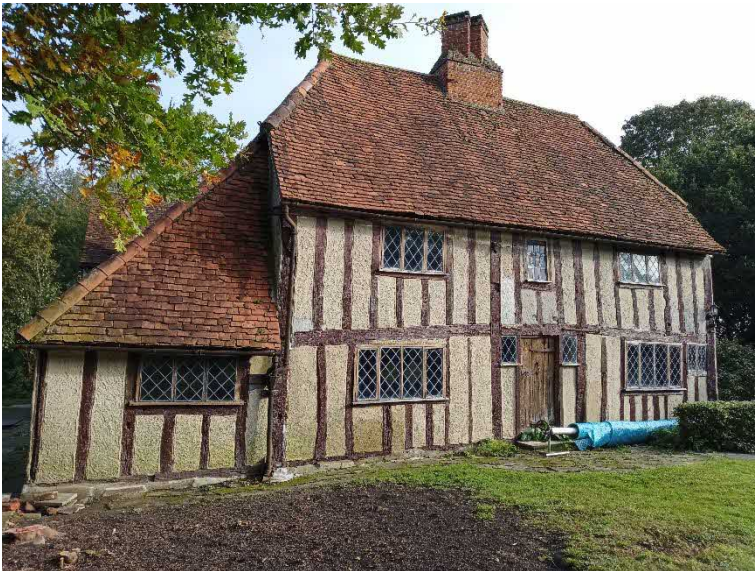
Fig 1. South elevation (original 17<sup>th</sup> century building)

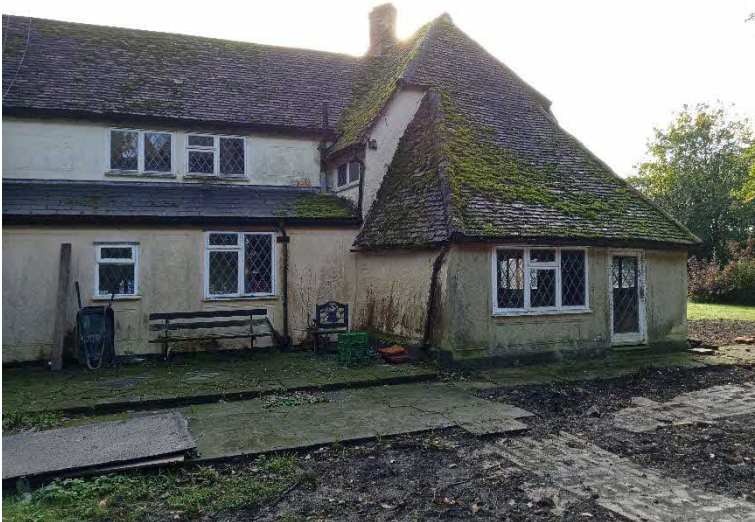
Fig 2. West elevation (original 17<sup>th</sup> century building and outshot with later extension to North)

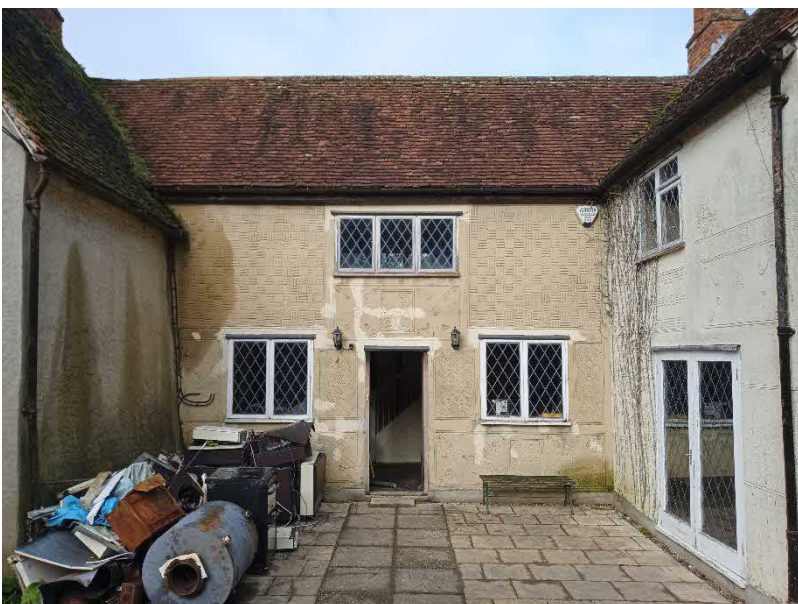
Fig 6. East elevation (later 1964 extension forming an H shape courtyard and new front door facing East)

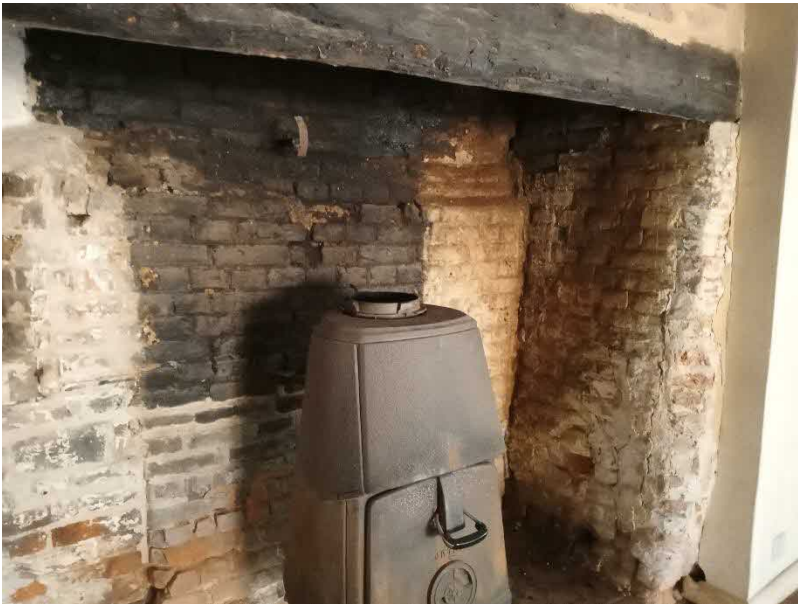
Fig 10. West bay of 17<sup>th</sup> century fireplace

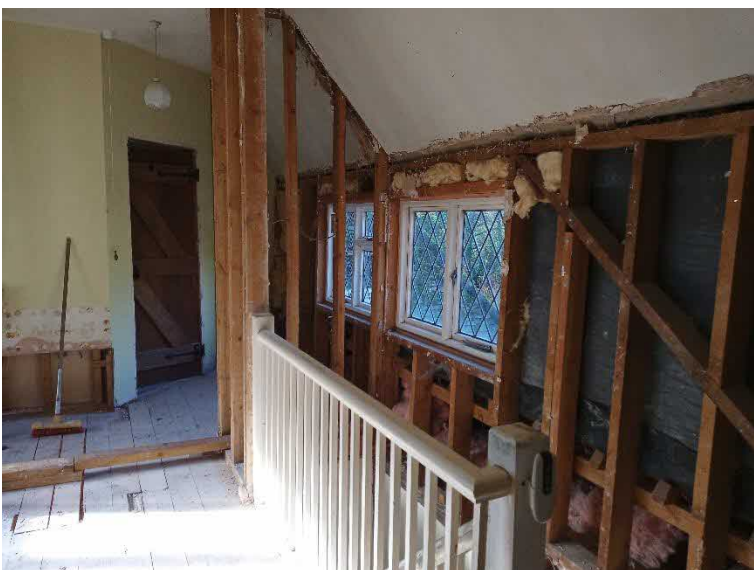
Fig 15. Staircase within later extension

(7) The existing staircase is a 1960's pine staircase, handrail and balustrade. The proposal is to replace the staircase with a more in-keeping staircase with a better arrangement. The insertion of the new staircase will not alter any historic fabric due to it being located in the later 1960's extension.

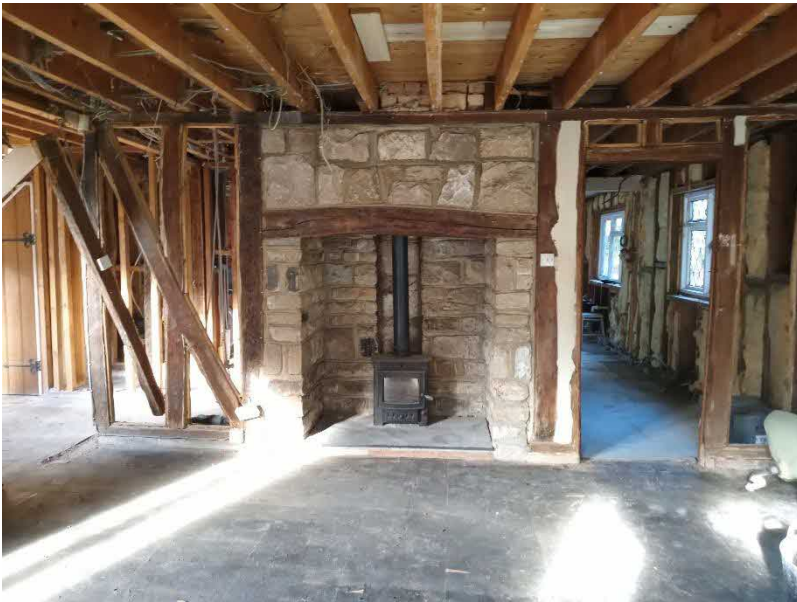
Fig 16. Later faux fireplace within 1964 extension

(8) The proposal is to remove the boiler flue chimney located off of the kitchen external wall. The chimney is not historic and removal will assist in the improved layout. The fireplace located between the dining and kitchen room has been constructed stonework and bricks, all materials from the 1960's period. It is also proposed to remove the false fireplace and replace with a simpler fireplace layout with wood burning stove.

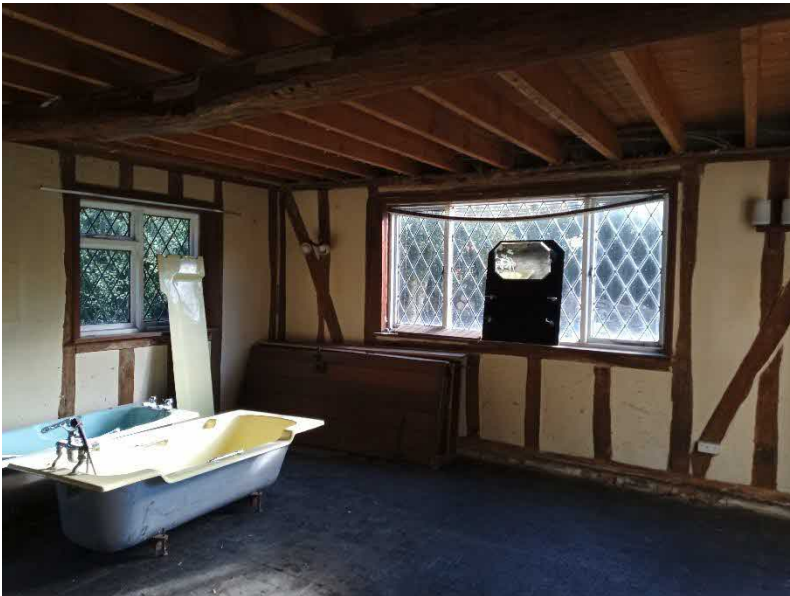
Fig 17. 1964 Extension. Faux Oak timbers within wall.

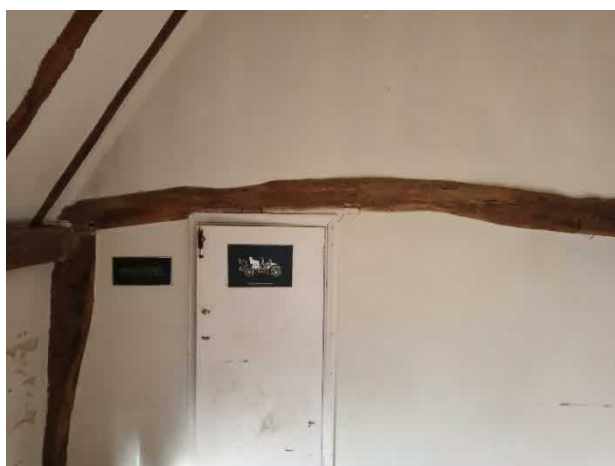
Fig 25. View of cupboard from East bedroom

(1) There are some cupboards to one side of the chimney stack which can be accessed from both rooms either side of the stack. The cupboards are formed with softwood timber and plasterboard finish. The cupboards are not of any historical significance. The proposal is to block up the cupboard off one of the bedrooms to form a large cupboard to the other.

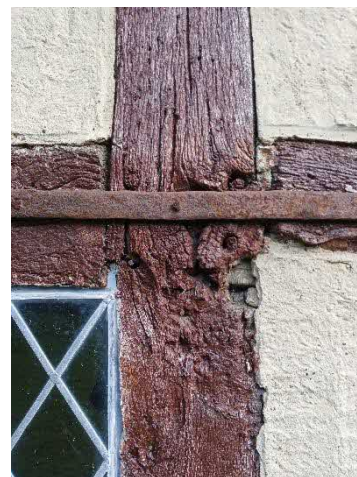
Fig 26. View of poor condition timber and cement lime render.

(2) The external walls are in a very poor condition with little to no insulation. The proposal is to remove the cement render, both to infill panels between studs and over studs, and replace with chestnut laths and lime render. The proposal will improve the appearance of the building, improve the weather resistance, reverse the unsympathetic cement render and improve the breathability of the building.

The cement render is leading in damp to the timber frame and resulting in deterioration of the structure. Looking at some of the inspection holes, the cement render has been applied over a EML mesh. The removal of the render therefore maybe possible without harming the structure of the building. The proposal is to install chestnut laths and lime render. The proposal will both improve the appearance of the building, plus improve the breathing quality of the fabric, thus leading to the long-term conservation of the building. It is therefore considered the proposal is an enhancement and will result in no harm to the significance of the building.

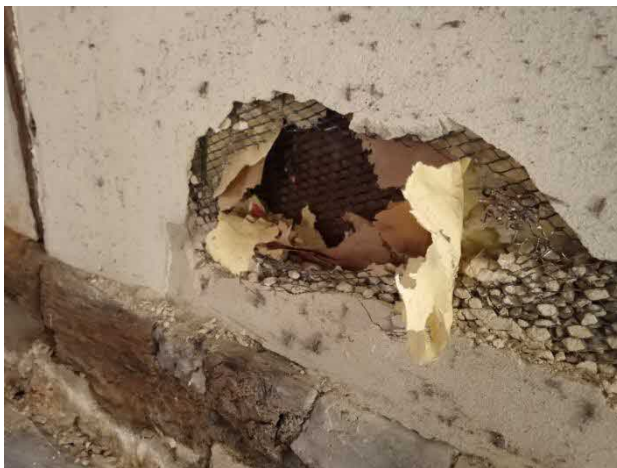
Fig 27. View of external wall within 17<sup>th</sup> century building showing plaster on EML both internally and externally

(4) Internally, the walls are currently lined with plasterboard or cement render on EML mesh. The proposal is to remove the cement render and plasterboard and replace with chestnut laths and lime plaster. Where the studwork is currently exposed within the rooms, the laths will be installed between studs to ensure they continue to be exposed. Refer to method statement within appendix B for lime plastering internally and externally.

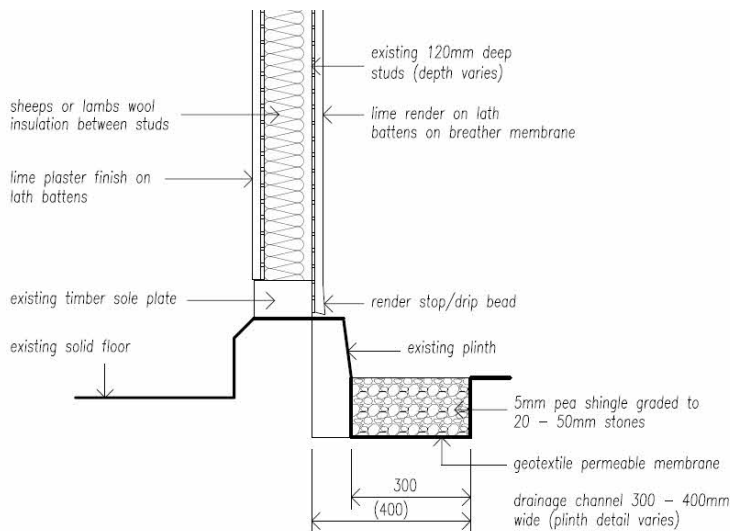
Fig 28. Architects detail for proposed external wall build up.

External and internal wall finishes to the 17<sup>th</sup> century building are to be repaired using lath and plaster, with insulation inserted, in accordance with the below method statement;

2. Provide either oak or chestnut riven laths. The textured surface and exposed grain provides a better key. Laths to be nailed either over timber studs or between studs to battens fixed to the side of studs, spaced leaving approx 5-10mm gap, using 40mm Stainless Steel Annular Ring Shank Nails. Fix every lath the same way until you come to fix the eighth lath, move this one over one joist, to create a staggered joint, this will help prevent long, continuous cracks from developing.

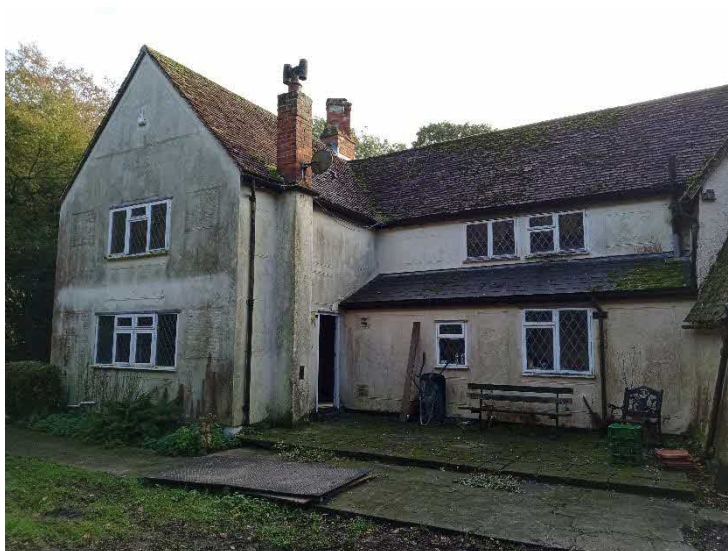
Fig 29. Existing single storey extension to be demolished.

(6) The plans include for the demolition of a single storey extension and construction of a single storey extension to the rear elevation (West). The extension will form a downstairs coat room and W.C and utility room accessed off the kitchen. The extension will have rendered external finish and lead rolled roof. The break throughs to access the extension will not remove any historic fabric as it is off of the 1960's softwood studwork extension. A lead valley will need to be formed between the extension the rear of the historic outshot.

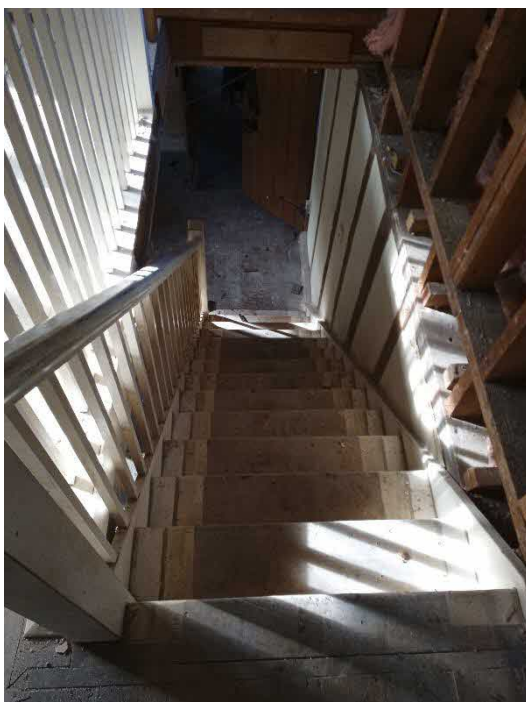
Fig 30. Existing 1960's staircase to be demolished.

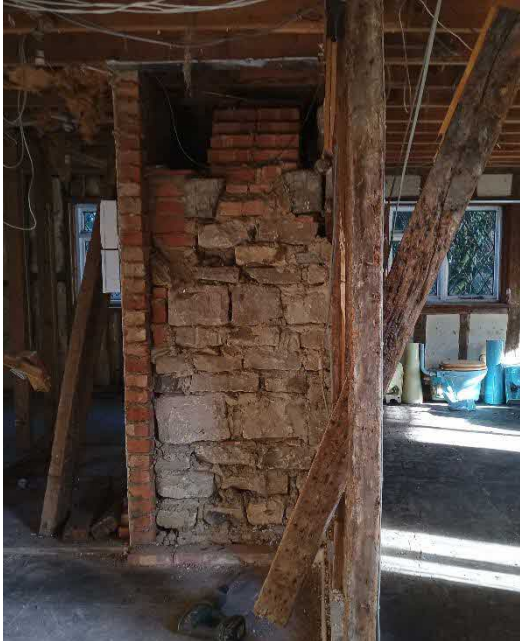
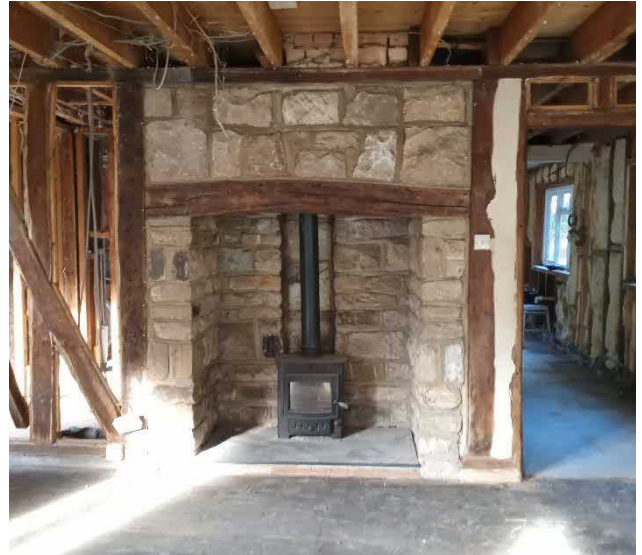
Fig 31. Faux fireplace to be removed

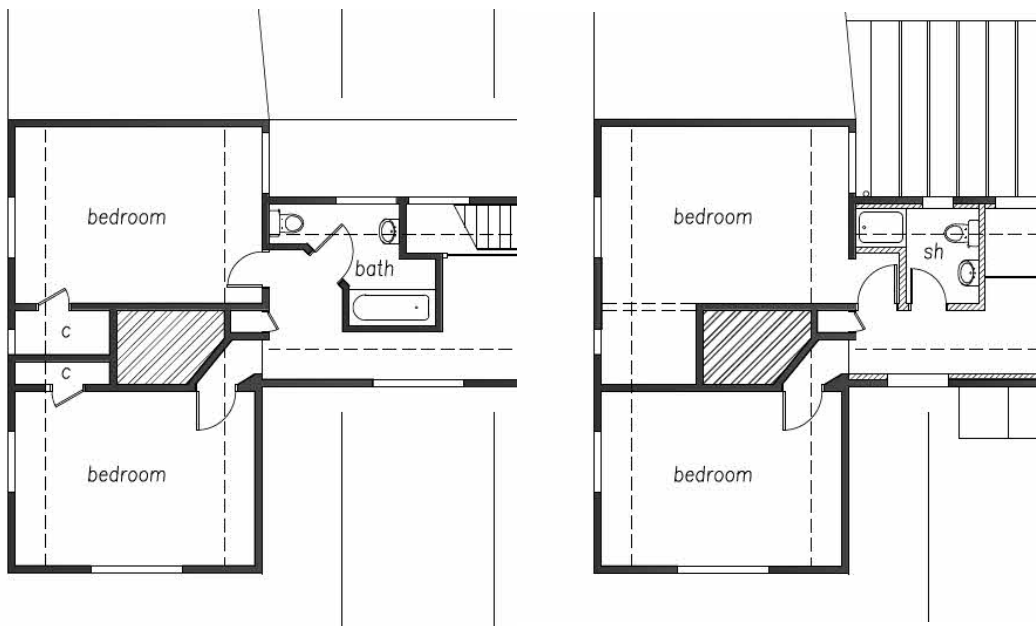
Fig 32. Extract from proposed plans

(9) The proposal is to re-arrange the stud wall layout on the 1st floor landing forming the current bathroom. The current bathroom layout is complicated and blocks a lot of light to the hallway. The proposal is to regularise the layout, as shown below. (alterations to the cupboard between bedrooms (item 1) is shown below also).

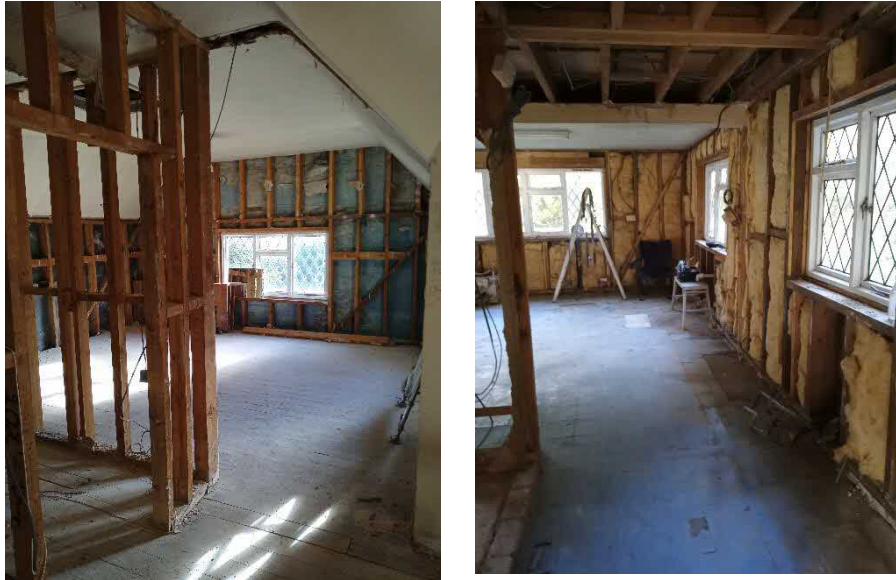
Fig 33. 1<sup>st</sup> floor external walls within 1960's extension.

- (10) A new stud wall will be constructed on the landing to separate the North wing from the landing. The North wing is to be converted into a master suite bedroom, so the new stud wall will form the separation.
- (11) The external walls to the entire 1960's extension is constructed from pine studwork. The proposal is to internally line the walls with insulated backed plasterboard to greatly improve the thermal efficiency of this part of the building.
