Morgan Architectural Services
P/O Morgan Engineering Consultants Ltd
Spaces, Sutton Point,
6 Sutton Court Road,
Sutton
London
SM1 4FS

Heritage Statement listed building consent application

3 South Terrace, Surbiton, Surrey KT6 6HT

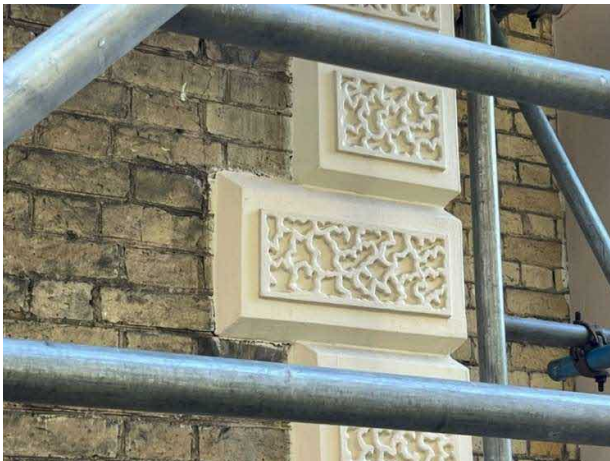
Detailed stone sets to corner returns.

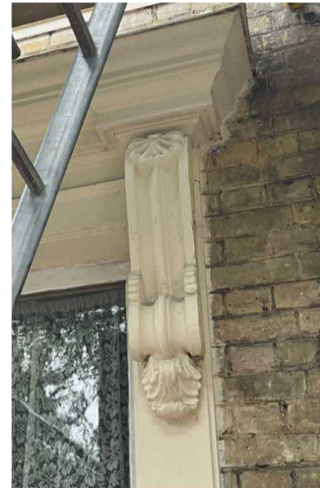
Stone supports to pelmet.

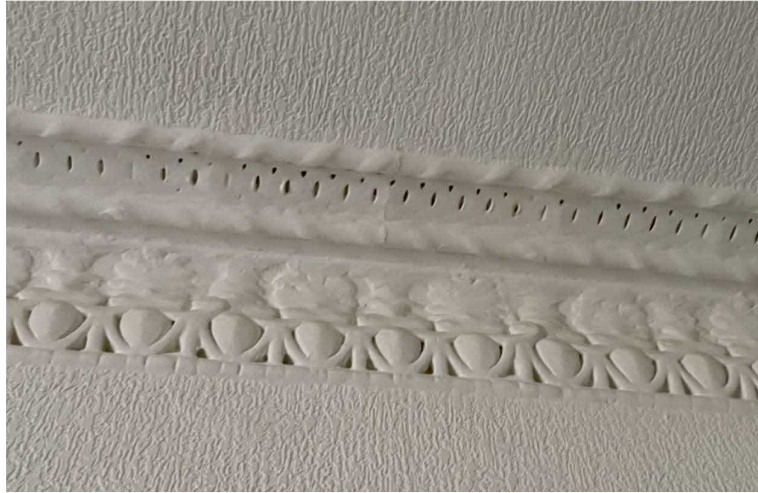
Cornice to ground floor only.

The existing cornice was in bad condition and was only present to the ground floor only. A moulding of this cornice has already been taken and it will be replicated throughout at ground floor level to match existing. The same goes for the existing wooden architraves, skirting boards and beading throughout. All will be replicated where required to match the identical moulded profile of the existing/original.

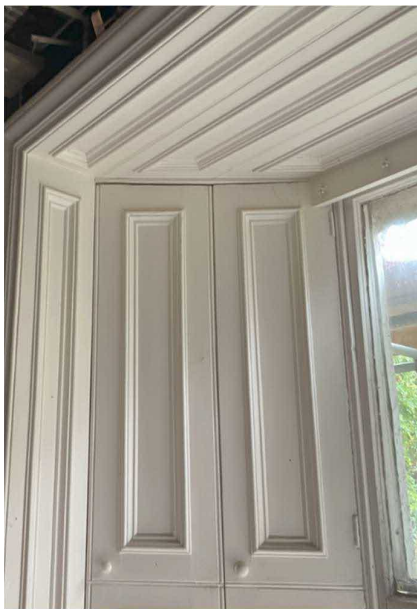
Wood panelling and shutters around windows and doors at rear of ground floor.

The existing Georgian wood panelling to the rear lounge & kitchen/diner will remain as existing and be fully refurbished. All existing marble fireplaces will remain in the property and be covered/protected during the works to preserve the Georgian features. The existing floorboards will be sanded/refurbished and will remain on show in certain areas and rooms throughout.

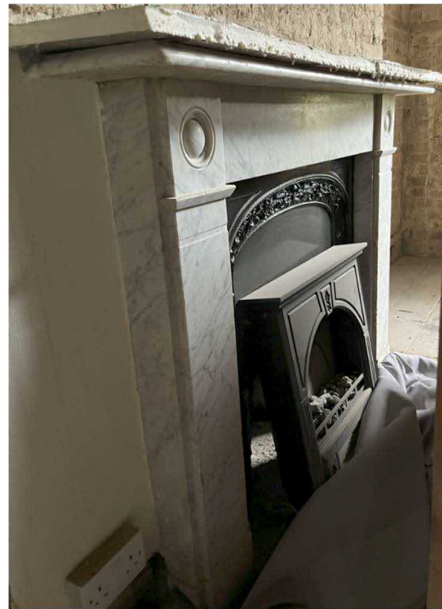
Cast iron fireplaces with marble surrounds.

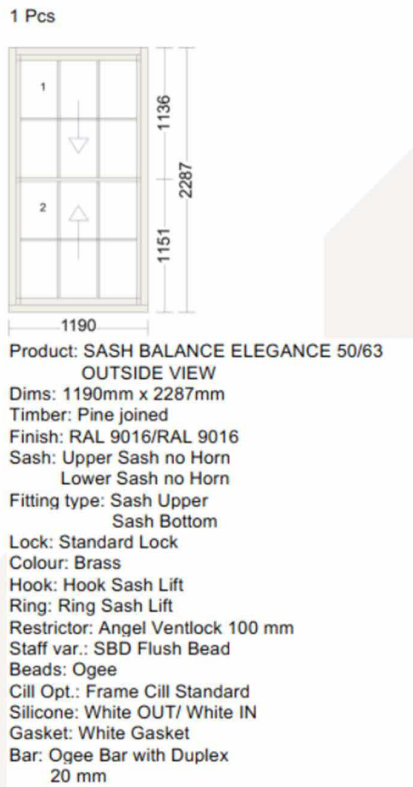
W3 - Ground Floor – FRONT - Right Window

The existing out-of-character steel and uPVC windows will be replaced with double-glazed timber sash windows in white with brassware & beading to match original Georgian features. The existing timber windows will also be replaced with new timber sash windows in white with brassware & beading to match original Georgian features; given many of them are in bad condition/broken also.

Example below of front elevation:

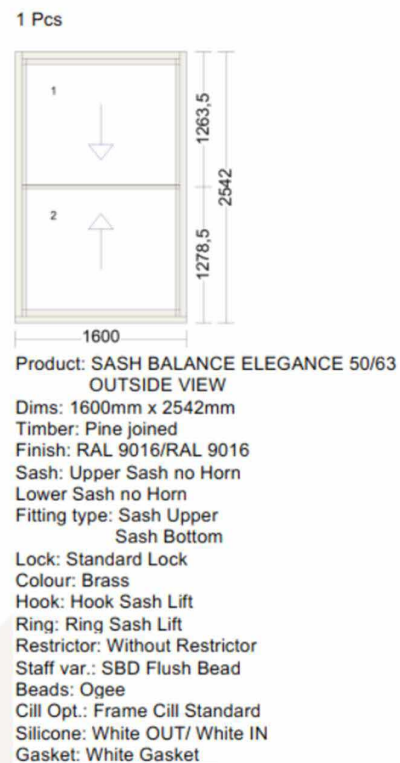
W20 - Ground Floor – BACK - Lounge Window

Example below of rear elevation:

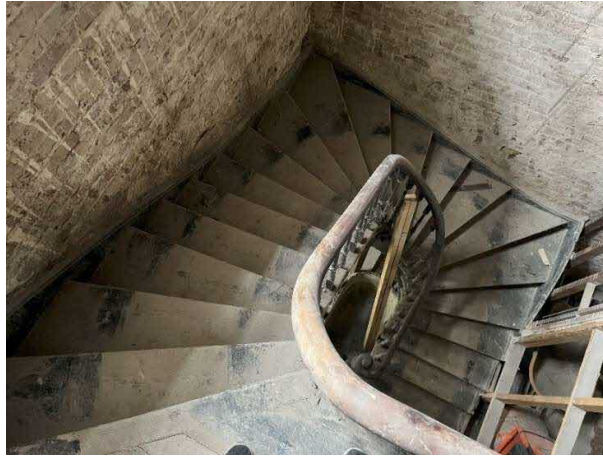
The existing grand curved staircase will remain as existing and be fully refurbished, including all balustrades, handrail, risers and goings.
