DESIGN & ACCESS STATEMENT

HERITAGE STATEMENT

For additional alterations to the approved works at:

THE OLD FARM HOUSE

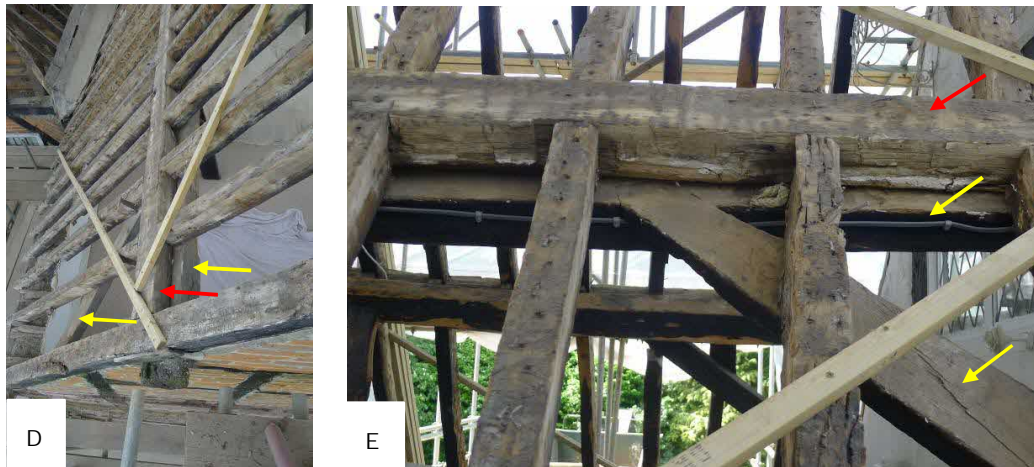
D: Detail from above of the east slope of the west range. Note the original purlin and brace [yellow arrows] and the later purlin [red arrow] showing a history of adaptation and alteration to the roof frame.

E: Detail of the northern end to the east slope of the west range. Note the original purlin and brace [yellow arrows] and the later purlin [red arrow].

Photos B, D & E show that the common rafters to the roof were adapted within a later phase of alteration to the roof frame, possibly 18th century. The common rafters are nailed/spiked in place rather than using traditional joints and have had birds-mouth joints provided so that they could be reused to sit on the wall plates [Photo B]. All of which reflects that the common rafters illustrate a later phase of adaptation to the building.

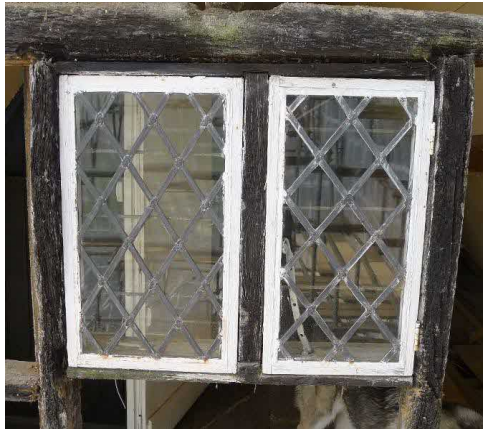
The photo on the left is of the east gable attic window

Timber framed metal casements with diamond pattern leadwork. The casements are poorly constructed and have been subject to a history of ad-hoc repair.

The casements are different sizes and in a poor condition.

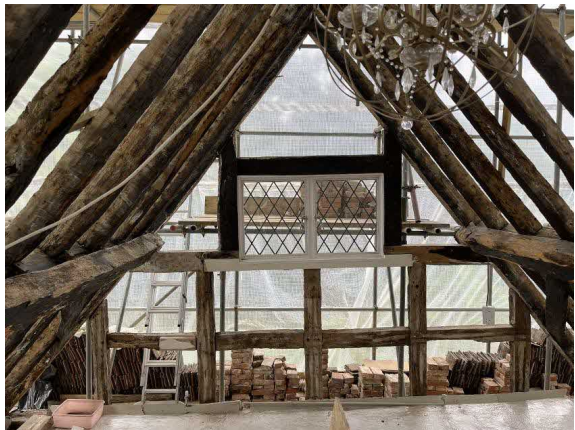
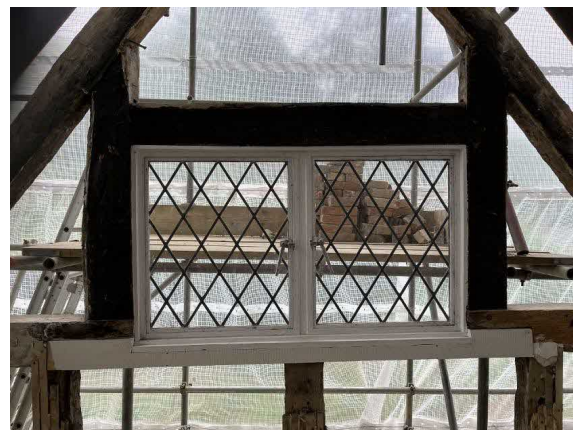
The photos above show an internal view and detail of the north gable attic window. This is a 20th century metal casement window with diamond pattern leadwork.

The original collar of the historic timber frame was cut to accommodate this window. The priority within the ongoing repairs was to reinstate the primary structural performance of the collar.

The reinstatement of the missing section of the collar meant that the existing window could not be reinstated in its original location, as the repair has reduced the size of the opening.

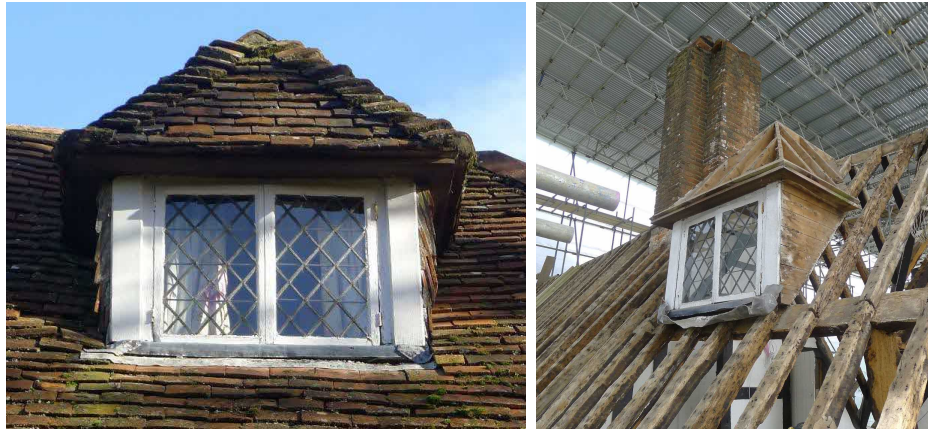
The photos above show the casement window to the west dormer, before repair works [left photo] and in the process of the repair works [right photo]. This is the third window it is proposed to replace.

The dormer was added in the 20th century and the window is anticipated as being contemporary with the addition of the dormer.

The timber casements were found to be in a poor condition requiring extensive repair. The casements were of a poor initial construction and detailing and would need to be replaced for a functional weathertight window to serve the dormer. The dormer is elevated and is exposed to the prevailing weather and will need regular maintenance and repair.

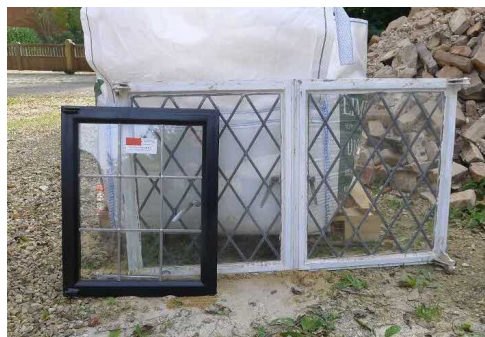
The photo above shows a sample of the proposed replacement metal framed window against the metal casement removed from the north gable. The leadwork can be made to match the diamond/diaper pattern of the existing window. The traditional detailing of the sample window would provide a replacement window that is consistent in materials and appearance whilst the double glazing would provide the benefit of improved thermal performance.

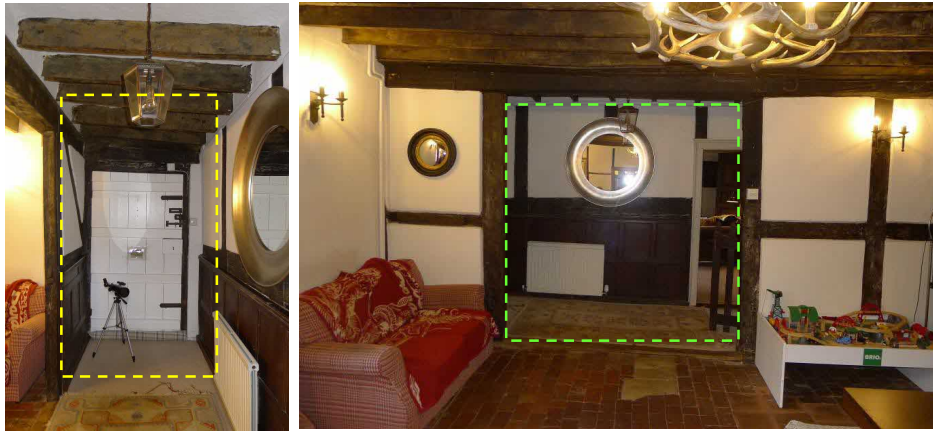
The photo on the left shows the south entrance door within the 'cross passage'. It is proposed that an oak framed glazed door be inserted to create an entrance lobby – approximate location illustrated by the yellow dashed lined rectangle.

The photo on the right shows the existing opening between the dining room and the 'cross passage' where the proposed glazed screen partition and door is to be located, illustrated by the green dashed lined rectangle.

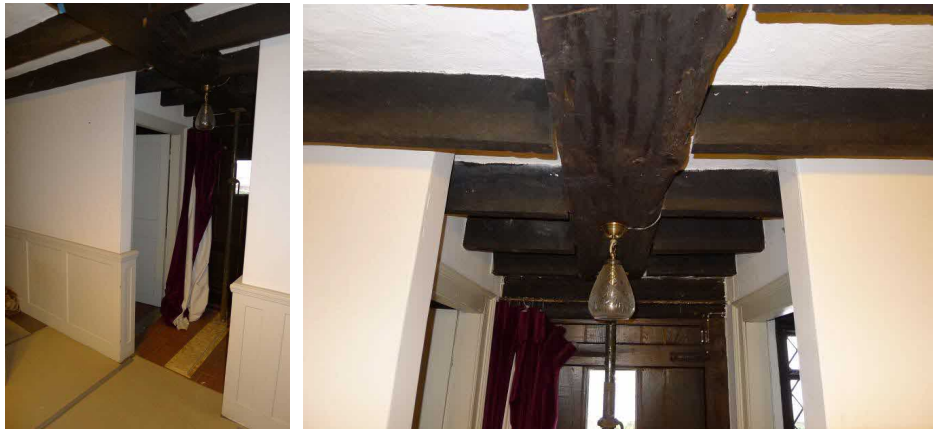
The photos above show a view and a detail of the existing opening where it is proposed to add a door to create an entrance lobby to serve the door to the north gable of the west range.

The ground floor room to the north of the west range has been sub-divided by a solid wall in the 20th century to create the WC and a small boot room.

The existing rear/north door is ledged vertical boarded door. It is proposed that the inner door be of a similar design set within a timber frame.

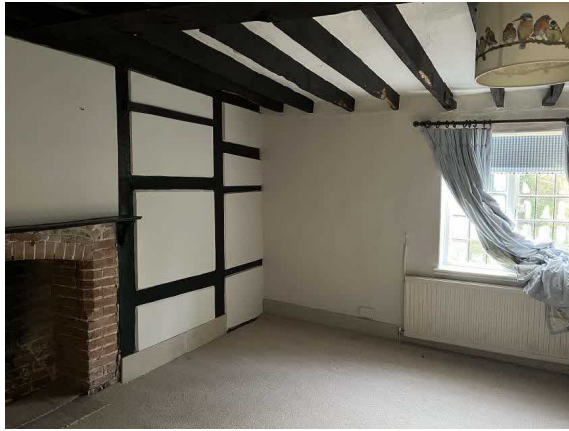
The proposed shower room/WC is to be sub-divided from the bedroom by stud partition walls that are fully reversible and are not to be fixed in a manner that damaged historic fabric.

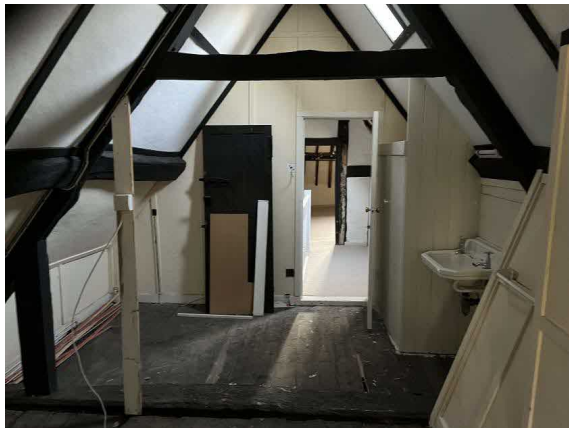
The proposed reinstatement of attic/second floor bathing facilities will be created by the provision of stud partition walls to replace lightweight soft-board walls to form the room.
