The outbuilding.

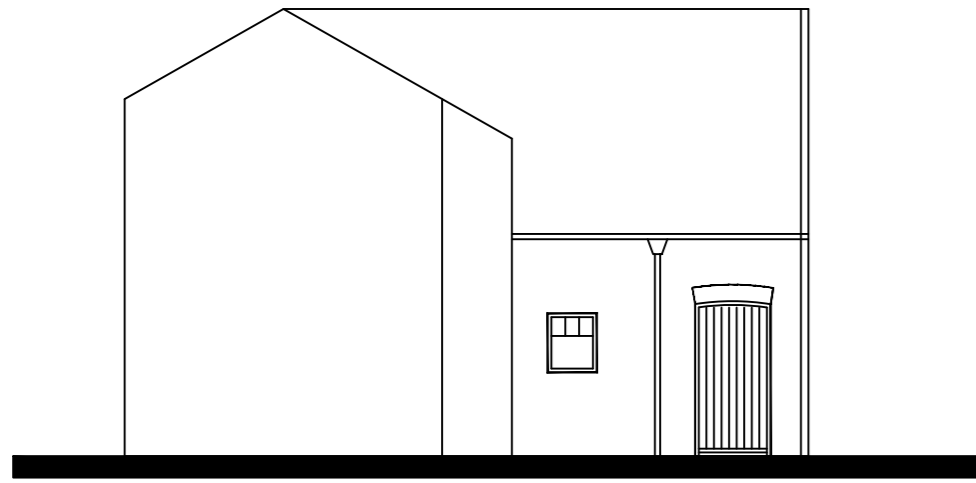
Refurbished North Elevation

North Elevation
Side window and door replaced like for like style.
