SCHOOL HOUSE

OVERVIEW	<ul style="list-style-type: none"> Convert existing outbuilding to home gym Existing oak purlins and beams to be restored Reroof Existing windows and doors to be replaced Double doors installed in existing opening Improve thermal performance of walls and roof New insulated solid floor
WALLS	<p>Dry-line internal face of existing walls:</p> <ul style="list-style-type: none"> Allow 50mm minimum clear cavity to inside face of existing walls with breather membrane to L.A approval. Form 100mm x 50mm treated softwood studwork independently fixed top and bottom. Infill studwork with 100mm Celotex GA 400 insulation batts (or similar approved) between studs. Internal face finished with 30 + 12.5 mm Celotex PL4030 (or similar approved) insulated plasterboard (taped and sealed to form VLC) with plaster skim coat
FLOORS	<ul style="list-style-type: none"> Existing dirt floor to be dug out to lay new floor slab with DPM over, 75mm rigid insulation board and 75mm screed. New floor finish TBC by clients. Structure to be assessed by SE to determine whether underpinning is required.

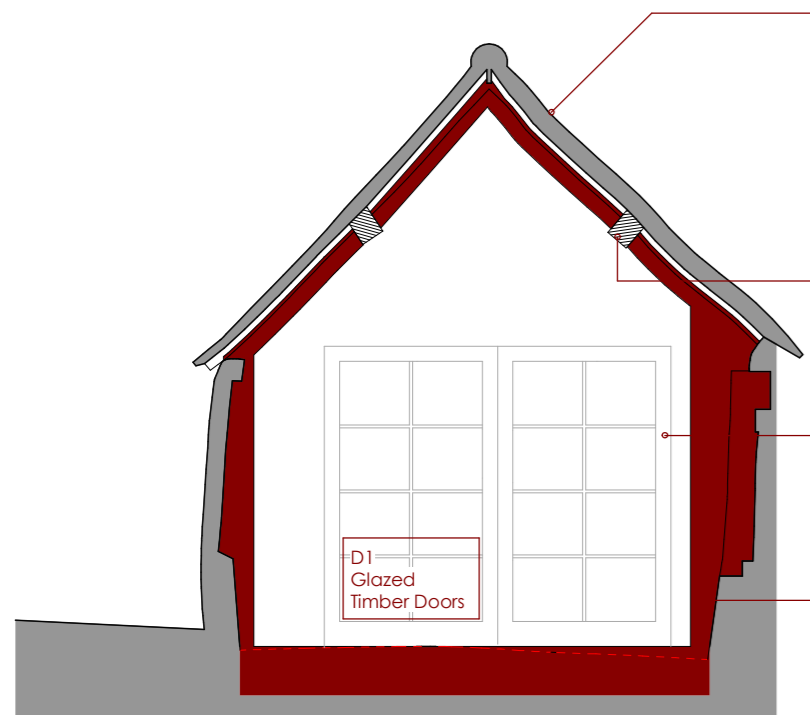
Section B-B
1 : 50

Reroofing:
Remove existing tiles and bitumen underfelt and replace with new Type 1F felt and roof tiles (re-use existing tiles). Fit 25mm RECTICEL EUROTHENE GP insulation between rafters, ensuring min. 50mm ventilation gap above. Fit 100mm RECTICEL EUROTHENE GP insulation beneath rafters with 12.5mm foiled back plasterboard and skim finish

new double glazed conservation rooflight by "The Rooflight Company" or similar

Existing oak purlins and cross beams to be restored using a low impact micro-strip sandblasting to gently remove paint and stain. By PROTINUS or similar. Oak beams to be retained as expressed features between new roof insulation

New double glazed timber doors installed within existing garage door opening

Existing timber door and casement side windows replaced with double glazed double timber doors. Modern brickwork below existing windows removed to allow reinstatement of double doors

Dry-lining:
Allow 50mm minimum clear cavity to inside face of existing walls with breather membrane to L.A approval. Form 100mm x 50mm treated softwood studwork independently fixed top and bottom. Infill studwork with 100mm Celotex GA 400 insulation batts (or similar approved) between studs. Internal face finished with 30 + 12.5 mm Celotex PL4030 (or similar approved) insulated plasterboard (taped and sealed to form VLC) with plaster skim coat

existing mix of brick, render, stone, and timber boarding to be retained externally and restored/repaired as required
