HERITAGE STATEMENT

Application 23/03643/FUL

Replacement rear and front elevation windows at

Daphne, Park Road, Chipping Campden, Gloucestershire GL55 6EA

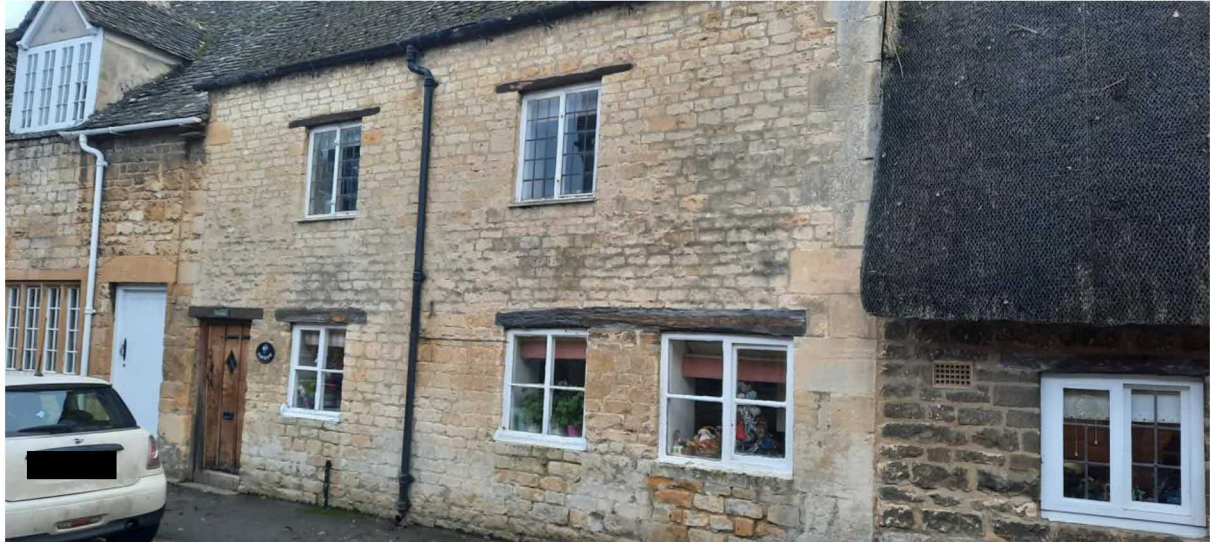
Photograph 1 – Front elevation of Daphne

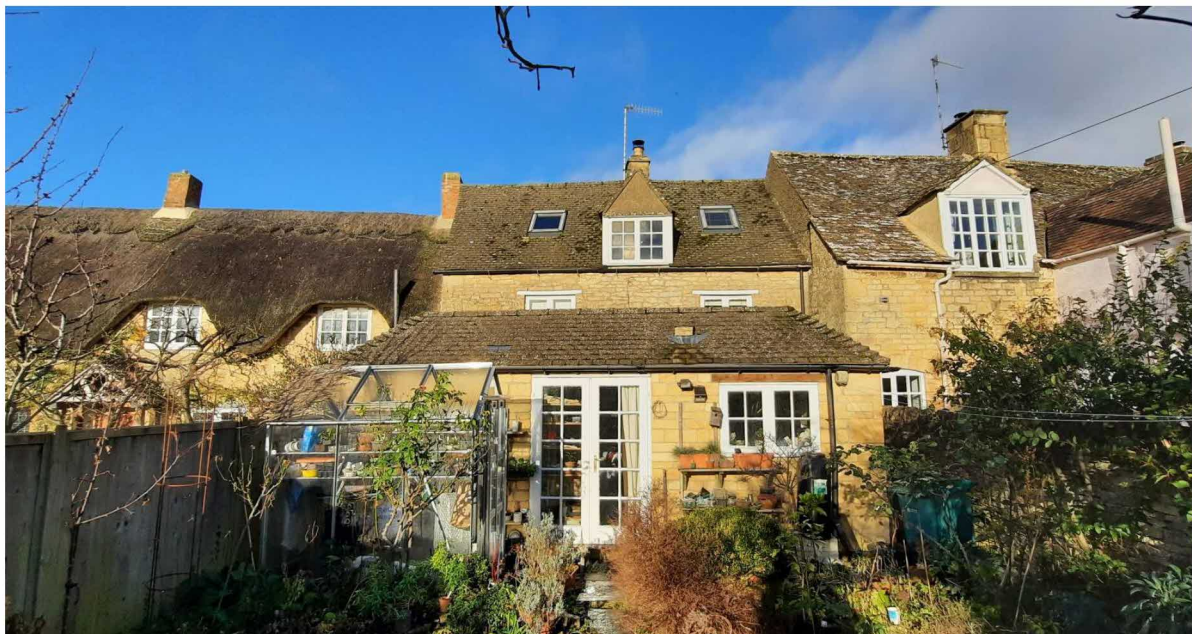
Photograph 2 – rear elevation

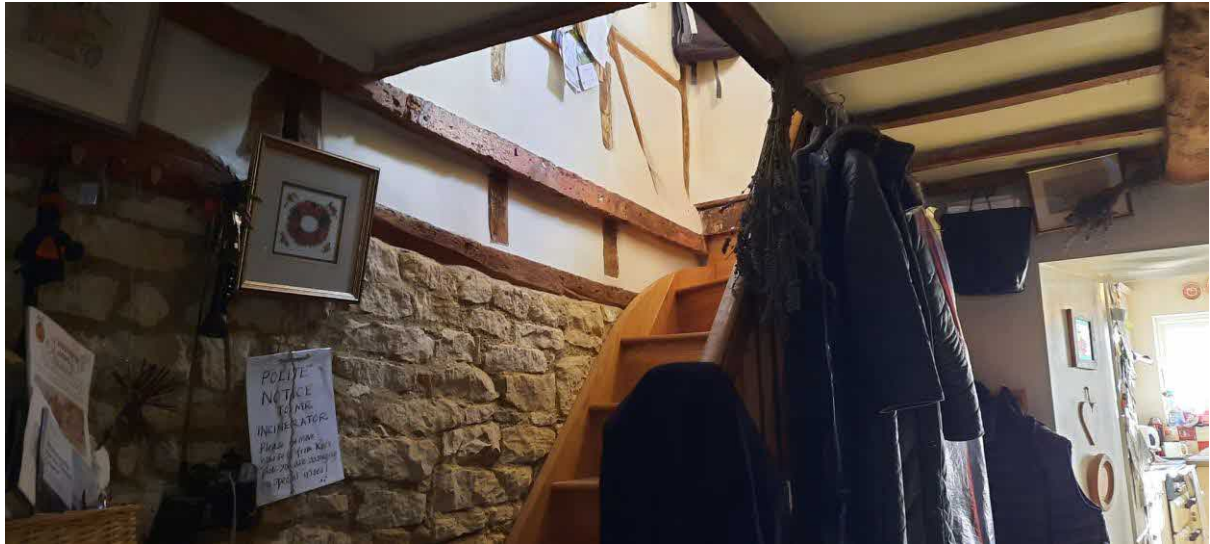
The party wall between Daphne and Pavement Cottage is built of exposed Cotswold stone up to first-floor level. At second floor level there is the remains of a wattle and daub exposed timber wall which may be left over from a timber frame house which predated Daphne, or may have been part of the adjacent house at Pavement Cottage.

Photograph 7 – hallway showing wattle and daub party wall up the stairs

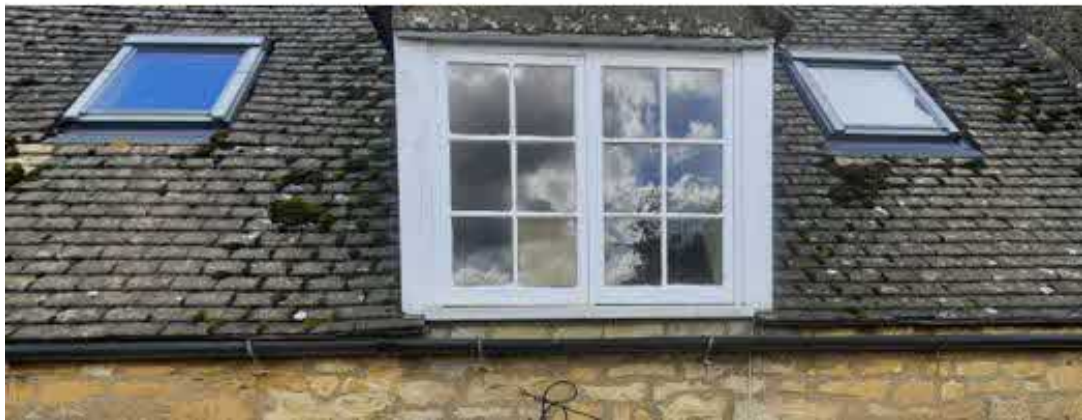
At the rear of the roof is a double dormer window which incorporates two window casements which provide light into the bedroom and bathroom within the attic. These are made of painted softwood. There is no intention to renew these windows at this stage, as the windows are sound.

Photograph 7 – dormer window on rear elevation

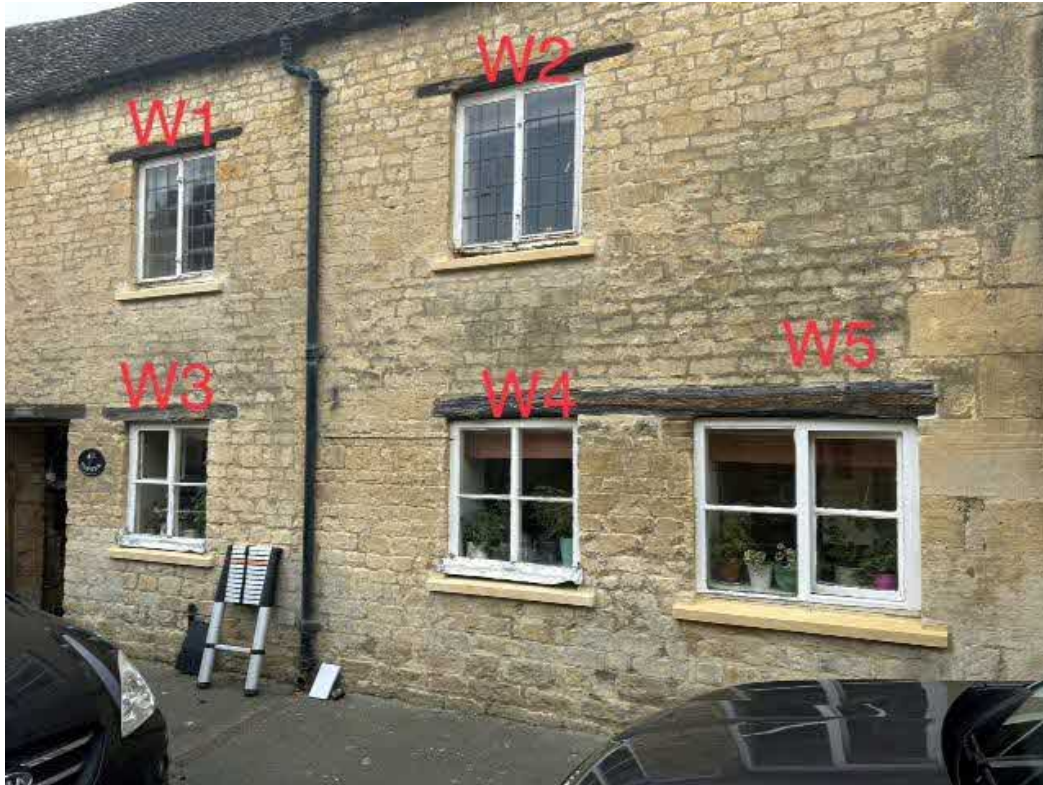
Photograph 8 – Front elevation (after new sills installed), showing window reference numbers

The proposals for each window are described and tabulated below. Window and door numbers are shown on the photographs below and cross-referenced to the planning application.

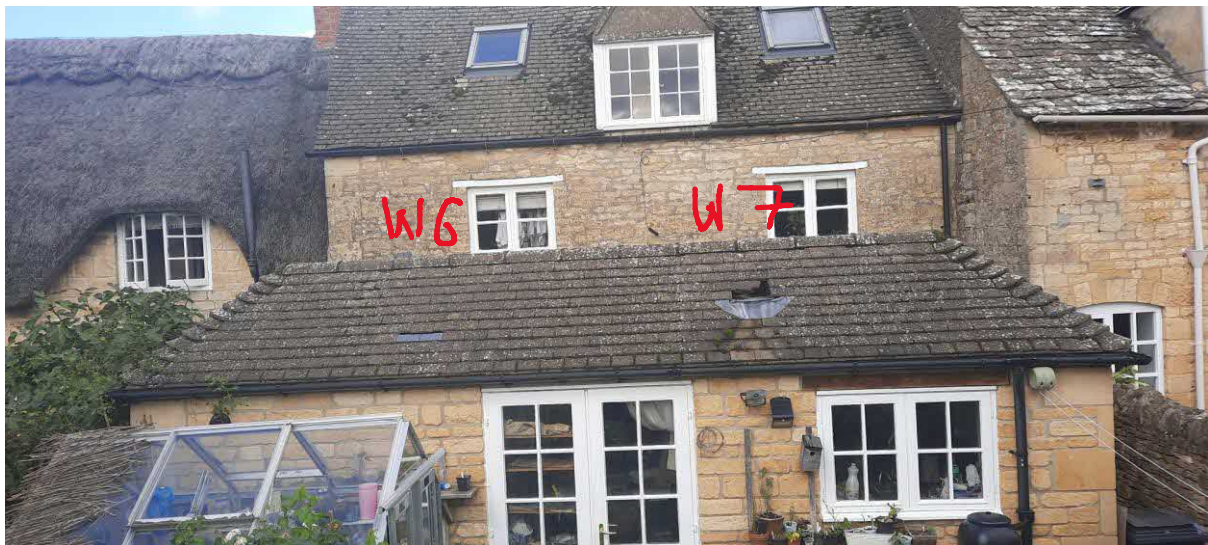
Photograph 9 – Rear elevation, showing window reference numbers

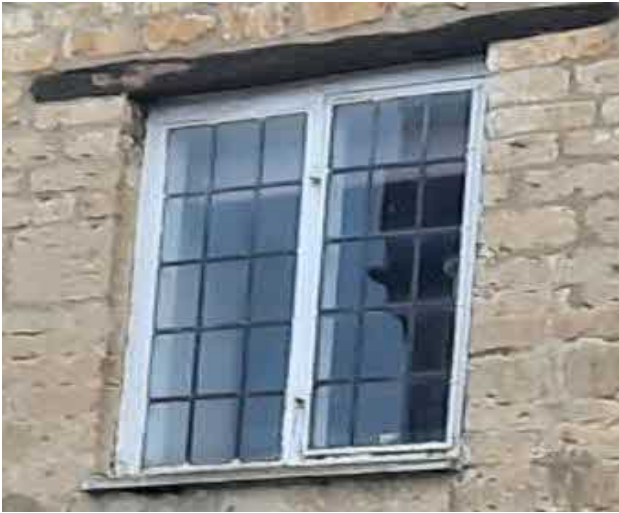
<p>W2 (front elevation, first floor right) – taken before sill was replaced</p>	<p>Cut away existing stone and insert Cotswold stone windowsill, weathered and throated with stooled ends. 35mm overhang, with drip. Manufactured by Wrights of Campden. Note- this work was carried out in August 2023. Remove existing window and provide hot dip galvanized polyester powder coated (Oyster white) steel window with hermetically sealed double-glazed units and primed meranti hardwood subframes, manufactured and installed by Holdsworth Windows, Shipston on Stour. Slim W20 sections hung on close fitting barrel hinges with brass</p>

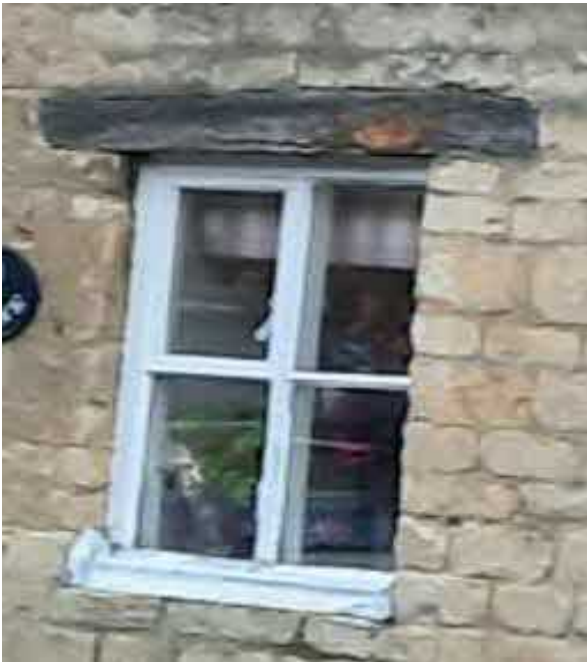
<p data-bbox="555 1816 1145 1921">W3 (front elevation, ground floor left) – taken before sill was replaced. The rotten wooden sill is temporarily covered with lead</p>	Cut away existing stone and insert Cotswold stone window sill, weathered and throated with stooled ends. 35mm overhang, with drip. Manufactured by Wrights of Campden. Note- this work was carried out in August 2023. Remove existing window and provide hot dip galvanized polyester powder coated (Oyster white) steel window with hermetically sealed double-glazed units and primed meranti

<p>panes are fixed. Softwood window sill which does not overhang the face of the external wall, and is affected by wet rot. The window aperture is likely to be original 17th century and has an exposed hardwood lintel.</p>

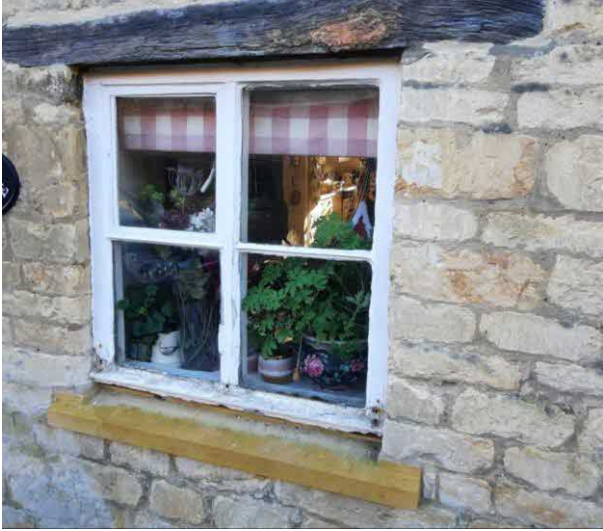
<p>W3 (front elevation, ground floor left) – taken after sill was replaced</p>	<p>hardwood subframe, manufactured and installed by Holdsworth Windows, Shipston on Stour. Slim W20 sections hung on close fitting barrel hinges with brass pins, fitted with weatherstripping, locking handles and stays. Double-glazed units made using low 'E' glass with a gas filled cavity. Hardwood timber subframe constructed using Ex. 3" x 3" for the head, jambs and sills. Sub-frame painted oyster white to match windows. Windows divided into 4 panes to match existing appearance. One opening upper pane. Other three panes to be fixed.</p>
W4	<p>2 light window with wooden frame and central wooden mullion. The mullions and jambs are chamfered internally. Steel transom let into the wooden frame to form 4 fixed single glazed panes. Softwood window sill which does not overhang the face of the</p>

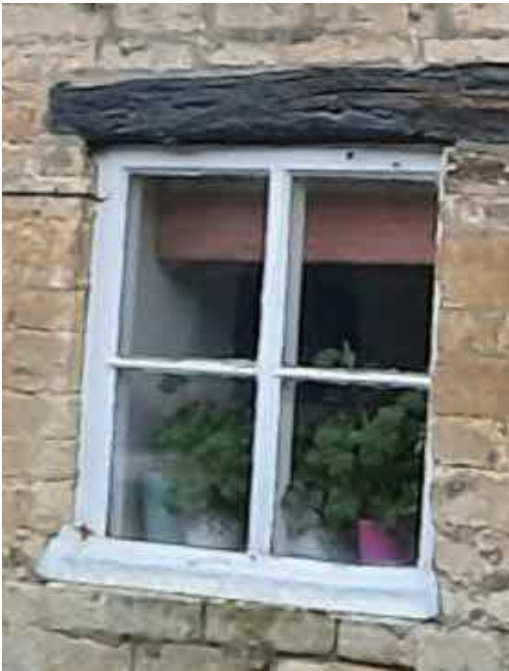
<p>external wall, and is affected by severe wet rot. The window aperture is likely to be original 17th century and has an exposed hardwood lintel.</p>	<p>W4 (front elevation, ground floor centre) – taken before sill was replaced. The rotten wooden sill is temporarily covered with lead</p>

<p>Cut away existing stone and insert Cotswold stone windowsill, weathered and throated with stooled ends. 35mm overhang, with drip. Manufactured by Wrights of Campden. Note- this work was carried out in August 2023. Remove existing window and provide hot dip galvanized polyester powder</p>

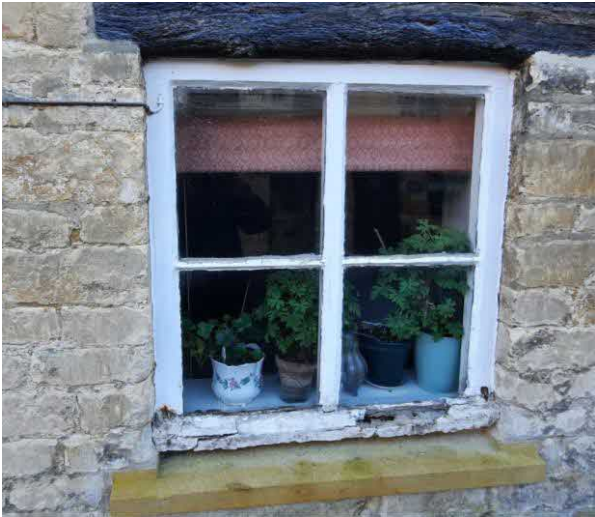
<p>W4 (front elevation, ground floor centre) – taken after the sill was replaced. The rotten wooden sill can be seen</p>	<p>coated (Oyster white) steel window with hermetically sealed double-glazed units and primed meranti hardwood subframes, manufactured and installed by Holdsworth Windows, Shipston on Stour. Slim W20 sections hung on close fitting barrel hinges with brass pins, fitted with weatherstripping, good quality locking handles and stays. Double-glazed units made using low 'E' glass with a gas filled cavity. Hardwood timber subframe constructed using Ex. 3" x 3" for the head, jambs and sills. Sub-frame painted oyster white to match windows. Windows divided into 4 panes to match existing appearance. One opening upper pane, other three panes to be fixed.</p>

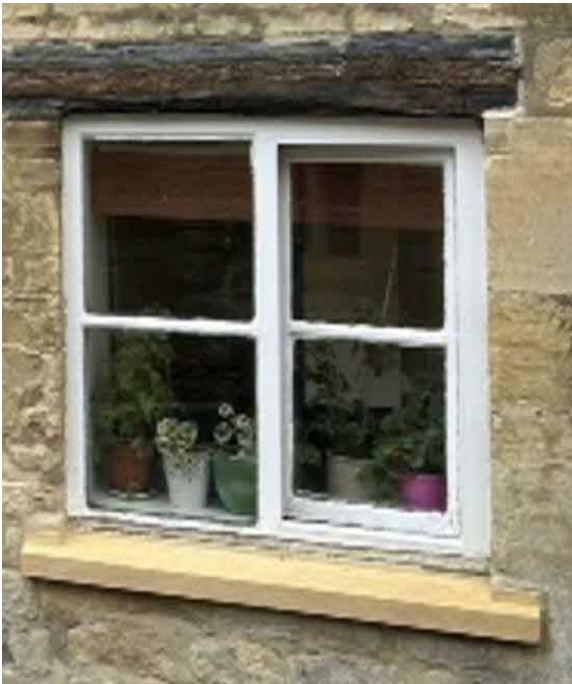
<p>W5 (front elevation, ground floor right) – taken after sill was replaced</p>	<p>Campden. Note- this work was carried out in August 2023. Remove existing window and provide hot dip galvanized polyester powder coated (Oyster white) steel window with hermetically sealed double-glazed units and primed meranti hardwood subframe, manufactured and installed by Holdsworth Windows, Shipston on Stour. Slim W20 sections hung on close fitting barrel hinges with brass pins, fitted with weatherstripping, locking handles and stays. Double-glazed units made using low 'E' glass with a gas filled cavity. Hardwood timber subframe constructed using Ex. 3" x 3" for the head, jambs and sills. Sub-frame painted oyster white to match existing windows. Windows divided into 4 panes to match existing appearance. One opening upper pane, other three panes to be fixed.</p>

W5	<p>2 light window with softwood frame and central wooden mullion. Installed when the two cottages were knocked together and the original door filled in, probably in the</p>		<p>Remove existing cement fillet, cut away existing stone and insert Cotswold stone windowsill, weathered and throated with stooled ends. 35mm overhang, with drip. Manufactured by Wrights of</p>

<p>early to mid 20th century. Softwood transoms to divide the window into 4 single glazed panes. The left hand (east) light is fixed. The right-hand light is a side opening casement, with monkey tail latch and casement stay. No windowsill. Painted cement fillet applied to head of brickwork. Exposed hardwood lintel. Window affected by wet rot.</p>	  <p>W5 (front elevation, ground floor right) – taken before sill was replaced</p>

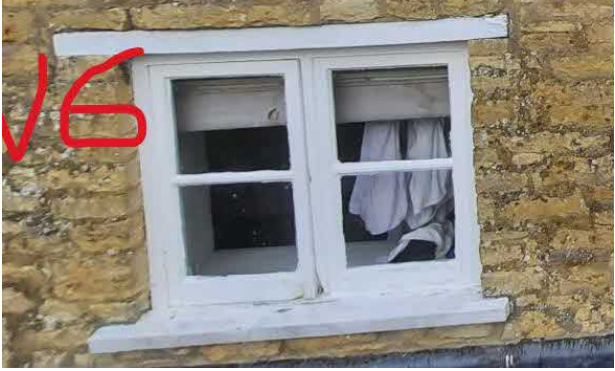
<p>W6 (rear elevation, first floor left)</p>	<p>(Oyster white) steel window with hermetically sealed double-glazed units and primed meranti hardwood timber subframe, manufactured and installed by Holdsworth Windows, Shipston on Stour. Slim W20 sections hung on close fitting barrel hinges with brass pins, fitted with weatherstripping, locking handles and stay. Double-glazed units made using low 'E' glass with a gas filled cavity. Hardwood timber subframe constructed using Ex. 3" x 3" for the head and jambs and sub-sill. Hardwood sill, weathered and throated with drip. Sub-frame and sill painted oyster white to match windows. Windows divided into 4 panes to match existing appearance. One side opening light, other light to be fixed.</p>

W6	2 light window with softwood frame. Central wooden mullion with sunk		Remove existing window and sill and provide hot dip galvanized polyester powder coated

<p>rounded edges on the inside. Window likely to date from early or mid 20th century. Softwood transom to divide it into 4 single glazed panes. The right hand (east) light is fixed. The left-hand light is a side opening casement, with monkey tail latch and casement stay. Painted softwood window sill, weathered and throated with drip. The window aperture in likely to be original 17th century and has an exposed, painted hardwood lintel. Window and sill affected by wet rot.</p>
