**COMMUNITY DIAGNOSTICS CENTRE (CDC), PLYMOUTH
FLOOD RISK ASSESSMENT AND DRAINAGE STRATEGY**

Rev:
P1

Notes:
Planning Issue

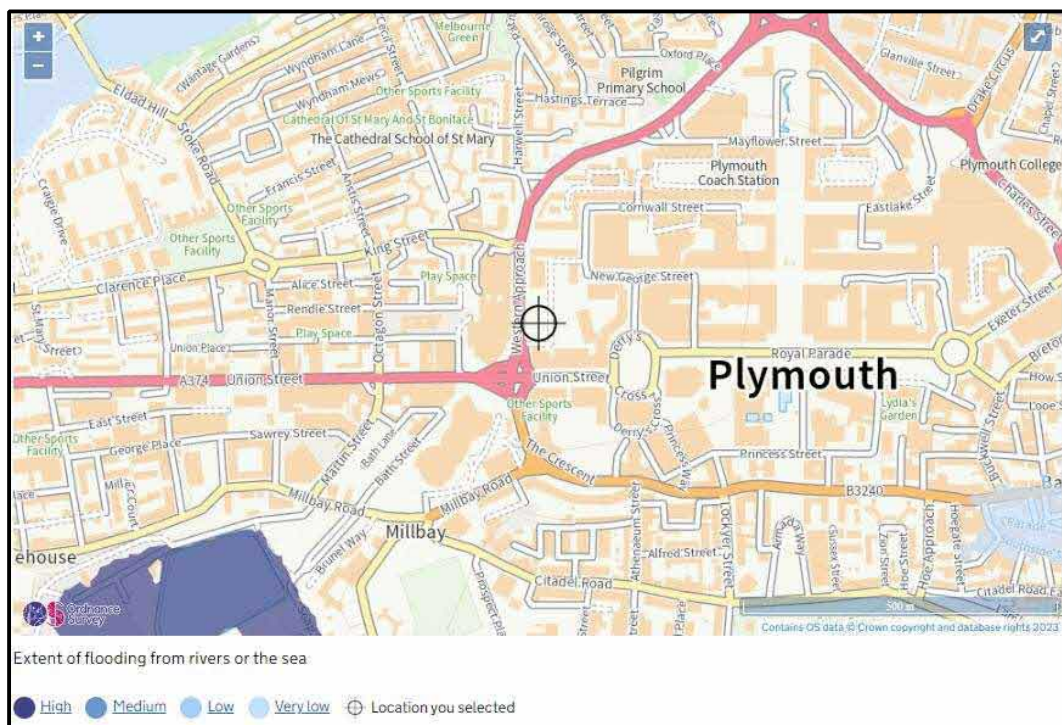
Figure 3.1 Extract from EA flood map for planning: Rivers and Sea

3.1.1 The EA flood risk from rivers or the sea map (Figure 3.1) shows the entire site is sufficiently far away from any tidal plain or fluvial flood extents to be at very low risk. As such, the site is considered to be located within Flood Zone 1 with less than a 1 in 1,000 annual probability of river or sea flooding. The Plymouth City Council (PCC) Strategic Flood Risk Assessment (SFRA) L2 discusses a discrepancy with the extents of Millbay Tidal Flood Zone, however it does confirm the site should be designated to lie within Flood Zone 1.
