Issued for: **PLANNING**

Project/Client: **LEY FARM** Project No: **1492009**

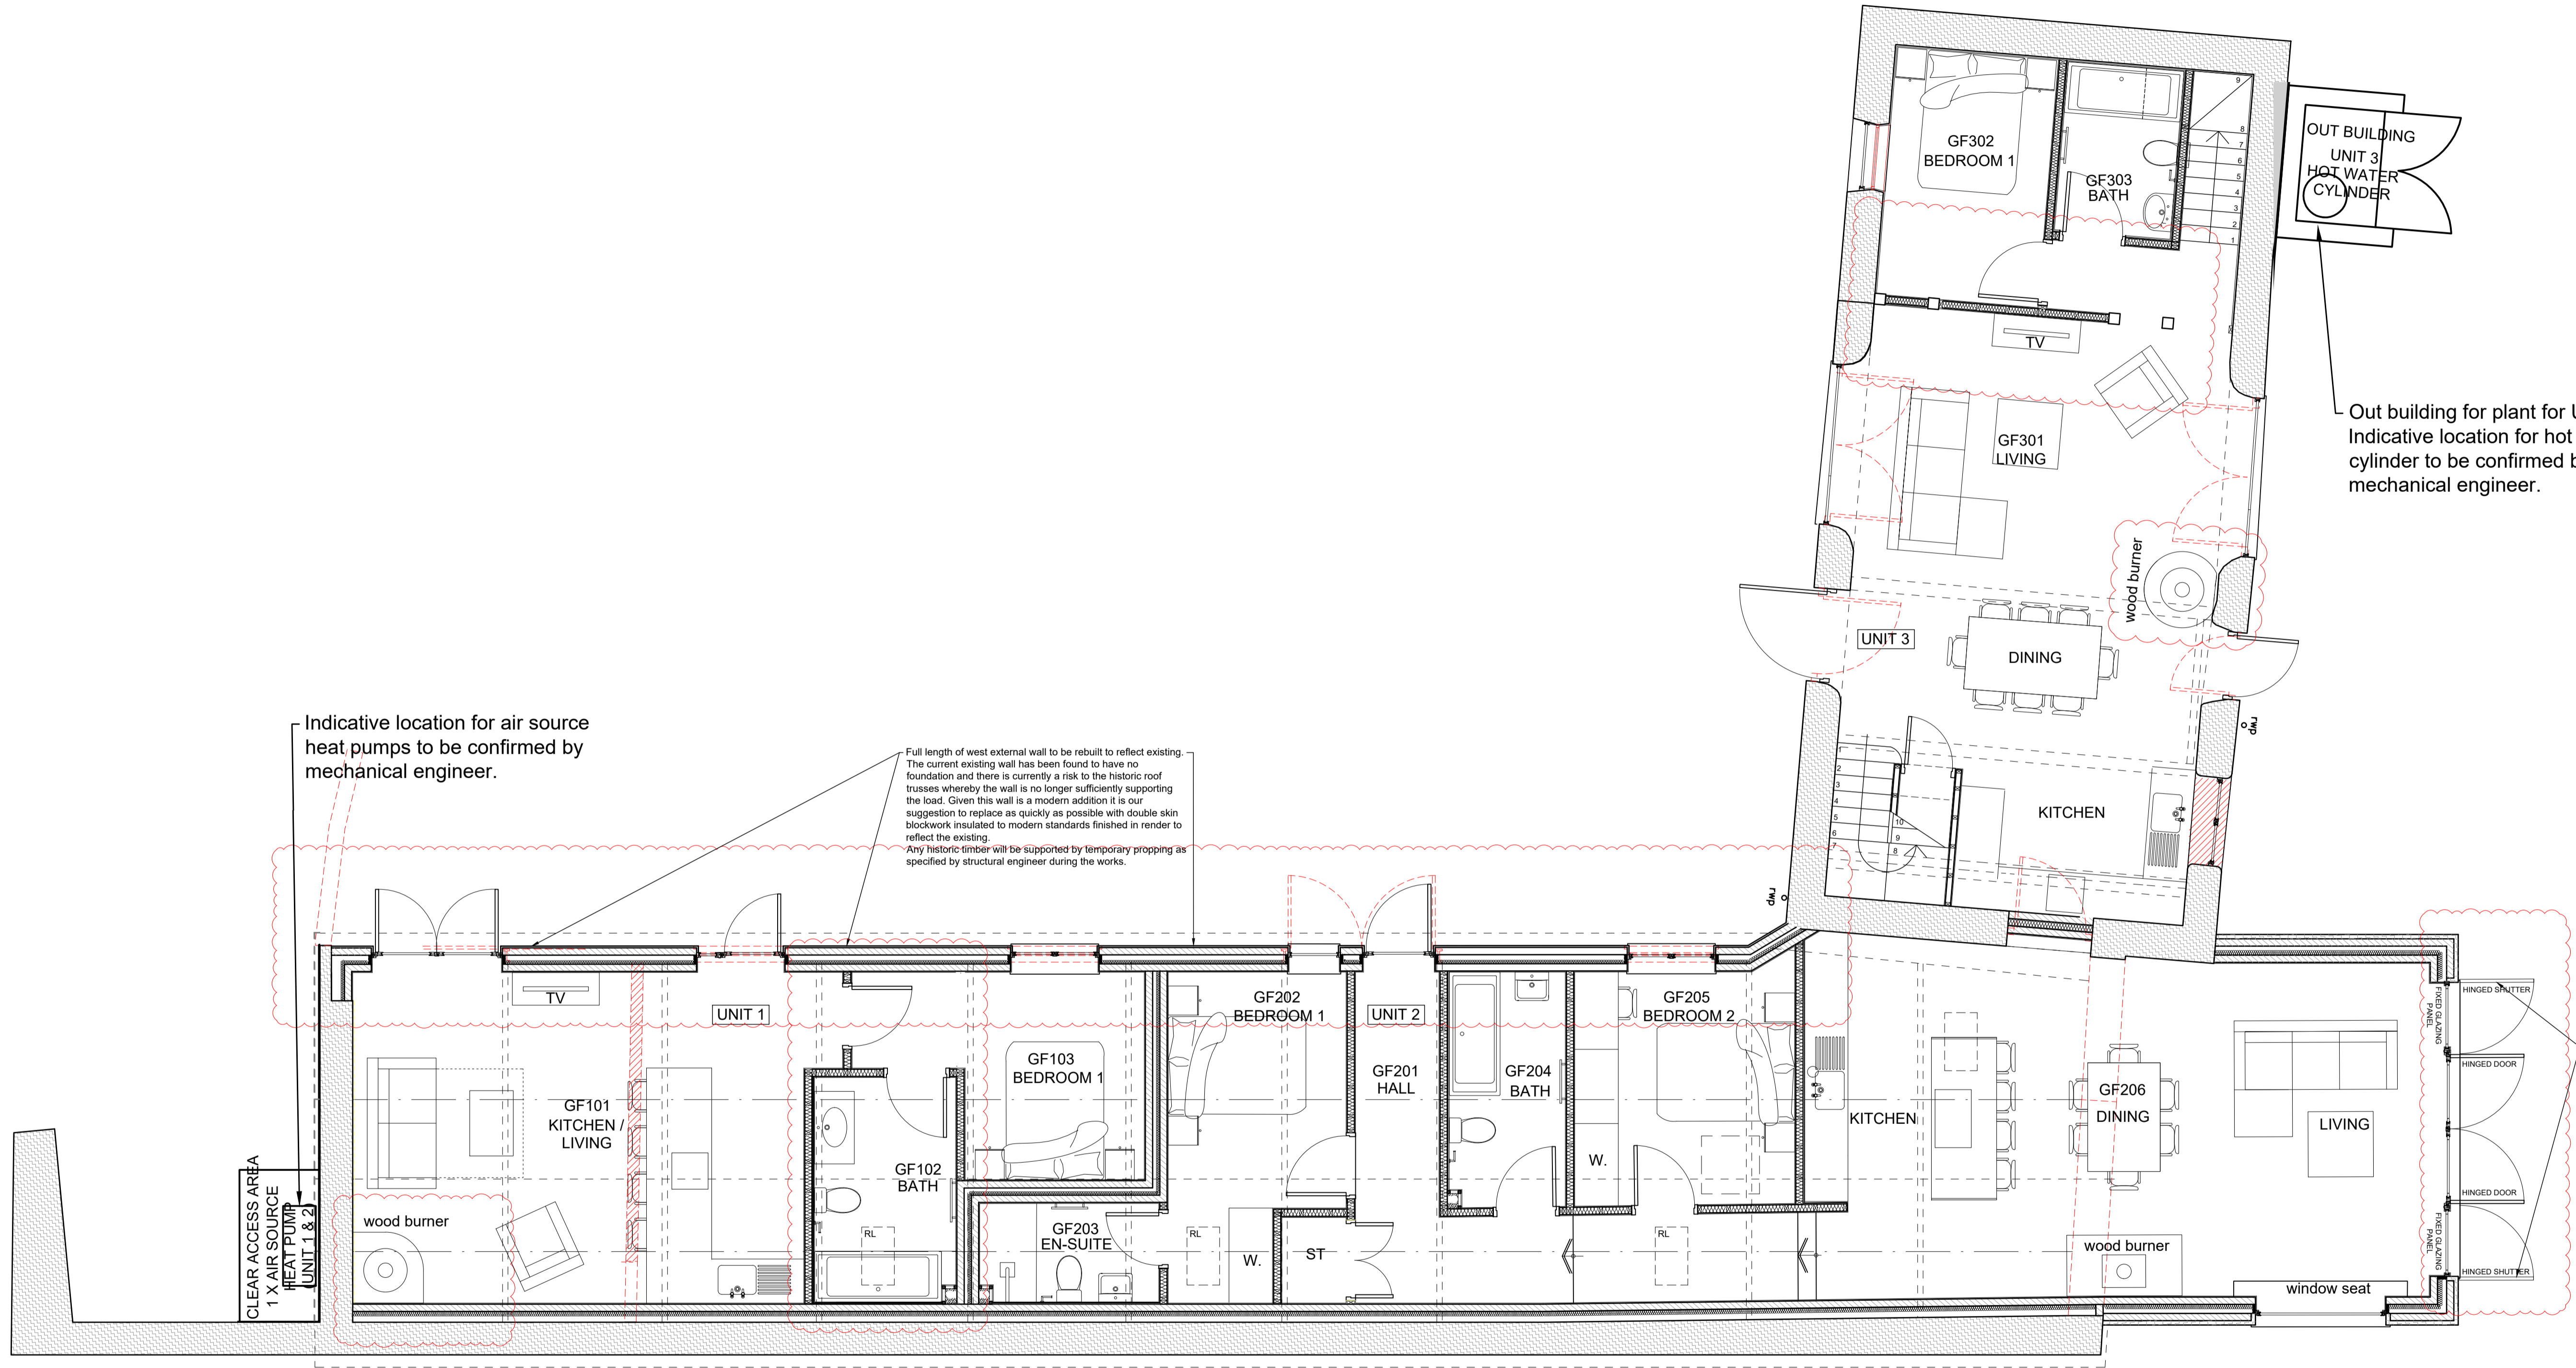
Full length of west external wall to be rebuilt to reflect existing. The current existing wall has been found to have no foundation and there is currently a risk to the historic roof trusses whereby the wall is no longer sufficiently supporting the load. Given this wall is a modern addition it is our suggestion to replace as quickly as possible with double skin blockwork insulated to modern standards finished in render to reflect the existing. Any historic timber will be supported by temporary propping as specified by structural engineer during the works.

Full length openable timber shutters conceal fixed glazed side panels.
