# Arboricultural Impact Assessment Addendum & Method Statement

## Hallgarth The Manor House, High Pittington, Durham

<p>Site Address</p> <p>Hallgarth The Manor House, High Pittington, Durham, DH6 1AB</p> <p>Date</p> <p>Arboricultural Impact Assessment (AIA) (Addendum) and Arboricultural Method Statement – 17<sup>th</sup> December 2023</p>
<p>Introduction</p> <p>A pre-development Tree Survey and AIA were undertaken at Hallgarth The Manor House Hotel for a proposed holiday / camping pod development, and a report prepared dated 6<sup>th</sup> May 2023. The AIA was based upon a site layout shown on the Tree Location and Tree Constraints Plan ref: TLP_TCP02 dated 11.10.2023 that accompanied the report. The proposed layout of the scheme has changed and an updated AIA is now required for the revised scheme to:</p> <ol style="list-style-type: none"><li>1) Assess the implications of the proposed development upon the trees;</li><li>2) Provide recommendations to minimise the impact of the proposals upon the trees where possible.</li></ol> <p>This report should be read alongside the previous Tree Survey and AIA, which provides Site Survey, Tree Survey information and the Methodology for the

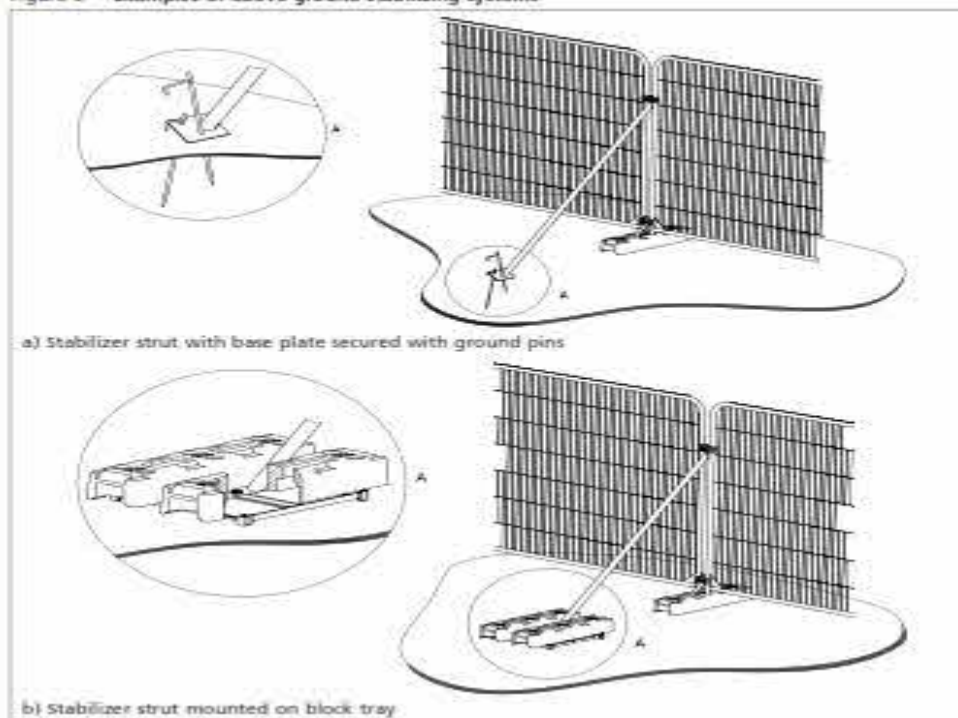
Figure 3 Examples of above-ground stabilizing systems

- 1.5 Where the site circumstances and associated risk of damaging incursion into the RPA do not necessitate the default level of protection, an alternative specification should be prepared by the project arboriculturist and, where relevant, agreed with the local planning authority. For example, 2 m tall welded mesh panels on rubber or concrete feet might provide an adequate level of protection from cars, vans, pedestrians and manually operated plant. In such cases, the fence panels should be joined together using a minimum of two anti-tamper couplers, installed so that they can only be removed from inside the fence. The distance between the fence couplers should be at least and should be uniform throughout the fence. The panels should be supported on the inner side by stabilizer struts, which should normally be attached to a base plate secured with ground pins (Figure 3a). Where the fencing is to be erected on retained hard surfacing or it is otherwise unfeasible to use ground pins, e.g. due to the presence of underground services, the stabilizer struts should be mounted on a block tray (Figure 3b)". (BS 5837: 2012).
