HAY BARN ELEVATIONS & SECTION AS PROPOSED

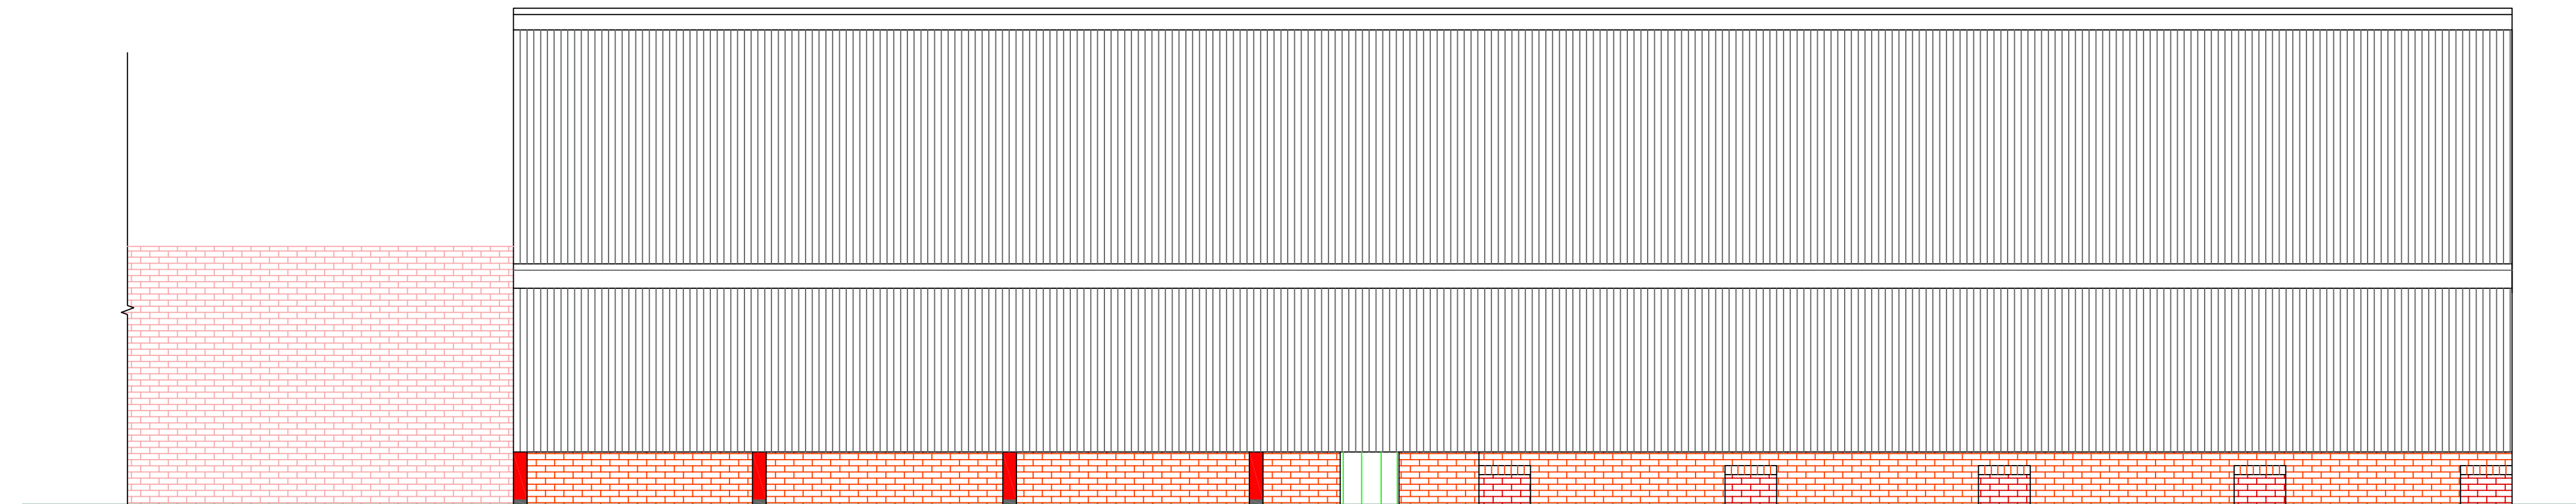
NORTH ELEVATION

WALLS
NORTH WALL UPPER CLAD WITH CORRUGATED STEEL SHEETING WITH MATT BLACK
FINISH COMPLETE WITH ALL CORNER TRIMS BELOW BLACK STAINED TIMBER FASCIA
WITH BLACK ALUMINIUM HALF ROUND GUTTER AND DOWNPIPES DISCHARGING TO
DITCH VIA UNDERGROUND UPVC PIPEWORK

NORTH WALL LOWER SOFT RED SUFFOLK BRICKS IN LIME MORTAR TO LOW LEVEL
WALLING AND BUTTRESSES WITH TIMBER LIVESTOCK DOOR RETAINED
LOWER SECTION OF OAK POSTS EXPOSED AT EAST END IN BLACK STEEL POST
SHOES MIN 50MM ABOVE FINISHED GL
