# Colchester Archaeological Trust

**CAT Report 1976  
issued November 2023**

**Historic building recording at Pond Mead,  
High Street, Widdington, Essex, CB11 3SB**

**CAT project ref.: 2023/09a  
ECC code: WDPM23**

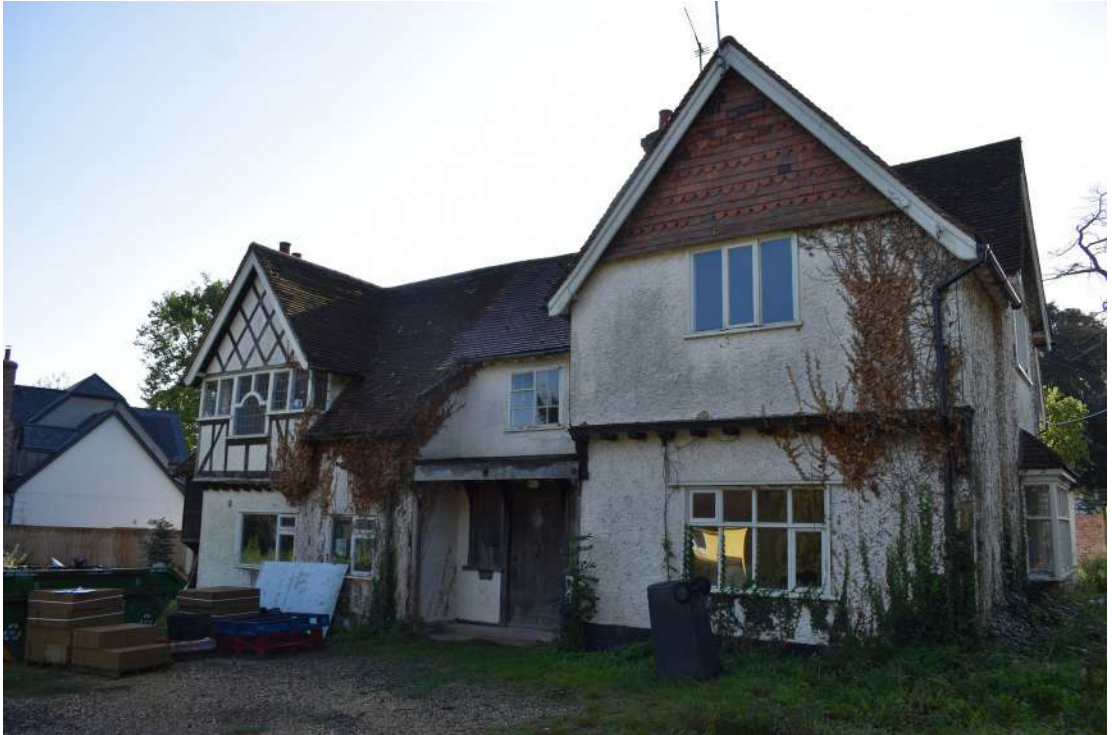
**Photograph 3** North-west elevation. Photograph taken facing east.

Unless otherwise stated, the exterior of Pond Mead is covered pebble-dash render painted off-white.

Range 1 is supported on a brick plinth (brick dimensions: 225 x 110 x 65mm) laid in Stretcher bond, which is visible on the north-west and south-west elevations. Range 2 has a Flemish bond brick plinth (brick dimensions: 210 x 110 x 65mm), visible on the north-west and north-east elevations. The plinth of range 3 comprises brick (brick dimensions: 210 x 105 65mm) laid in English bond. Range 5 has a plinth constructed from unidentified stone topped with a row of Header bond bricks (brick dimensions: 225 x ? x 65mm). Range 7 has a brick plinth (brick dimensions: 220 x 110 x 65mm) laid in Stretcher bond while range 9 has an English bond brick plinth (brick dimensions: 230 x 110 x 60mm). Range 10 has the appearance of an English bond brick plinth (brick dimensions: 225 x 110 x 65mm), but the walls are constructed of brick and clad in pebble-dash render. All plinths are painted black.

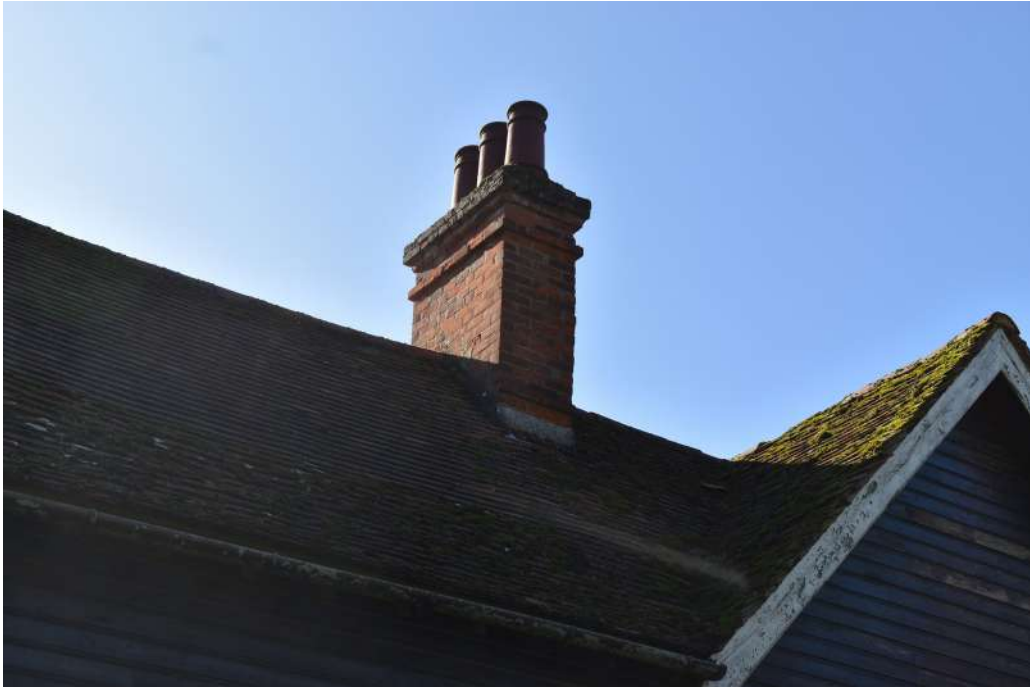
**Photograph 4** Detail of north-eastern chimney. Photograph taken facing south.

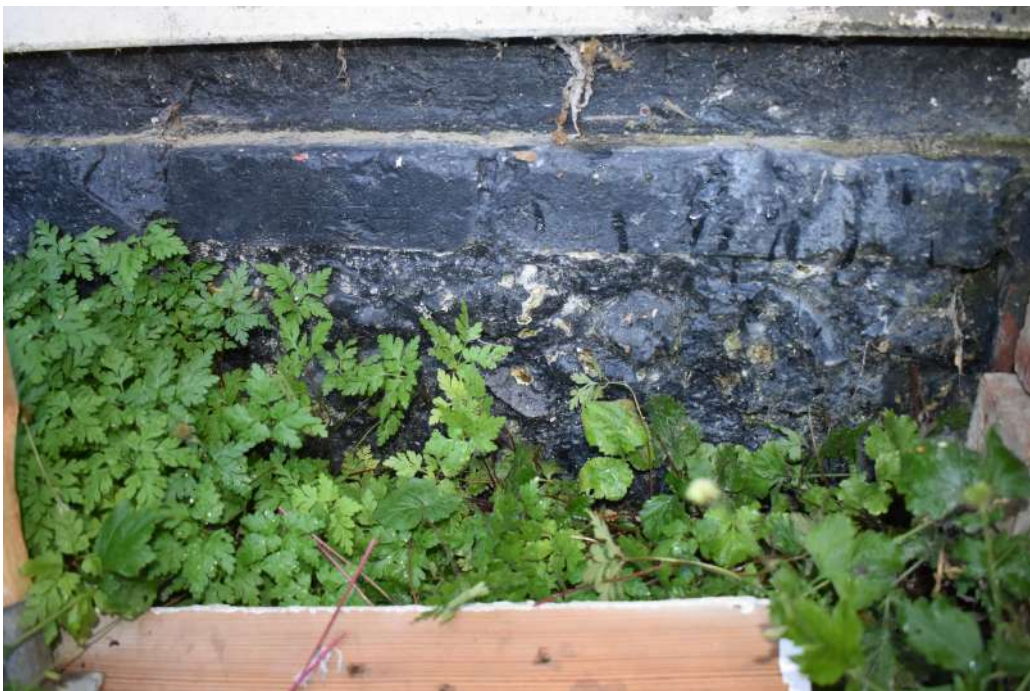
**Photograph 5** Detail of stone plinth on north-west elevation. Photograph taken facing south-east.

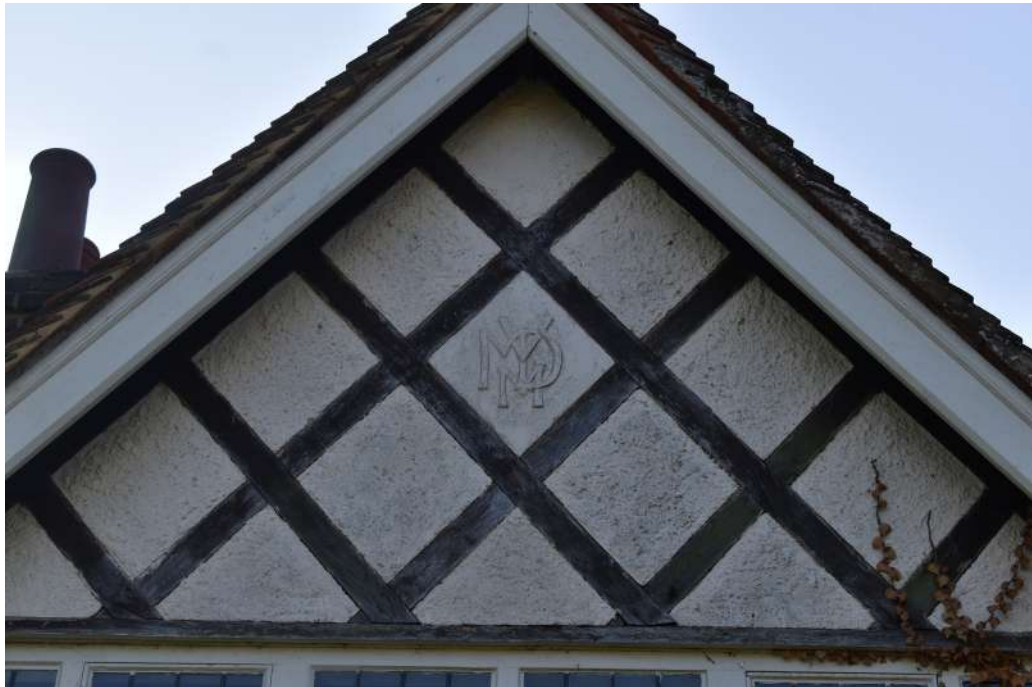
On the north-west elevation, ranges 1 and 2 both have prominent gables. The gable-end of range 1 is clad with decorative terracotta hanging tiles, while range 2 has an exposed timber-frame, comprising machine-cut timbers painted black, with an embossed monogram emblem, which reads 'VMMD'. The electoral register from 1918 (Plate 1) records a woman of the name Violet Mary Moore-Dillon living at Pond Mead. Both gables have a jetty with exposed joists but are slightly different in style. The joists of range 1's jetty have been rounded at the ends and the outer joists both have lightly decorative brackets. The ends of the joists of range 2's jetty are also rounded but with a ridged design and no brackets. Between the two gables is a catslide roof and a flat-roof recessed porch, which has a large timber-door flanked by two single-light fixed windows. The door is secured with iron strap hinges and has a diamond-shaped

**Photograph 6** Detail of monogram emblem and exposed timber-framing on north-west elevation. Photograph taken facing south-east.

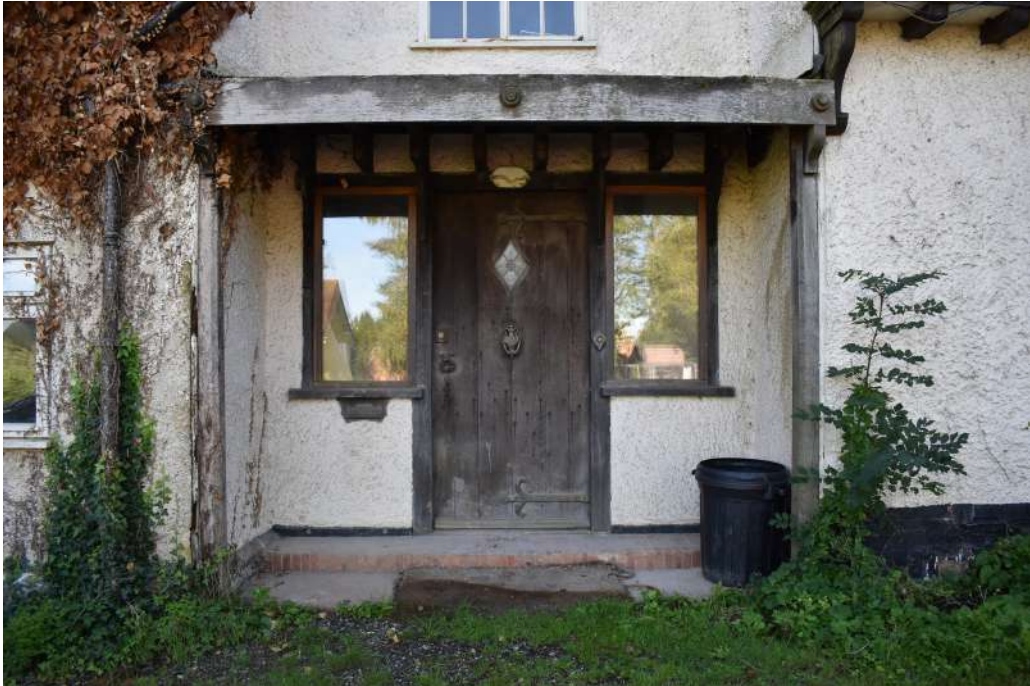
**Photograph 7** Detail of door on north-west elevation. Photograph taken facing south-east.

Plain, vertically planked timber-doors were a favourite choice, usually embellished with by elaborate hinges, knobs, and knockers, particularly when set in a recessed porch. Door furniture was an area where Arts and Crafts designers could exhibit their skill, especially as the plain door allowed the work to stand out. The front door at Pond Mead is a great example of this. The door itself is plain timber, while the hinges, handle and knocker are more decorative. The addition of a modest-sized stained glass window is a further display of hand-craftsmanship.

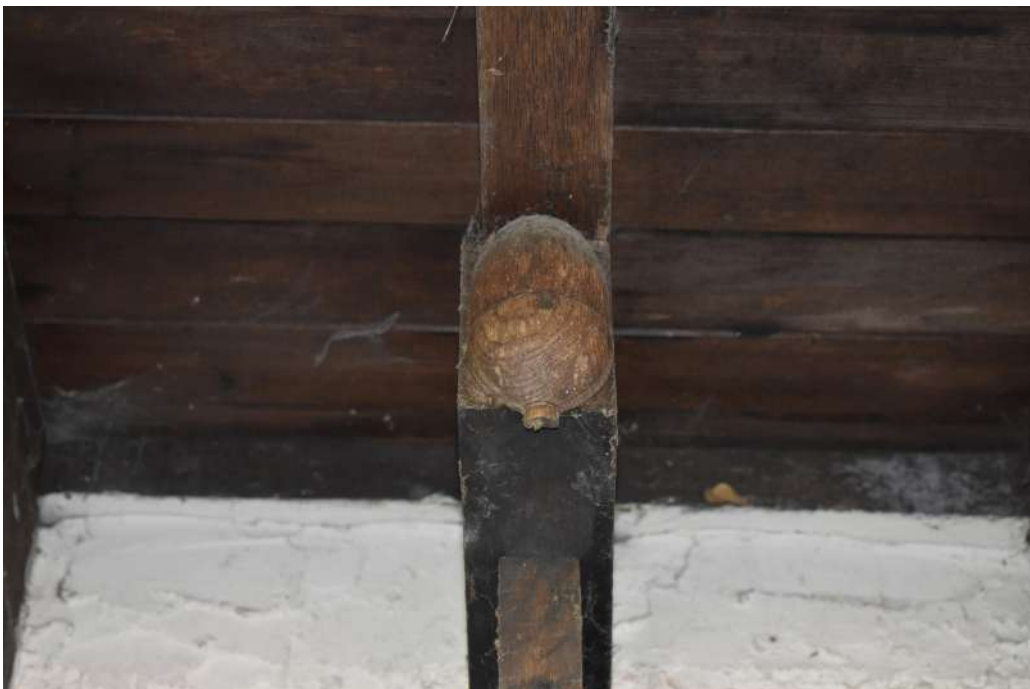
**Photograph 8** Detail of carved acorn in doorway of north-west elevation. Photograph taken facing south-east.

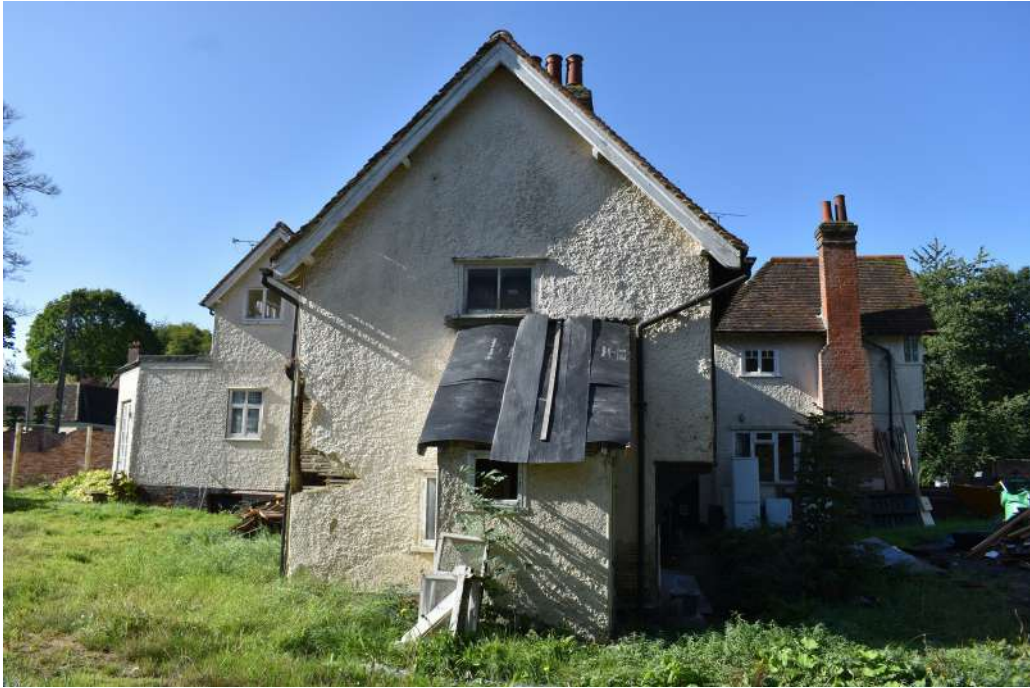
The north-east elevation is busy with fenestration, spread across ranges 5, 6, 7, 9 and 10. All of the windows are timber-framed with a varying number of lights and types of openings. Notable windows include a four-light fanlight on range 10, comprising yellow and blue glass in a chequerboard pattern, and two windows with leaded (with square quarries) upper-lights. A blocked cellar window is present at the bottom of range 10, which has an arched brick lintel. Two timber doors are also present – one on range 1 and the other on range 10. A large chimney is located on range 2, comprising red brick (brick dimensions: 215 x 105 x 65mm) laid in Flemish bond. At the south-eastern end of the elevation, range 10 has a small east-facing elevation with a set of double-patio doors and three brick steps.

**Photograph 10** North-east elevation. Photograph taken facing south-west.

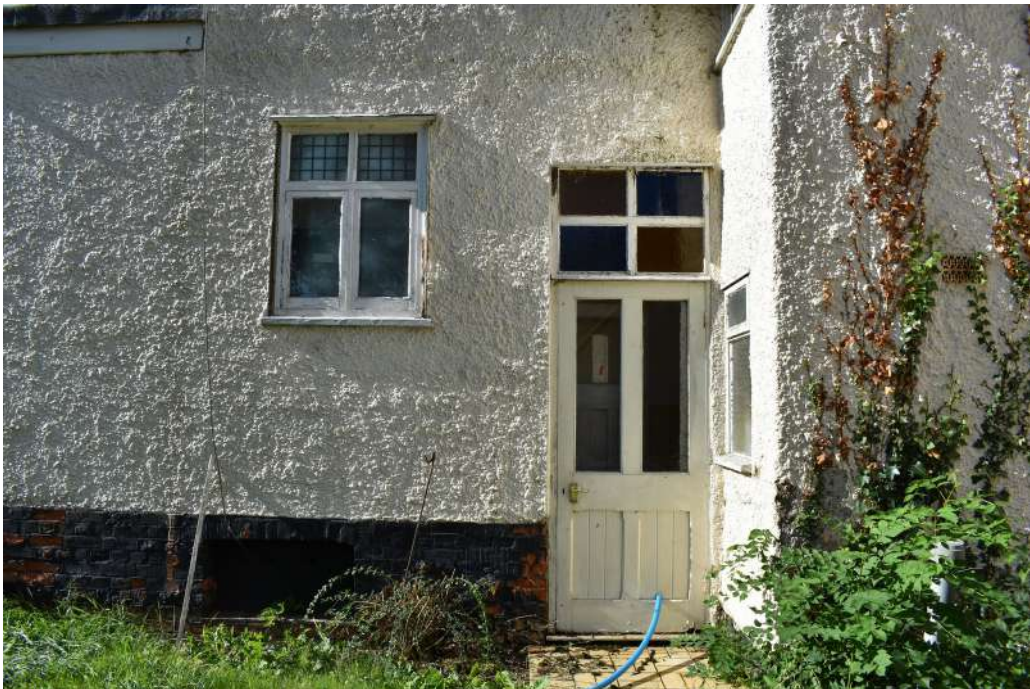
**Photograph 11** Detail of blocked opening, window and door on north-east elevation. Photograph taken facing south-west.

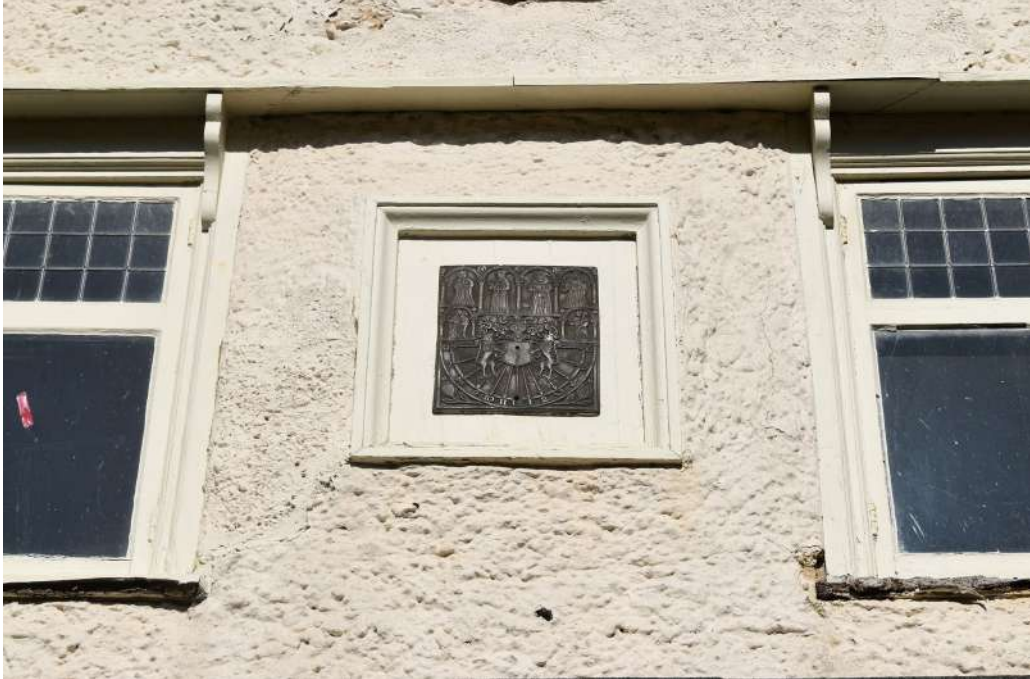
floor and one on the ground floor. The first floor windows are both timber-framed corner windows, with leaded glass in the top rows of lights. The leaded windows comprise square quarries. These corner windows flank a brass sundial which has been set into the wall of range 9, which depicts a friary scene with rearing lions either side of a coat of arms<sup>1</sup>. The gnomon is missing from the sundial. The ground floor window is metal-framed with ten-lights, the top five of which are leaded with diamond-shaped quarries.

**Photograph 12** Detail of sundial on south-east elevation. Photograph taken facing north-west.

<sup>1</sup> Auction listings for sundials of the same design suggest they are a copy of a historic Flemish design and are Victorian in origin.

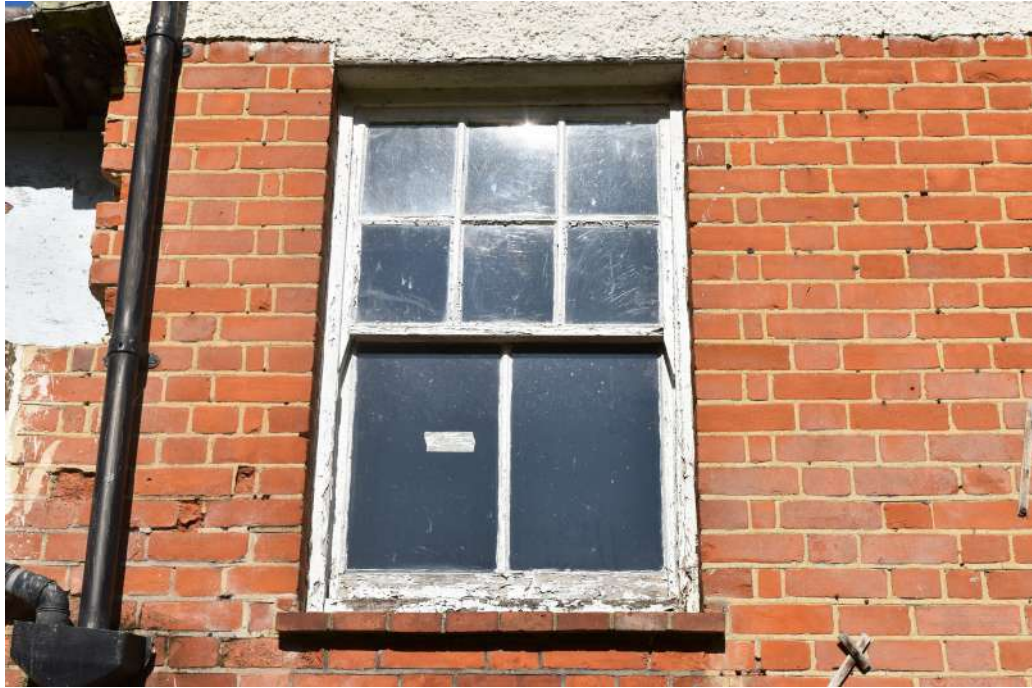
The south-east elevation of range 10 has a gable clad in decorative hanging-tiles, in the same style as those used on the gable of range 1. Two windows are present on range 10, one on the ground floor and one on the first floor. The ground floor window has four lights and a metal frame. The top two lights are leaded with diamond-shaped quarries. The first floor window is timber-framed with eight lights, the top four of which are leaded with square quarries.

**Photograph 13** Detail of window on south-east elevation. Photograph taken facing north-west.

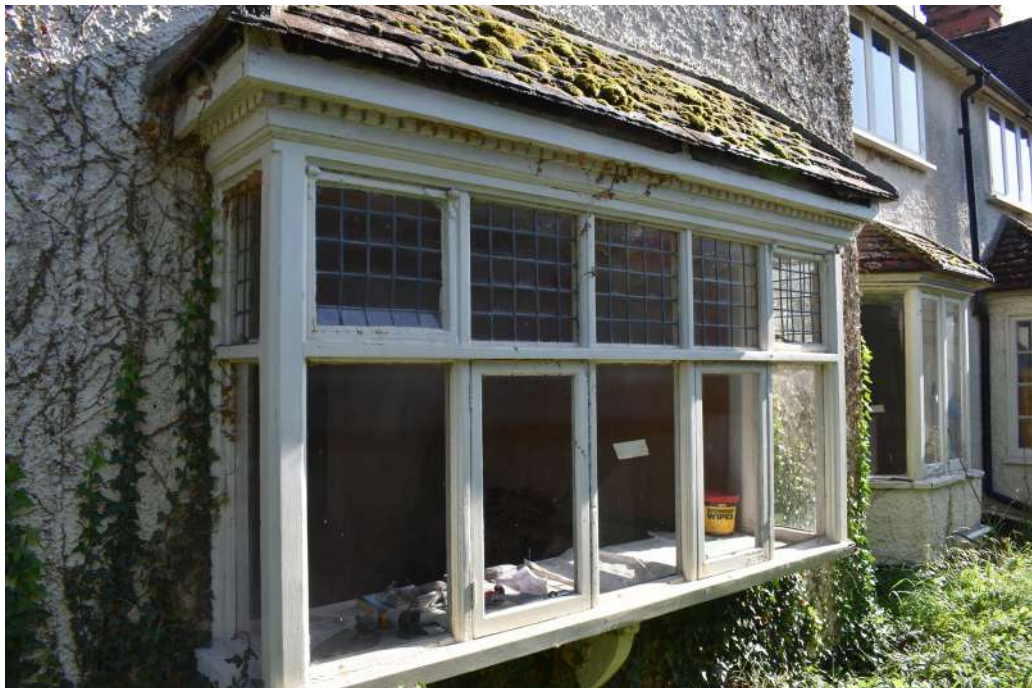
Two gables are present on the south-west elevation, one on range 1 and the other on range 3. Range 1 has a plain gable and a window on the ground and first floors. The ground floor window is a fourteen-light timber-framed oriel window. The top row of lights are leaded with small square-shaped quarries. The roof of the oriel window is clad in plain-tile while the base is support on three carved timber brackets. The window on the first floor is four-light with a timber-frame.

**Photograph 14** Detail of window on south-west elevation. Photograph taken facing north.

A number of the windows used are also typical of this period. Oriel windows were originally fashionable during the 17th century, after which they fell in popularity. They made a resurgence during the Arts and Crafts movement as, similarly to the bay window, they allowed natural light to flood a room, a juxtaposition to stereotypical dark and dingy conditions of Victorian interiors.

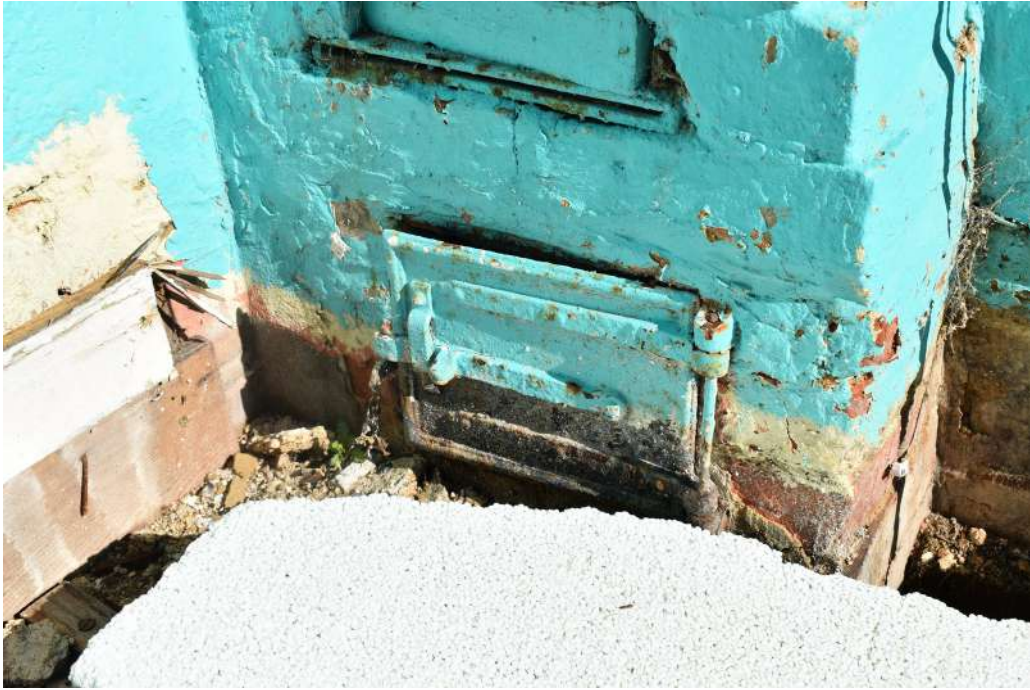
The removal of the conservatory has exposed an interior door on the south-west elevation of range 4. Also exposed on this elevation is an iron clean-out door at the base of the chimney.

**Photograph 15** Detail of clean out door in south-west elevation. Photograph taken facing north.

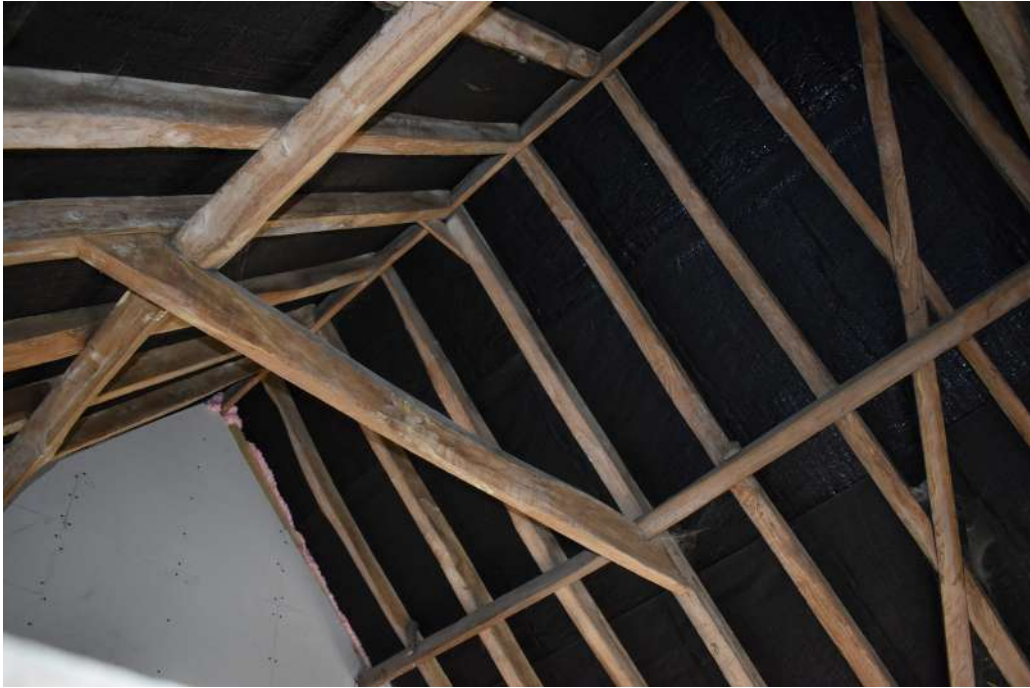
Most of the roof structure was inaccessible at the time of recording but from what could be observed much of the roof appears to be constructed from pairs of rafters, rising from the wall-plates, to meet at a ridge-board at the apex of the roof. A single purlin is present on each roof pitch, clasped by a collar. The roof structure recording in range 3 also has diagonal through-bracing. The timbers used comprise a combination of hand-sawn and machine-cut with no obvious signs of reused.

**Photograph 16** Detail of roof structure above room 22. Photograph taken facing south-east.

The first floor of range 3 comprises of 3 rooms, including room 22. There is a large chimney breast dominating the north-western wall and two replacement windows in the south-western wall. The doorway leading from room 21 has been inserted, as evidenced by an empty mortice in the joist above. The plaster of the ceiling of room 22 has been removed, exposing the roof structure above.

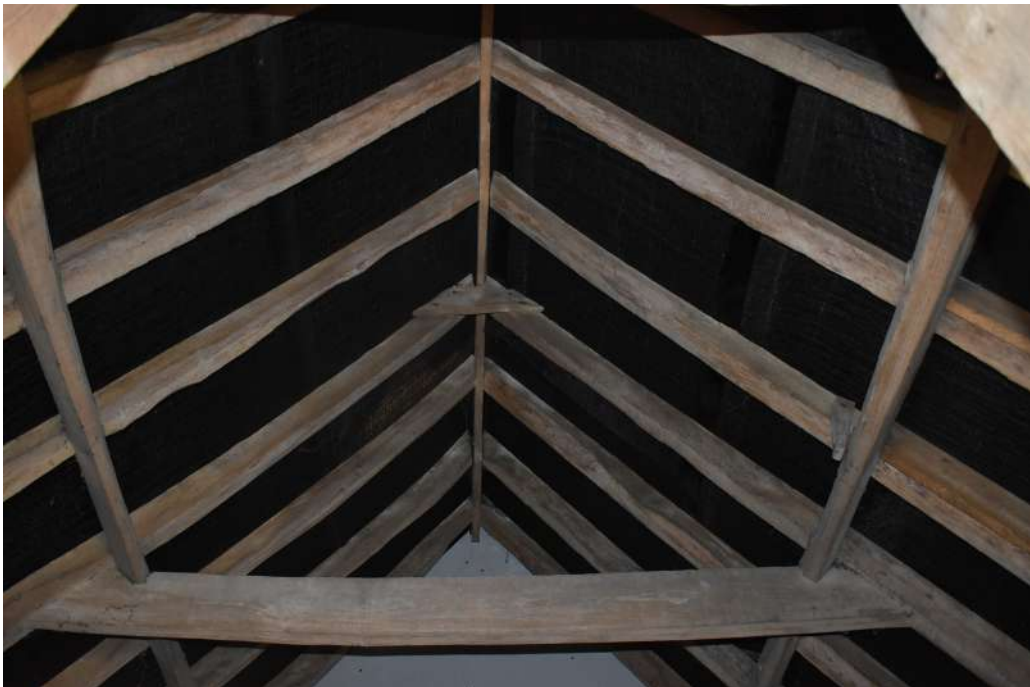
**Photograph 17** Detail of roof structure above room 24. Photograph taken facing north-west.

Room 24, located in range 3, has a replacement window in the south-west wall and a modern inserted cupboard space against the north-east wall.

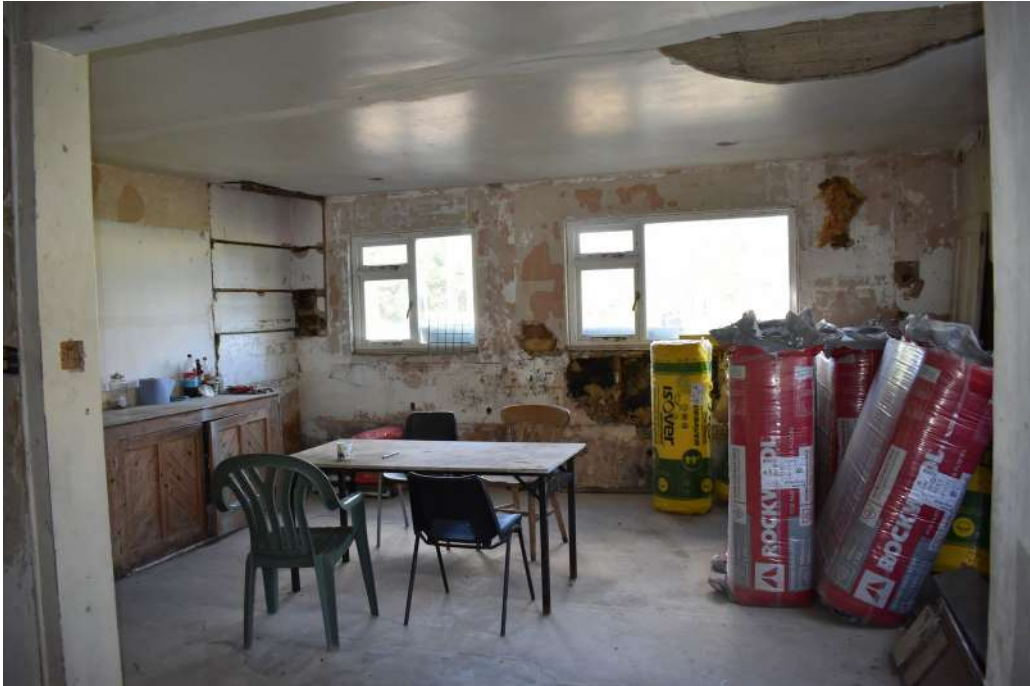
Rooms 1 and 2 occupy the ground floor of range 2. Room 1 has a poured concrete floor. An area of damage to wall has revealed the timber-frame beneath, which comprises machine-cut timbers, and damage to the ceiling has exposed the timber laths beneath. A brick fireplace is present on the north-east wall. It has an arched brick lintel with a rectangular opening. The bricks are a combination of red and yellow in colour. Room 1 has three replacement windows, two in the north-west wall and one in the north-east wall.

**Photograph 18** Interior of room 1. Photograph taken facing north-west.

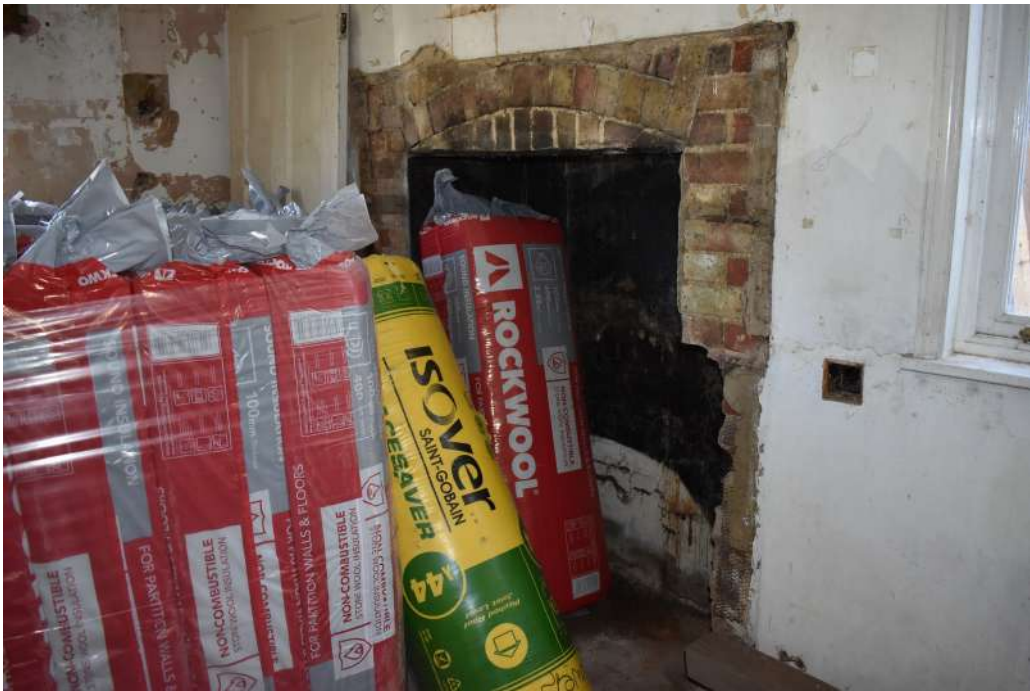
**Photograph 19** Detail of fireplace in room 1. Photograph taken facing north.

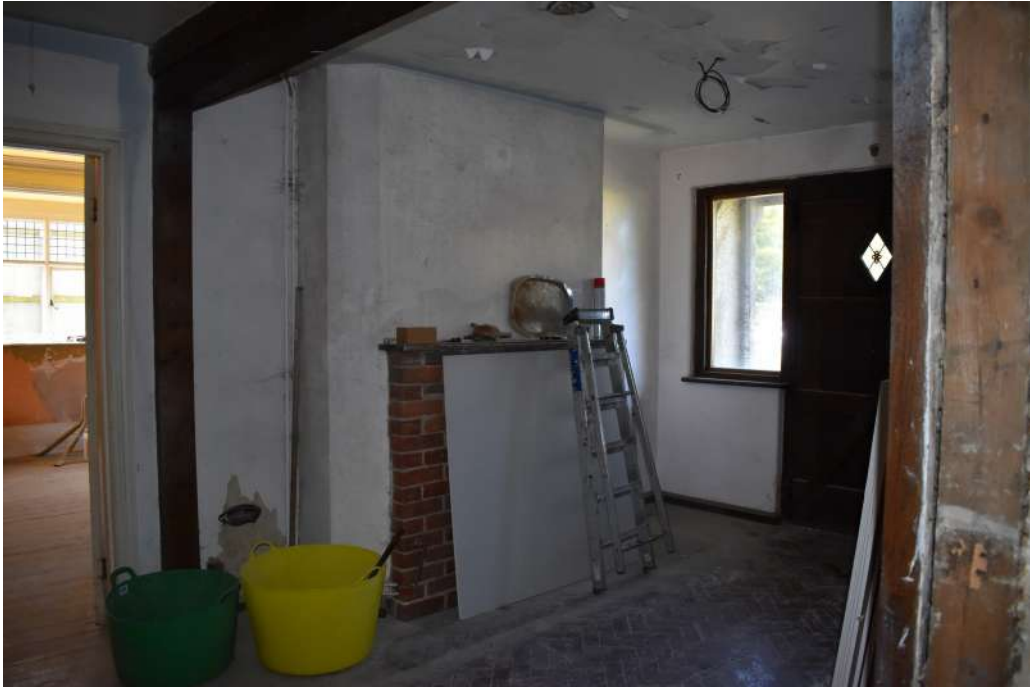
Room 2 is the entrance hall of Pond Mead. The floor is wooden parquet, laid in a herringbone pattern. In the north-east of the room, a flight of three wooden steps lead down into room 1. On the south-western wall is a chimney breast with a brick skin, imitating a brick fireplace, but without an opening, with a wooden mantel. Large areas of damage to the plaster on the south-east wall has uncovered the machine-cut timber-framing and laths beneath. A set of double doors are located in the south-east wall, along with a four-panel door in the south-west wall.

**Photograph 20** Interior of room 2. Photograph taken facing west.

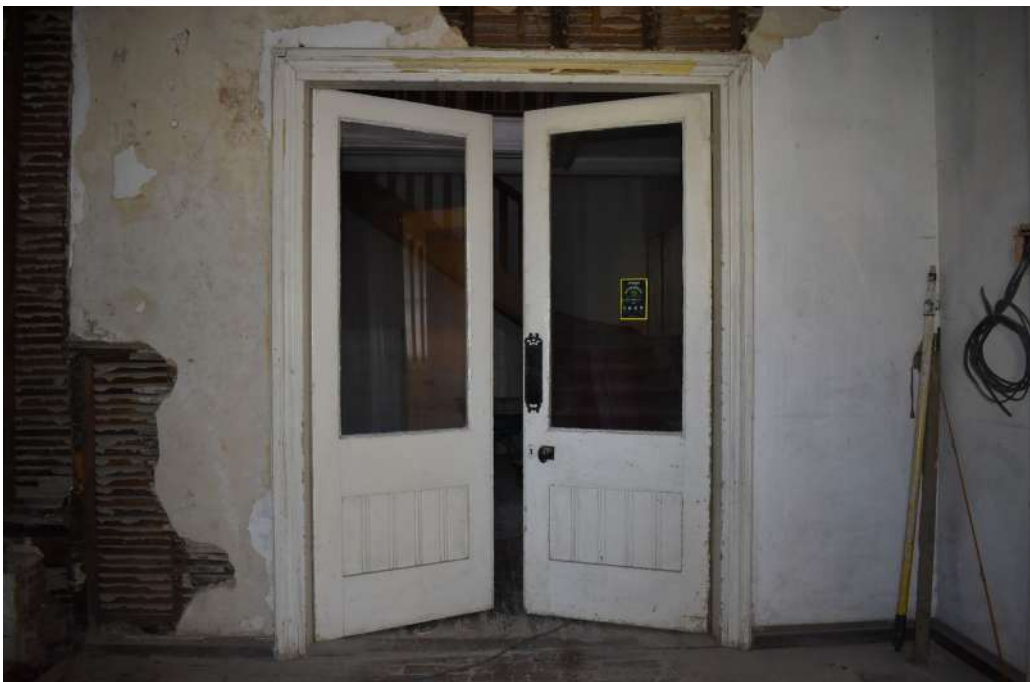
**Photograph 21** Detail of doors in room 2. Photograph taken facing south-east.

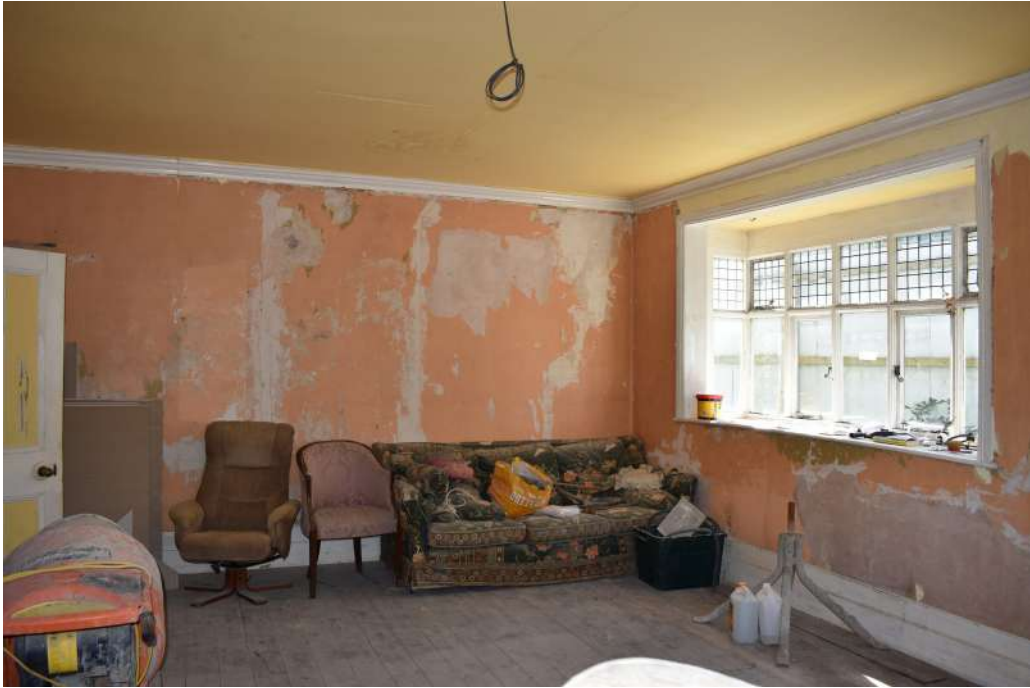
Room 3 dominates the ground floor of range 1 and has the original cornicing and skirting boards. A fireplace is located on the north-east wall. It is brick-built with a timber chimney-piece and tiled hearth. The chimney-piece has a timber overmantle with a mirror between two plain panels and a timber mantle. On both edges of the chimney-piece, the timber has been carved to imitate a stone column. Within the fireplace is a cast-iron fireback and fire-grate. The fire-grate is relative simple in design while the fireback depicts two sitting lions, each resting their paws on a shield, either side of a rose.

**Photograph 22** Interior of room 3. Photograph taken facing south.

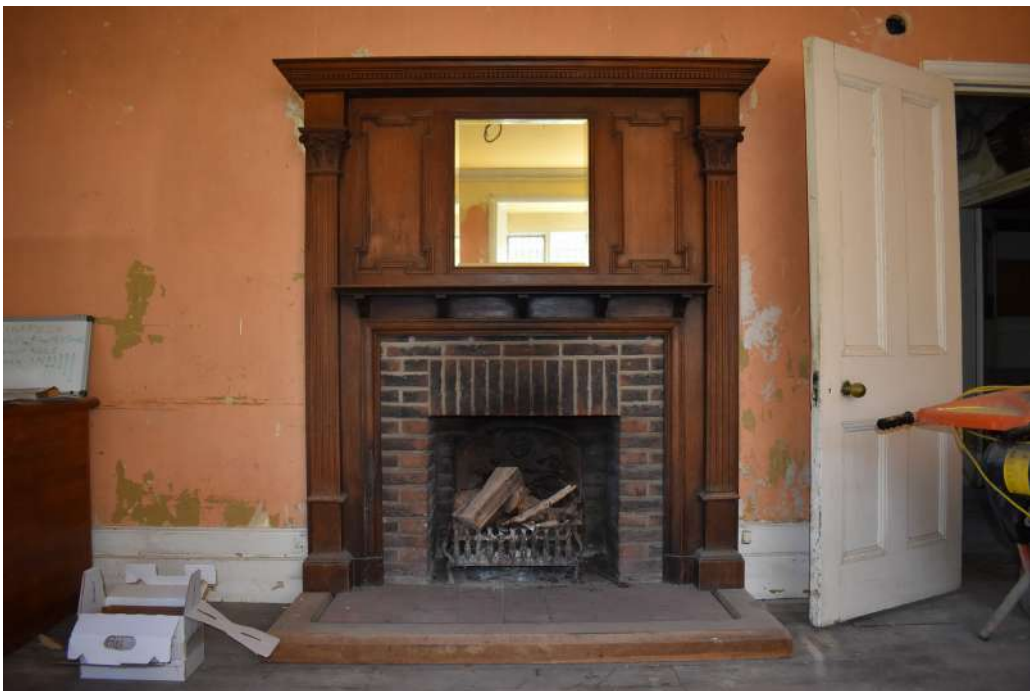
**Photograph 23** Detail of fireplace in room 3. Photograph taken facing north-east.

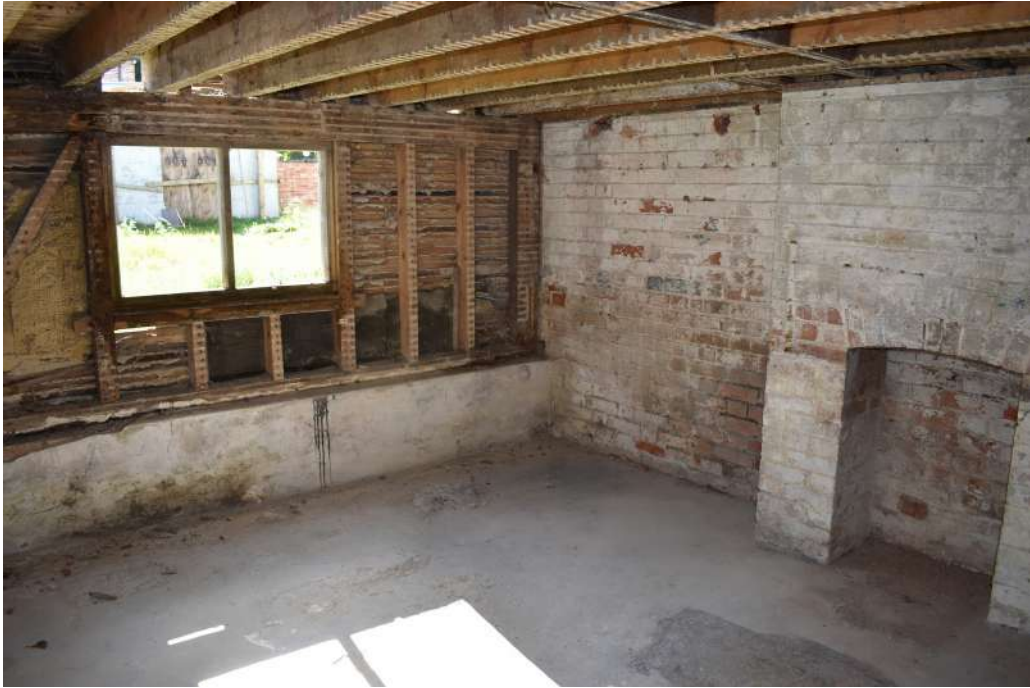
Room 5 is located within range 7. The floor is poured concrete. Three of the walls are timber-framed while the fourth is exposed red brick. The timber-frame comprises machine-cut wood with through-bracing. A brick fireplace, with an arched brick lintel, is located on the south-west wall. Two windows are present in room 5, one in the north-east wall and one in the south-east wall.

**Photograph 24** Interior of room 5. Photograph taken facing south.

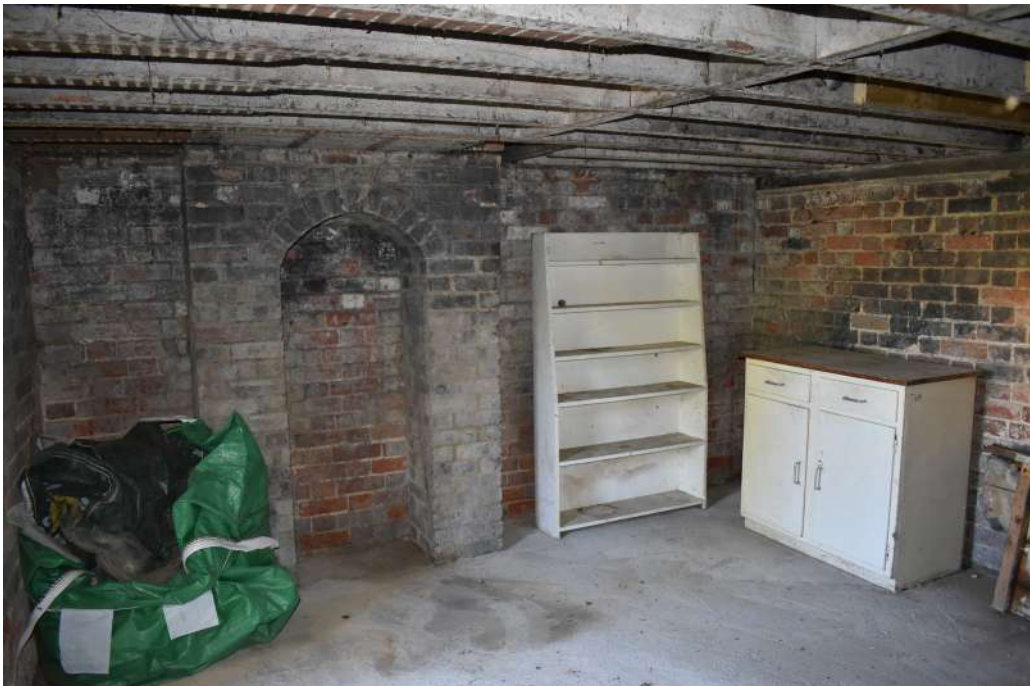
Room 6 is located in ground floor of range 6. All four walls of room 6 are exposed brick while the floor is poured concrete. The south-western brick wall is built on the stone plinth of range 4. A brick arch with two brick piers is located on the north-east wall, creating support for the fireplaces in the rooms above. On the opposite wall, a short length of wall projects into room 6. It comprises a mixture of red and yellow bricks laid in Stretcher bond and was probably inserted to offer support to the floor above. To the north-west of this wall is a blocked doorway. There is an opening, with iron bars, and a door in the north-west wall.

**Photograph 25** Interior of room 6. Photograph taken facing east.

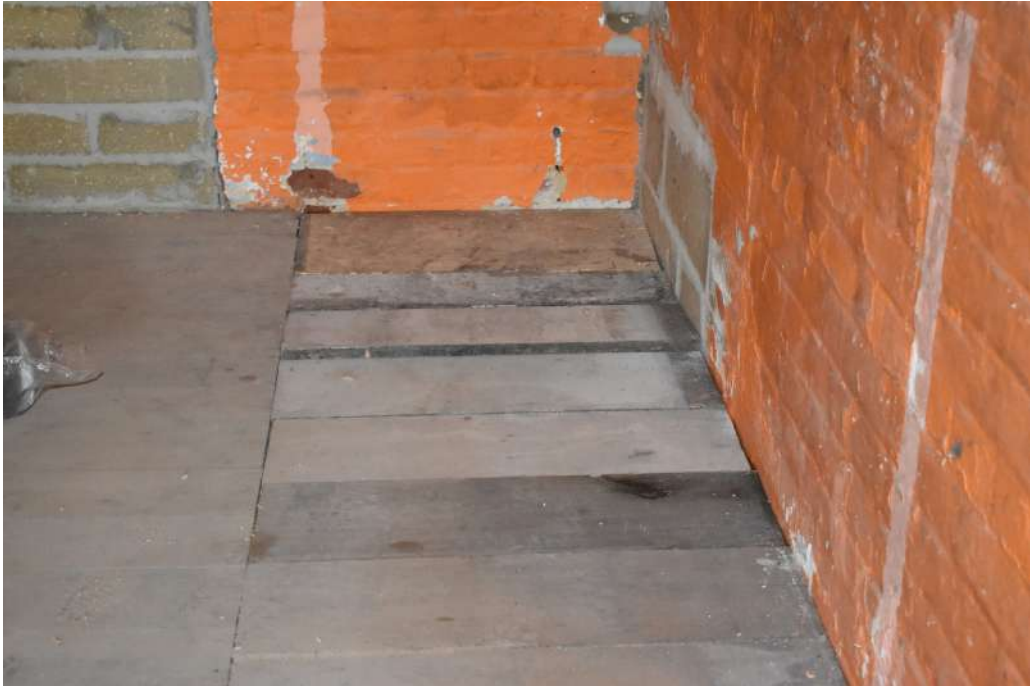
Room 7 is one of two rooms occupying the ground floor of range 5. The floor is mostly exposed timber floorboards, except in a small area adjacent to the north-west wall where it is laid with orange quarry tiles. In the southern corner of the room is a blocked

cellar entrance, evident in the floor and wall. A further blocked doorway and window are present in the south-east wall.

**Photograph 26** Detail of blocked cellar entrance. Photograph taken facing south.

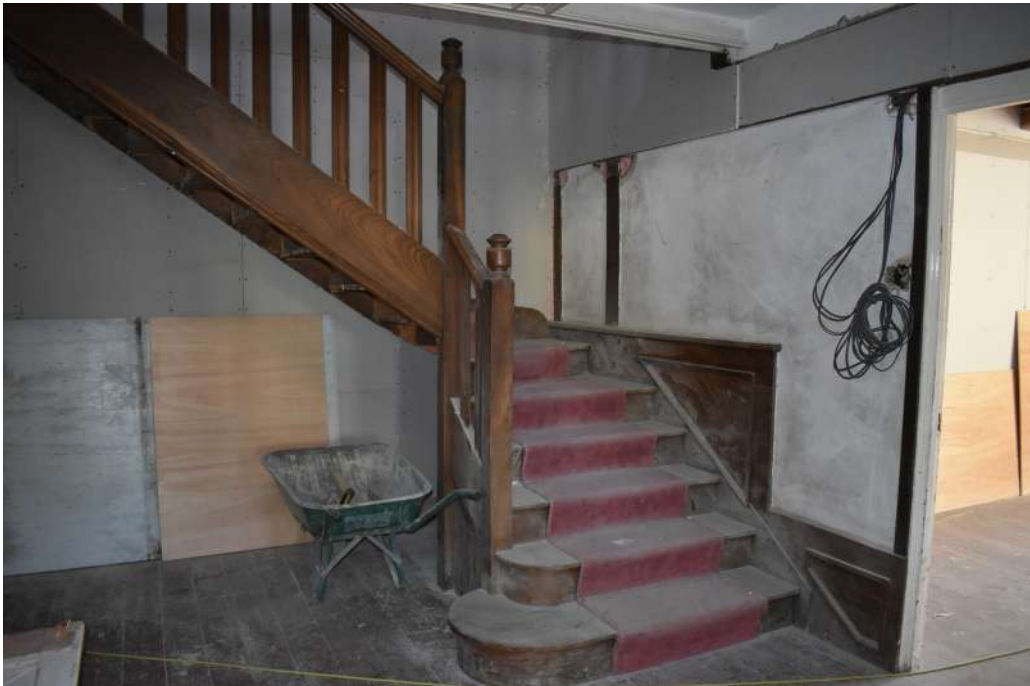
**Photograph 27** Detail of staircase in room 8. Photograph taken facing south.

In the southern corner of room 8 is an original winder timber staircase. The balusters are flat rectangles with a simple carved design, while the newel post is square and

topped with a variant of a ball finial. In the south-western wall are a series of timber-posts, a possible indication this wall was once open. The south-eastern wall of room 8 has been covered with modern plasterboard, which earlier plans indicate has blocked a doorway. There is a set of double doors in the north-west wall and a single door in the south-east wall.

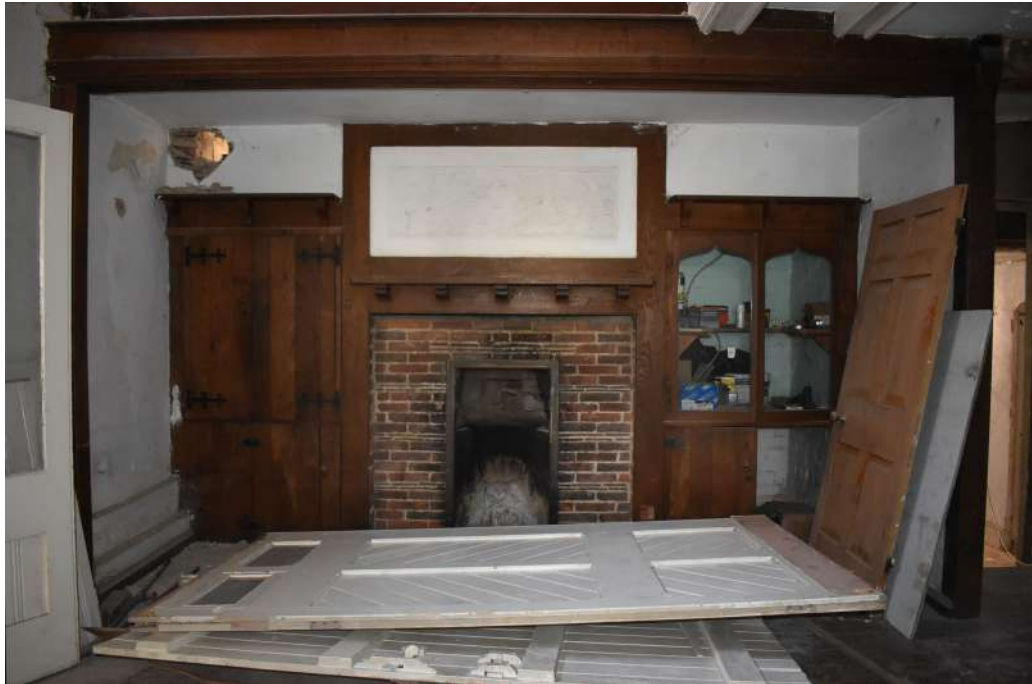
In the centre of the ground floor of Pond Mead resides the hall (room 8). Much of the floor above the hall is open, giving the room a double-height ceiling. The north-east wall is dominated by a brick fireplace, flanked by two in-built cupboards. The fireplace has a timber chimney-piece. The overmantle has been embellished with relief plasterwork in a wave-like pattern. The rest of the chimney-piece is relatively simple in design, with a timber mantle supported on lightly decorative brackets.

**Photograph 28** Detail of fireplace in room 8. Photograph taken facing north-east.

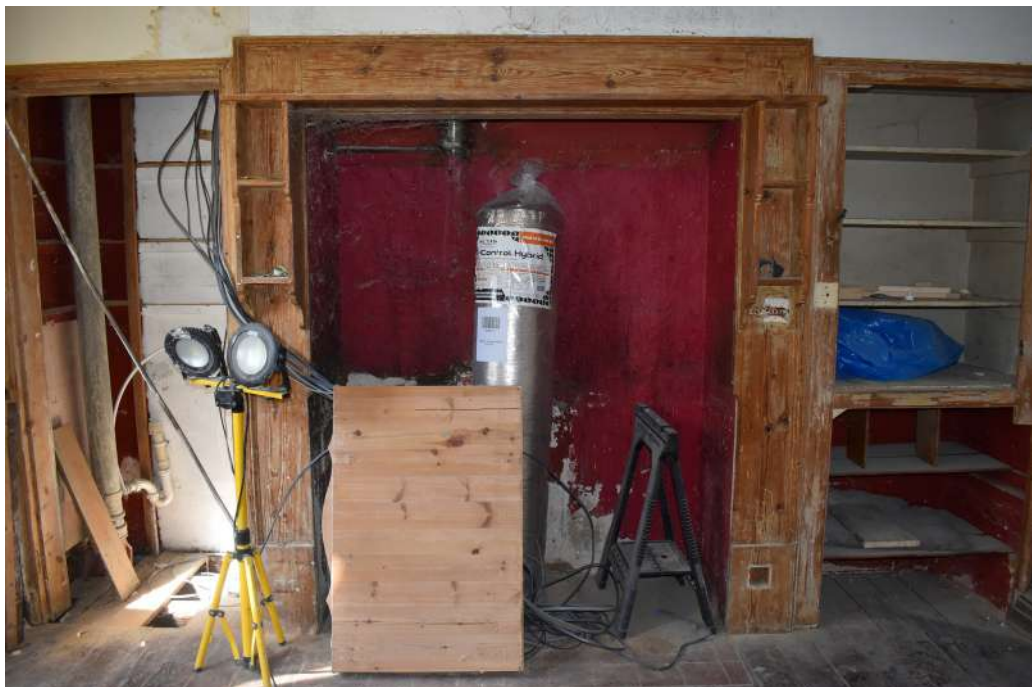
Room 9 is one of three rooms on the ground floor of range 3. The north-west wall is dominated by a large almost full-height fireplace, which, similarly to the fireplace in room 8, is flanked by two in-built cupboards. The size of the fireplace indicates it probably once housed a range cooker. It has a timber surround and a quarry-tile hearth. In the south-western wall is an inserted angled bay window. The south-eastern wall of room 9 is an inserted modern wall, dividing room 9 from room 11.

**Photograph 29** Detail of fireplace in room 9. Photograph taken facing north-west.

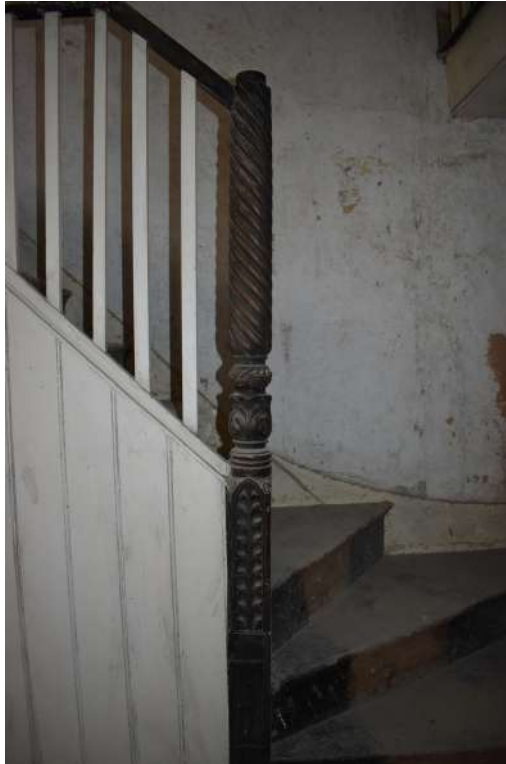
**Photograph 30** Detail of newel post on staircase in room 10. Photograph taken facing south-east.
