# Colchester Archaeological Trust

**CAT Report 1976  
issued November 2023**

**Historic building recording at Pond Mead,  
High Street, Widdington, Essex, CB11 3SB**

**CAT project ref.: 2023/09a  
ECC code: WDPM23**

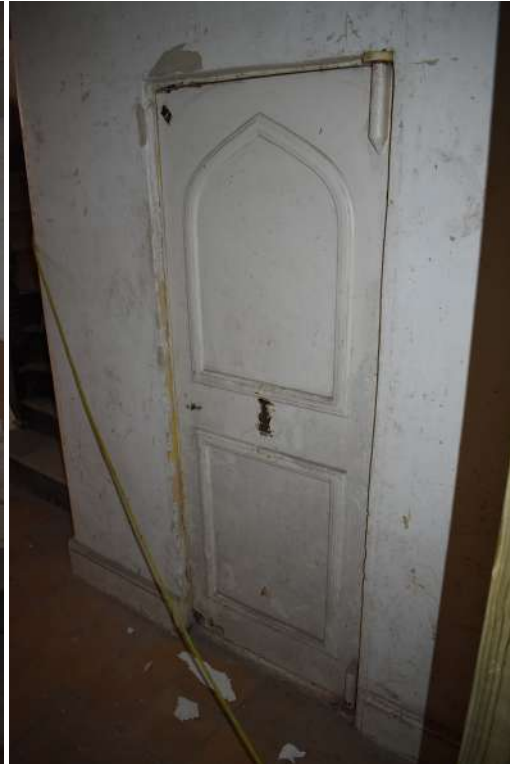
Room 10 is the second room that occupies the ground floor of range 5. The floor is laid with orange quarry tiles. In the southern corner of room 10 is an in-built safe, possibly a silver room but as it was locked the interior could not be recorded to confirm this. It has a heavy metal door with an arched panel design. Adjacent to the safe is original timber staircase, beneath which is a cupboard. The staircase has plain rectangular balusters with an intricately carved newel post. Against the north-eastern wall is a small inserted room. It has a four-panel door and a curved wall. There is a replacement window in the north-east wall.

**Photograph 31** Detail of safe in room 10. Photograph taken facing east.

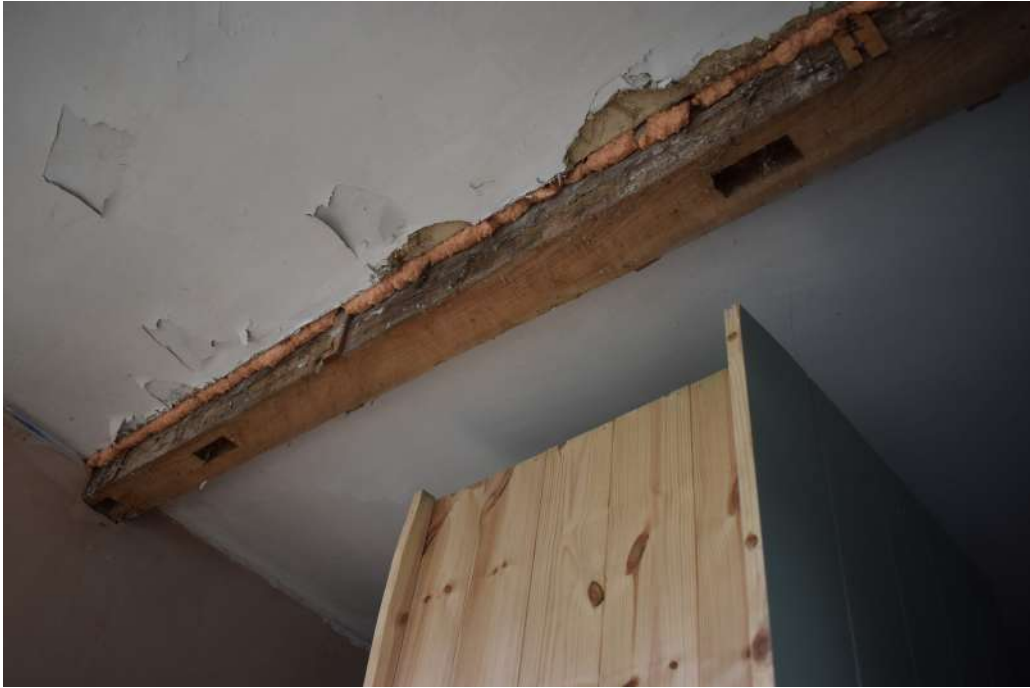
Room 11 is the middle of the three rooms in range 3. The insertion of a bay window in the south-western wall has exposed the wall-plate, complete with empty mortices from the removal of the studs in the timber-frame. The wall-plate comprises a machine-cut timber.

**Photograph 32** Detail of empty mortices in girding-beam above window in room 11. Photograph taken facing south-west.

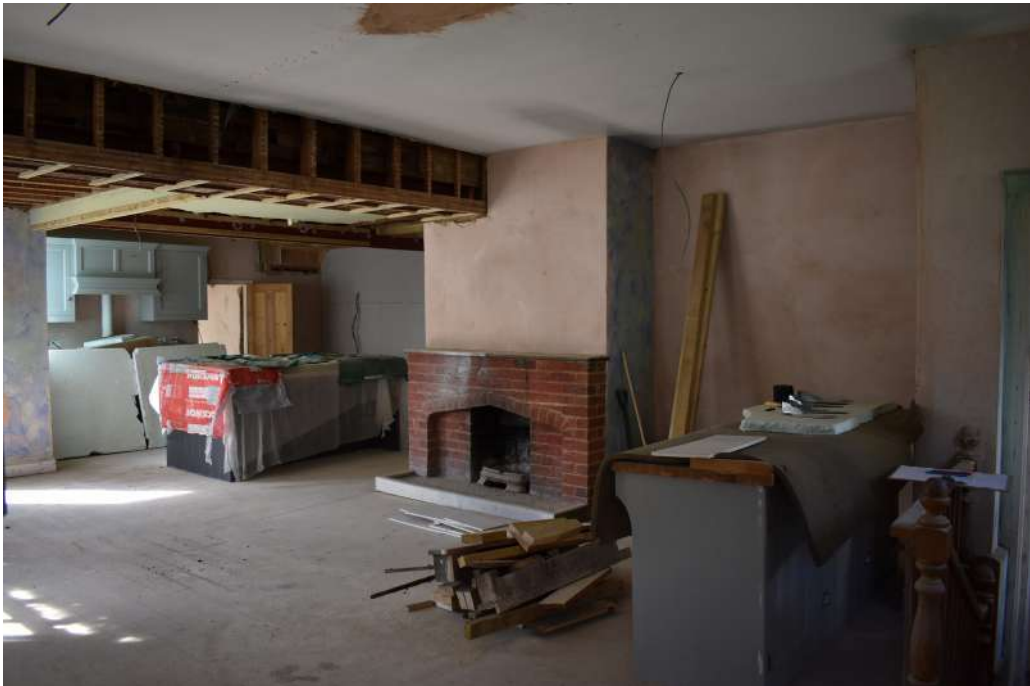
Room 12 occupies the ground floor of ranges 4, 9 and 10. A small flight of original stairs are present in the north-east of the room. They have plain square balusters and carved newel posts topped with acorn finials. A fireplace is located on the north-western wall, with a brick surround with '1830' carved into one of the bricks. The hearth is laid with bricks in a herringbone pattern and a simple grate is present in the opening. Windows are present in the north-eastern and south-eastern walls, three of which have leaded top windows. Double patio doors are present in the eastern wall, while a single-light door and a four-panel door are located in the south-western wall.

**Photograph 33** Interior of room 12. Photograph taken facing west.

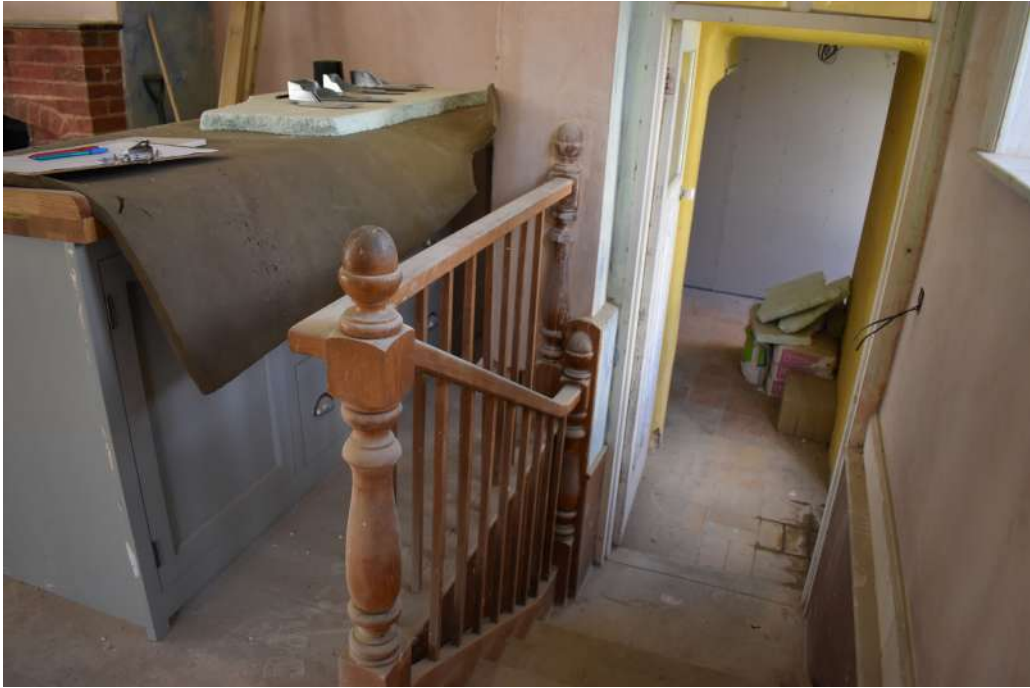
**Photograph 34** Detail of staircase with bannister and newel posts in room 12. Photograph taken facing north-west.

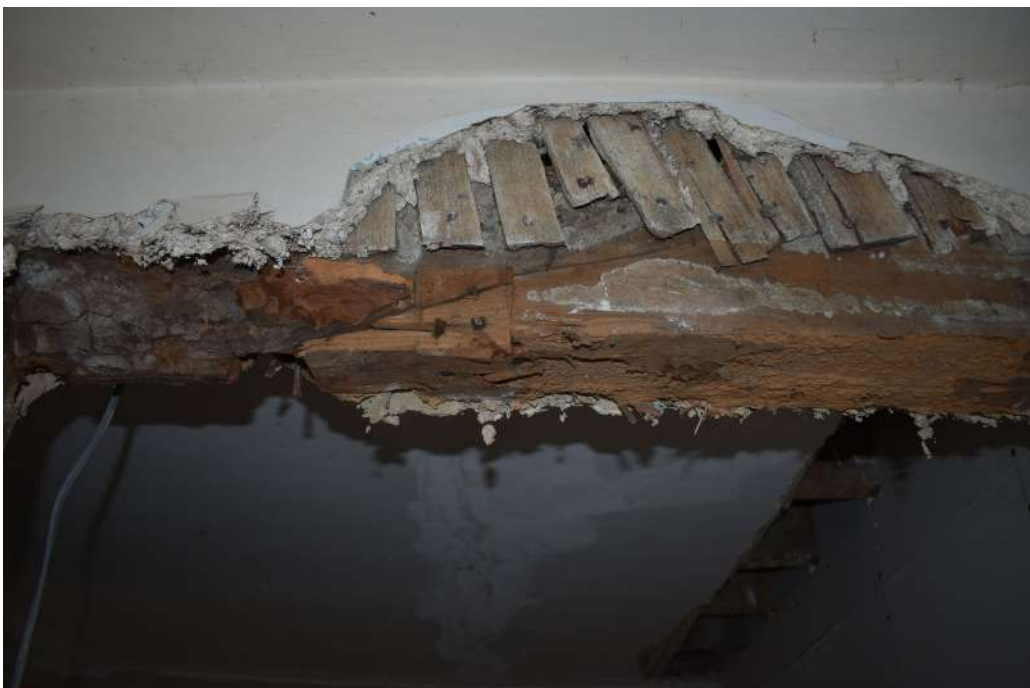
Room 13 is the last room in range 4. Against the south-eastern wall is a fireplace with a timber surround. The surround has six hand-painted tiles on either side of the opening and the phrase '*EAST-WEST-HOME'S-BEST*' carved below the mantel. A proverbial saying with origins in the mid 19th century expressing the idea that wherever you travel to, home is always the best place to be. An inserted bay window is present in south-west wall and a four-panel door in the south-east and north-east walls. The widening of a doorway in the north-western wall has revealed a splayed-scarf joint in a ceiling joist between rooms 11 and 13. The timber appears to be hand-sawn and crudely prepared as it still has bark on its underside.

**Photograph 35** Detail of splayed scarf-joint in girthing-beam in room 13. Photograph taken facing north-west.

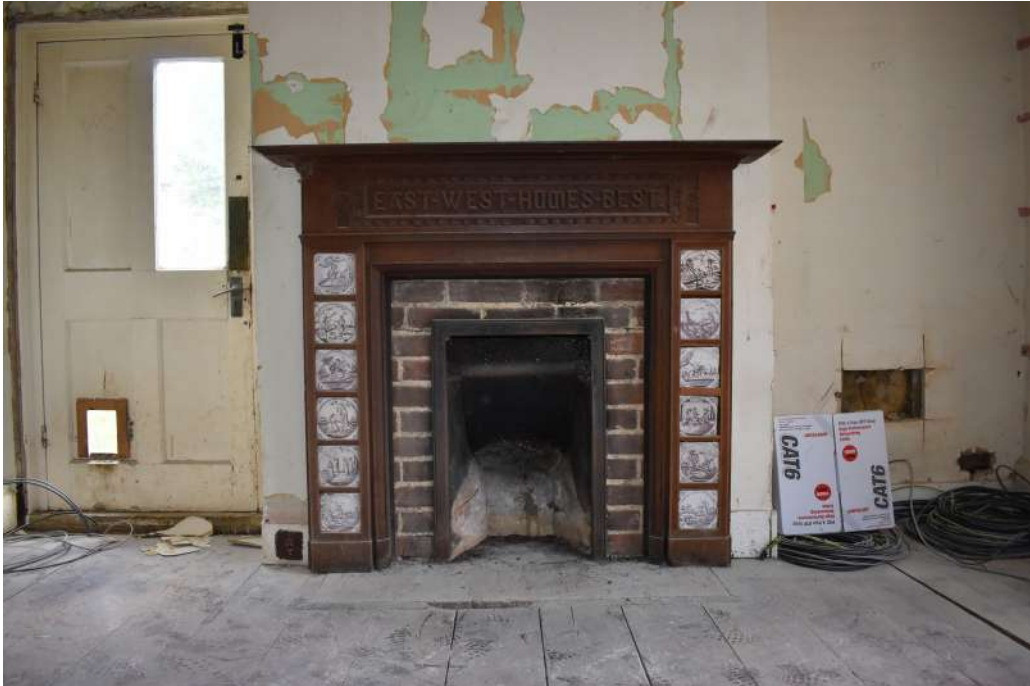
**Photograph 36** Detail of fireplace in room 13. Photograph taken facing south-east.

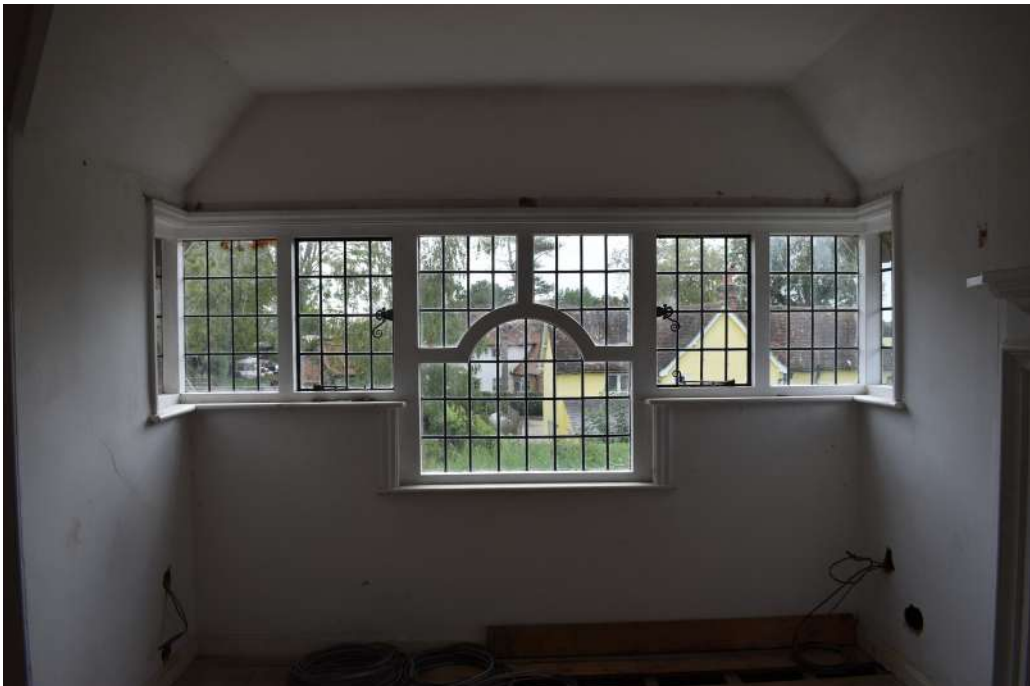
Occupying the first floor of range 2 are rooms 14 and 15. Room 14 has a fireplace in the north-eastern wall, with a timber and square brick surround. A window is present in the north-eastern and north-western walls, the north-western of which is a leaded corner window. There are in-built cupboards on the north-western wall and a four-panel door in the south-eastern wall. Room 15 has a four-panel door in the southern wall, a Crittall window in the north-western wall and recessed shelving unit in the south-eastern wall. A chimney breast is also present in the south-western wall.

**Photograph 37** Detail of window in room 14. Photograph taken facing north-west.

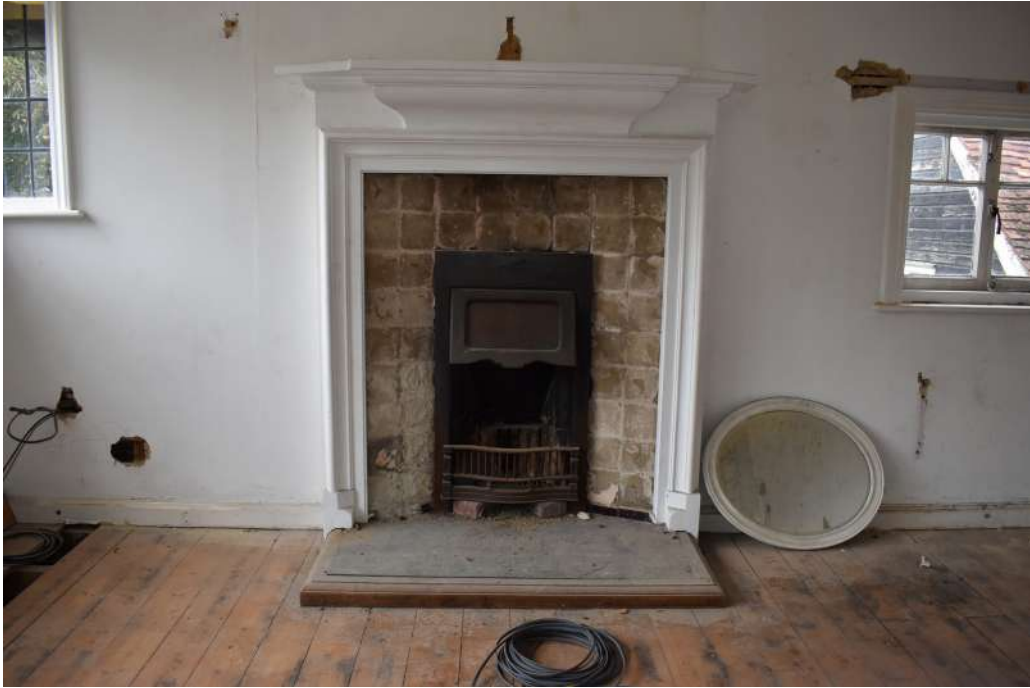
**Photograph 38** Detail of fireplace in room 14. Photograph taken facing north-east.

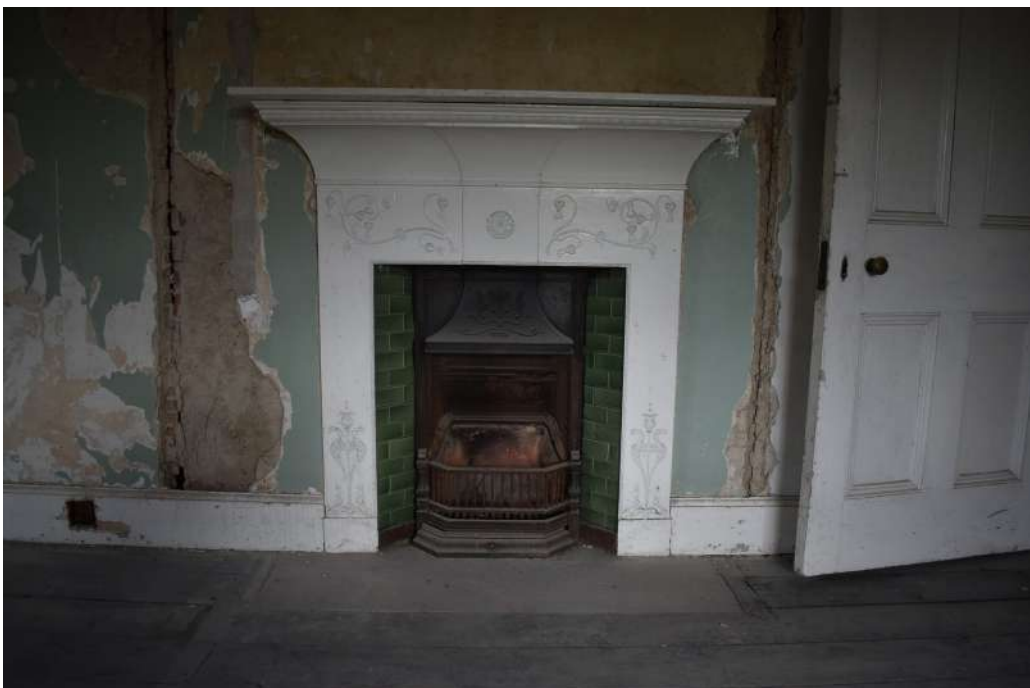
The first floor of range 1 is dominated by room 16. A fireplace is located in the north-eastern wall, which has a cast-iron surround with green tiles and a cast-iron grate. The surround has a simple floral design. Above the fireplace, removal of the wallpaper has revealed two sets of graffiti, one reads '*Papered March 9/1902 A Johns*' and the other '*papered by S. P. Leyerton 27/4/15*'. A full-height timber cupboard is located against the south-western wall. Two doors are present in room 16, a four-panel door in the north-eastern wall and a vertically-planked door in the south-eastern wall. A replacement window is located in the south-west and north-west walls. Several loose roof timbers were located in room 16 at the time of recording, these appeared to be hand-sawn and have a mixture of 'VII' and 'VIII' carpenter's marks.

**Photograph 39** Detail of fireplace in room 16. Photograph taken facing north-east.

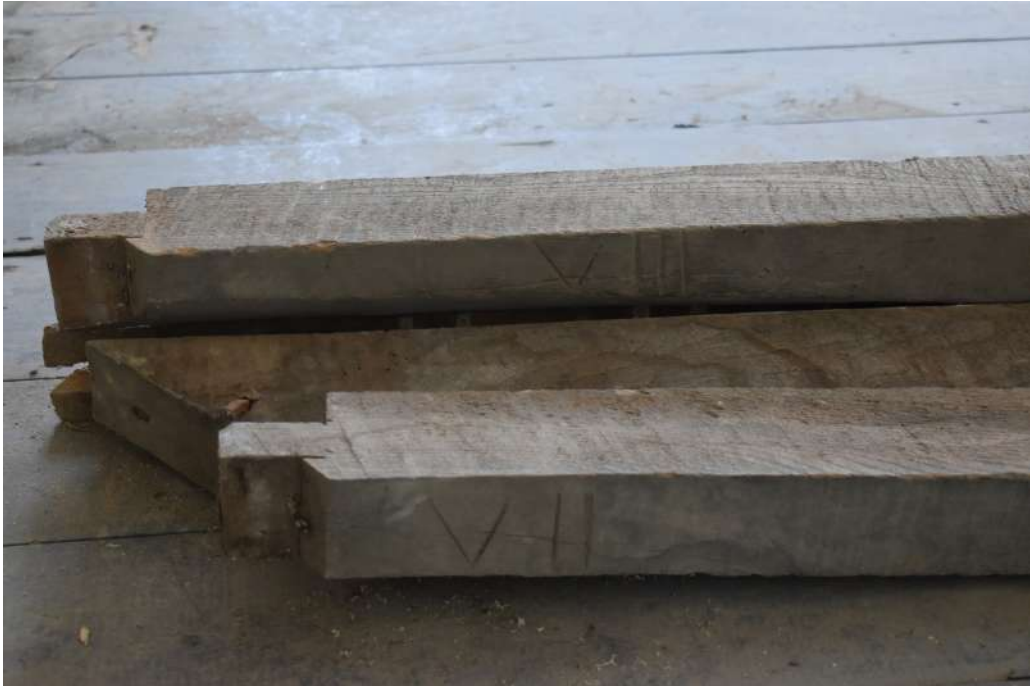
**Photograph 40** Detail of carpenter's marks on loose timbers in room 16.

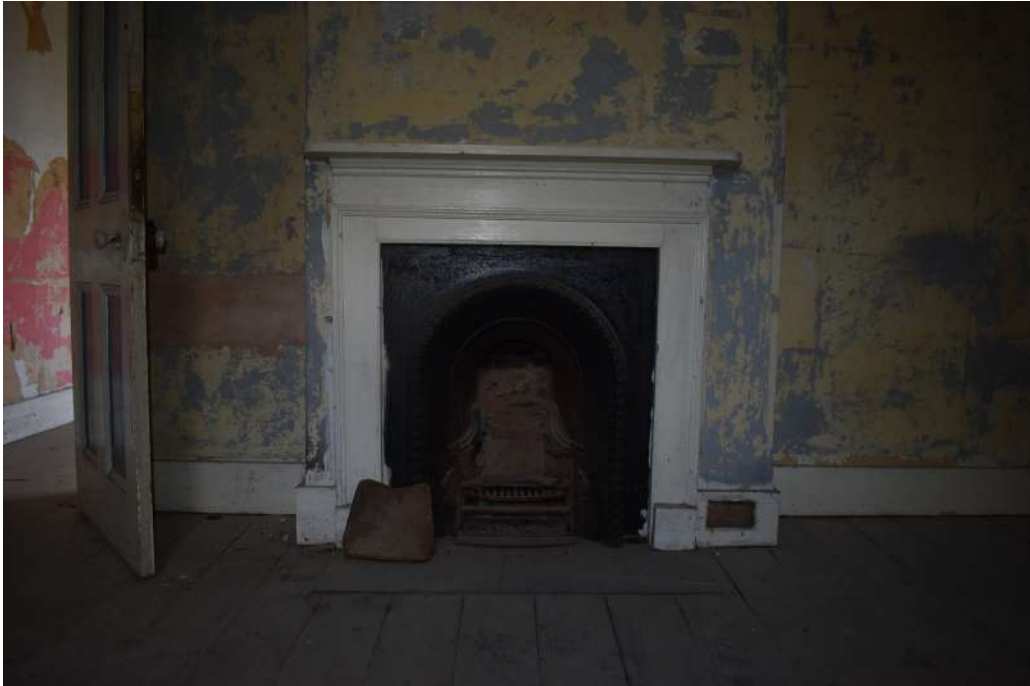
Rooms 17 and 18 reside in the first floor of ranges 6 and 7. Room 17 has a fireplace in the south-western wall, with a cast-iron surround, a replacement window in the north-eastern wall and a blocked window in the south-eastern wall. Room 18 also has a cast-iron fireplace, in the north-eastern wall, which has a simple floral design painted white and blue. Damage to the plaster has exposed the bricks of the south-eastern and south-western walls, including a brick arch above the doorway to rooms 19 and 20. There is a replacement window in the north-western wall and a horned-sash window in the south-eastern wall. A hand-sawn roof timber was located on the floor of room 18 at the time of recording, which had a 'XII' carpenter's mark. A four-panel door is present between rooms 17 and 18.

**Photograph 42** Detail of fireplace in room 17. Photograph taken facing south-west.

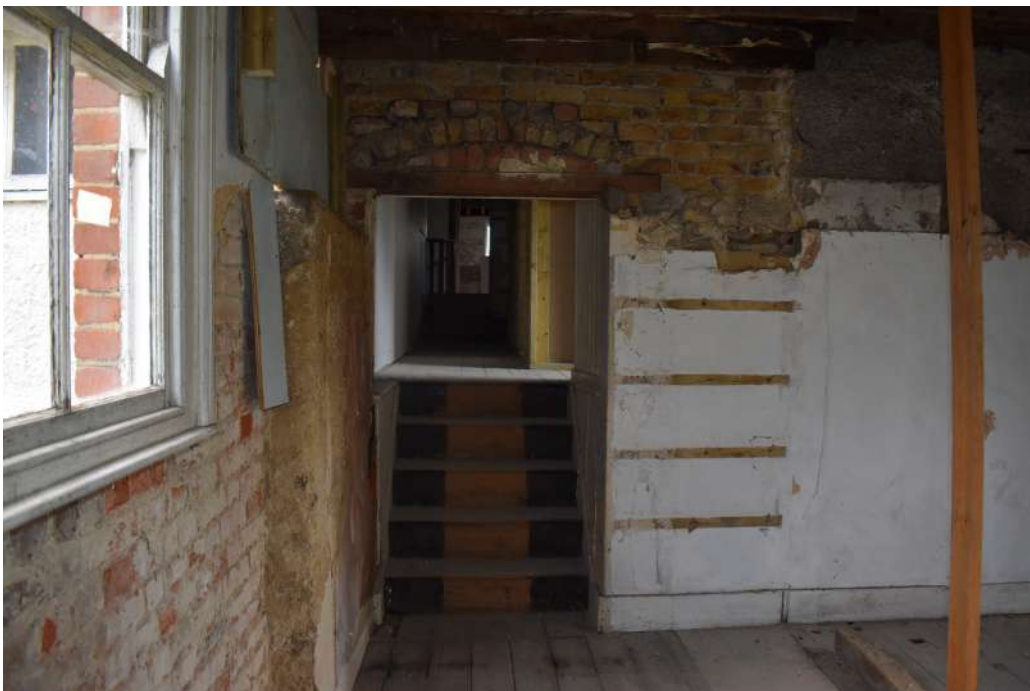
**Photograph 43** Detail of opening in room 18. Photograph taken facing south-west.

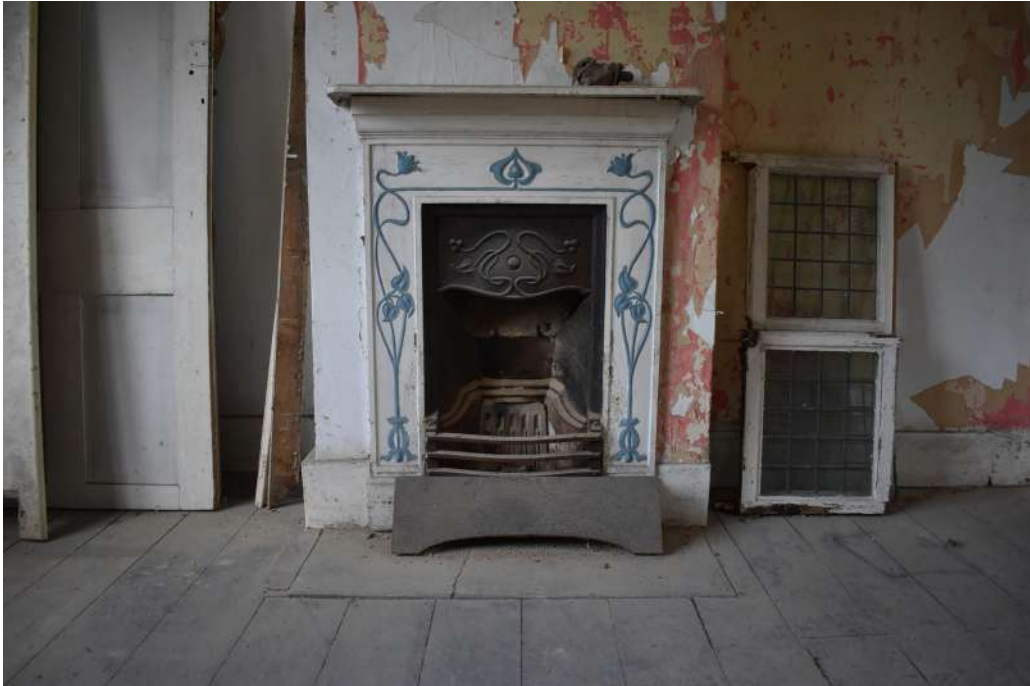
**Photograph 44** Detail of fireplace in room 18. Photograph taken facing north-east.

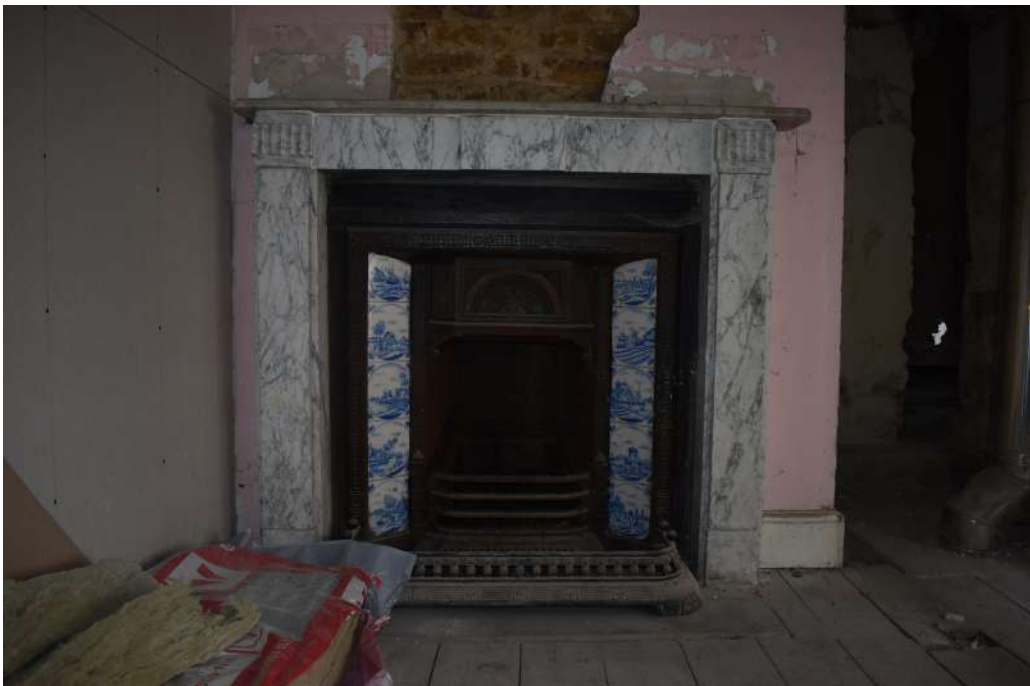
Room 19 is located in range 5, adjacent to room 20. A replacement window is located in the north-west wall as well as a roof light in the ceiling. Room 20 has a fireplace in the south-western wall, with a marble surround, blue and white painted tiles and a cast-iron grate. A window is present in the north-western wall and a dividing wall has been inserted, abutting the fireplace, to create a hallway adjacent to rooms 19 and 20.

**Photograph 45** Detail of fireplace in room 20. Photograph taken facing south-west.

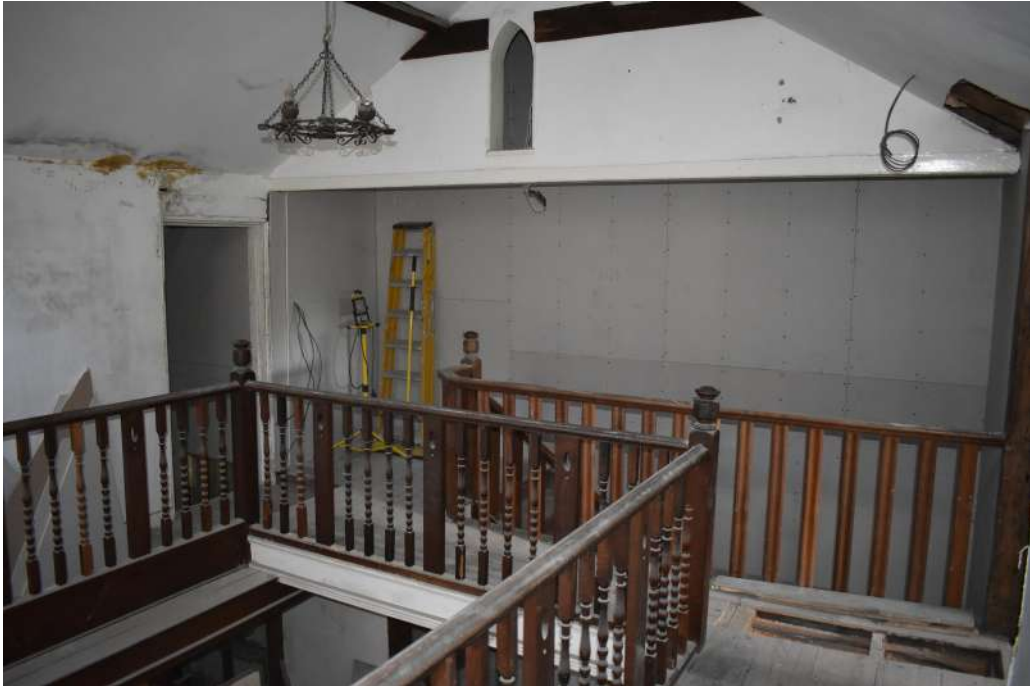
Room 21 is the main landing area on the first floor. Much of the floor is open, creating a balcony looking down into room 8. Surrounding the balcony is a timber balustrade comprising turned balusters, with intermittent rectangular posts, and newel posts in the same design as the staircase. In the north-western wall is a simple stained glass window, composed of colourless glass with glass in shades of yellow in a circular pattern. Above the stairwell, part of the roof truss has been filled in to create a wall.

Within the wall is a small arch-shaped opening and a small timber-door, blocked on one side.

**Photograph 46** Interior of room 21. Photograph taken facing east.

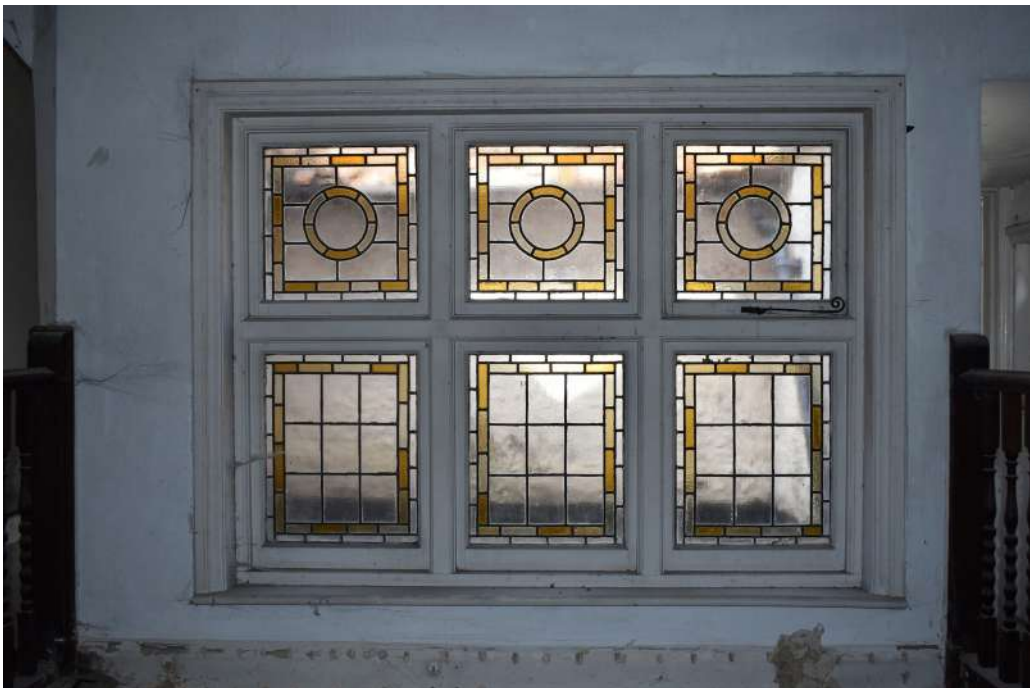
**Photograph 47** Detail of window in room 21. Photograph taken facing north-west.

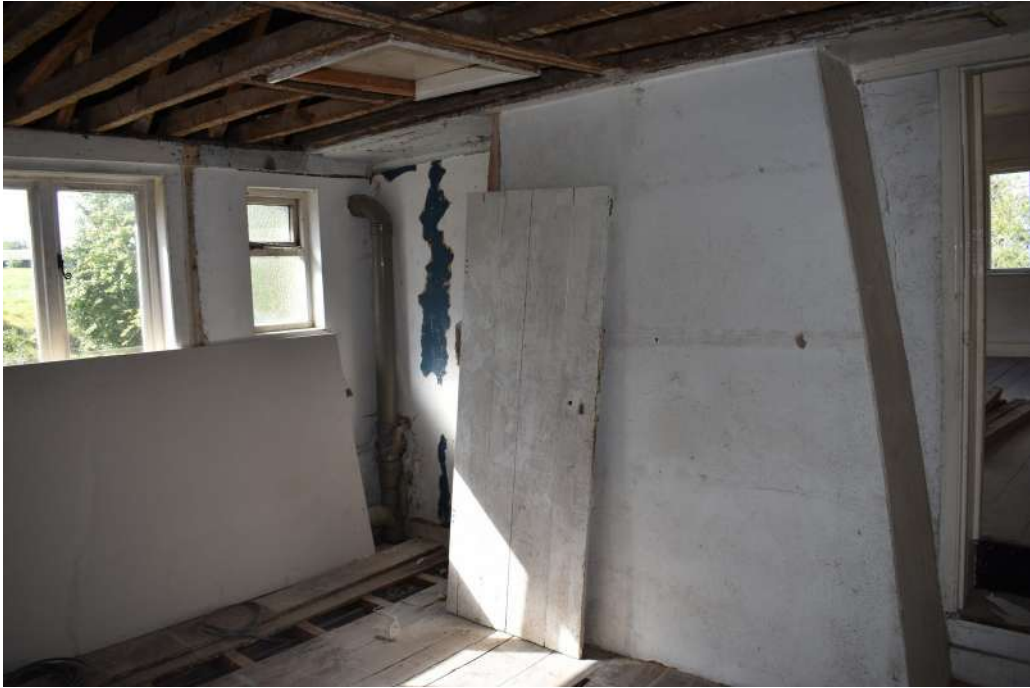
The first floor of range 3 comprises of 3 rooms, including room 22. There is a large chimney breast dominating the north-western wall and two replacement windows in the south-western wall. The doorway leading from room 21 has been inserted, as evidenced by an empty mortice in the joist above. The plaster of the ceiling of room 22 has been removed, exposing the roof structure above.

**Photograph 48** Interior of room 22. Photograph taken facing west.

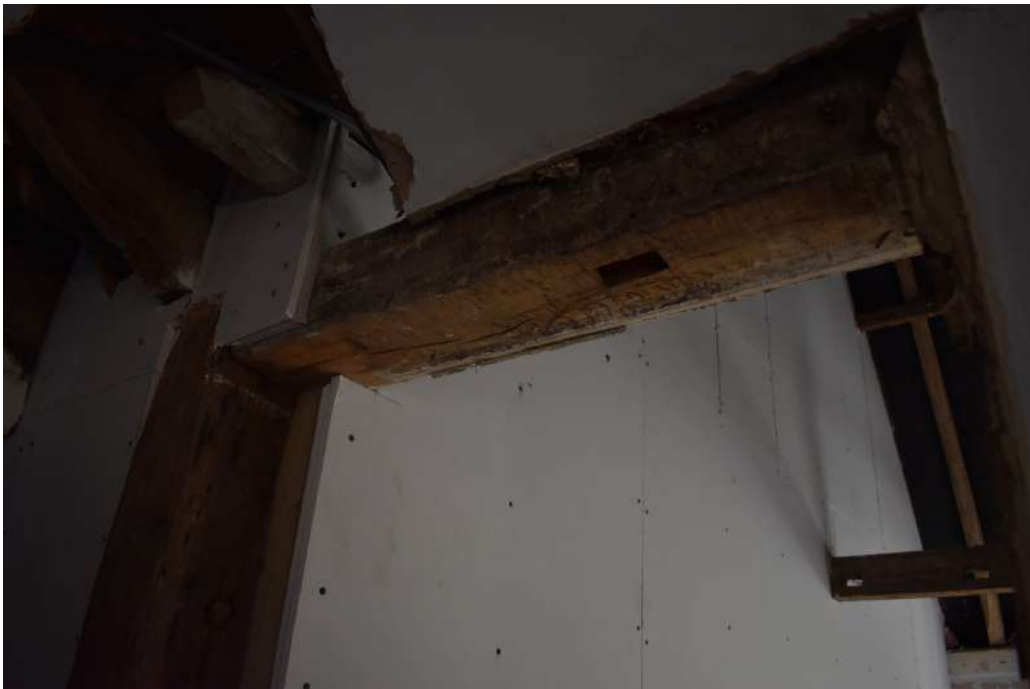
**Photograph 49** Detail of empty mortice in wall-plate in room 21. Photograph taken facing south-west.

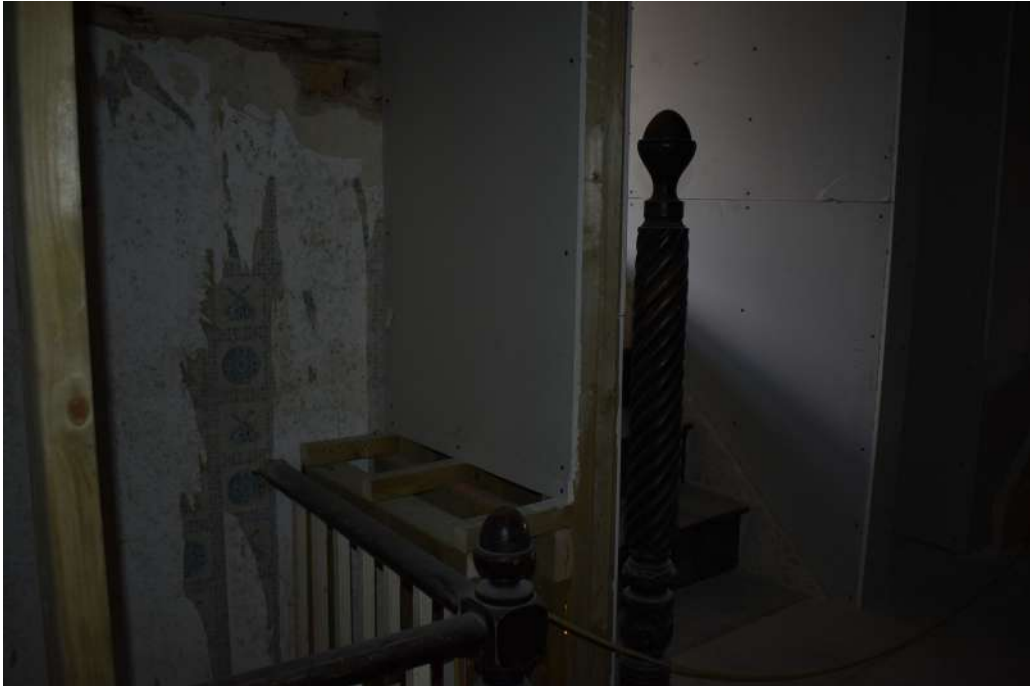
Room 23 is a hallway located in range 5. A timber balustrade is present around the stairs rising from room 10, it has simple rectangular balusters with carved newel posts topped with acorn finials. A small set of stairs, leading to room 25, have a newel post with a carved swirl design with an acorn finial. There is a replacement window in both the north-east and south-east walls. Three sets of modern timber stairs have been inserted into the hallway along with modern dividing walls.

**Photograph 50** Detail of newel posts in room 23. Photograph taken facing south.

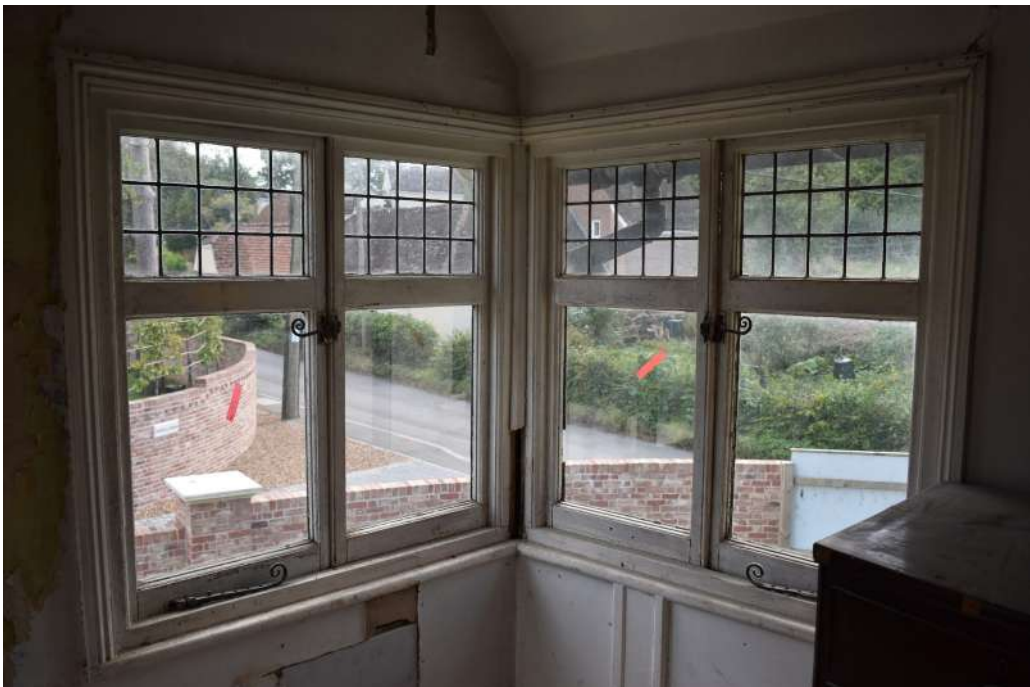
**Photograph 51** Detail of window in room 26. Photograph taken facing south.

Room 26 straddles the first floor of ranges 4 and 9. A fireplace is located on the north-eastern wall, adjacent to a blocked doorway. The fireplace has a timber surround with navy blue tiles. There are two corner windows in room 26, one on the eastern corner of the room and the other on the southern corner, both of which have leaded upper

windows. Modern cupboards have been inserted on the south-western wall and the north-western wall is a modern insertion.

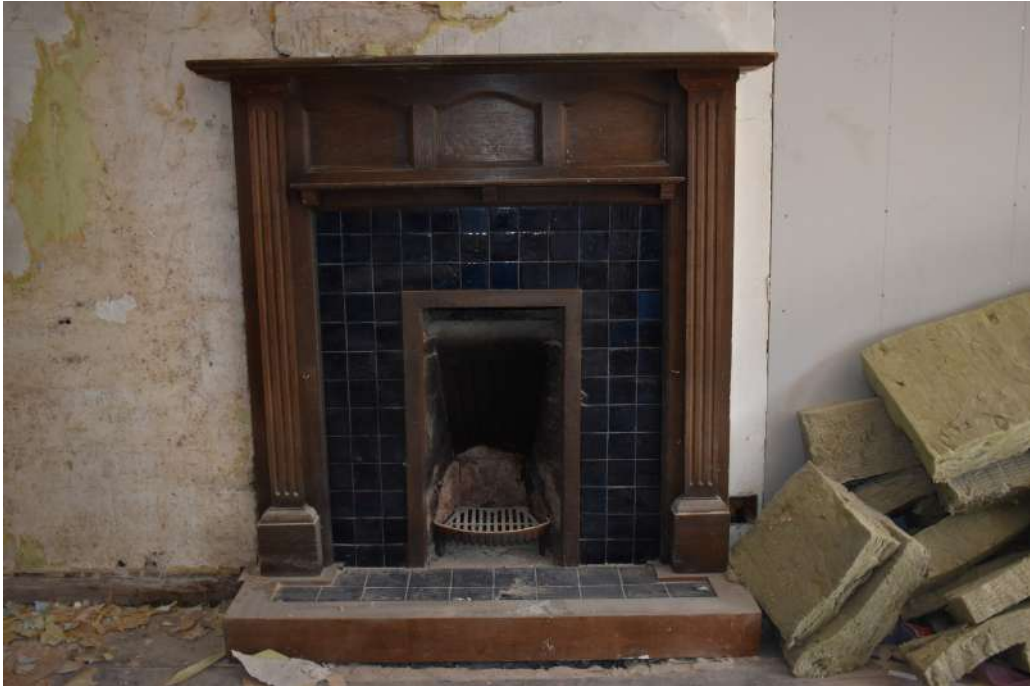
**Photograph 52** Detail of fireplace in room 26. Photograph taken facing north-east.

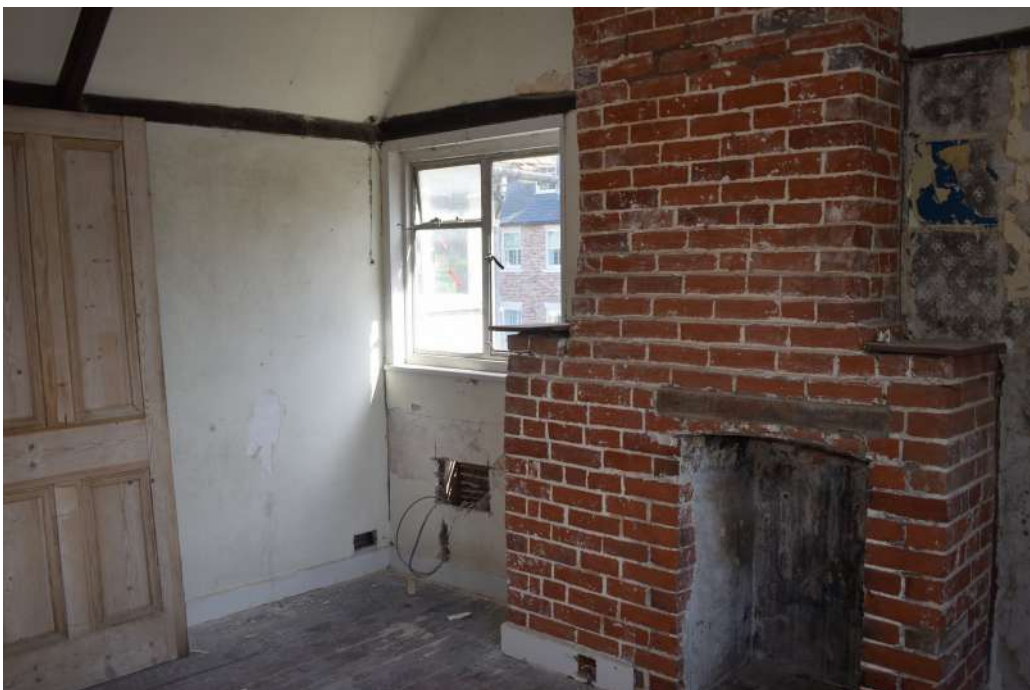
Room 27, the last room in range 3, has a brick-built fireplace on the south-eastern wall, it is simple in design with a tiled hearth and timber lintel. The ceiling of room 27 is high and has exposed rafters and collars, There are three replacement windows, one in the south-east wall and two in the south-west wall.

**Photograph 53** Interior of room 27. Photograph taken facing east.

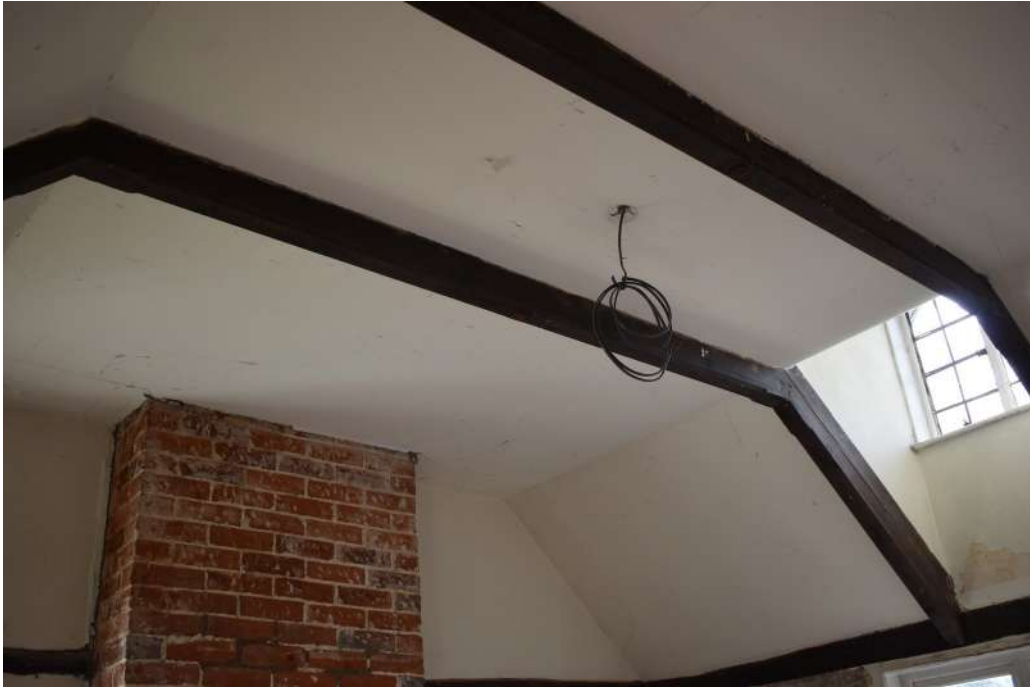
**Photograph 54** Detail of exposed roof structure in room 27. Photograph taken facing south.

Most of the roof structure was inaccessible at the time of recording but from what could be observed much of the roof appears to be constructed from pairs of rafters, rising from the wall-plates, to meet at a ridge-board at the apex of the roof. A single purlin is present on each roof pitch, clasped by a collar. The roof structure recording in range 3 also has diagonal through-bracing. The timbers used comprise a combination of hand-sawn and machine-cut with no obvious signs of reused.

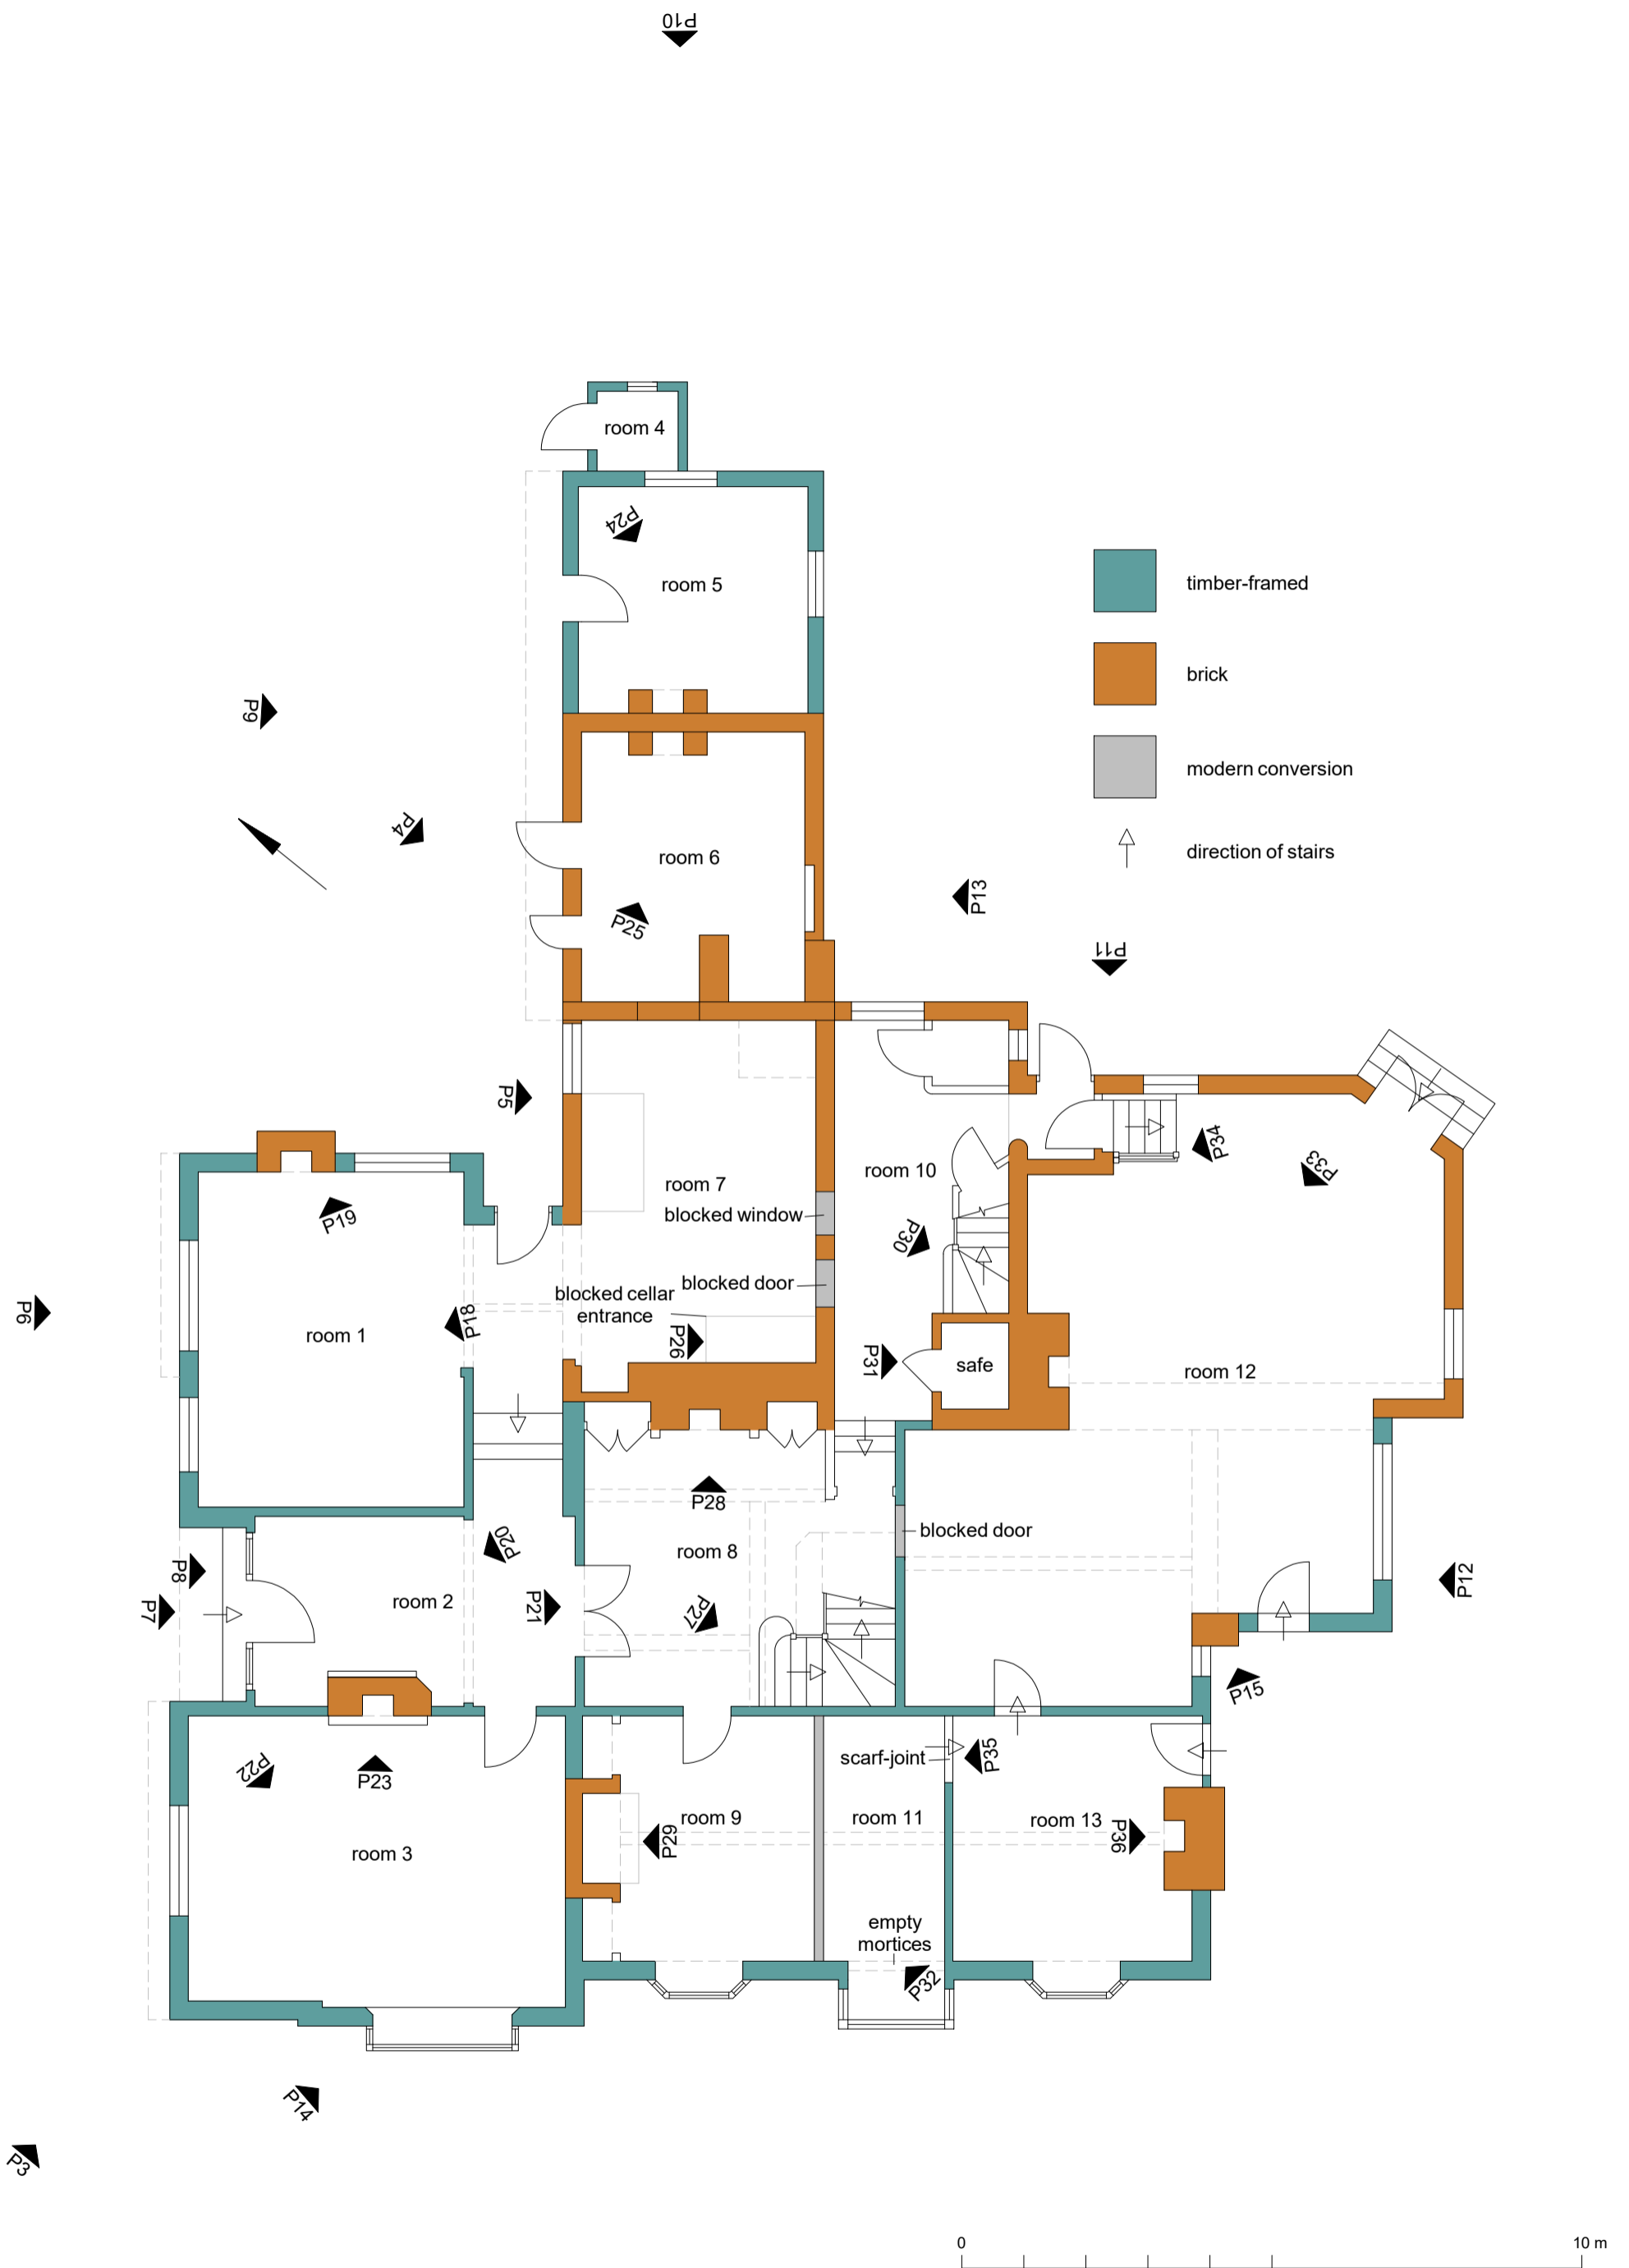
Fig 3 Ground floor plan. Location and direction of photographs reproduced in the text shown.

Almost thirty rooms, over two floors, were recorded at Pond Mead, which have been assigned individual room numbers (see Figs 3&4). Some conversion work had started to take place prior to the building recording, including the insertion of dividing walls.
