# Colchester Archaeological Trust

**CAT Report 1976  
issued November 2023**

**Historic building recording at Pond Mead,  
High Street, Widdington, Essex, CB11 3SB**

**CAT project ref.: 2023/09a  
ECC code: WDPM23**

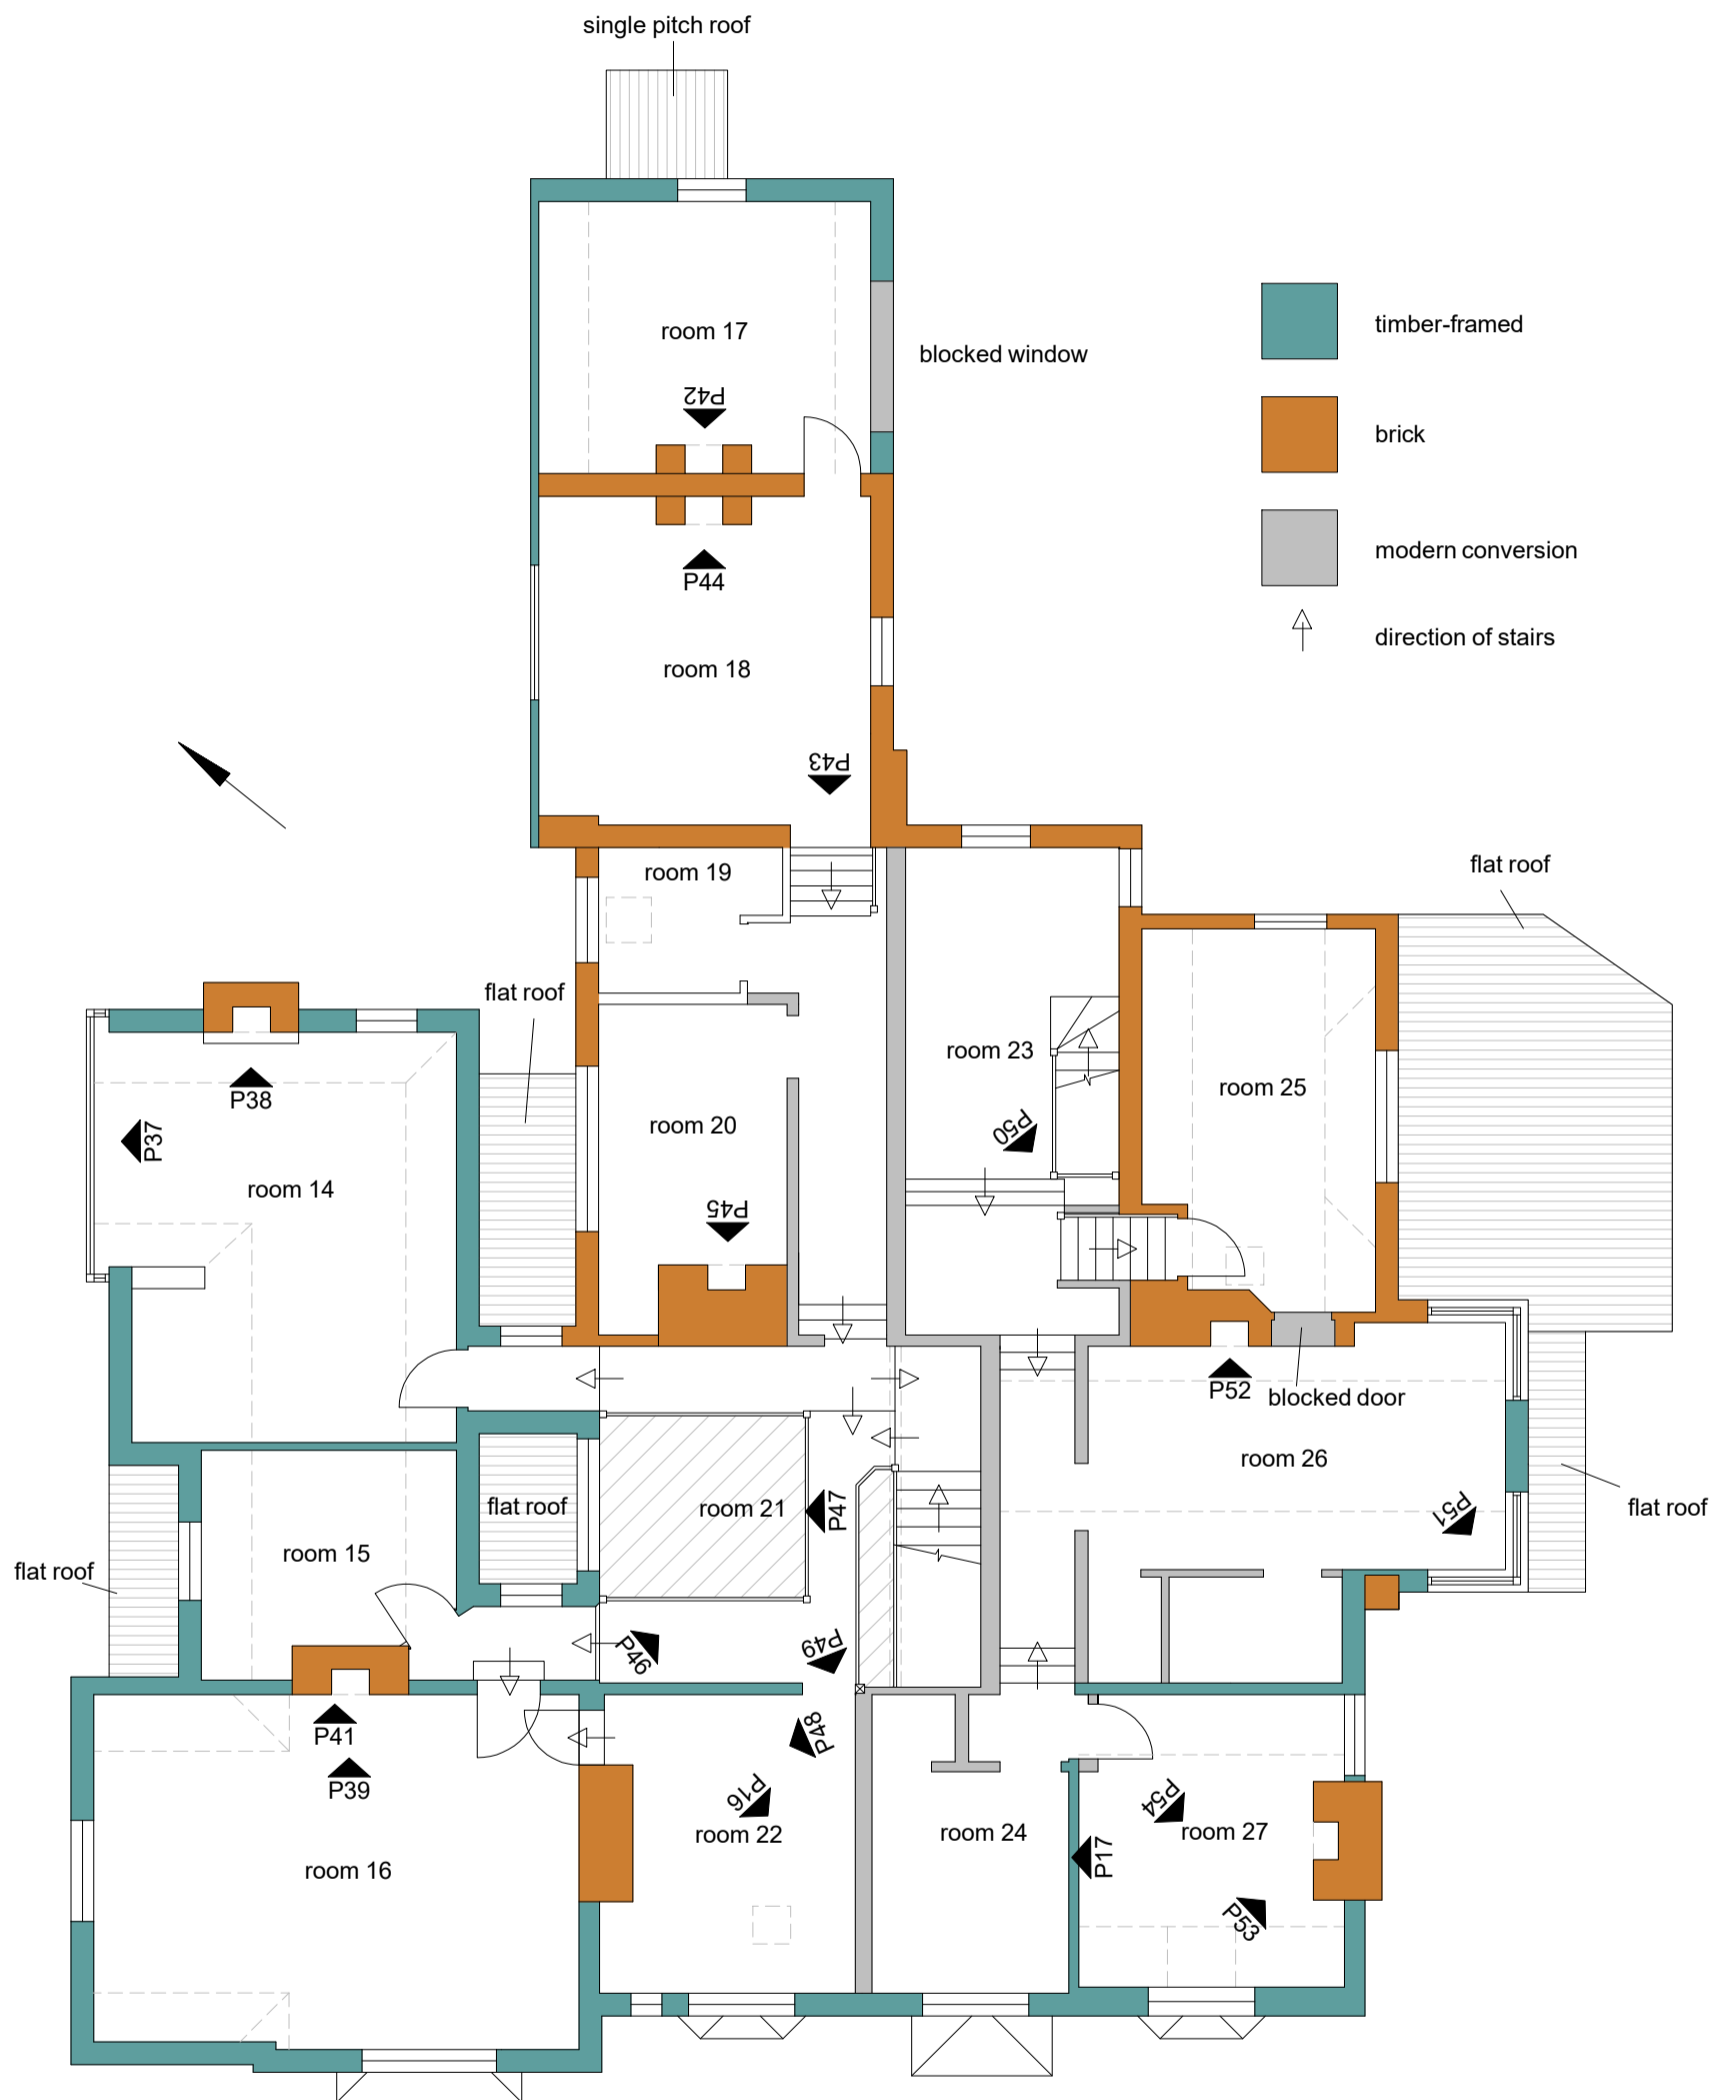
Fig 4 First floor plan. Location and direction of photographs reproduced in the text shown.

Almost thirty rooms, over two floors, were recorded at Pond Mead, which have been assigned individual room numbers (see Figs 3&4). Some conversion work had started to take place prior to the building recording, including the insertion of dividing walls.

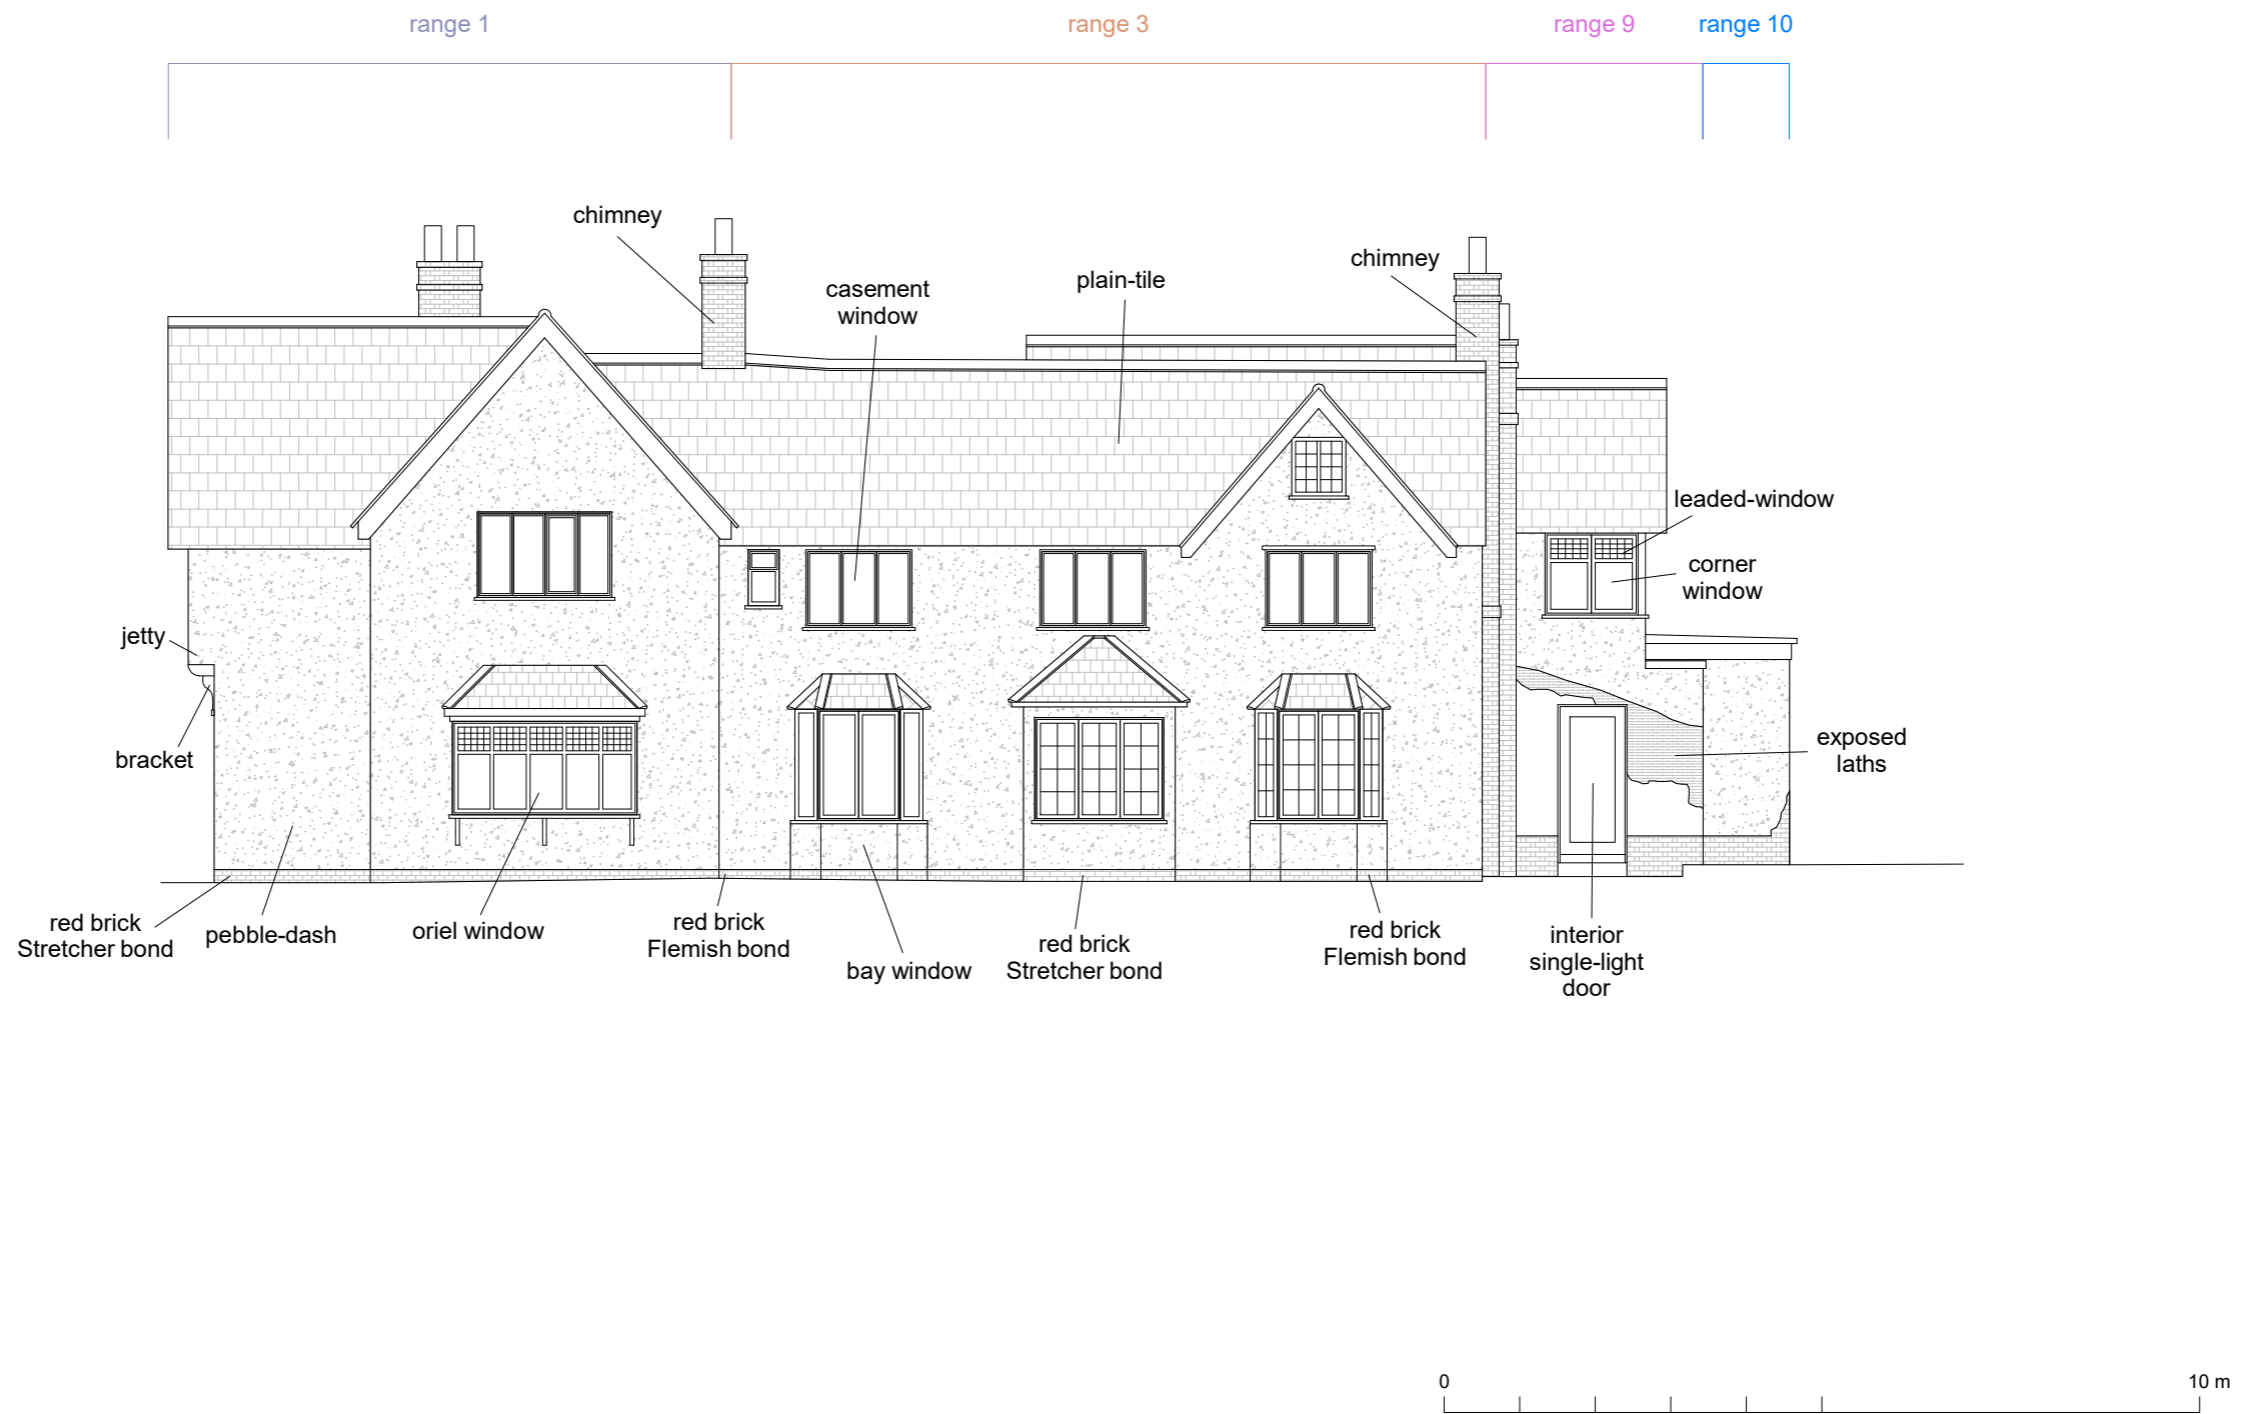
Fig 9 South-eastern elevation.
