HERITAGE IMPACT ASSESSMENT

REFURBISHMENT AND ALTERATIONS AT GII LISTED HOUSE — WHITE COTTAGE, 1 PARK STREET, KINGS CLIFFE. PE8 6XN

December 2023

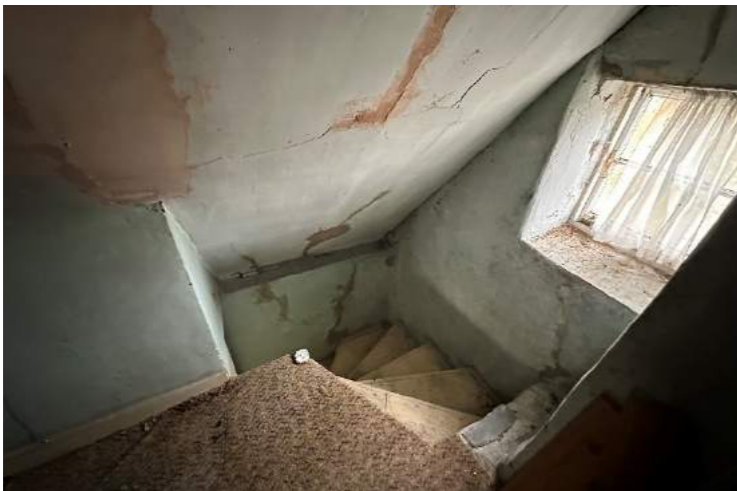
Fig 13. Second floor stair

Second floor: narrow winder staircase lit by small casement window (Figure 13), opens directly into loft space. Two rooms separated by a timber framed partition (Figure 14). Steeply sloping ceilings open to ridge with exposed purlins and cross members. Plain lath and plaster walls and ceilings in poor condition.

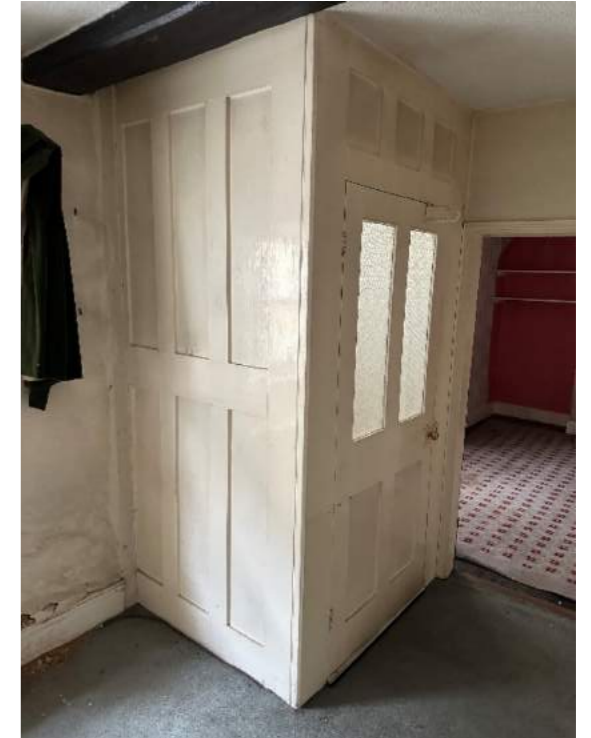
Fig 18. Timber lobby

6.4 Timber lobby to be taken down (figure 18).

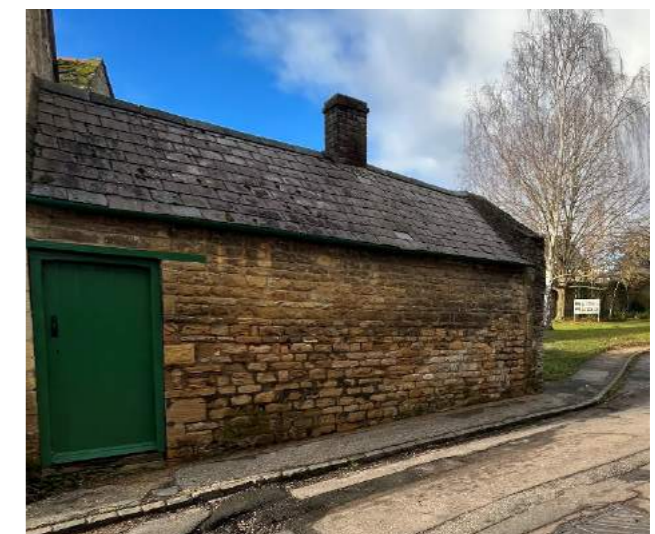
Fig 19. External door to kitchen to be infilled internally & chimney stack to be removed

6.5 External timber door to be infilled internally (Figure 19).

This door offers some insight into the original configuration and layout of the buildings, which has undoubtedly changed over time. The kitchen is clearly of a different age to the main part of the house, and was also clearly subservient given the bare (now painted) stone walls. It therefore has **low** historic value, being only particularly relevant to the history of the building itself and not having wider historic or architectural interest.

The door will be retained and fixed shut externally so there will be no visible difference from the outside. Internally, the door is already partially obscured by kitchen cabinetry — to allow for a more aesthetic installation in the kitchen when the new kitchen units are installed, the door opening will be infilled internally with timber studworks and insulation, prior to the walls

being lined. This is entirely reversible, and as the original opening can still be read externally, the impact is considered to be **negligible**.

The age of the chimney breast is unclear since it is presently plastered (Figure 20); however, the brick chimney stack (Figure 19) is incongruous with the construction of the rest of the property and also other chimney stacks immediately surrounding that are of a similar age to either the original house or this later infill, so quite clearly a later addition to the structure. Most likely the entire element is a C19, possibly early C20 addition when this part of the building was brought into use as part of the dwelling to provide a cooking area. As such it is considered to have **negligible** historic since the evolution of the building is more clearly identified by the bare internal stone walls, and **negligible** architectural value - being a plain brick chimney with no unique features,

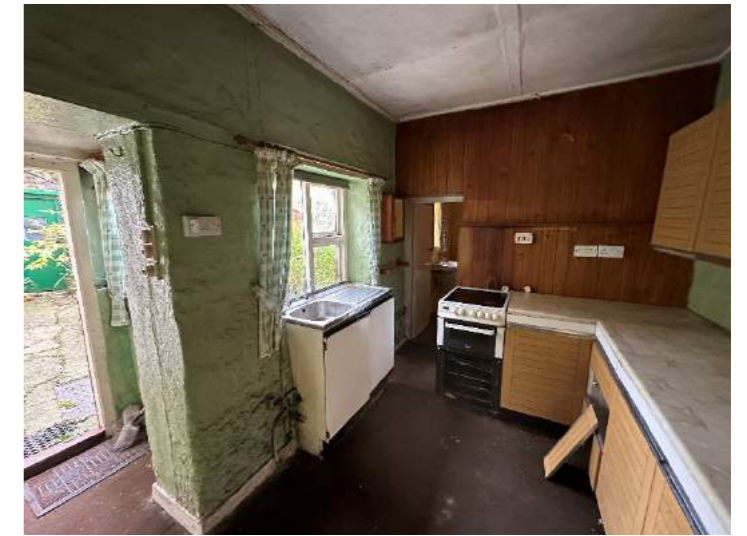
Fig 20. Chimney breast to be removed

The structure occupies a significant portion of the room and compromises the layout of the kitchen considerably. It is proposed to take down the stack and the majority of the breast to provide for a less constrained layout that offers sufficient space for the number of occupants. A nib will be retained from the chimney breast so that it remains identifiable, while building recording could provide a record of the arrangement prior to removal. As such, the impact of the work is considered to be **negligible**.

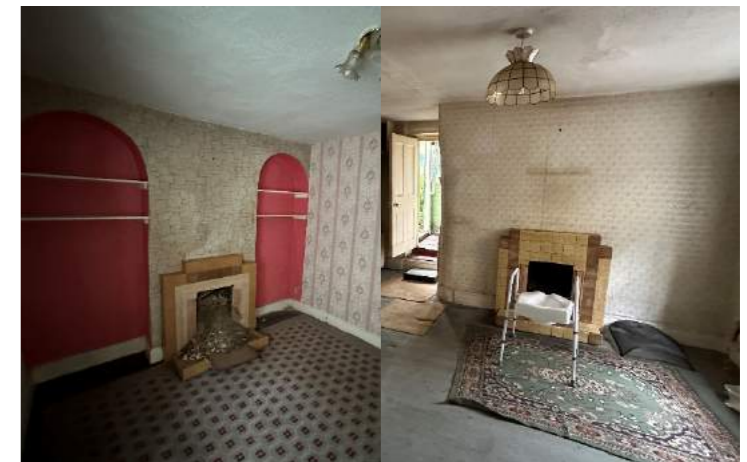
Fig 21. Fire surrounds In Ground Floor reception rooms

6.7 Fire surrounds to be removed and new wood burning stoves installed (Figure 21)

The fireplace recesses will be restored to their original configuration, and new timber surrounds installed with stone hearths - unless the original hearths are uncovered, in which case they will be retained if in sound condition.

New small woodburning stoves will be installed into the fireplace recesses, and the chimneys lined for both functioning of the stoves and for safety.

The overall impact of these works is considered to be **negligible**, and generally positive since it will remove incongruous C20 surrounds and restore some of the original character of the spaces. The stove and liner installations are largely reversible.

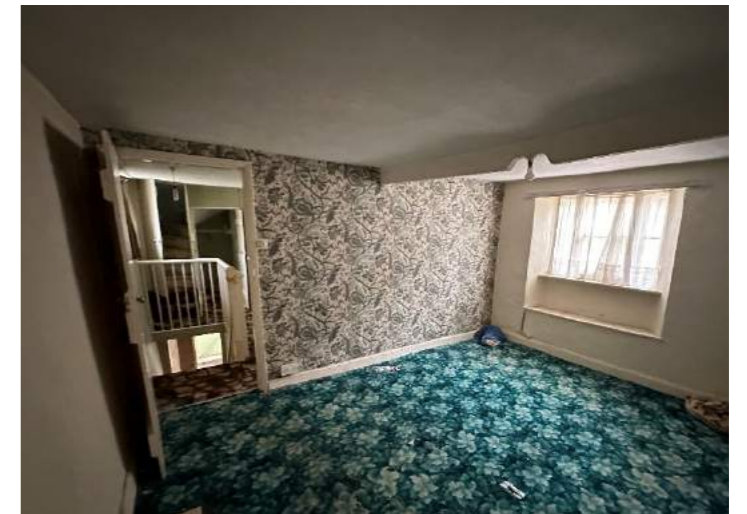
Fig 22. Door leading to First Floor bedroom to be removed

6.8 Door to be removed (Figure 22)

The shower room will be formed by subdividing the bedroom at the south end of the building (Figure 22). The subdivision will be formed through the construction of new timber stud and plasterboard partitions creating both the shower room and a small lobby to provide access to the bedroom.

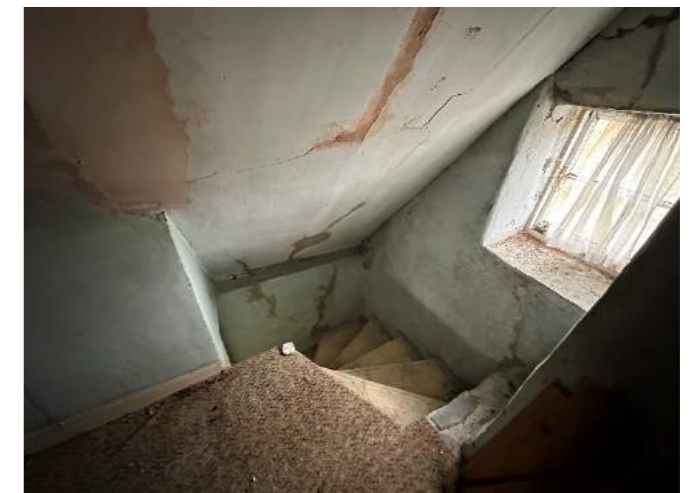
Fig 24. Existing attic stair/landing

The attic stair is a tight winder with very limited headroom (Figure 24). While it is recognised that little could be done to improve this, the addition of a guarding at the top and a handrail will make the stair much safer to use on a daily basis once the attic rooms are in use — especially since the single bedroom could be used by a child or an elderly occupant.

A new timber stud and plasterboard partition will be installed at the top of the attic stair to form a landing (Figure 24). The door from the foot of the stair will be reinstated to the bedroom.

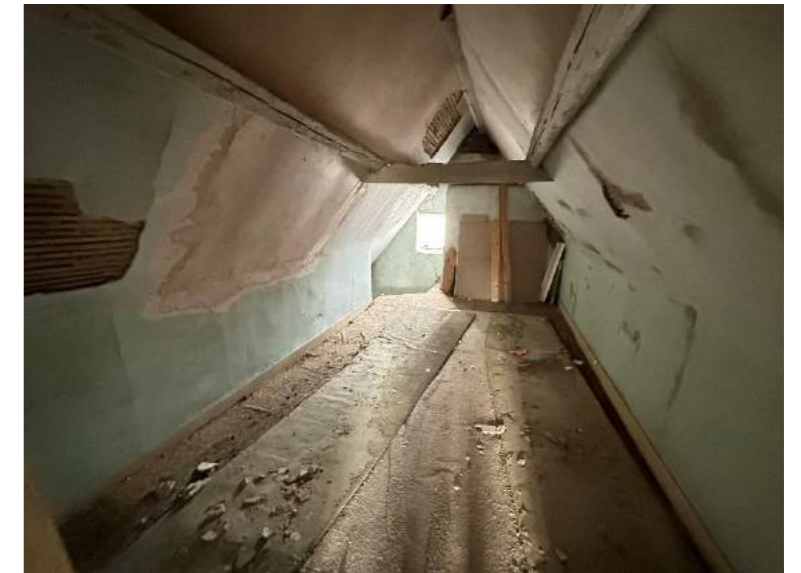
Fig 25. Existing attic room - to be bedroom

6.13 New partition to be installed to dressing area (Figure 25).

6.15 New conservation rooflights to be installed (Figure 25).

These will provide essential natural light and ventilation to the bedroom, which will not have any windows following the formation of the stair landing. Even if the landing were not formed the existing window over the stair is not sufficient in size to provide the necessary level of light and ventilation for the room.

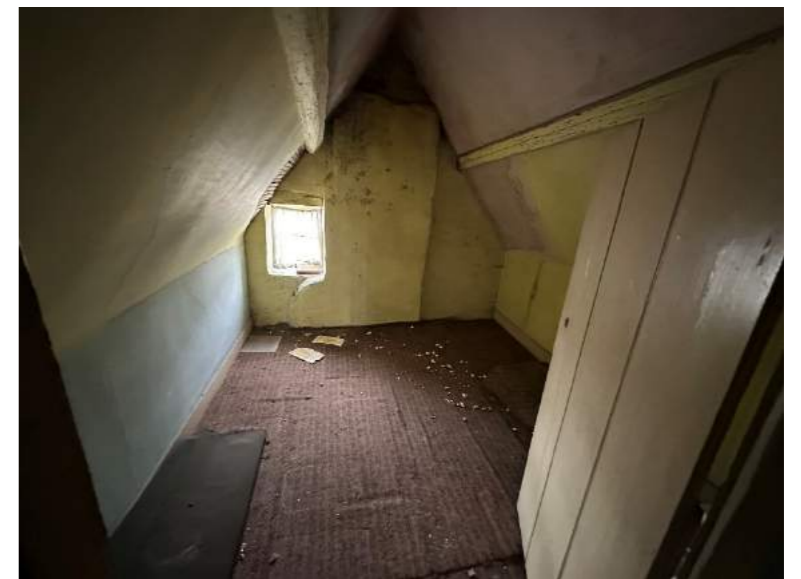
Fig 26. Existing attic room - to be converted into ensuite

6.14 Ensuite bathroom installed (Figure 26)

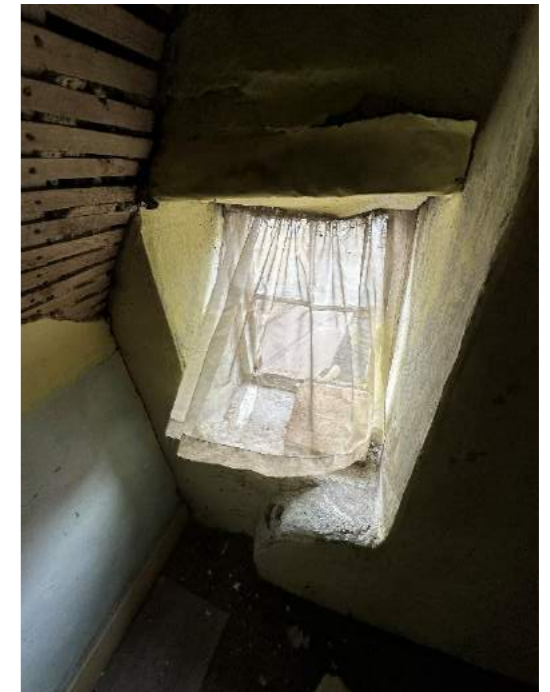
Fig 27. Existing attic room window condition

Many of the existing windows are in poor condition (Figure 27). Where possible these will be repaired, but in some instances it will be necessary to replace either the casement, or in the worst case scenario the entire window/door (for example at second floor the lower casement is actually missing).

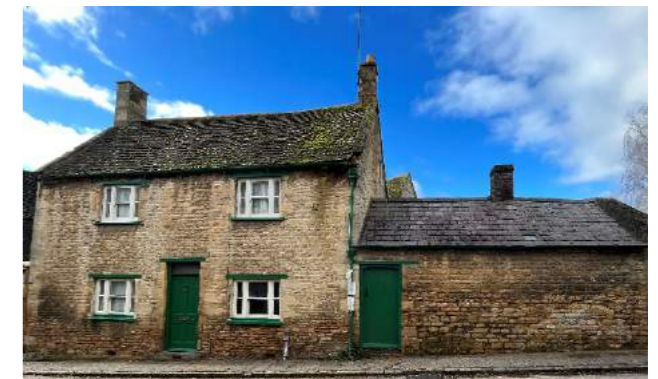
Fig 28. Existing green joinery

The lintels and cill will be changed in colour from the present green (Figure 28) to a dark grey colour to match No4 Park Street opposite (Figure 29). This is considered in keeping with the conservation area at that location, so overall impact is **low**.

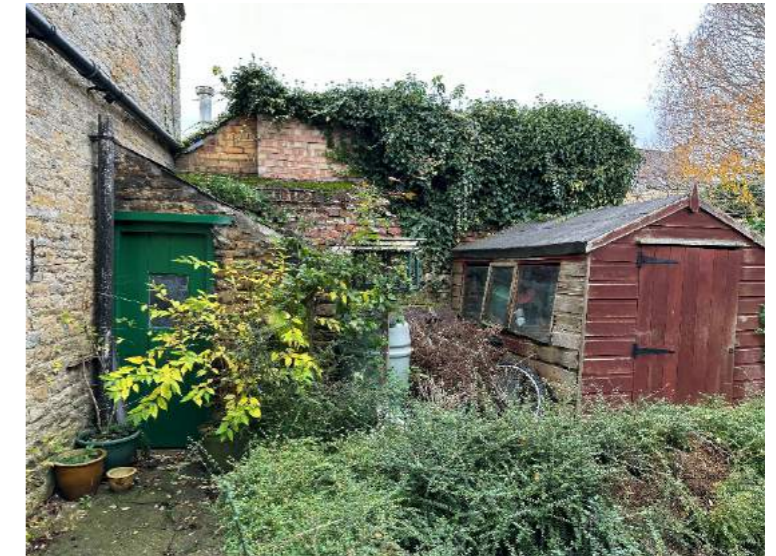
Fig 30. Existing outhouse and timber shed.

6.27 Re-purposing of WC outhouse (Figure 30)

The WC will be removed and essential repairs/making good carried out. The structure will be retained as an external store.

6.29 Replacement timber garden room (Figure 30)

This will replace the existing dilapidated timber shed, and will occupy the same footprint and be of a similar height. Details of the proposed replacement have been provided. While this is more contemporary in nature, it is a small lightweight timber structure that would be removeable and clearly subservient to the historic asset, and is therefore considered to have **negligible** impact.
