## Ground Floor Plan Window & Door Replacement Schedule

Rev.	Description	Author	Date
CLIENT Carol & Steve Whitehead			
PROJECT Pond Cottage, The Green, Wingrave, Bucks HP22 4PD			
TITLE Window and Door Schedule			RCAD no. 144.LBC.004
SCALE 1:50	STAGE PL	AUTHOR RC	DATE 01.01.2022
			SHEET SIZE A2

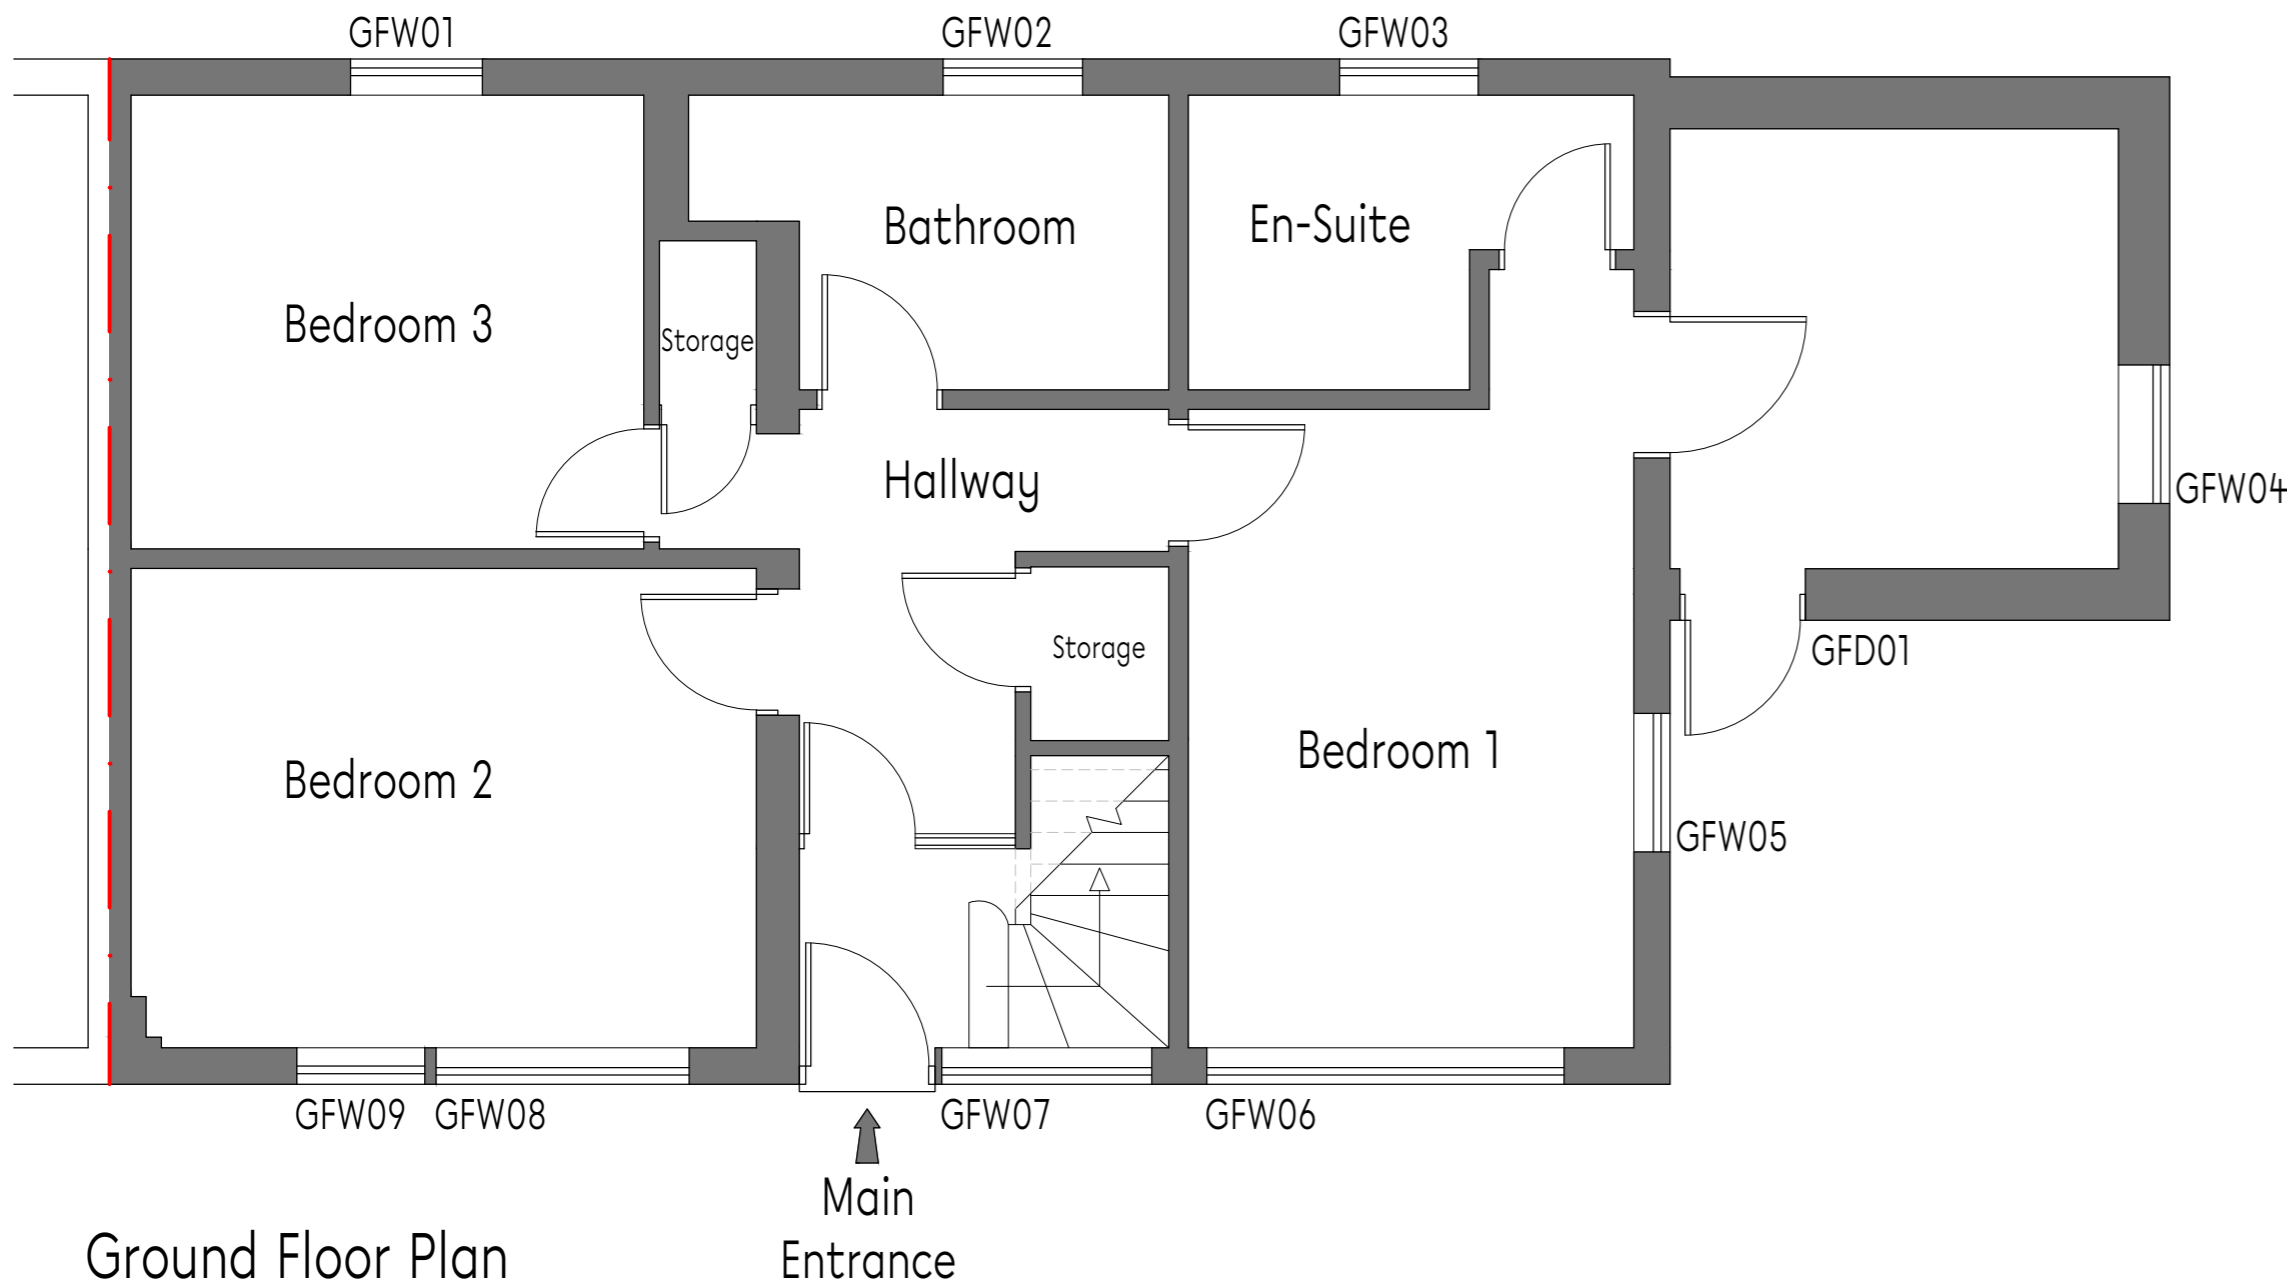
Window	History	Existing Design	Condition & Defects	Proposed Design	Int Cill Height	Width	Height
GFW01	Opening created and window installed in 1990	Multi-pane flush casement double glazed white painted timber windows with top opening panel	Rotting timber frame and failed glazing panels	To match existing	1060mm	870mm	800mm
GFW02	Opening created and window installed in 1990	Multi-pane double glazed sash white painted timber windows with top opening panel	Window no longer opens, rotting timber frame and failed glazing panels	To match existing	510mm	915mm	1370mm
GFW03	Opening created and window installed in 1990	Multi-pane double glazed sash white painted timber windows with top opening panel	Window no longer opens, rotting timber frame and failed glazing panels	To match existing	510mm	915mm	1370mm
GFW04	Installed when extension was built in 1999	Multi-pane flush casement double glazed white painted timber windows with top opening panel	Rotting timber frame and failed glazing panels	To match existing	600mm	915mm	1280mm

GFW05	Opening created and window installed in 1990	Multi-pane flush casement double glazed white painted timber windows with top opening panel	Rotting timber frame and failed glazing panels	To match existing	600mm	915mm	1285mm
GFW06	Originally a barn door, opening was converted into a window in 1990	Multi-pane flush casement double glazed white painted timber windows with top opening panel	Rotting timber frame and failed glazing panels	To match existing	430mm	2360mm	1590mm
GFW07	Originally a barn door, opening was converted into a window and door in 1990	Multi-pane flush casement double glazed white painted timber windows with top opening panel	Rotting timber frame and failed glazing panels	To match existing	430mm	1390mm	1590mm
GFW08	Originally a timber sash window, replaced with new window in 1990	Multi-pane flush casement double glazed white painted timber windows with top opening panel	Rotting timber frame and failed glazing panels	Timber sash window to reinstate this original building feature	325mm	1750mm	1690mm

GFW09	Originally a timber door which was converted into a full length window in 1990	Multi-pane flush casement double glazed white painted timber windows with top opening panel	Rotting timber frame and failed glazing panels	To match existing	0mm	845mm	2070mm
GFD01	Installed when extension was built in 1999	Multi-pane white painted timber door	Rotting timber frame and failed glazing panels	To match existing	0mm	850mm	2100mm
FFW01	Opening created and window installed in 1990	Multi-pane double glazed sash white painted timber windows with top opening panel	Window no longer opens, rotting timber frame and failed glazing panels	To match existing	310mm	1060mm	1460mm
FFW02	Opening created and window installed in 1990	Multi-pane double glazed sash white painted timber windows with top opening panel	Window no longer opens, rotting timber frame and failed glazing panels	To match existing	540mm	915mm	1230mm

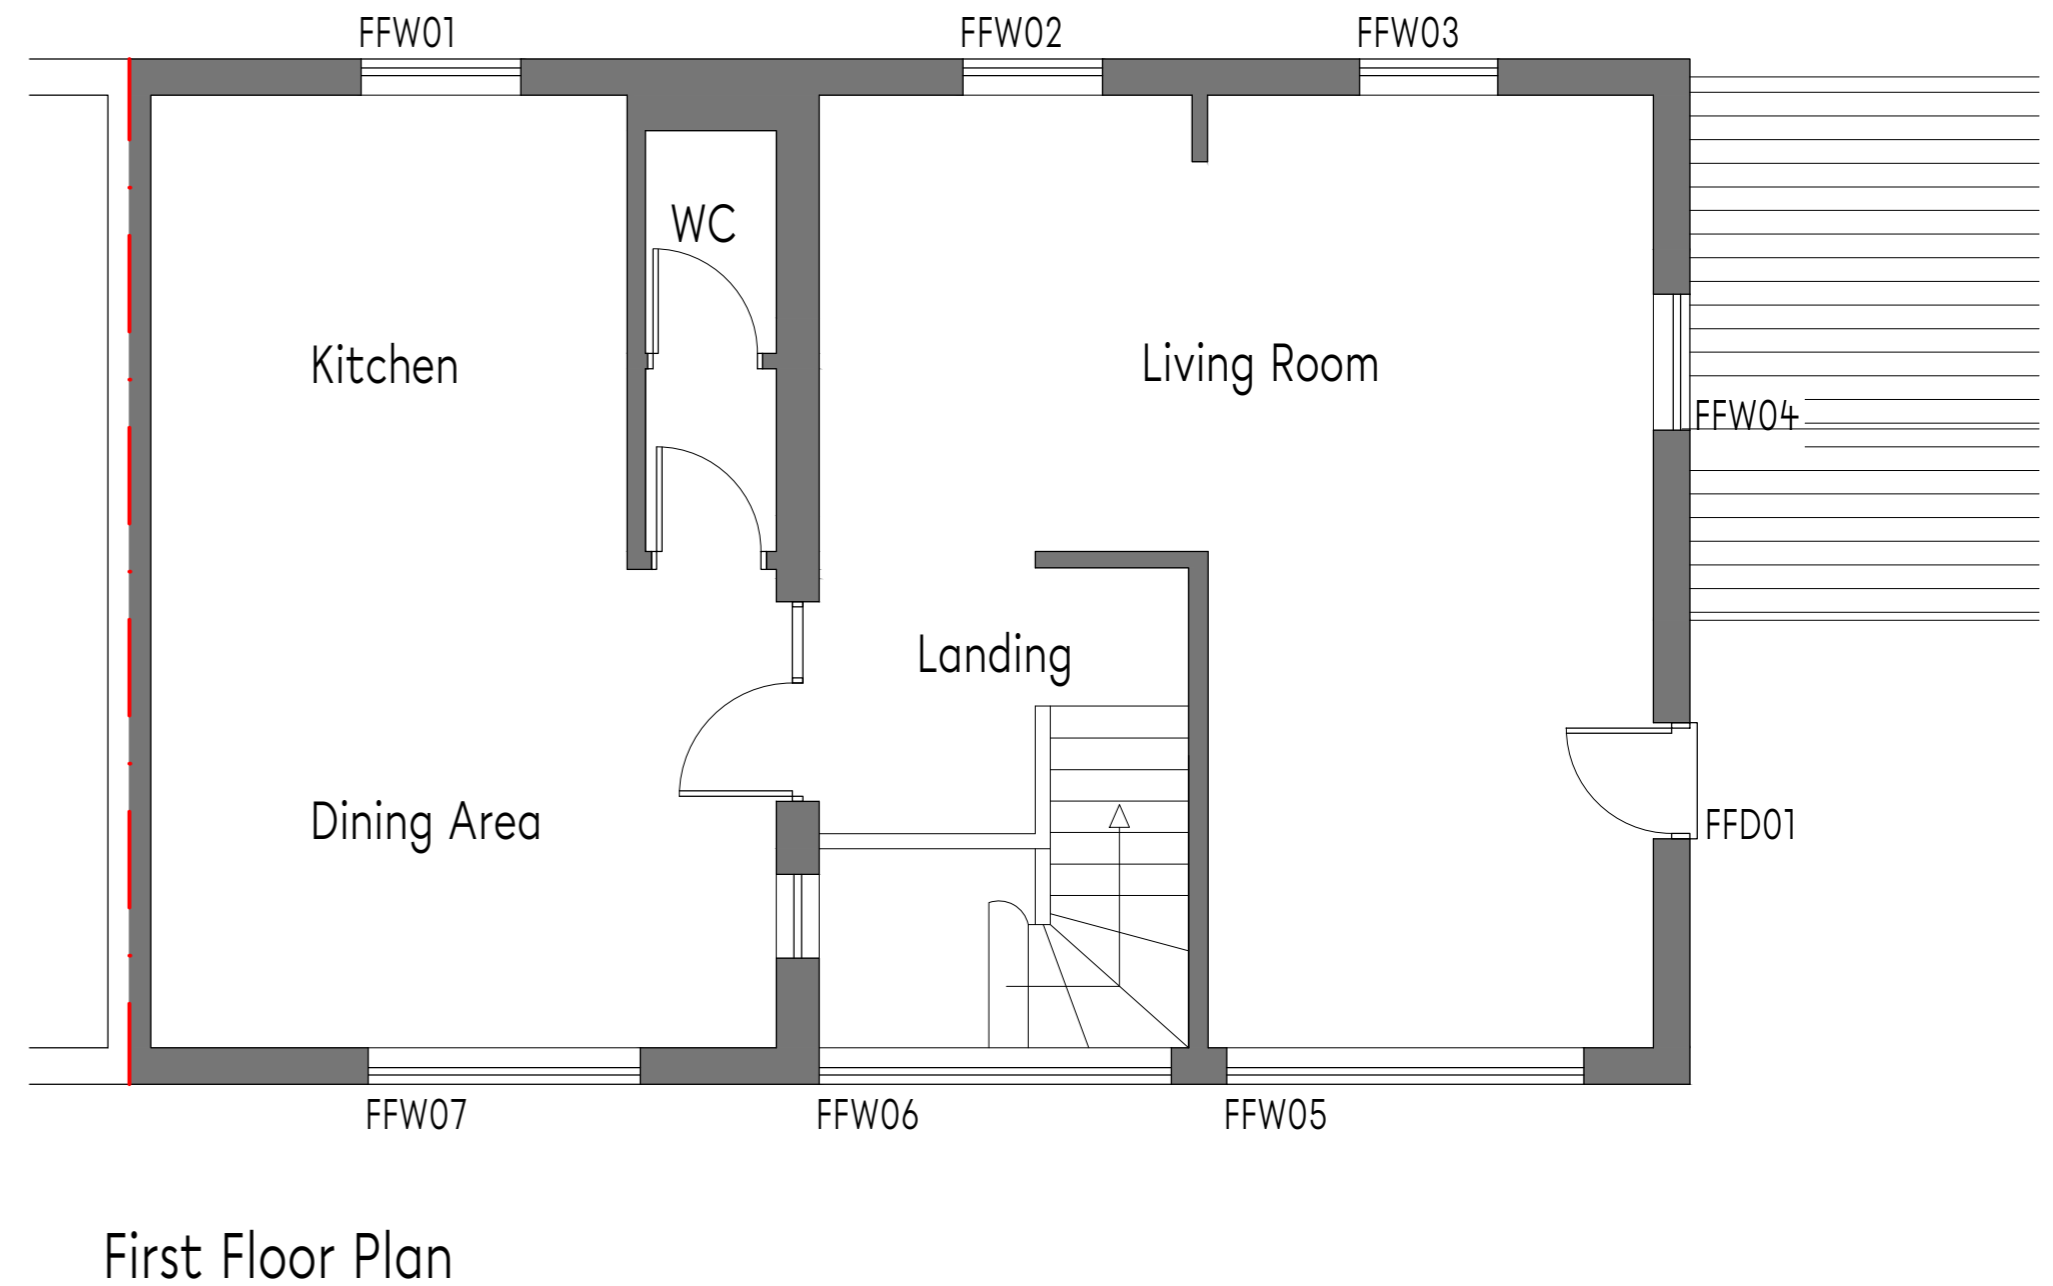
First Floor Plan

FFW03	Opening created and window installed in 1990	Multi-pane double glazed sash white painted timber windows with top opening panel	Window no longer opens, rotting timber frame and failed glazing panels	To match existing	540mm	915mm	1190mm
FFW04	Installed in 1999 as part of the extension. Originally a doorway.	Multi-pane double glazed sash white painted timber windows with top opening panel	Window no longer opens, rotting timber frame and failed glazing panels	To match existing	1430mm	900mm	300mm
FFW05	Opening created and window installed in 1990	Multi-pane flush casement double glazed white painted timber windows with top opening panel	Rotting timber frame and failed glazing panels	To match existing	220mm	2360mm	1520mm
FFW06	Opening created and window installed in 1990	Multi-pane flush casement double glazed white painted timber windows with top opening panel	Rotting timber frame and failed glazing panels	To match existing	220mm	2330mm	1520mm

FFW07	Opening created and window installed in 1990	Multi-pane flush casement double glazed white painted timber windows with central opening	Rotting timber frame and failed glazing panels	To match existing	765mm	1800mm	980mm
FFD01	Door installed in 1999 as part of the extension.	Multi-pane white painted timber door	Rotting timber frame and failed glazing panels	To match existing	0mm	1860mm	930mm
