SCHEDULE OF CONDITION

91 High Street SELKIRK TD7 4BZ

Ref: ME57666

Date: 06 January 2021

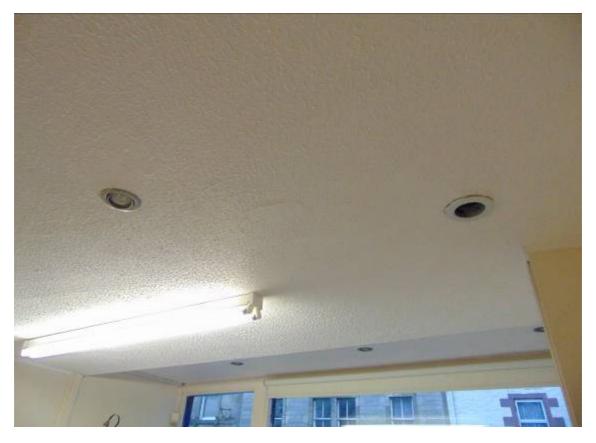
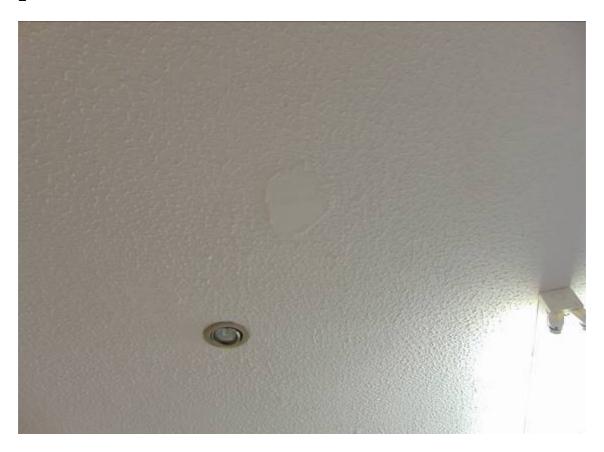
Ref	Element	Description	Condition	Photo
1.0	Internals			
	Front Shop/Reception			
1.1	Ceiling	Plasterboard ceiling with textured coating.	Generally in satisfactory condition. Some minor marks and scuffs with previous patch repairs.	1&2

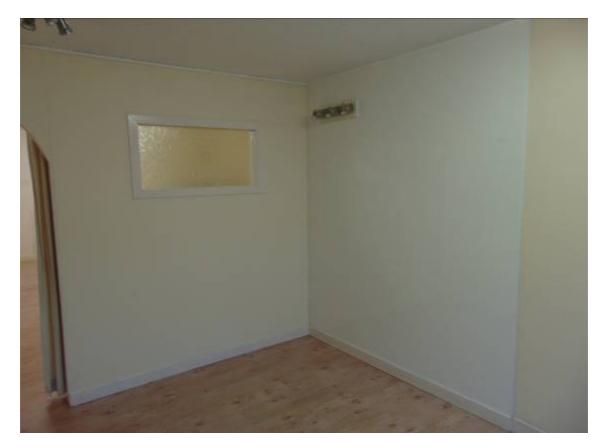
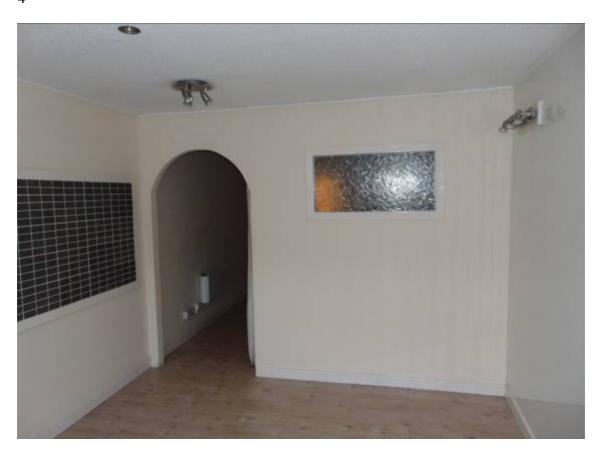
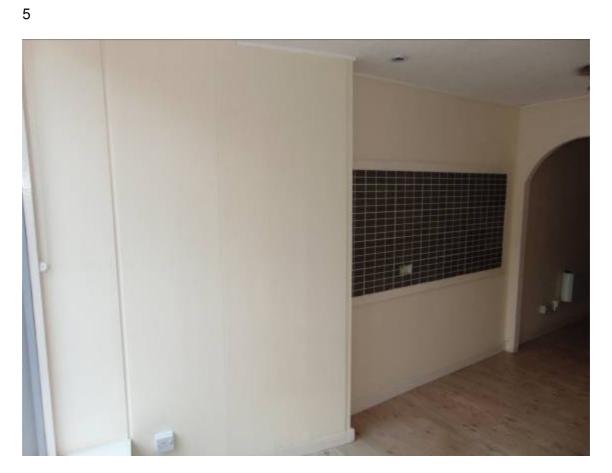
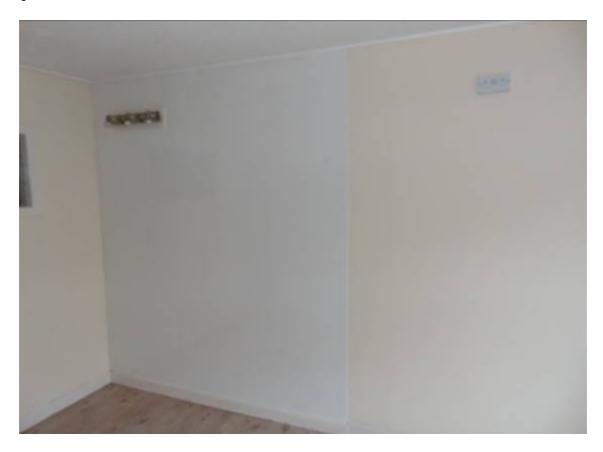
1.2	Walls	Mix of plasterboard lined with skim coat and paint finish and moisture resistant board.	The walls again are generally in satisfactory condition with some minor scuffs and marks.	3-6

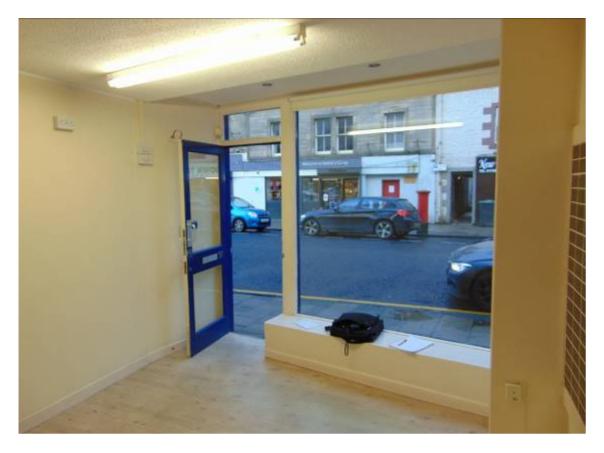
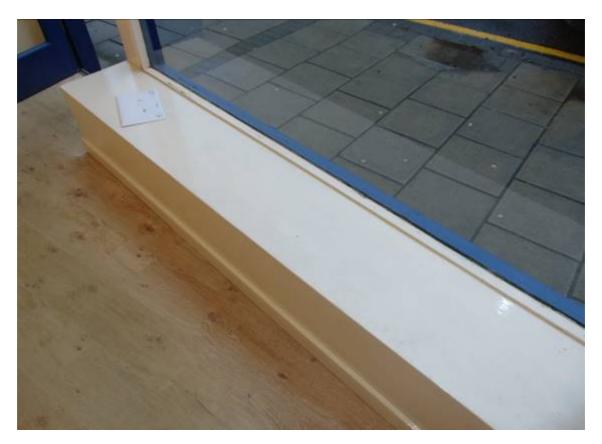
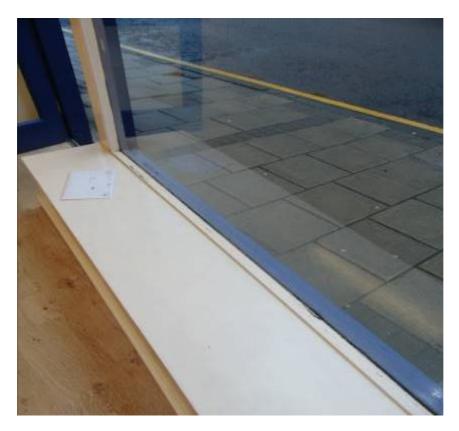
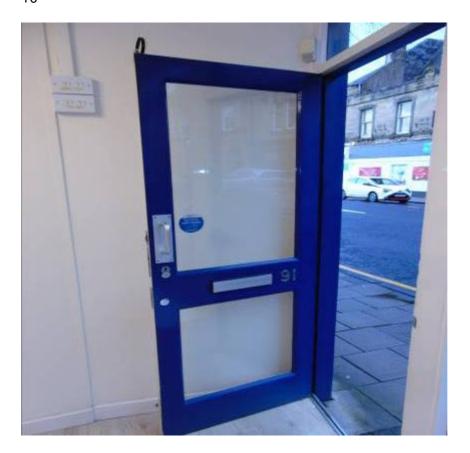
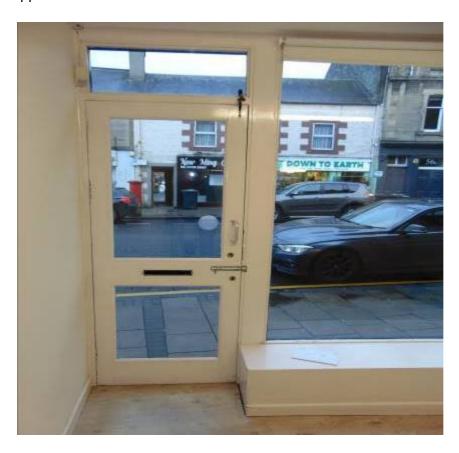
1.4	Doors & Windows	Timber framed, single glazed shop frontage incorporating a single door.	The door generally in satisfactory condition. Minor scuffs and marks to decoration. Draught cover missing from letter box.	7-11

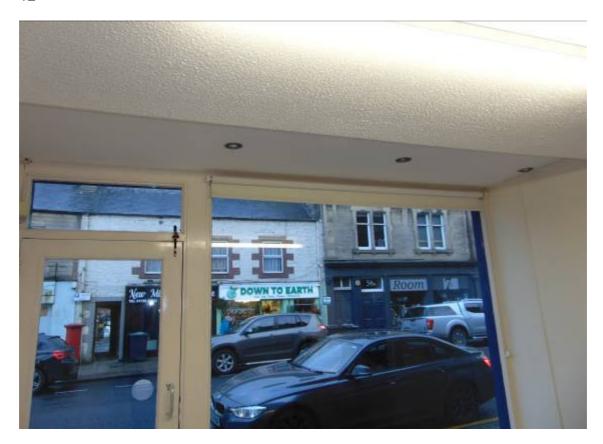
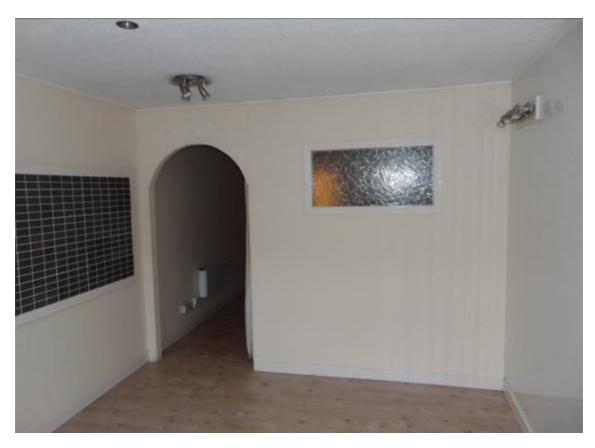
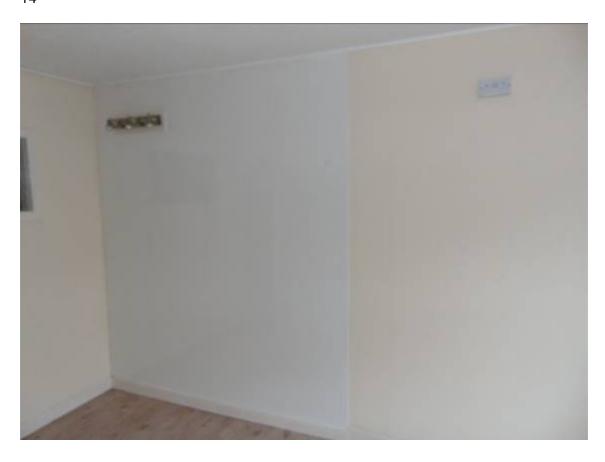
1.5	Joinery	Painted timber skirting boards, facings and architraves.	All joinery in satisfactory condition with minor scuffs and marks.	
1.6	Lighting	Wall mounted light fittings, spot lights and fluorescent strip lights.	Lighting in fair condition with some defective and missing bulbs. Some lights were not operational at the time of inspection.	12-14

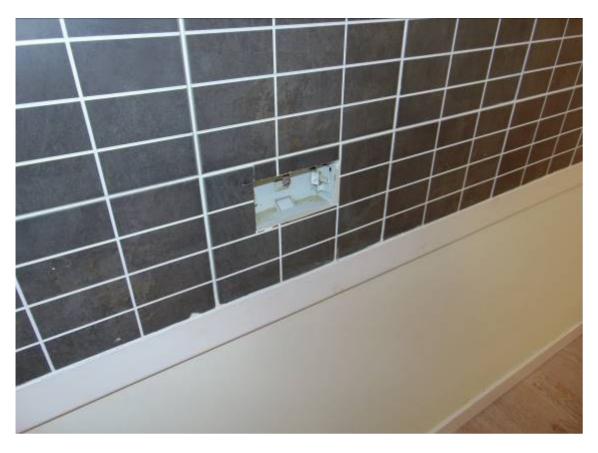
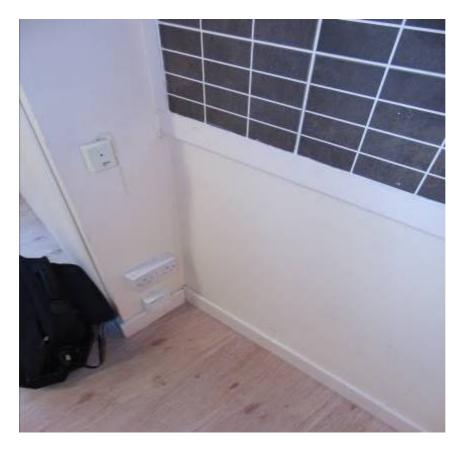
1.7	Electrical fittings	Surface mounted sockets, switches and trunking	Casings in satisfactory condition. Sockets not tested during inspection.	15 & 16

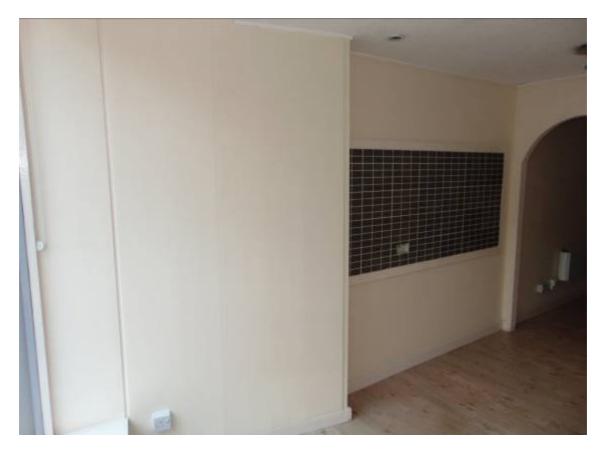
1.8	Fixtures and Fittings	Wall mounted timber frame with tiled insert.	Previous tenants fixture remains.	17
2.0	Back Shop Area			
2.1	Ceiling	Plasterboard ceiling with textured coating.	Generally in satisfactory condition. Some minor marks and scuffs.	18-20

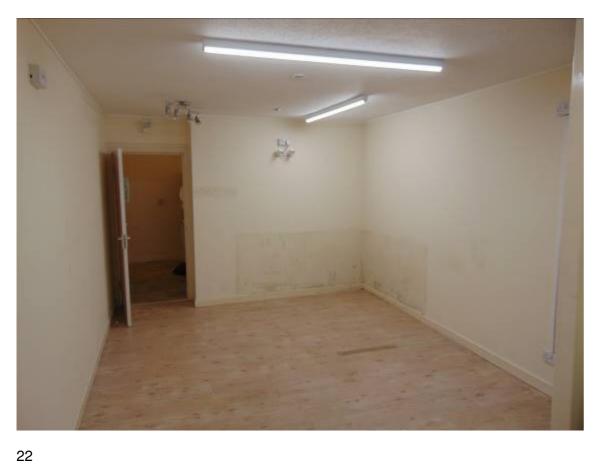
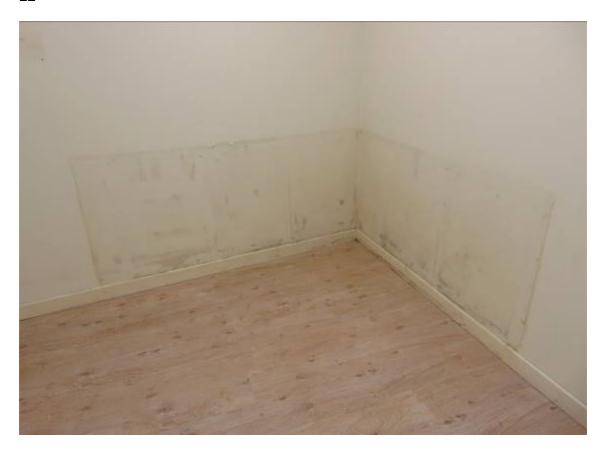
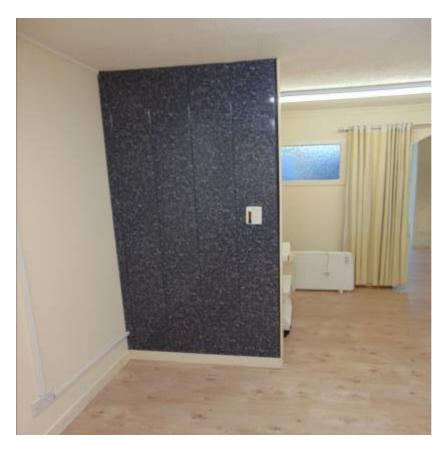
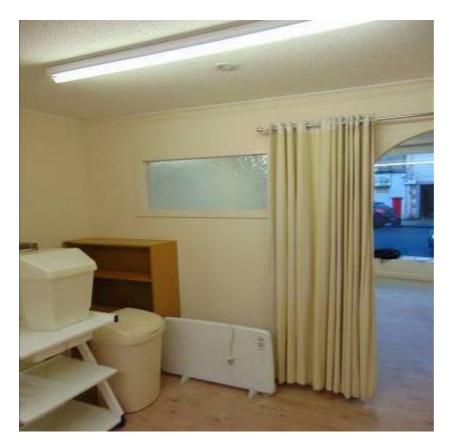
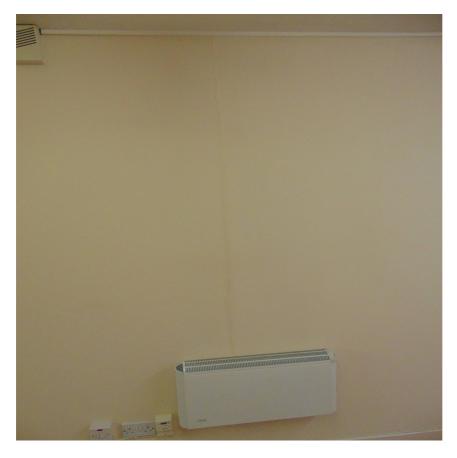
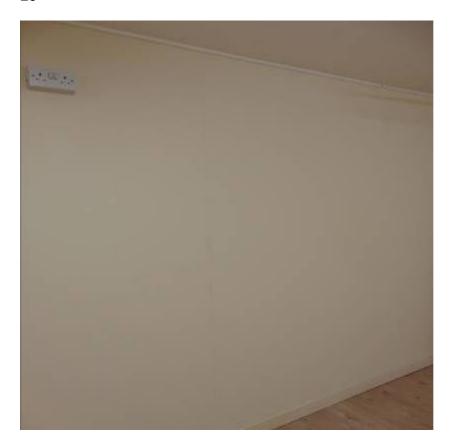
2.2	Walls	Studwork wall, plaster boarded and finished with a skim coat, lining paper and paint finish, plasterboard lined walls and partitions.	 Walls in fair condition with marks, scuffs, and some tearing of the lining paper. Redundant fixing holes and marks to wall where previous tenants fixtures and fittings have been removed. 	21-31

Ref	Element	Description	Condition	Photo
			 Damp staining and mould spores noted to the surface of the wall where the previous fixtures have been removed. Showerboard fixed to small partition divider.

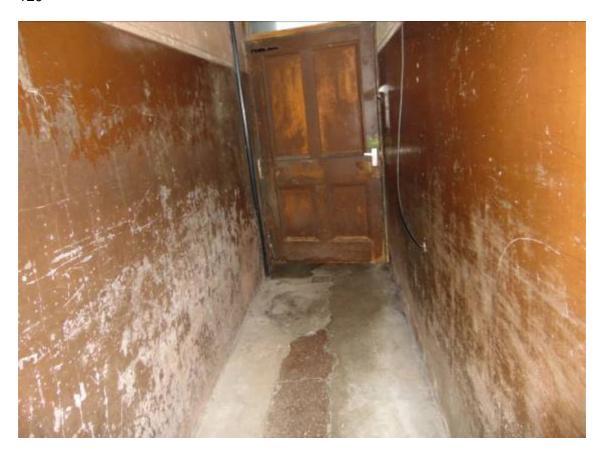
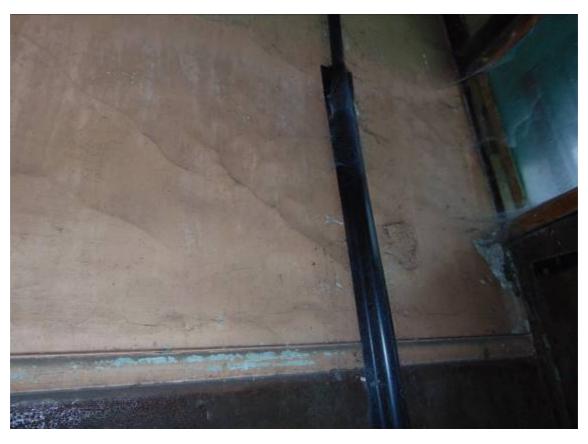
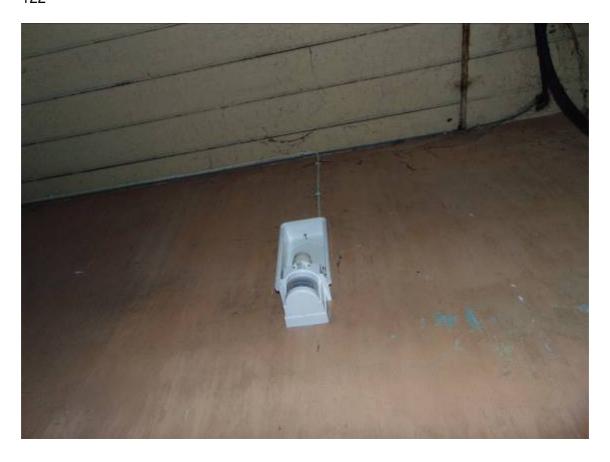
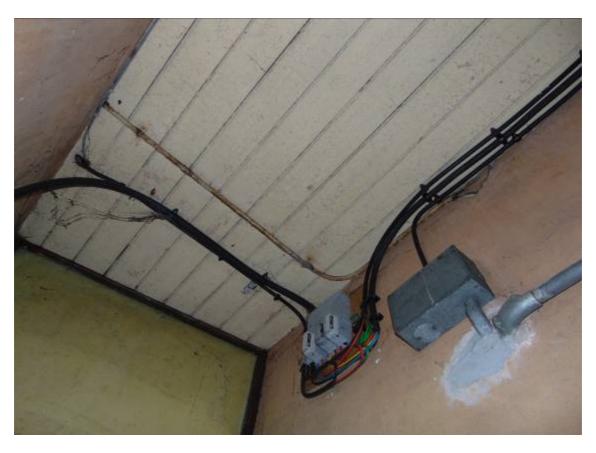
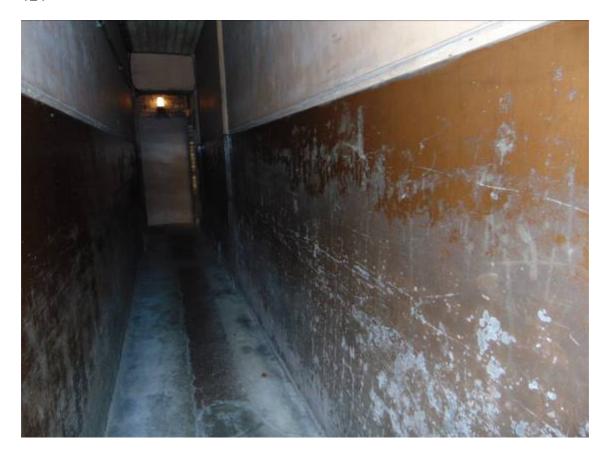
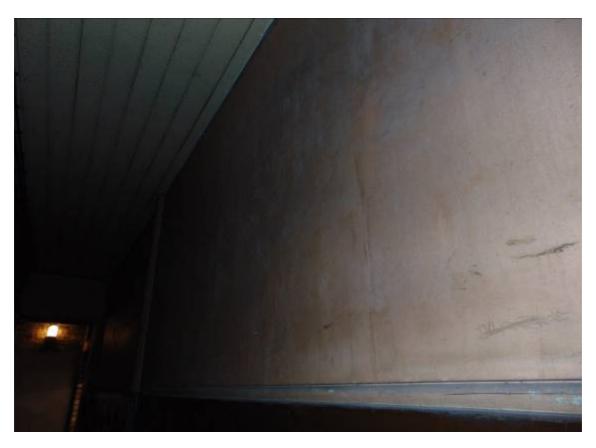
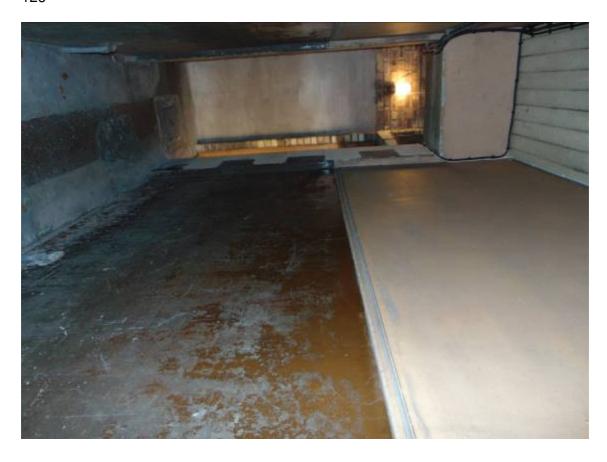
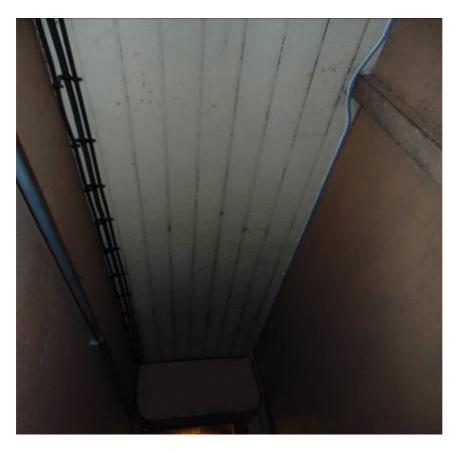
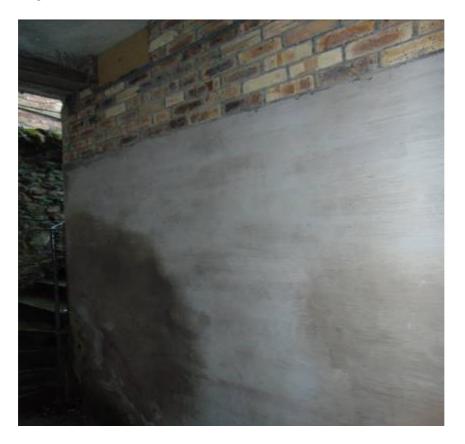
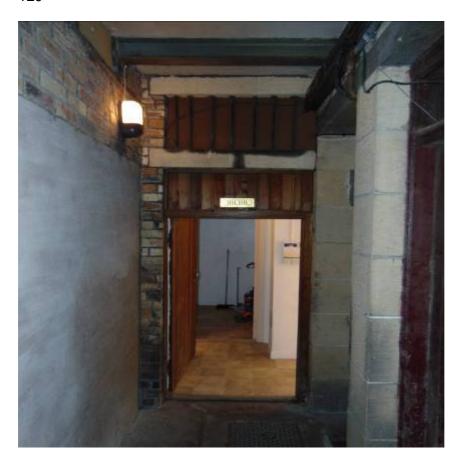
6.6	Communal Area/Walkway	Communal passageway to rear entrance.	Cracking and poor decoration noted to communal side passageway walls. Cracking and patch repairs noted to concrete floor. Joinery and door in poor decorative order. Missing light diffuser and lighting not operational at time of inspection.	117- 129
