Hubbard Conservation

Statement of Significance: **Crossways, Little Heath Lane, Potten End, Berkhamsted, HP4 2RY.**
September 2023

Introduction and methodology.

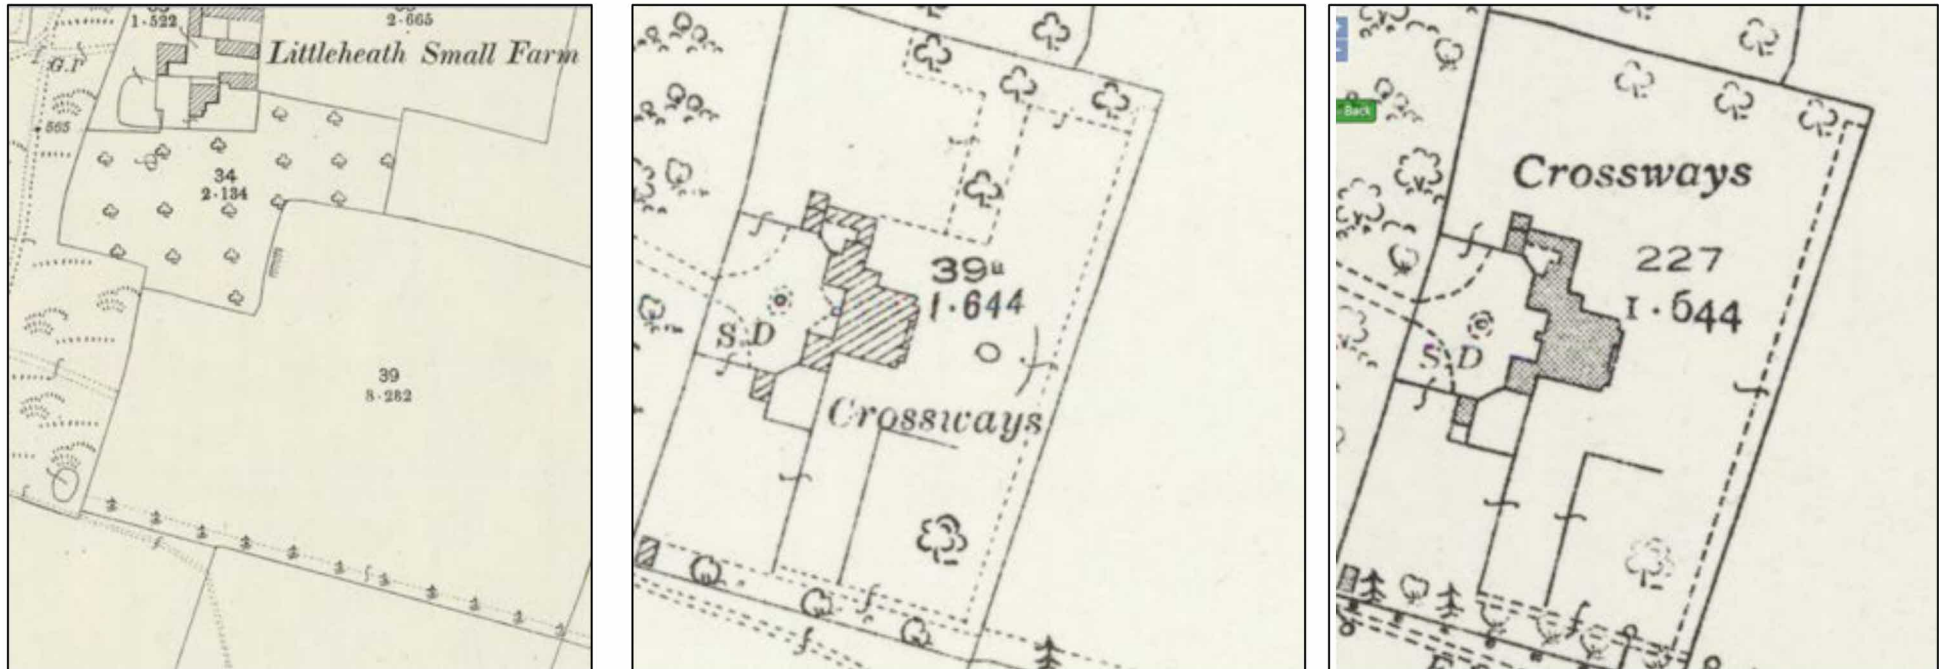
Figure 3: Historic maps showing the evolution of the plot/house of Crossways. Hertfordshire XXXII.6. OS maps 25"

Left to right: Revised 1897, published 1898 shows the plot (39) as vacant. Revised 1923, published 1925 shows Crossways occupying plot 39. Revised 1939 published 1943. Reproduced with the permission of the National Library of Scotland.

The 1839 tithe map shows much of the surrounding land of Little Heath in the ownership of the Countess of Bridgewater. Sometime after 1539 the Bridgewater family took ownership of several manors collating the land. The Ashridge Estate eventually purchased little Hitchen's meadow sometime after 1839. After which, in 1848, the Ashridge Estate passed to the Earls of Brownlow (part of the Egerton family). Adelbert Brownlow-Cust (1844-1921 – 3rd Earl Brownlow) issued instruction to sell the estate in his will. The estate was broken up, sold to various purchasers including the National Trust. Some portions were auctioned off in June 1924, including Crossways (Plot 39) (Fig. 3) as freehold, as Lot 48.

The plan (Plan No. 5 of the sales particulars dated 1924) appear to show Crossways as a single block with two small extensions to the east and west sides of the south elevation, without the outbuildings or flanking pavilions; this appears to be an incorrect depiction as the OS maps dated 1923-1925 shows the building layout pretty-much as it is today, as does the Indenture plan dated 6th October 1924 for the subsequent purchase. Lot 48's description concurs with this theory noting the outbuildings, even though they do not appear on the plan-form. Fig. 3 shows Plot 39 as vacant with a track (as existing) leading to the plot from Little Heath Lane c1897- 1898. By 1923 Crossways is constructed pretty-much in its existing plan-form (Fig. 3), and shows little in the way of obvious change to plan-form on the 1939 revised map (Fig. 3).

In the case of Crossways, the earliest map evidence dated 1925 (Fig. 3) provides some indication of the earlier garden layout, which is partially echoed in the existing garden. The maps appear to indicate several sections to the garden, of which the entrance (west), the southwest kitchen garden areas, and the southeast terraces remain readable. The east garden shows little detail on the maps, however there is a large curved yew-hedge and short circular equivalent existing. A horticulturalist might be able to establish if these are historic features, although the height is significant, preventing a through-view to the extended setting (Fig.8). Again, based on the map evidence, it appears that the northern garden area might have been subdivided partly towards the northeast corner. The ground drops away in this area, and is thought to have been a sunken-tennis court.

The 1923 OS map (Fig. 3) shows the house and its outbuildings largely in its present form. Plan 5 of the 1924 sale particulars show a much simpler plan. It is possible that this was extracted from early estate plan which shows the pavilions as absent, and two small extensions to the south at both the west and east ends. It is difficult to be certain as to the accuracy of this plan, but needless to say (and based on the accuracy of the OS maps), it would appear the pavilions and outbuildings were present by 1923. Also, the indenture plan of October 1924⁴ shows the plan form matching that of the OS map (Fig. 10). There is nothing in terms of fabric evidence to suggest Plan 5 was the primary structure.

The flat roofed area (Room G1) is visible from both the west and east, although the eastern wall is mostly obscured by a lean-to extension (Room G2). The historic maps (Fig 3) appear to suggest the western side of G1 might have been truncated sometime after 1939. It is worth noting that the flat roof construction lacks the sophistication of design afforded to the rest of the property, and appears to be 'squeezed-in' between the lean-to and the north pavilion (Fig. 15). The character and colour of the brickwork differs greatly on the east side (G1) when compared to the east wall of the outbuilding. The brick voussoirs above the east window appear to be the only example on site, again suggestive of an adaption (Fig. 15). The brickwork of the lean-to has more in common in terms of colour to that of G1, although the outbuildings and lean-to share the same Flemish bond.

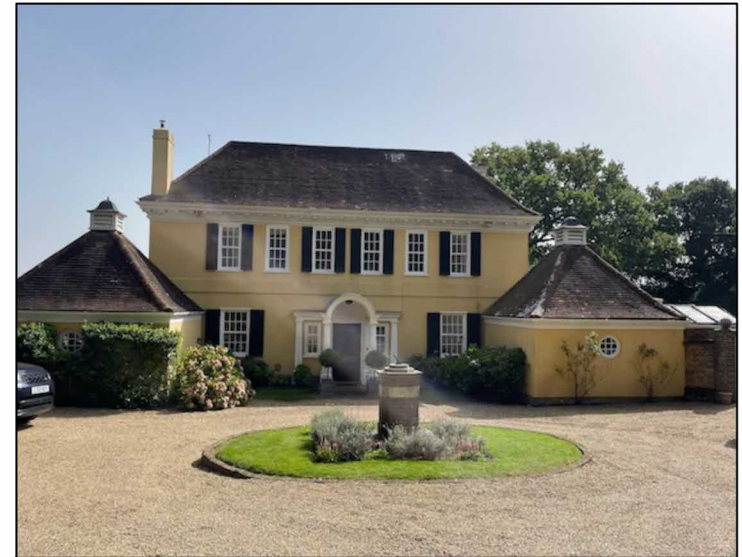
Figure 5: view of the dated sundial central to the forecourt © Hubbard Conservation.

Hard landscaping would reflect the Arts and Crafts philosophy of celebrating traditional crafts, presenting a link between the house and the garden wherever possible. In the case of Crossways the dated (1911) sundial, resting on a plinth of brick and stone, takes center stage in the forecourt. The circumference of the sundial is enhanced by the softened effect of the grass and soft planting and yet is defined by a low stone curb (Fig.5).

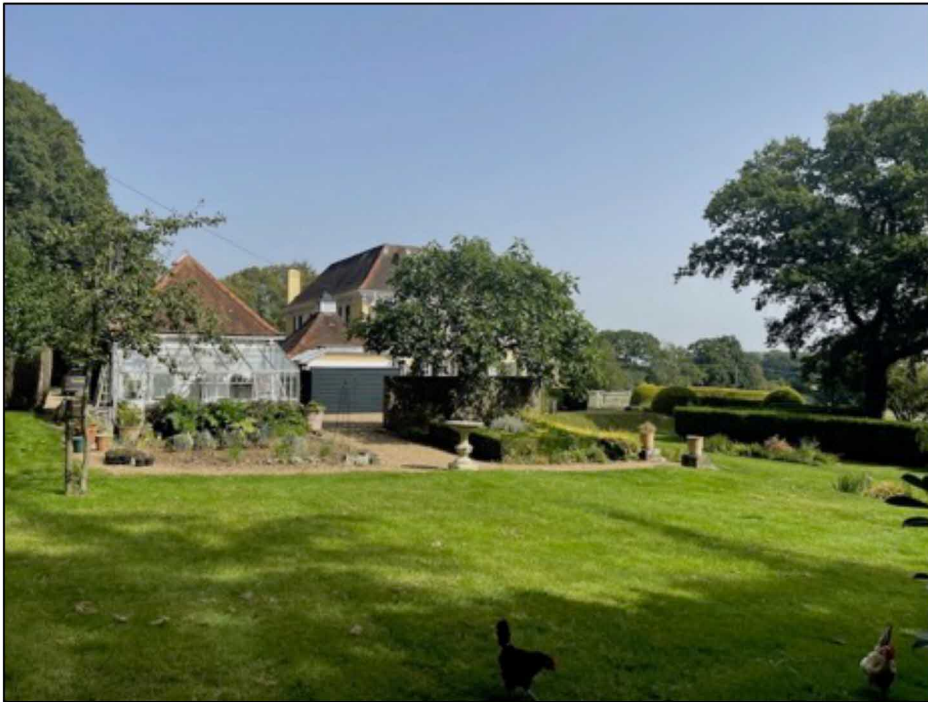
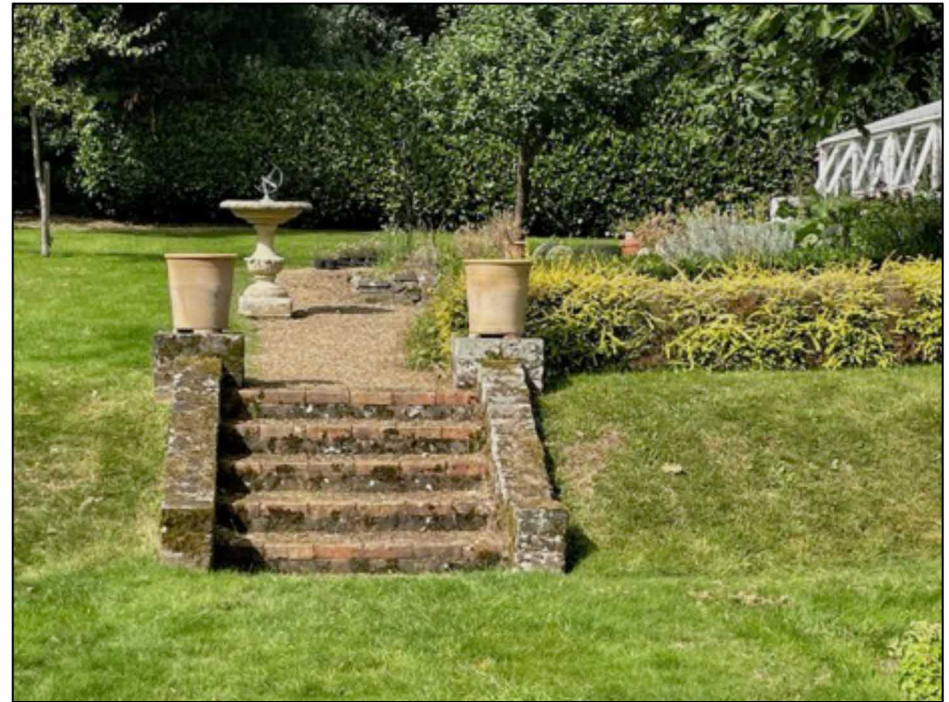
Figure 6: The left photograph shows the southwest corner of the garden, referred to in this report as the kitchen garden. The right photograph shows an example of the brick steps leading from the southwest terrace to the southern central terrace. Photographs © Hubbard Conservation.

The southwest corner of the garden presents as the kitchen garden, with a greenhouse and attached former stable, (although the suggestion of a kitchen garden is purely based on its location away from the house, next to the greenhouse). There is a small vegetable patch adjacent to the greenhouse; otherwise the area is laid to lawn, sloping down towards the next terrace. To the east of the greenhouse and former stable is a gravel area enclosed by a brick wall (Fig.12). There are some borders and box hedging adjacent to brick steps with stone strings and pillars (Fig. 6).

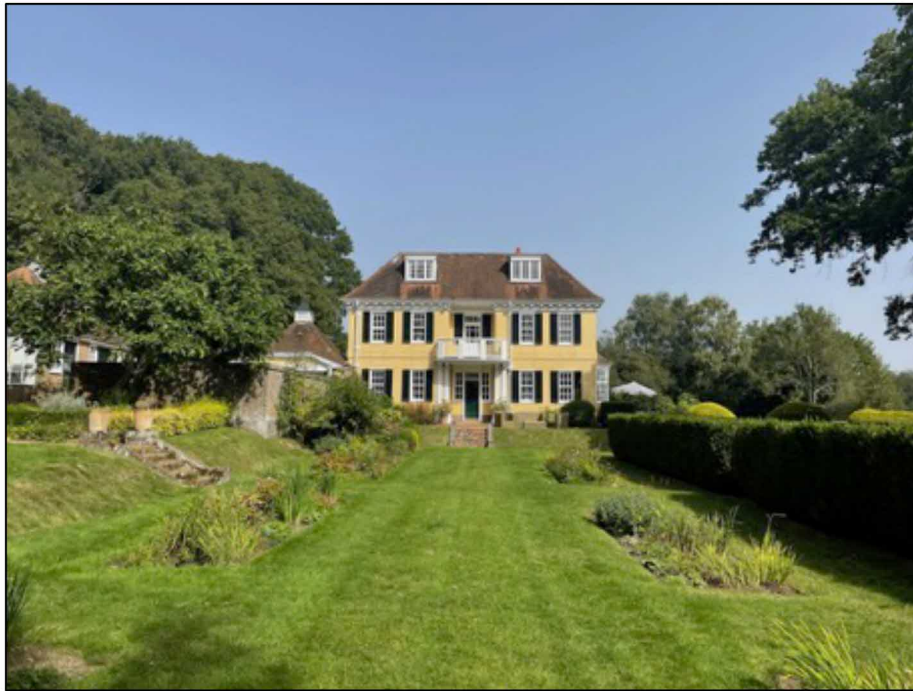
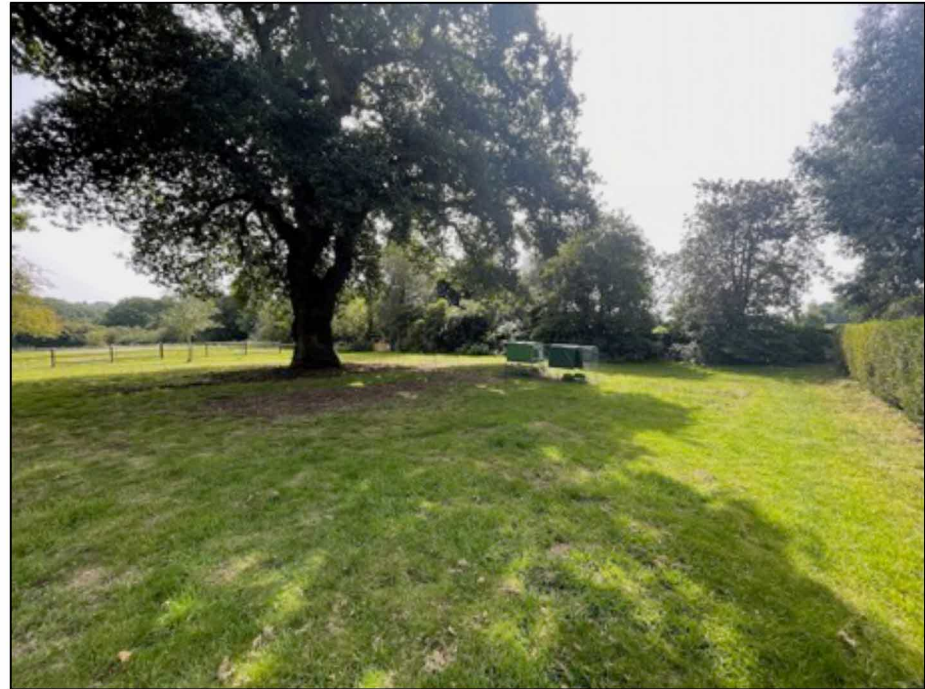
Figure 7: The left photograph shows the southern central section. The right photograph shows the south-eastern corner of the garden. Photographs © Hubbard Conservation.

The elevations of the house will be discussed later in the report, as they all appear to speak a different architectural language. The south and the east elevations appear to be designed as garden facing frontages. The southern central section of the garden echoes the grand south-facing elevation emphasizing its perfect symmetry. This section of garden is predominantly a lawned terrace with borders and steps, partitioned to its east by a box-hedge (Fig. 7). The southeast corner of the garden is predominantly lawn with a few established trees, offering unbroken views across the fields to the east (Fig. 7).

The southern elevation is the grandest garden elevation (Figs 14 & 7). Each floor has two 6/6 sash windows flanking central, recessed, doors to both floors. The ground floor door is flanked by 4/4 sash side window and resides below a 4-light oblong fanlight, all underneath moulded coving. Above, is a balcony (to accommodate the first floor door) with turned balusters carried on four consoles of four pilasters. The door is flanked by shutters and comprises a ½-glazed door with margin lights, underneath an oblong 4-light fanlight. There are two flat roofed dormer windows with 3-light timber casements.

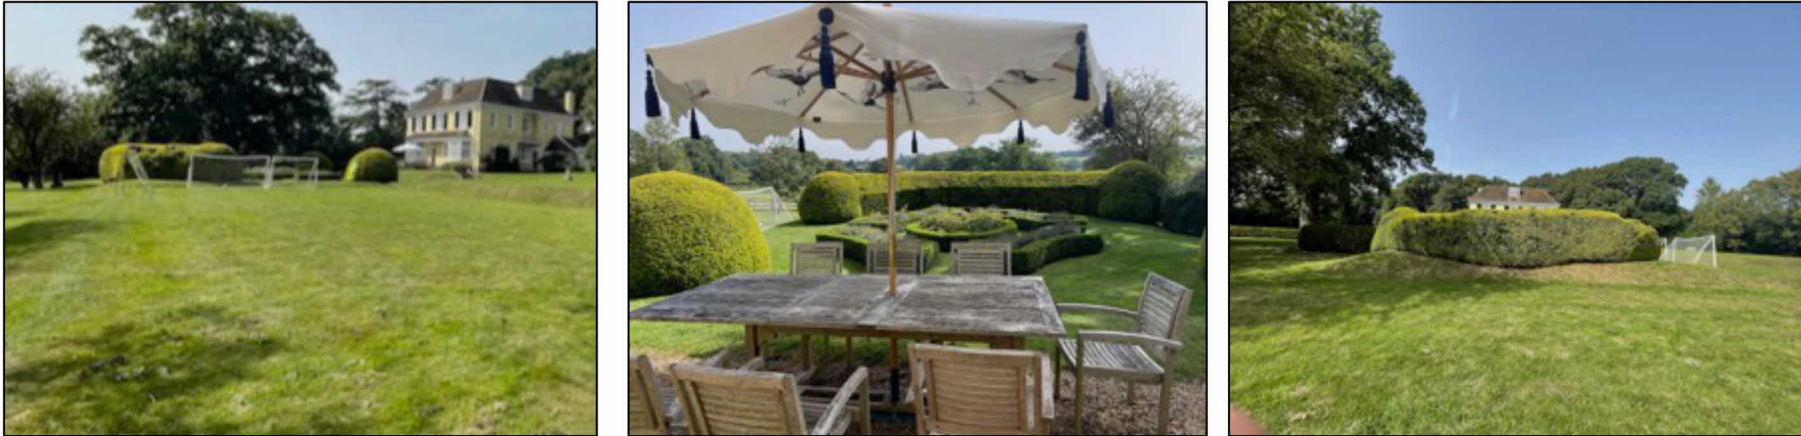
Figure 8: The left photograph shows the view (from the north) towards the east terrace in front of the eastern elevation. The central photograph shows the view towards the east from the house, and the right photograph shows the view west, towards the hedge. Photograph © Hubbard Conservation.

The southern elevation presents a sense of grandeur differing slightly from the eastern elevation. This presents the same symmetry at first floor, but the ground floor pentice and off center door presents a sense of country garden and domesticity. The gravel terrace continues from the south to the east, (although below the pentice; adjacent to the door, the path is laid as herring-bone brick), and provides two sets of steps leading east and north. As mentioned previously, it could be that some of the hedging (which dominates the east section of terrace/garden) could have been part of the earlier planting¹, although it would seem, (based on the restricted eastern view and the fact that the east steps lead to a side of a hedge and not towards a 'room'), that the hedging has taken over the garden somewhat or has altered the layout². Beyond the hedge the area drops to another lawned terrace.

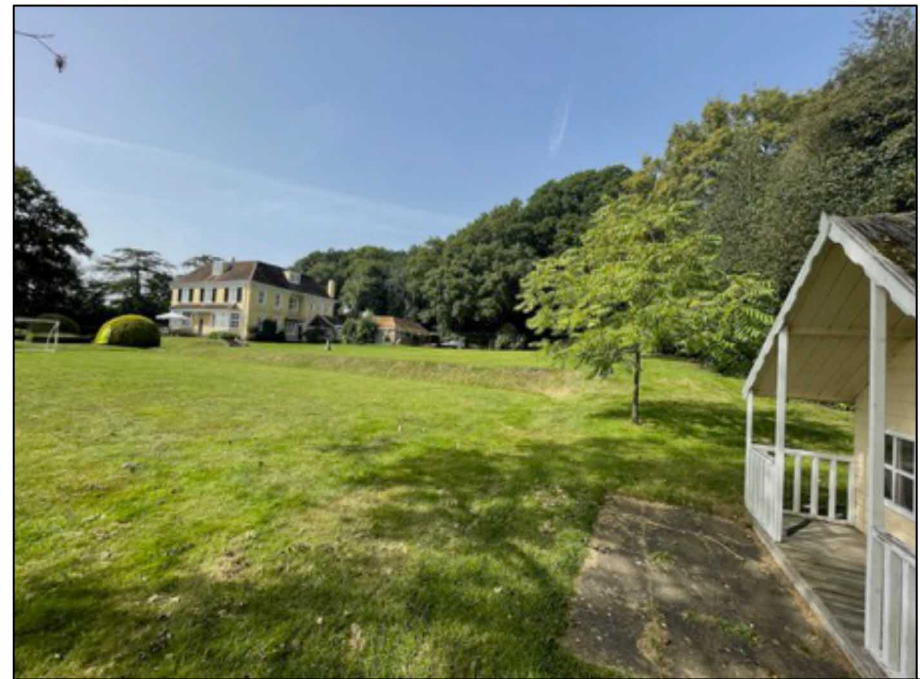
Figure 9: View from the northeastern corner of the garden of the northern section, with the sunken tennis court in the foreground. Photographs © Hubbard Conservation.

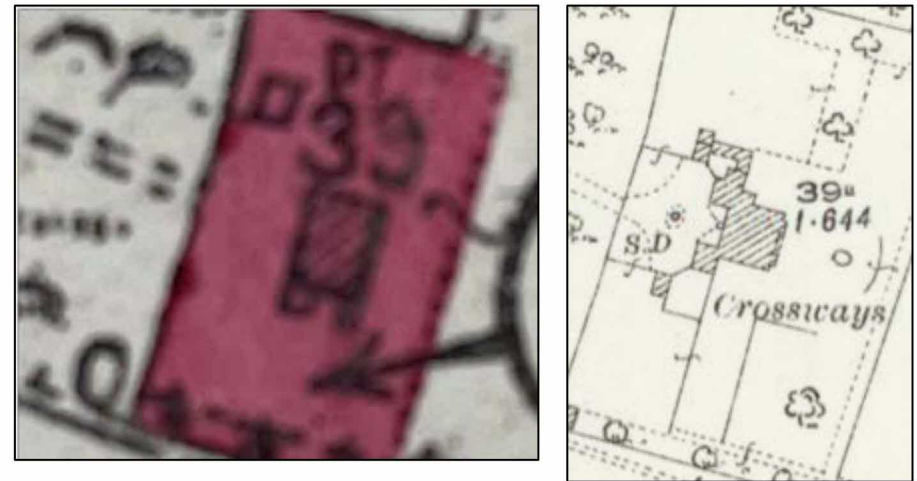
Figure 10: Left – Plan No. 5 sales particulars 1924. Right – 1923 OS map.

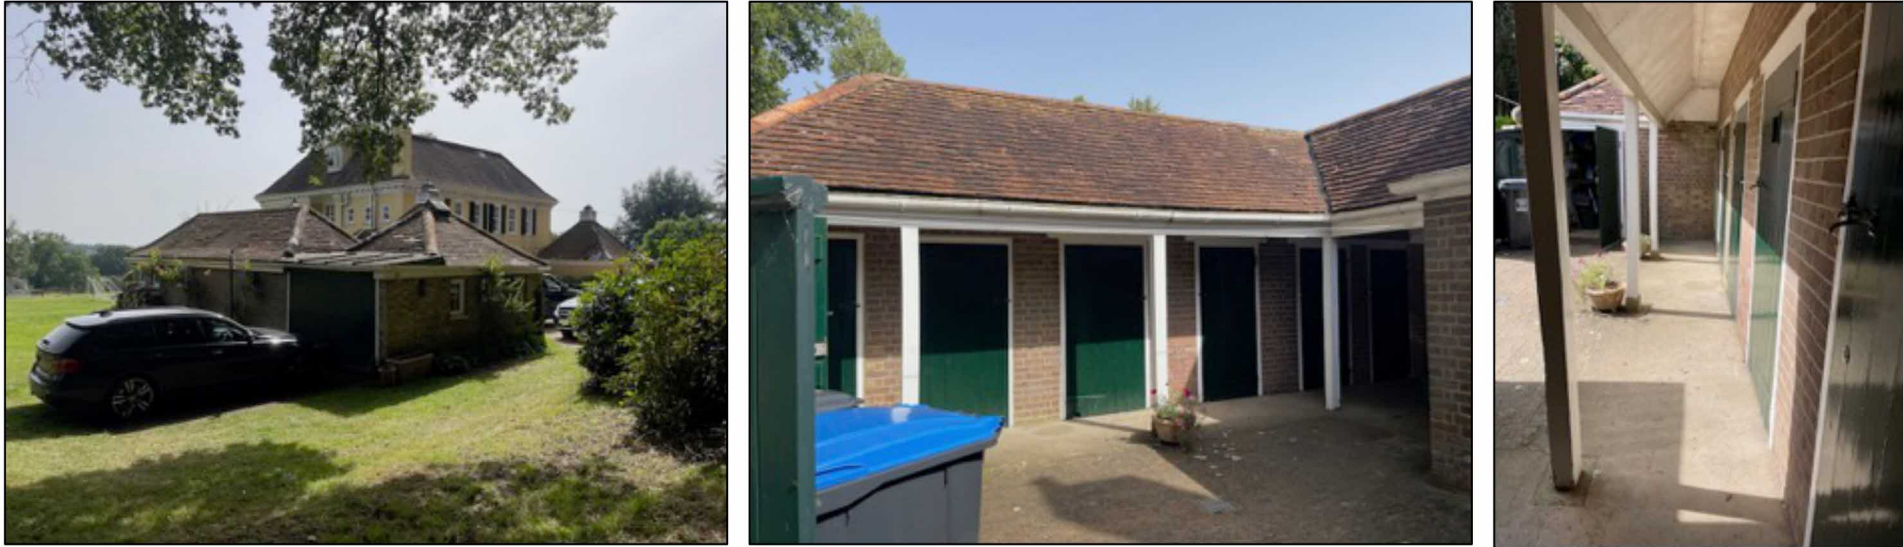
Figure 11: View of the northern courtyard of outbuildings, taken externally viewed from the west and internally viewed from the gate.
Photograph © Hubbard Conservation.

The northern gates provide access to a L-shaped range of ancillary outbuildings comprising a northern row of 6-sheds for domestic/ ancillary use for the kitchen wing and a garage at the western end. The courtyard is smaller than the southern version, comprising brick floor, with a cement path in front of the shed doors - underneath a full-length pentice. The sheds and garage are brick construction with a hipped clay-tiled roof and a lantern to the southeast hip. A flat-roofed area juts into the courtyard in the southeast corner, abutting the northeast corner of the north pavilion (room G1).

Each bay of the northern row of sheds have concrete floors, timber plank and battened/braced doors. All have slightly different features, which either reflect modern changes or earlier ancillary use. These changes include the internal dividing walls and ceiling treatments. There are three timber casement windows on the north elevation, and the former slot vents are blocked. The garage has a concrete floor, north-facing double timber garage

doors (located underneath a flat roof⁵), and three windows to the west elevation. Two comprise 4-paned timber casements, which flank a three-light casement. Pine timber vaulted hipped ceiling (Fig. 11).

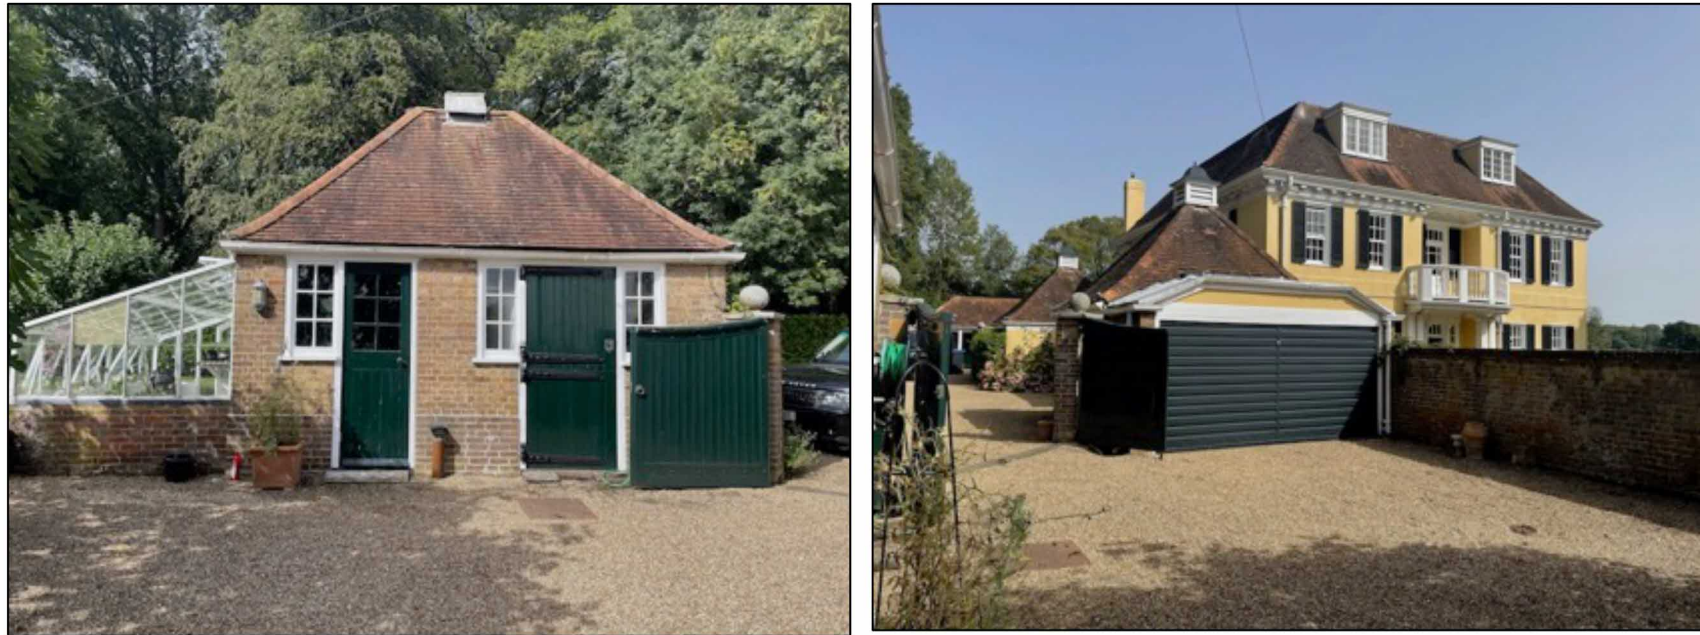
Figure 12: Southern courtyard. Stable/garden shed and greenhouse. View towards the modern garage extension off of the south elevation of the southern pavilion. Photograph © Hubbard Conservation.

The southern gates provide access to a larger gravel courtyard, roughly enclosed by an east and southeast section of brick wall, and a stable/garden room building to the west, which is attached to a greenhouse. The stable/garden room is a brick construction with a hipped clay tiled roof, and appears on the 1923 OS map. The 1939 OS map (Fig. 3) could indicate the presence of a greenhouse however the existing greenhouse is a later addition based on the change in plinth brickwork. The southern elevation of the south pavilion has been adapted to receive a roughly flat roofed modern garage, which is at

odds with the setting. The stable/garden room comprises two rooms (Fig. 12). The garden shed has a small corner fireplace and is boarded throughout with vertical pine boards, which also cover the vaulted ceiling. The floor comprises brick (likely engineering brick). The floor of the stable is concrete and there appears to be an echo of a gully. Timber wainscoting to all walls with exposed painted brick above. Engineering brick to threshold. Again, the stable doors have massive iron hinges.

The modern southern garage extension provides nothing in terms of preservation or enhancement, sitting uncomfortably within the courtyard; even more so when viewed to the side of the southern elevation of the main range (Fig. 12).

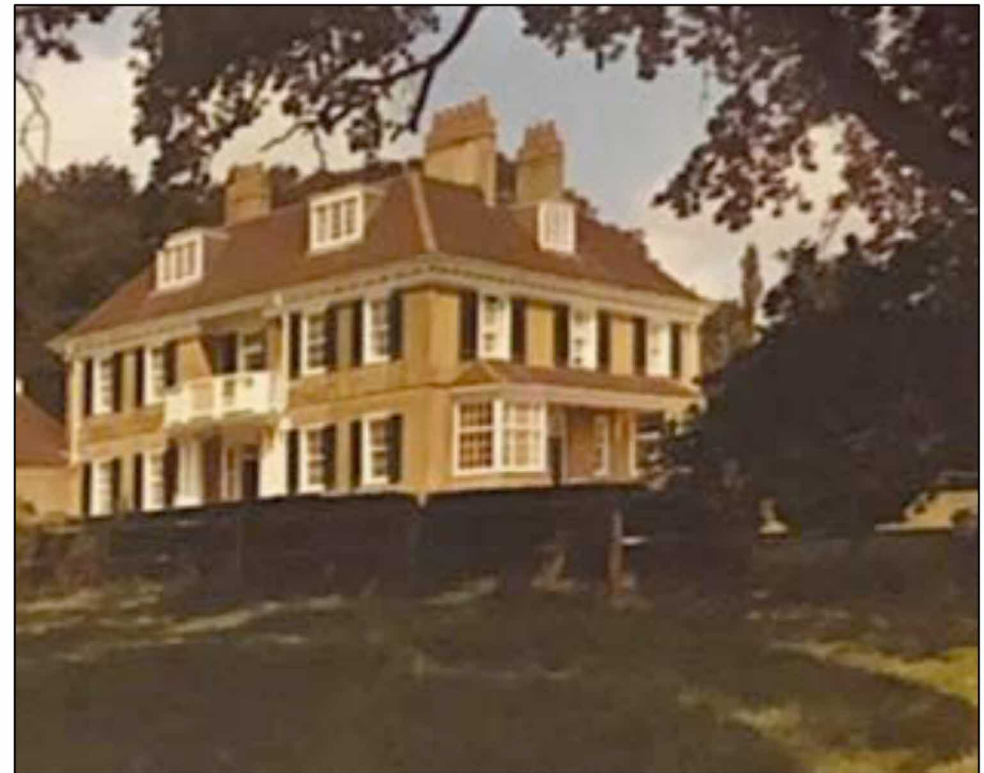
Figure 14: South and east elevation taken in the 1970s. Notice the vast chimneystacks, which were removed. Photograph © Hubbard Conservation.

The newspaper advertisement dated July 1st 1976 (Fig. 13) clearly shows four substantial chimneys, which no longer exist. Presumably these were removed between the late 1970s and 1987, as there is no mention of the chimneys in the 1987 listing. The historic photographs (Figs. 13 & 14) show multiple pots to each chimneystack; the northwest chimneystack is not visible. The size of the stacks and the quantity of pots would suggest that a fireplace heated each room prior to the secondary installation of central heating. This might have taken place sometime during the first half of the C20.

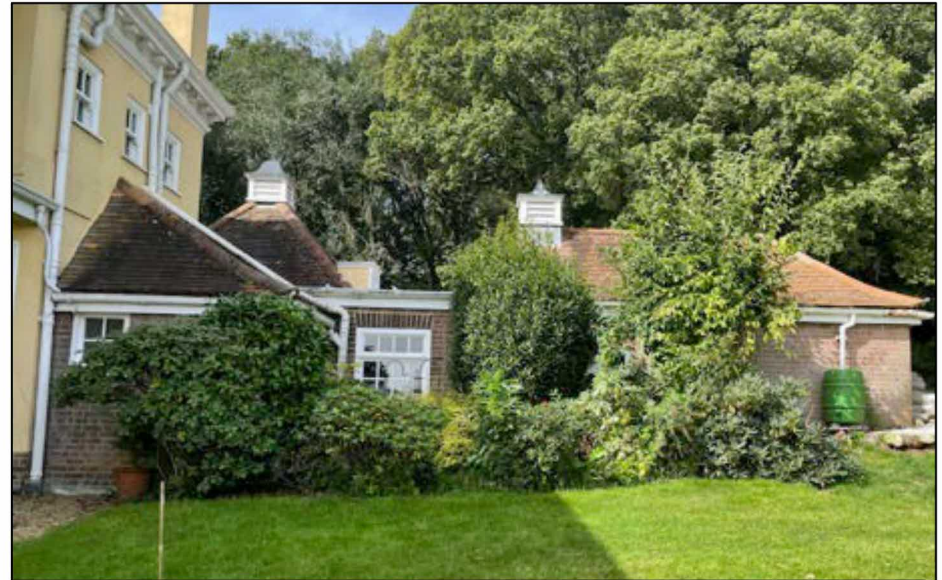
Figure 15: east side of the lean-to, flat roof extension (G1) and the outbuildings. Photograph © Hubbard Conservation.

The following will be discussed in the next section, but the detail is pertinent to this discussion: The flat roofed area (Room G1) traverses, and is visible from, the west and east sides. The historic maps (Fig 3) appear to suggest the western side, jutting into the courtyard, and might have been truncated sometime between 1939 - 1976. This flat roof construction lacks any sophistication and appears to be ‘squeezed-in’ between the lean-to and the north pavilion (Fig. 15).

It appears likely that rooms G3, G1, and the flat roofed part of G1 were remodeled after 1976 and amalgamated based on historic photographs. It is possible that this range might have been rebuilt, which might explain why the flat-roofed area sits so uncomfortably between the pavilion and the lean-to (Figs. 15 & 16).

With regard to the lean-to, it seems possible that this did not form part of the primary build, although it does appear by 1923. The roof extends west to meet the east pitch of the pavilion; again an uncomfortable arrangement as the roof bridges a natural gap between the northwest corner of the house and the pavilion, again suggesting a secondary addition or an after thought (Figs. 15 & 16).

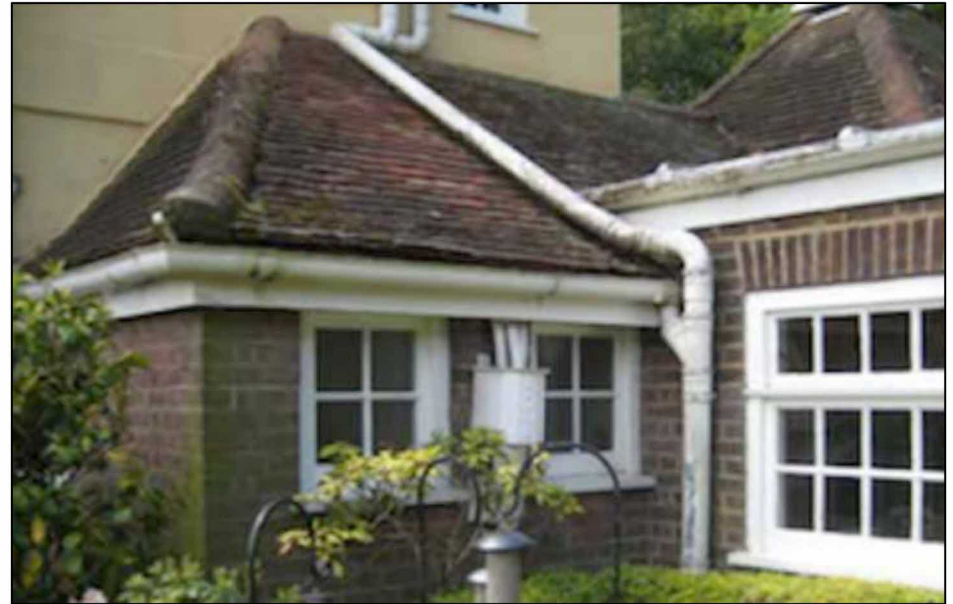
Figure 16: This photograph shows the uncomfortable nature in which the lean-to (G2) roof spans the roof of G1 to reach the northern pavilion roof. The way in which the entire roofs link is suggestive of a secondary, or evolutionary change.

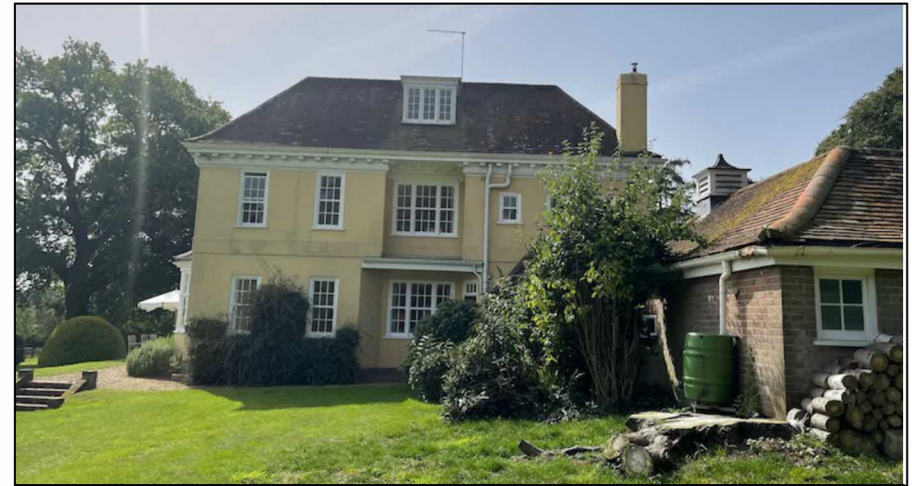
Figure 17: North elevation. Photograph © Hubbard Conservation.

The north elevation presents symmetry in plan-form, although the diminutive size of fenestrations to the western first floor windows reflects the fact that all of the service rooms (bathrooms and kitchen) are located specifically in the northwest corner of the property. To the eastern side at both ground and first floor level there are two 6/6 sash windows. The central bay is stepped back from the building line, again to both floors, the windows match comprising tripartite with a central 6/6 window flanked by 4/4. A flat canopy covers the ground floor window. To the west of this, the wall is oblique, housing a small door into G3 underneath a 3-light fanlight.

The remaining first floor windows comprise three small 2/2 sashes. There is a single, central, 3-light timber casement dormer window to the attic with a flat roof (Fig. 17).

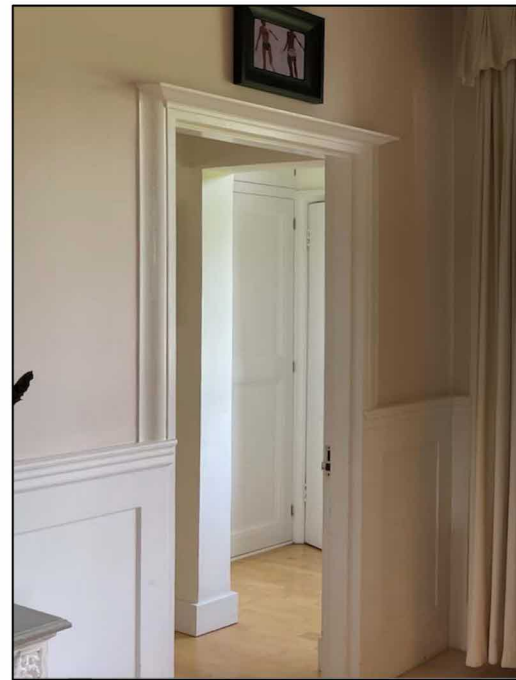
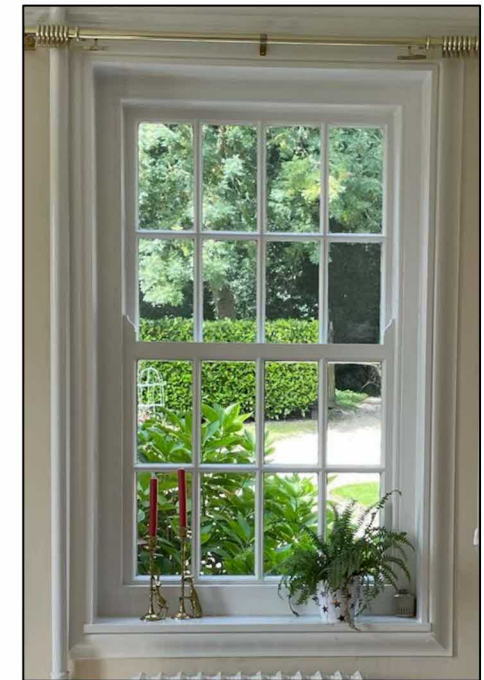
Figure 23: Left – simple Cyma-styled door architrave and projecting lintel of northwest door of G4 towards G2 & G3. Right – west facing window in G5 with the same window architrave. Photograph © Hubbard Conservation.

All of the door and window architraves have the same distinctive mouldings. These comprise a simple Cyma-styled moulding, which continues to the skirting boards also. Above each of the doors in G4 there is a projecting lintel emphasizing each door surround (Fig. 23).

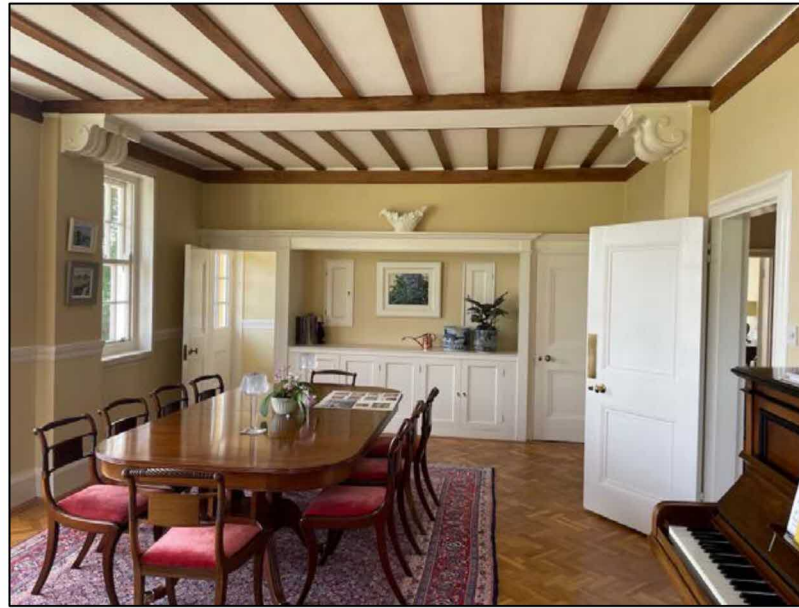
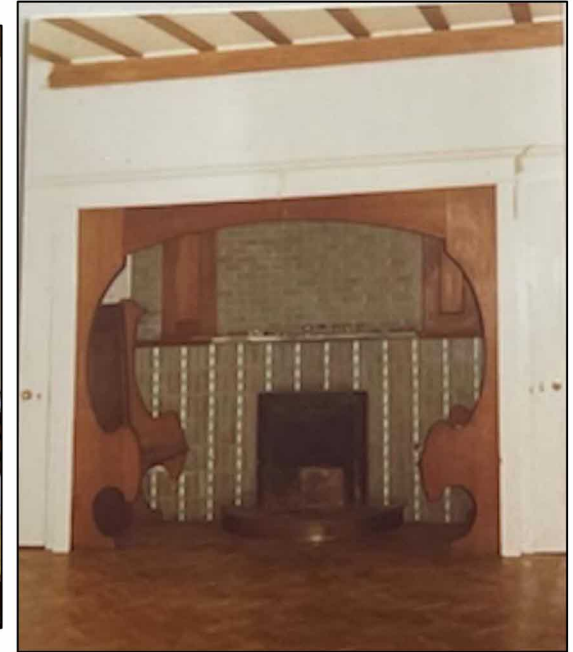
Figure 25: southern wall of G6. Right – Historic photograph c1976 of the removed inglenook fireplace and later fire surround and hearth, flanked by two doors. Left – the fireplace has since been removed, replaced by cupboards. The historic photograph shows wall cupboards; a replication of salt cupboards. It appears the location of these remains, but it's not clear if the doors have been replaced.

Scrolled corbels (double this time) again edge the ceiling. The question is are these resting on a pilaster detail similar to the hallway (G4) or is this a wall nib? If so, this might suggest this room was formally partitioned into two rooms. If this were the case, presumably there would have been a door into the hallway separate to the existing (perhaps), but there are no evident scars for a door. The floor-plan above on the first floor (rooms F4 & F5) comprises two rooms with a chimneystack between the two. If so, then the eastern part of the room would have been heated from the same chimneystack. However, to contradict this notion, if the southern part of the room was partitioned, the space would have been small and dimly lit (which contradicts the ethos of the building) and would have been dominated by the inglenook fireplace (Fig. 25); this feature was removed sometime after 1976. This large opening was flanked by seats, with a fireplace surround and hearth. Either side were doors; presumably these remain as existing, with a cupboard to the west and a door leading to a lobby

and external door to the east. The historic photograph shows wall cupboards, an echo of salt cupboards presumably. It appears the location of these remains, but it's not clear if the doors have been replaced. The aforementioned lobby is small, providing external access via a partially glazed door with a 3/3 oblong fanlight above.

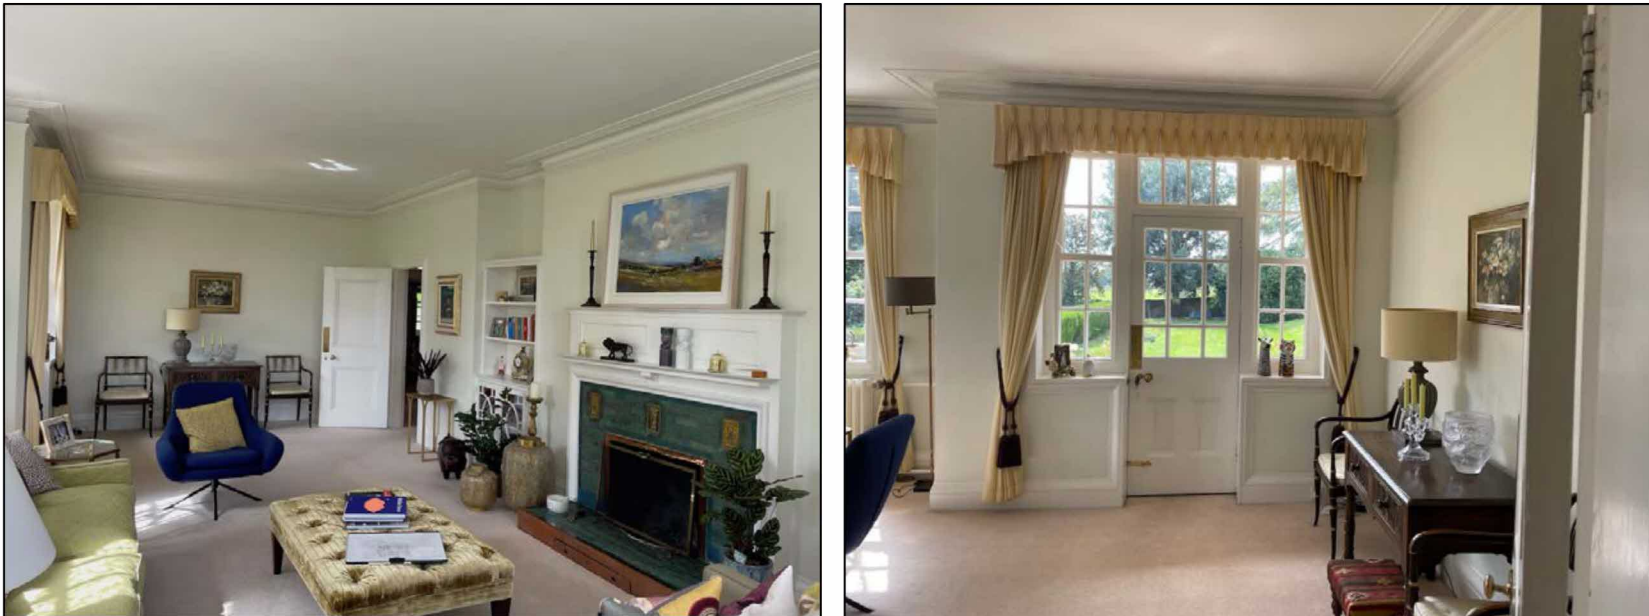
Figure 26: Room G7. Left photograph shows the view west and the right photograph shows the view south of the external door. Photograph © Hubbard Conservation.

G7- An elegant southeast-facing room lit from the east by a multi-paned bay window, and from two 6/6 sash windows to the south. Also lighting the room, and providing access into the southern part of the garden, is a partially glazed timber door, flanked by 4/4 sash windows, below a 4-light oblong fanlight. Moulded coving to the ceiling. Against the north wall is a timber Arts and Crafts chimneypiece with a tiled surround and hearth, edged in copper. This is flanked by shelving and glazed cupboards with timber tracery.

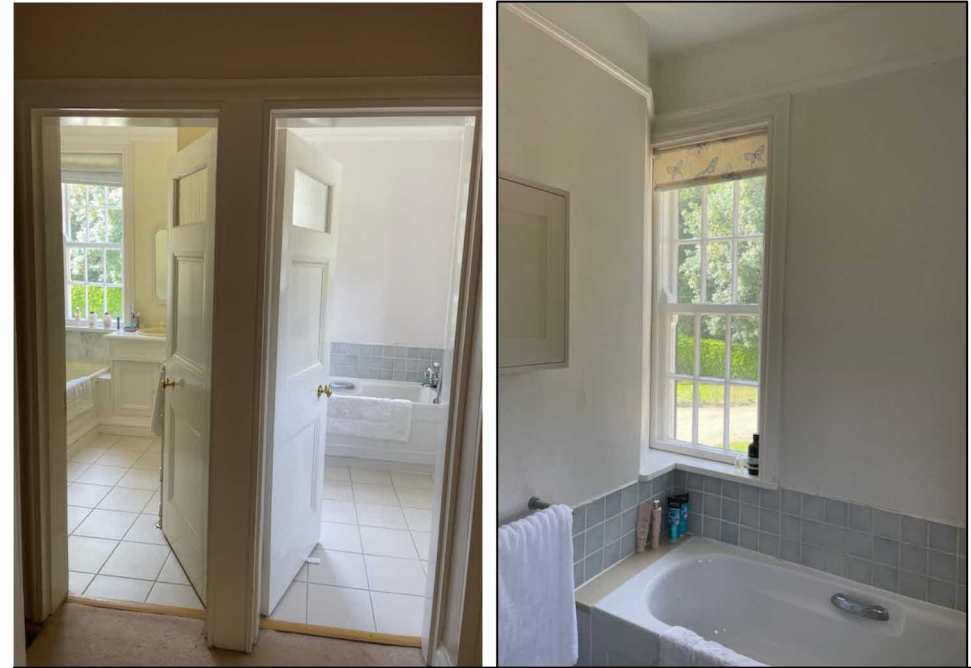
Figure 29: Rooms F1a (left) and F1b (right) the doorways of which are shown in the left hand side photograph. The right photograph shows the awkward junction of the cranked partition wall between the two bathrooms and how the wall has been created to keep the window revealed. Photograph © Hubbard Conservation.

F1a- There is a 6/6 sash window overlooking the western forecourt. The timber door has an integral fanlight set in a replica Cyma architrave. The replication is good, but there is a slight difference, which is noticeable when comparing with the equivalent in F1b (Fig. 29).

F1b- The partition wall between this room and F1a is cranked to meet the external west wall uncomfortably; set at an angle to ensure the window remains revealed. Again, the window matches that of F1a as a 6/6 (Fig. 29). Two further windows light the room from the northern side comprising 2/2 sash windows. The door matches that of F1a.

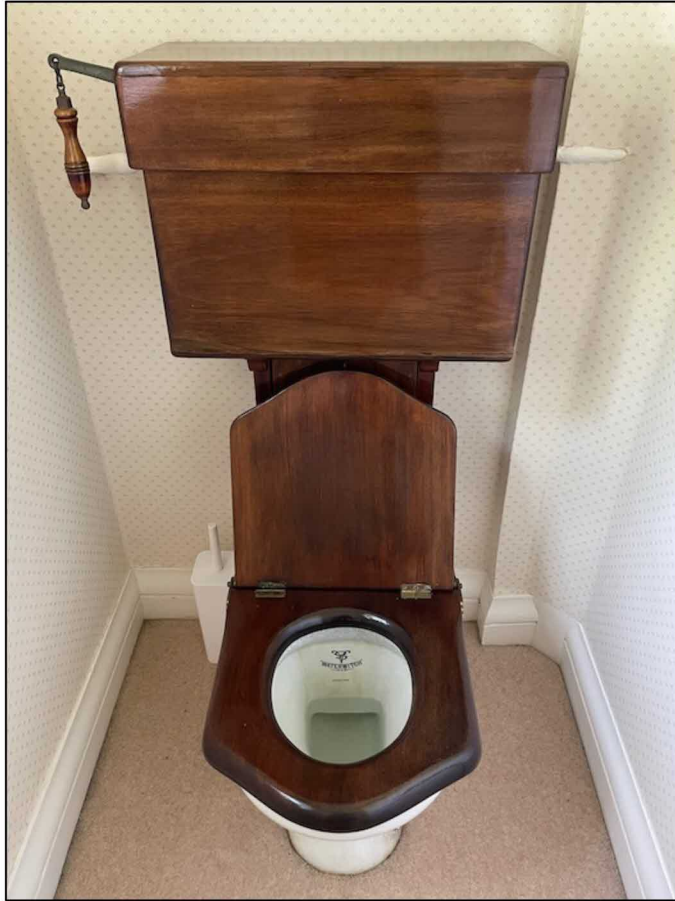
Figure 30: The Waterwitch WC in room F1c.
Photographs ©Hubbard Conservation.

F1c- Accessed via a 2-panelled door, this room is lit by a north facing 2/2 sash window. The windows, door, and skirting all have Cyma mouldings, suggesting this room has not been altered. The room houses an early Waterwitch WC, manufactured in Kirkstall, Leeds (Fig. 30).

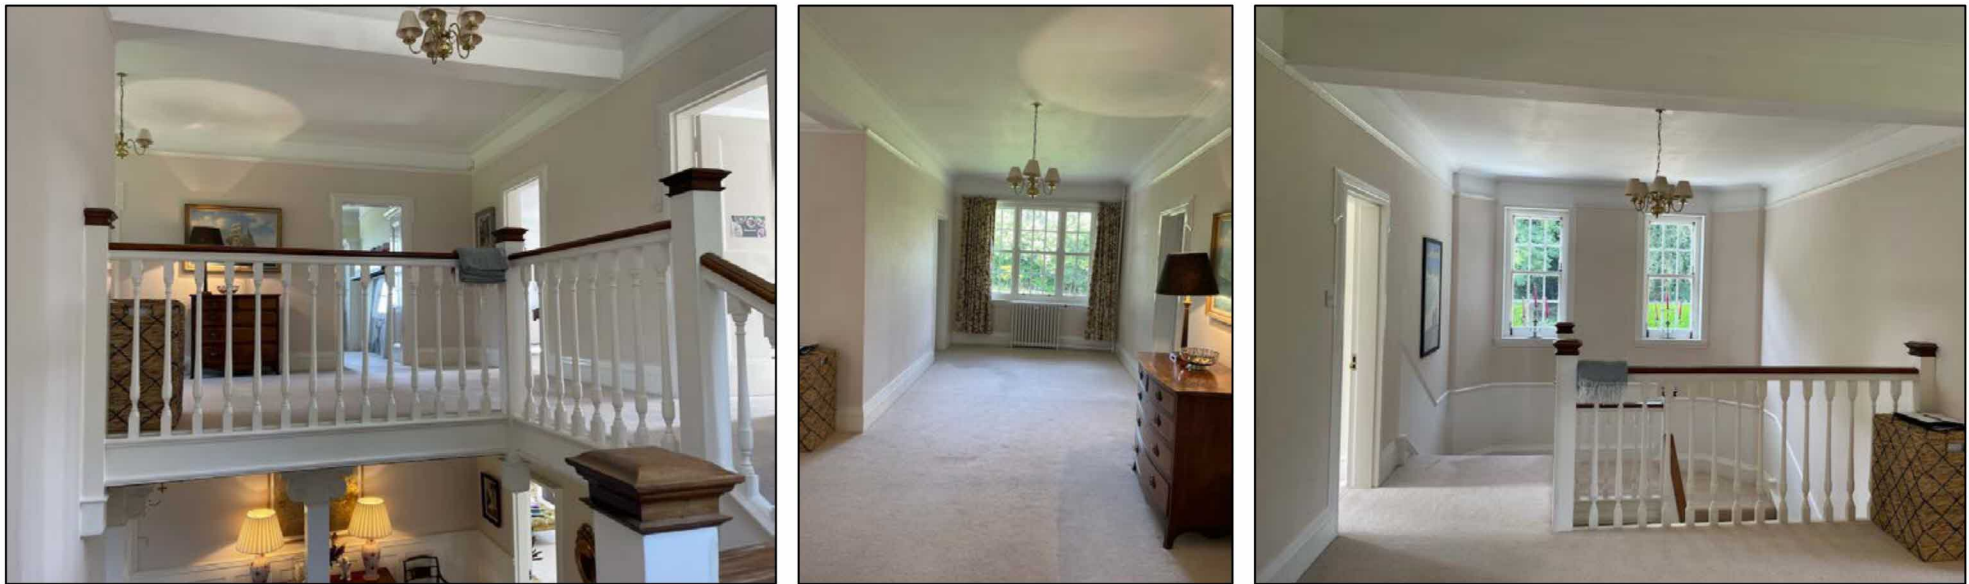
Figure 31: Hallway and stairs (F2). Left – shows the view east from the landing. The central photograph shows the view north of the tripartite window, and the right photograph shows the view west. Photograph © Hubbard Conservation.

F2- Large L-shaped landing providing access to all of the rooms. As mentioned previously, all of the doorframes present with Lugged and Cyma architraves (Fig. 29), and the skirting boards continue around the space with a Cyma moulding, and the picture rail follows suit. All of the doors comprise timber with 2-moulded panels, brass knobs, and keyholes. The stairs continue from the ground floor, not deviating in style or form. F2 is lit from two 6/6 sash windows to the west and a northern tripartite window comprising central 6/6 sash flanked by 4/4 (Fig. 31).

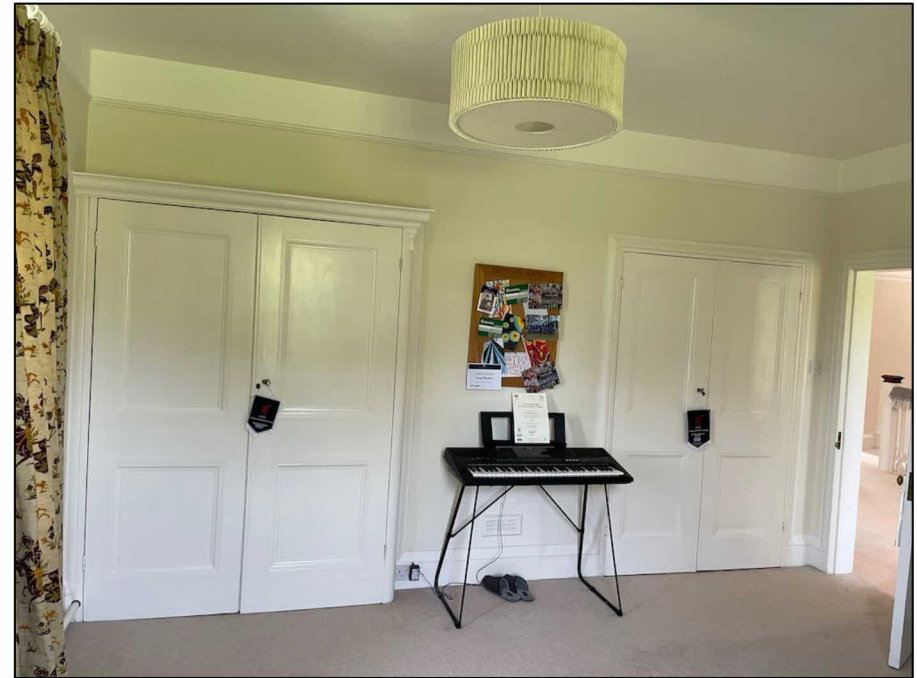
Figure 32: Cupboards in room F4. Photograph © Hubbard Conservation.

F4- This room is situated in the northeast corner of the first floor and is lit by 6/6 window to the north (which has a blind equivalent to its west) and tripartite window to the east comprising central a 6/6 sash window flanked by 1/1 sashes. The southern wall has two cupboards flanking the former fireplace. The southwest cupboard is flush with a Cyma architrave, and the southeast cupboard projects into the room with a basin inserted into the right side. The decoration of this cupboard suggests an Art Deco character with a pendant detail to the corner. It could be that the west cupboard is primary and that the east cupboard is a later addition, but of no less value in terms of architectural design and evolution (Fig. 32). A picture rail continues around the room, and Cyma detailing can be found through out.
