Hubbard Conservation

Statement of Significance: **Crossways, Little Heath Lane, Potten End, Berkhamsted, HP4 2RY.**
September 2023

Introduction and methodology.

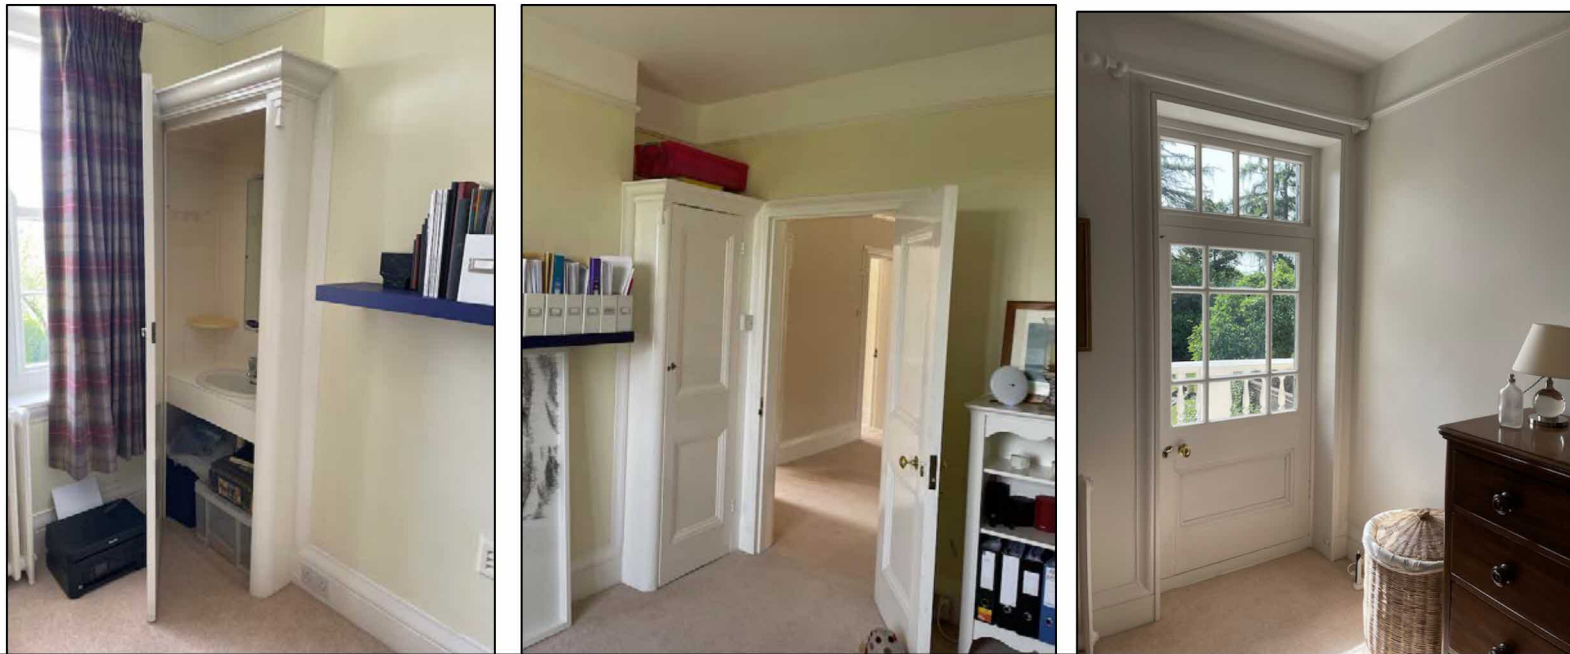
Figure 33: The left and central photographs show the projecting cupboards in Room F5. The right photograph shows the external door in room F6
Photograph © Hubbard Conservation.

F5- This room is the smallest of the east facing rooms, possibly a former dressing room. The room is lit by a tripartite window comprising a 6/6 sash window flanked by 1/1 sashes. Flanking the wide chimneystack are two projecting cupboards matching the design and style of the one found in F4 (Fig. 33). These have single doors each, the eastern of which has a

F6- Possibly the principal bedroom. The room is lit to the east by a tripartite window comprising 6/6 sash window flanked by 1/1 sashes, and from the south by a 6/6 sash window, which has an equivalent to its west which is hidden behind the modern built-in cupboard. To the west of this is an external door to the balcony comprising half glazed timber door with margin lights underneath an oblong 4-paned fanlight (Fig. 33).

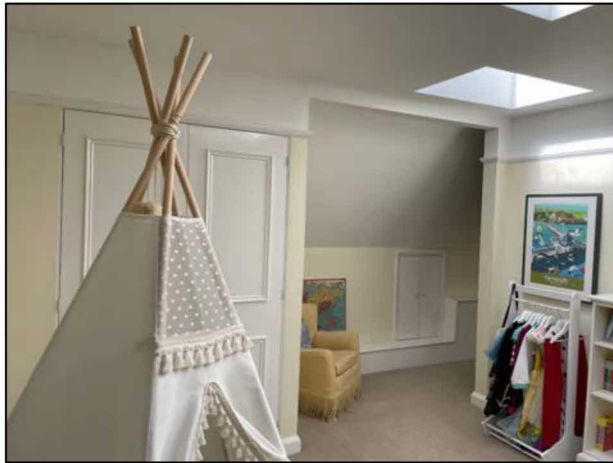
Figure 35: View towards the west side of S2 and the modern cupboard. Photograph © Hubbard Conservation.

S2- hallway lit by three roof lights. Picture rail continues around the room, however its authenticity is in dispute considering the same rail runs across the cupboard in the southwest corner, which was likely installed post c1970s. This cupboard houses a kitchenette unit. The hall provides access to all of the bedrooms, although S3 and S6 have a small separate lobby between the two rooms locating their doorways slightly away from the hall. The door architraves are plain at this level, as too the skirting boards. The door into S4 is small.

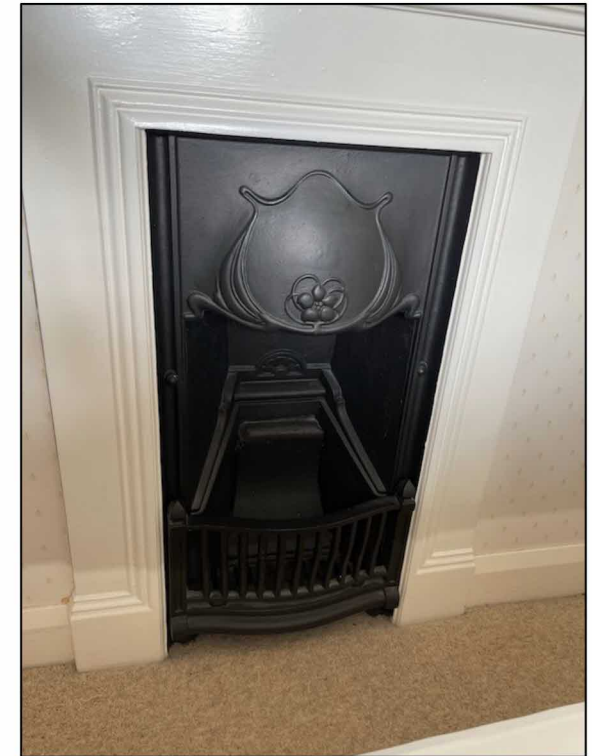
Figure 36: Fireplace in room S6. Photograph © Hubbard Conservation.

On this floor just two of the fireplaces have been retained in rooms S3 & S6, suggesting the first installation of central heating was not extended to the service quarter in the attic. The cast iron fireplaces match in an Art Nouveau styled relief pattern (Fig.36), which could provide a flavour of style of the missing fireplaces elsewhere in the building.

S3- The room occupies the southwest corner of the building and is lit from a south facing 3-light dormer windows with 8 panes each. The cast iron fireplace, timber surround and mantelshelf remains, which appear to match the one found in S6. As mentioned previously, the design has an Art Nouveau styled relief pattern (Fig.36).

S6- A 3-light dormer window facing south lights this room, located in the southeast corner of the building. As mentioned previously, the cast iron fireplace, timber surround and mantelshelf has been retained, which appear to match the one found in S3. The design of the fire grate has an Art Nouveau styled relief pattern (Fig.36).
