Proposal: Refurbishment, Alteration and Upgrading works to 18 Greville Place

This design report has been prepared by Noel Wright Architects to support an application for planning and listed building consent at 18 Greville Place, London NW6 5JH. It should be read in conjunction with the other documentation submitted.

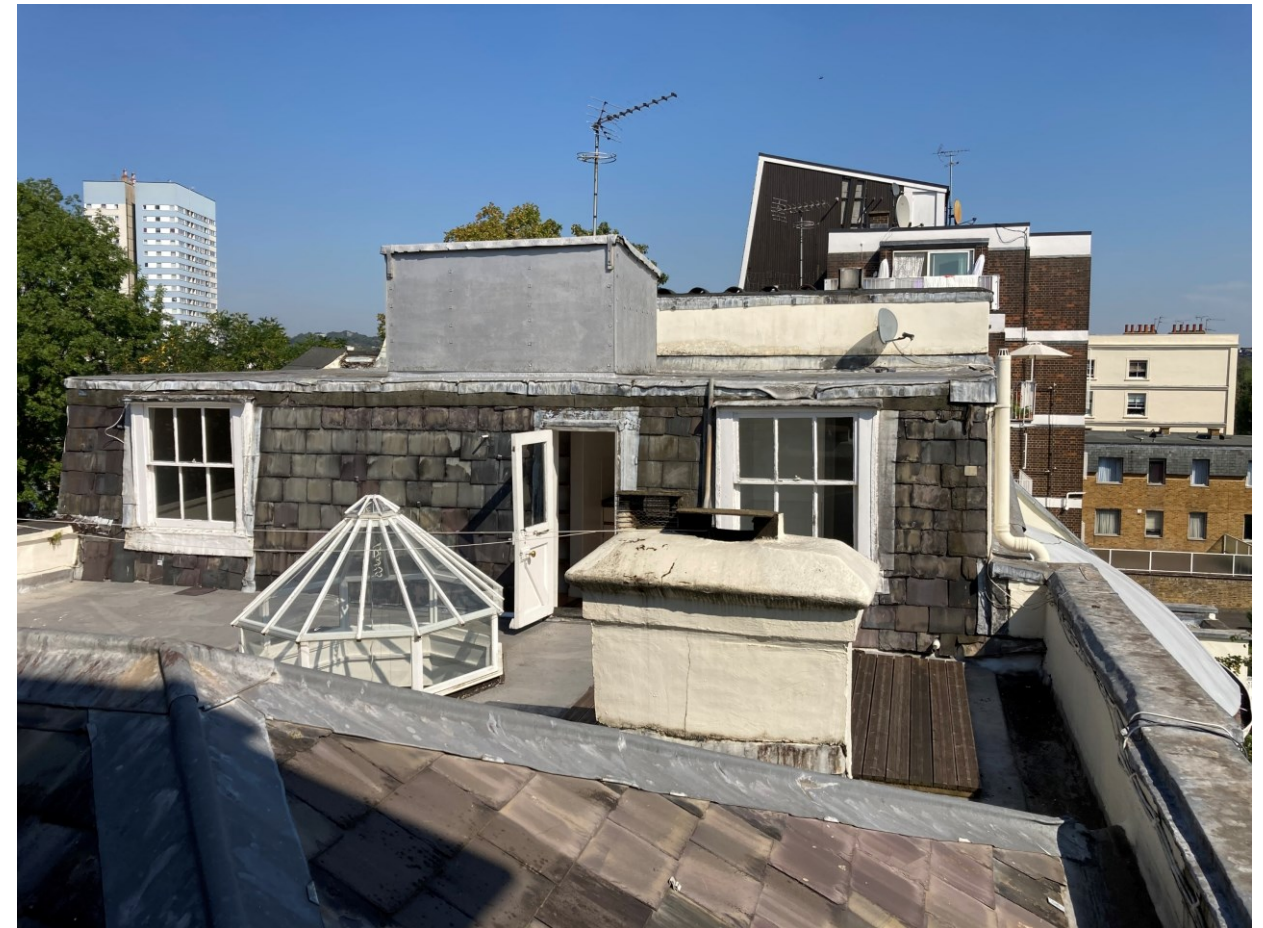
The mansard / second floor accommodation with the pitched roof and flat roof terrace area in the foreground. The large tank housing is central to the flat roof of the mansard.

this mansard style roof top accommodation is in a poor and dilapidated condition and requires a complete overhaul. In particular the roof and the south-west facing mansard wall (timber framed with slate facing) are regarded as very unsatisfactory. The accommodation has no thermal insulation.

The mansard (SW) wall is timber framed with its outer face slate hung. Windows are timber single glazed sash type. The roof is boarded on top with an asphalt waterproof covering. All these aspects of the building fabric are in poor condition.

There is an unattractive tank housing set above the roof. This visually detracts from the building overall and is visible from the street.

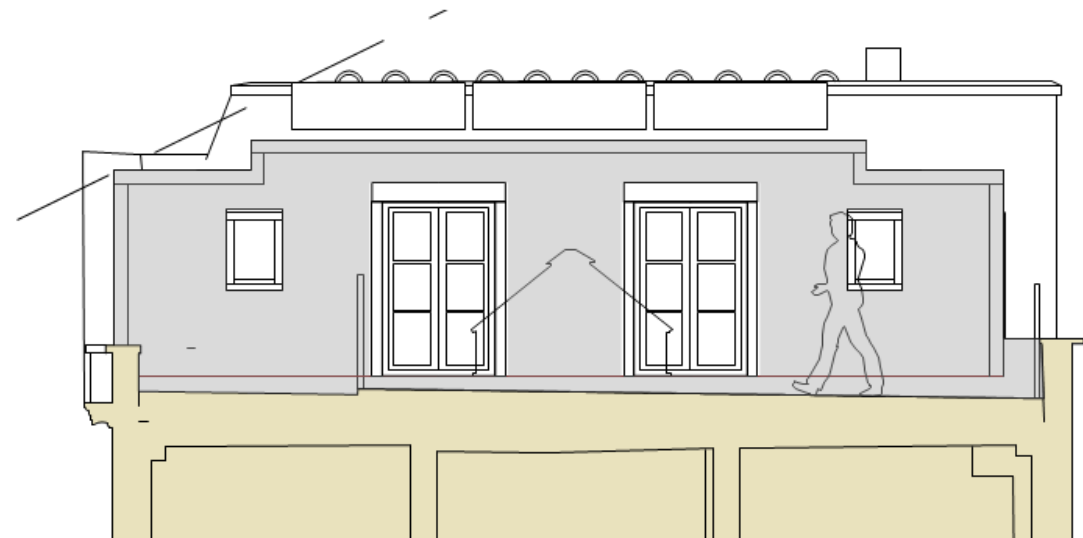
Drawing extracts illustrate the proposed rebuilt mansard in plan, section, and elevation

The mansard (SW) elevation remade to suit this increased roof height and altered fenestration proposals. The timber salvaged from the previous flat roof structure is suitable for reuse in the framing of this mansard elevation.

The flat roof remade with a deeper structural joist set at a raised height.

New windows suited to the altered plan.

(note drawing 109 indicating the height limitations that have been respected in the design, based on compatibility with the 'paired' building adjacent- no.20 Greville Place)

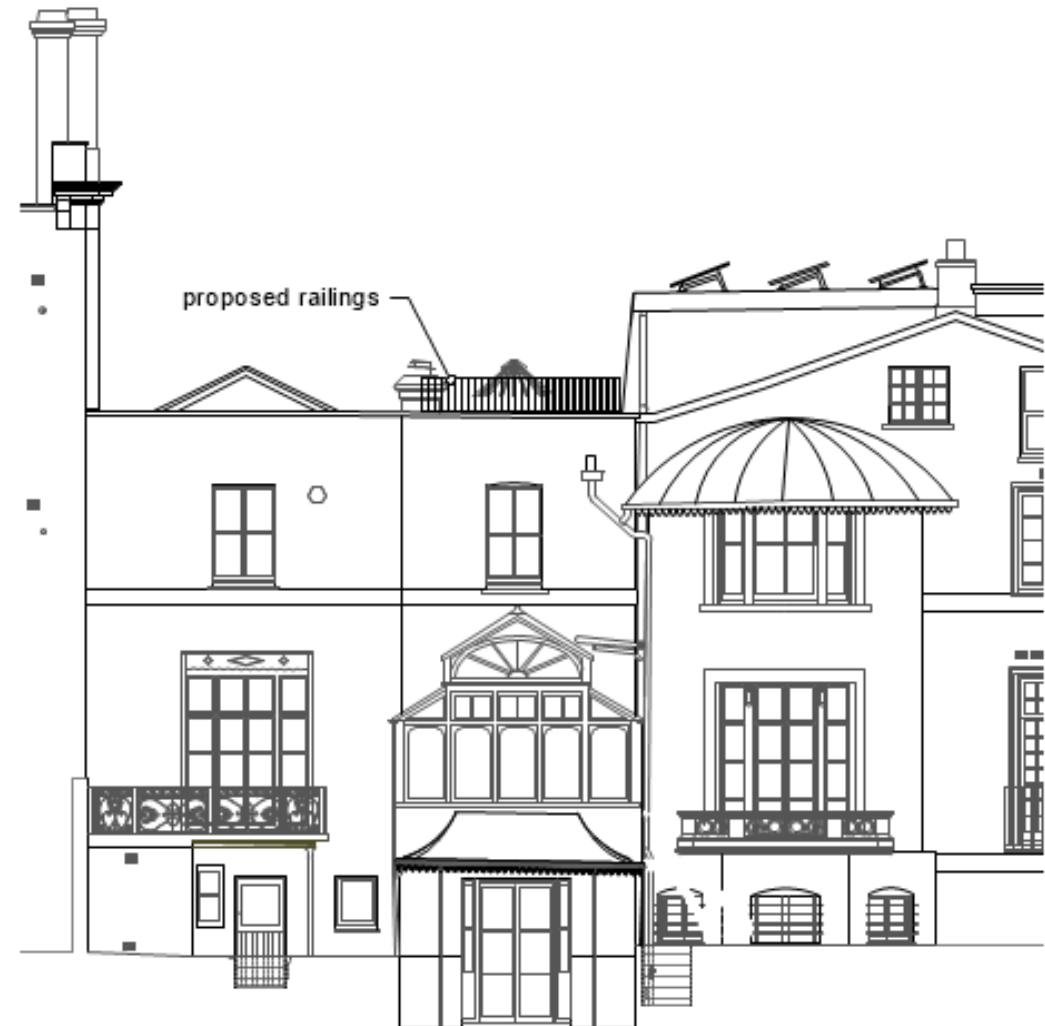
Rear / South East Elevation illustrating the impact of the safety balustrade

In order to avoid a visual impact on the street elevation of the building, this side will be set back from that elevation.

The balustrade to be purpose made in galvanised steel, painted.

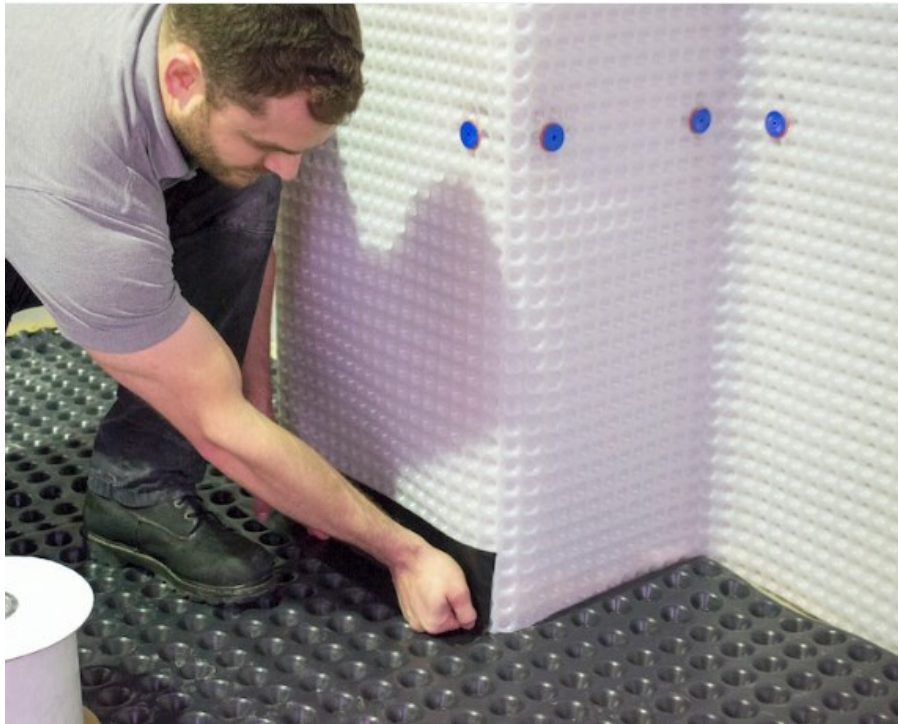
Above- example of the installation of a cavity drainage membrane to floor and walls.

A specialist company has been consulted in relation to the damp issues and has put forward a scheme of works to address this issue. (refer Appendix B- Wing Waterproofing). This scheme is for a cavity drainage type membrane system to the walls and floor, the scope of this covers all walls external, party wall and internal. This type of system avoids creating water pressure build up (unlike a 'tanking' membrane) and thus avoids creating altered and perhaps detrimental conditions in the existing structure.

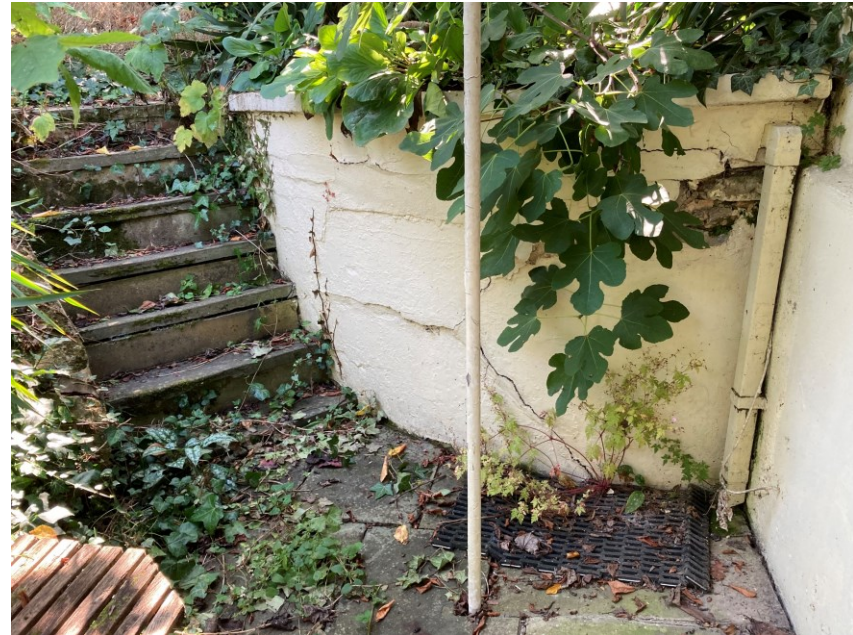
Above- the steps from the basement to the garden

Rendered masonry with concrete steps. The render is flaking badly and there are signs of significant movement in the associated retaining wall aspects. The condition is poor. Whilst having a characterful format, symmetrical either side of the conservatory wing, these steps are steep and are limited by short goings and tall rises.

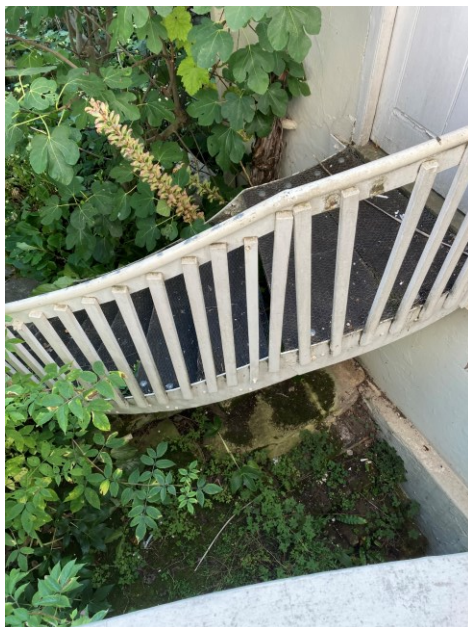
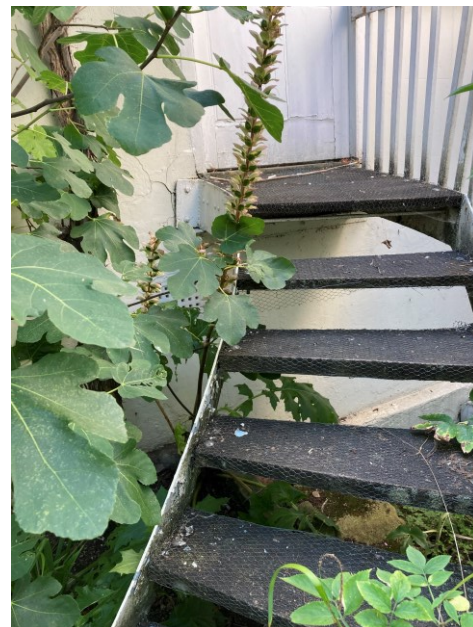
Steel Stringers with timber treads, which have deteriorated. Not of heritage value. The whole stair conveys a sense of unwanted movement and deflection, and the stairs are considered to be steep. The safety aspect is questionable. The top landing area is very limited in size.

Above- the steps from the conservatory to the garden

Proposals: to remake to a new format, in galvanised steel, painted.

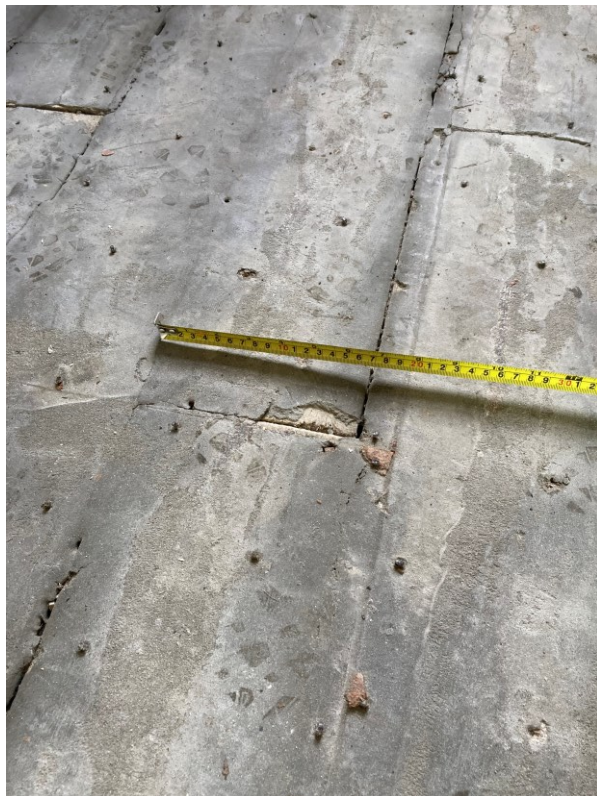
Example- FF bedroom 4, existing floor boards degraded by a application of levelling compounds, not suitable for refixing

- Ground floor- a 'character' traditional floorboard finished appearance
- Upper floors; floor boards salvaged from the ground floor may replace the degraded floor boards (see illustration) and make up quantities due to damage and cutting

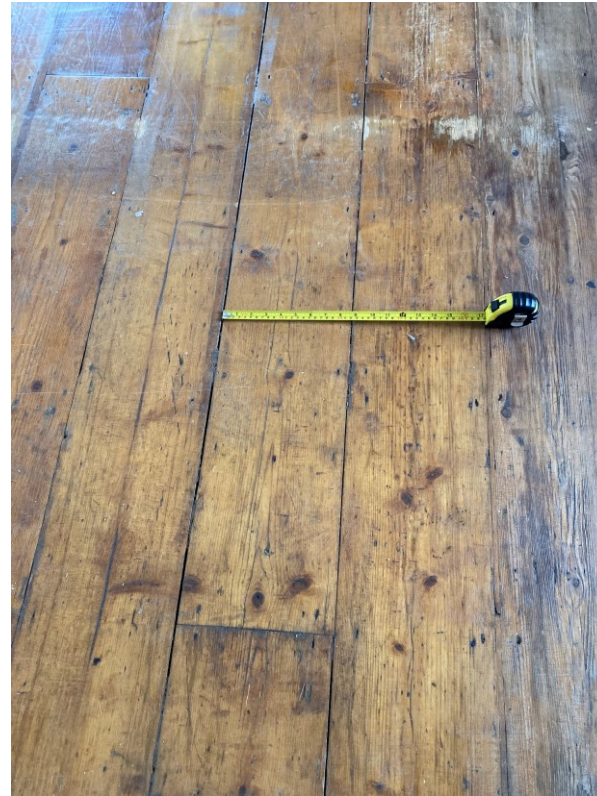
Example- FF Dressing Room, existing floor boards with attractive qualities and suitable for refixing
