FAIRFIELD HOUSE

43-47 High Street Newmarket

PROPOSED SCOPE AND SCHEDULE OF REFURBISHMENT AND ALTERATION WORKS

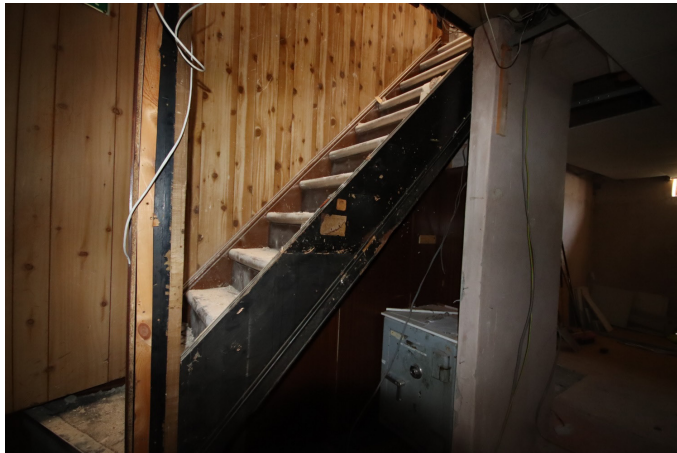
1. Existing internal stair case within shop.
 - Alterations to stair access to first floor from shop (formerly “Wiggs”). Board over stair well to shop with fire board retaining stairs within and extend ceiling joists over stairwell. Fire and sound protection to new ceiling above.

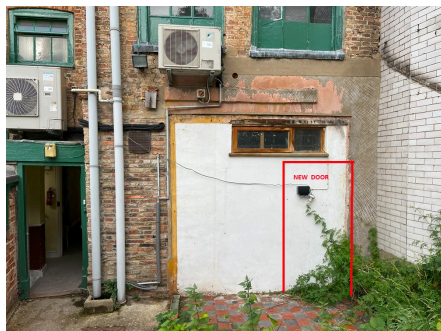
2. Doors
 - Form new door opening to the rear of the shop where window was originally positioned. (Planning reference for previous work (F/87/198/LB) The cement rendered rear to be improved visually with a panelled fire rated door to the rear. Existing rear door retained for access to the residential floors.

Block modern opening from shop to rear, remove existing rear modern door to shop.

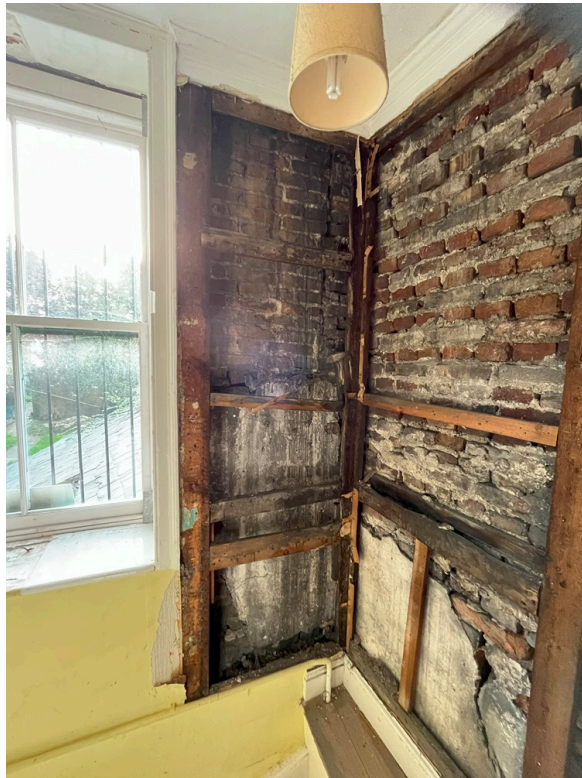
- Floors – fire and sound protection beneath floorboards.
- Walls – insulation to outside walls with plaster board finish or wood fibre board and lime plaster as internal finish.

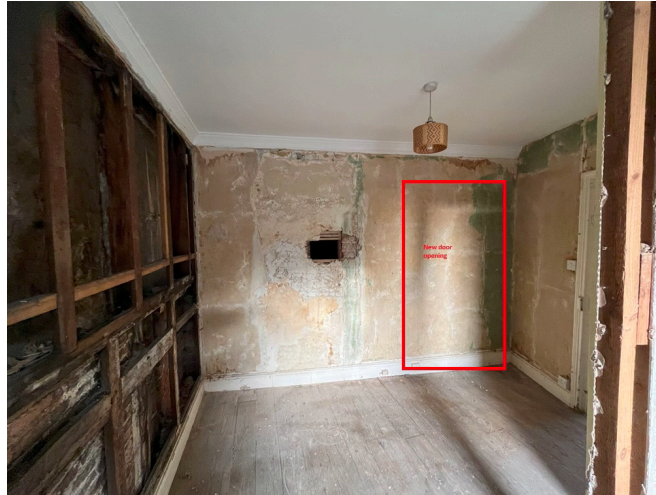
- Internal walls – form opening to stair well to 2nd floor through timber frame wall and repair surrounding lath and plaster. Re-plaster wall and paint with intumescent paint. Infill timber frame to stair well with sound and fire protection. Board to stair well with fireboard OR board with wood fibre board and lime plaster with intumescent paint to surface.

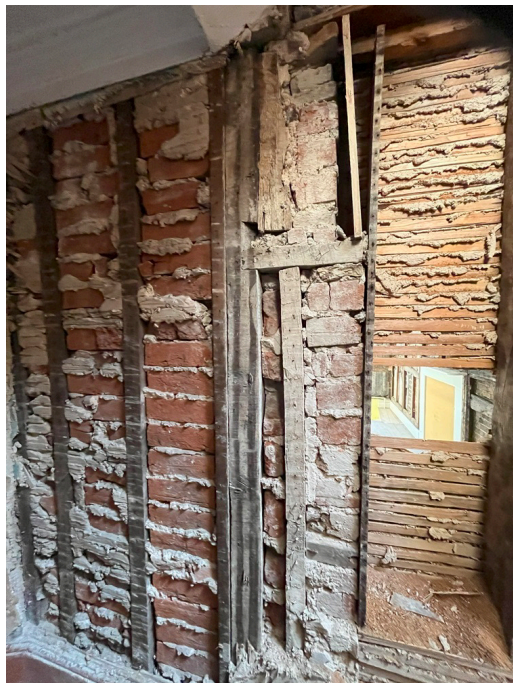
- Stairs to second floor – floor boards lifted and sound and fire protection barrier placed into void.
Walls to stairs to be repaired with wood fibre board over insulation and intumescent paint to surface where appropriate. Modern window to be replaced with double glazed similar window.

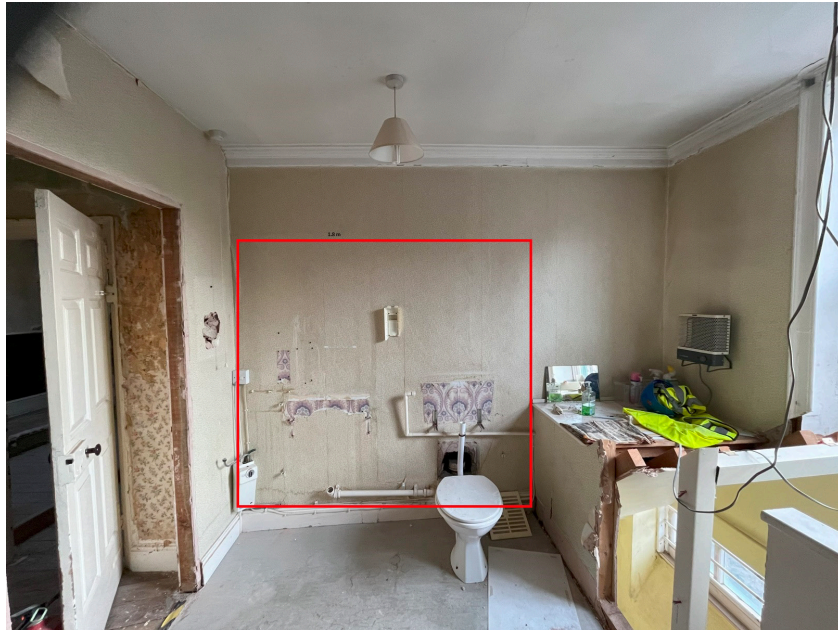
- Modern stud work within landing to be extended to landing area by 600 mm, to be reformed with fire and sound protection.

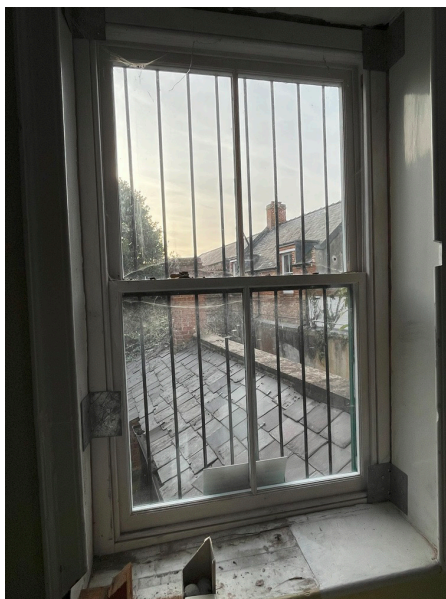
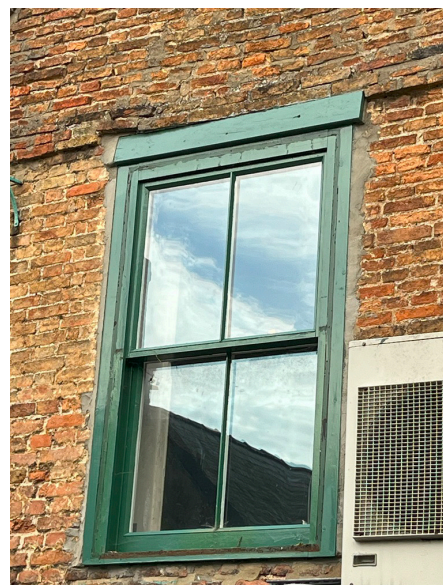
- Opening to be formed in existing wall to form enlarged area of bathroom – partially where an existing door has been blocked and partially to the lath and plaster existing wall.
- Window
Modern sash window to existing stairwell to be modified to form sash opening smoke vent retaining external appearance.

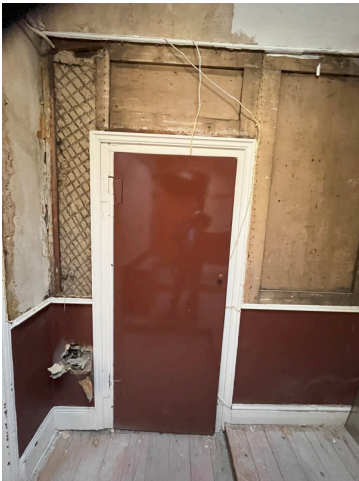
Replace

Replace door to new bathroom area with modern panelled unit.

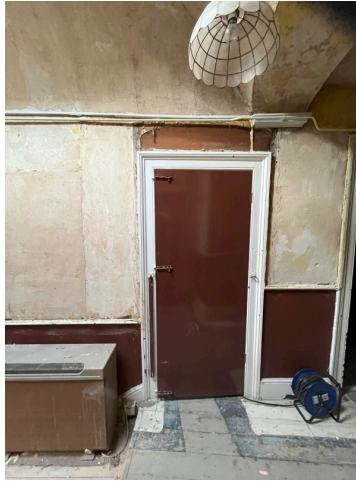
Block (to stair well to 2nd floor)

Remove door to stair well to 2nd floor, block opening with appropriate construction to provide sound and fire protection. 100 mm Rockwell or similar insulation to centre of wood fibre boards and lime plaster painted with intumescent paint.

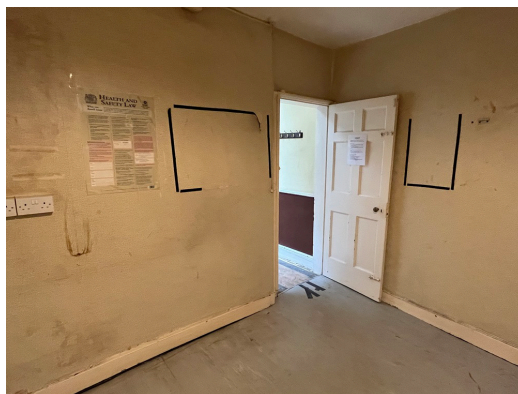
Door to kitchen

Retain doors to sitting room, bedroom 1 and kitchen. Upgrade to 20 minute fire door if required using “Envirograf” system.

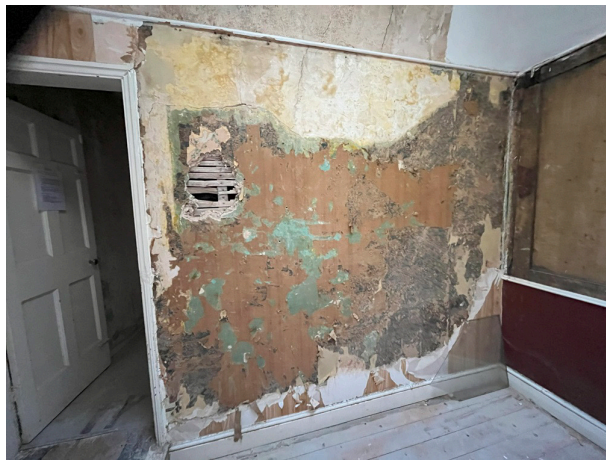
Wall to kitchen – remove inner hall side to wall and replace rotten timber frame where necessary. Re-board with wood fibre board and lime plaster with surface decoration.

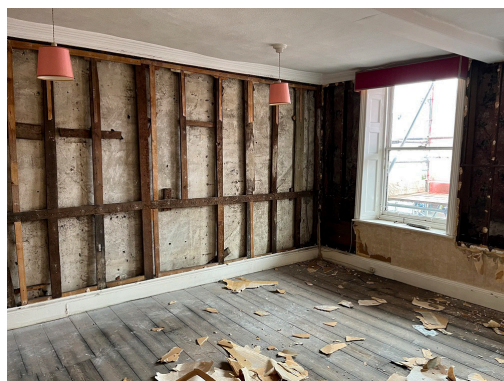
External / party walls to have insulation with similar finish and standard paint over the lime plaster. Wall to fireplace area to be repaired, fireplace retained and hearth area repaired with fresh air vent to flue.

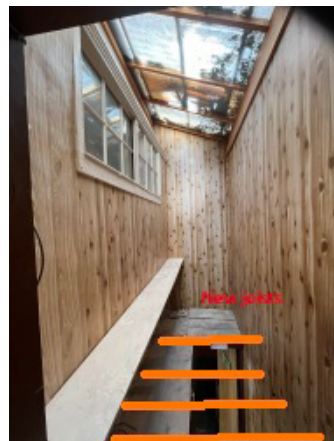
New floor over stair well.

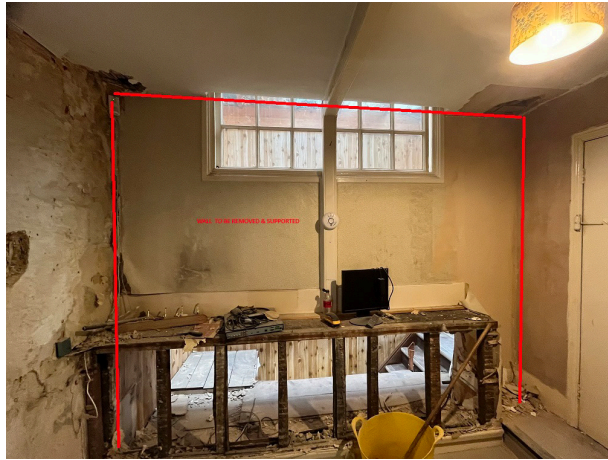
Wall removed.

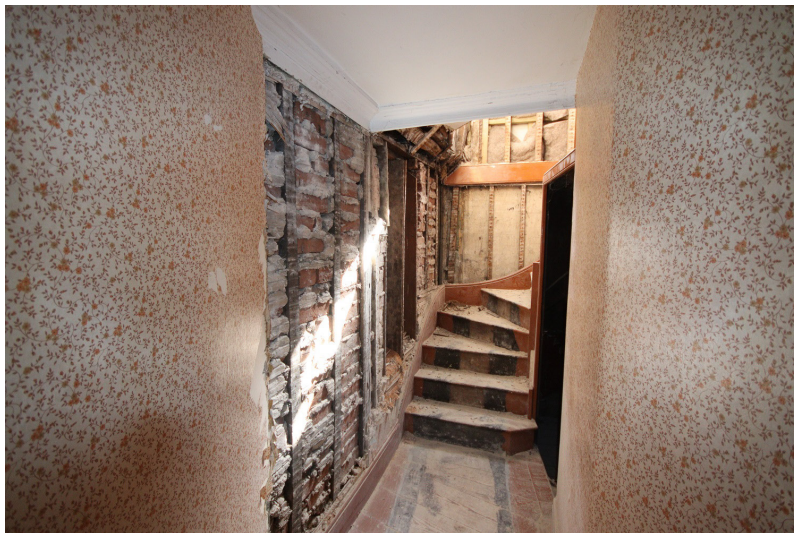
- The stair well area has been included as part of the 1st floor. The stairs themselves are to be retained with a new handrail to the wall.

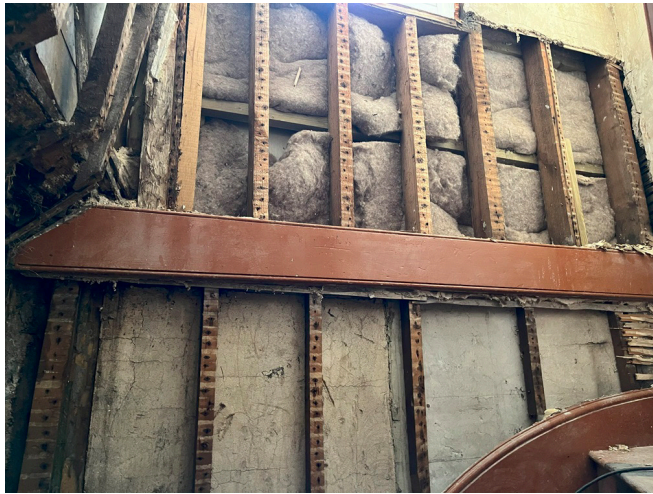
The hall area has lath and plaster to all walls which will be repaired and replastered where necessary. Insulation will be provided together with new wood fibre board to the internal elements with lime plaster over.

The walls between the outside roof area and interior are in places requiring remedial work in terms of stability of the lath and plaster. Some external elements had cement render to the walls of the attic rooms representing the bathroom and second bedroom.

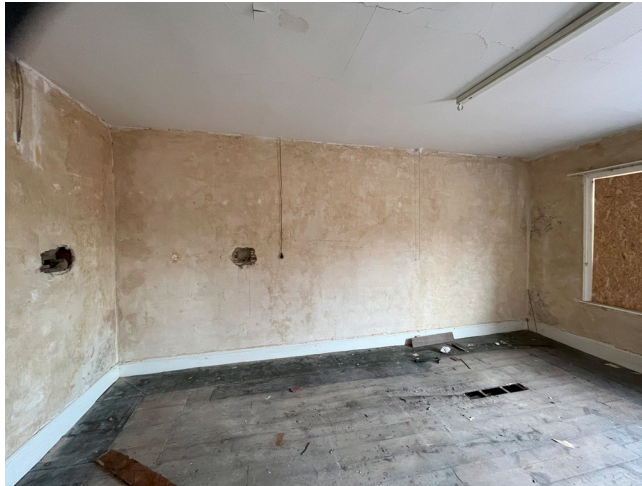
Insulation to be introduced to bathroom & other areas where possible. Lath and plaster ceiling and walls to be retained. External cement render to be removed and replaced by a lime render over insulation material.

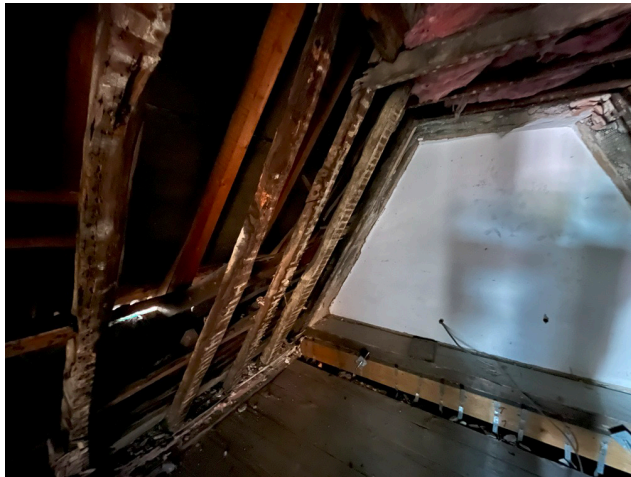
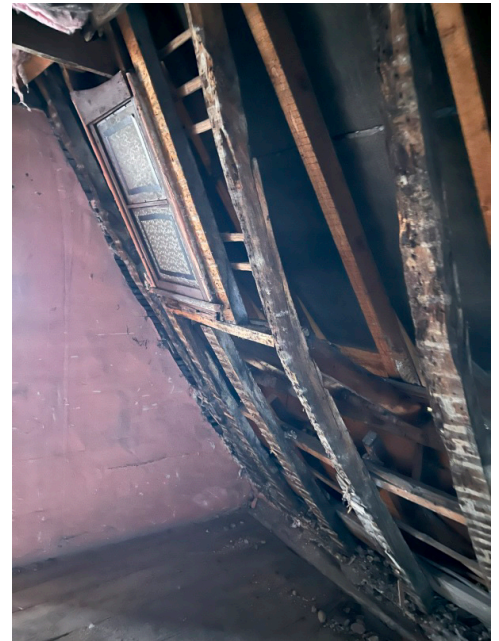
The attic room will be renovated with new purlin to one side and reopening of window element to pitch with introduction of Velux window to elevation facing adjacent building.

The vaulted ceiling to be insulated with provision for ventilation. Some exterior work will be required to the timber walls with a finish of lime based plaster render.

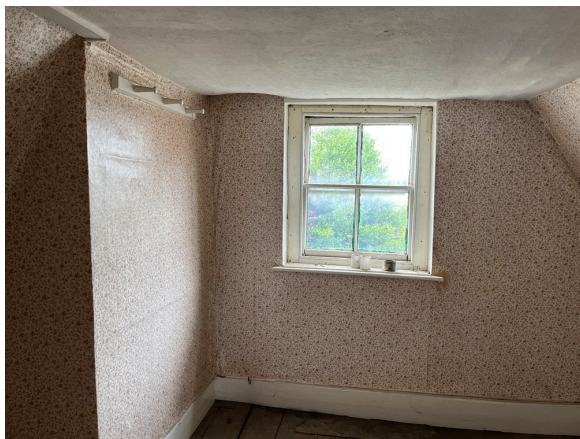
Modern windows to rear to be replaced or modified with double glazed exact copies.
