## Design and Access Statement

**Old Timbers, 65 Needham Road, Stowmarket, IP14 2AL**

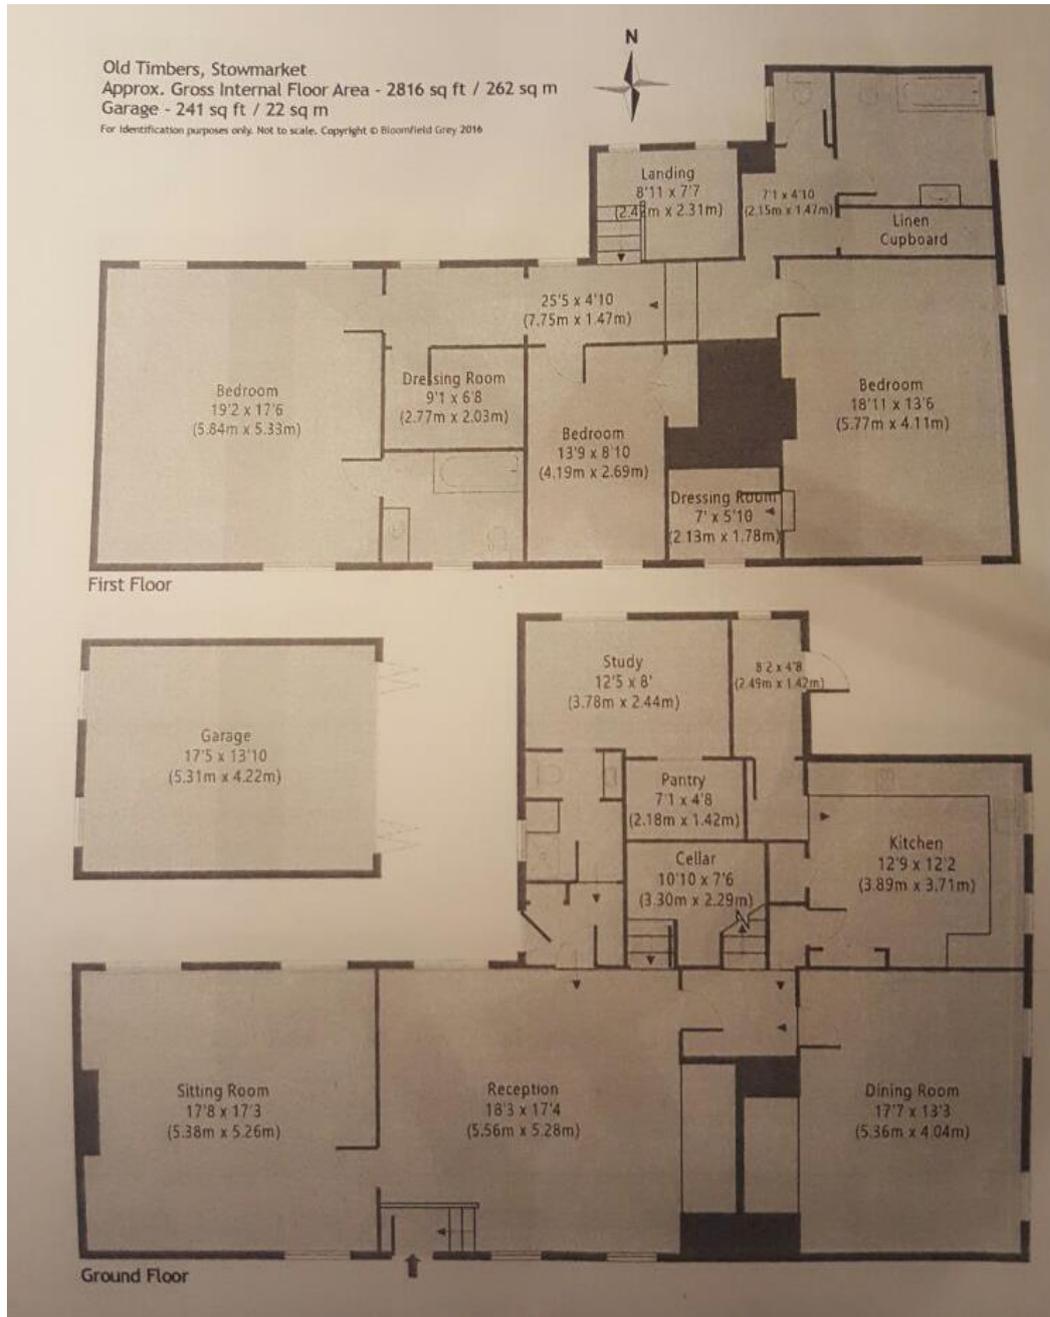
This property is as described above, with the ground floor layout as shown on the floorplan below:
