Hill Partnerships Ltd

Hengrove Bookend Plot E2

Remediation Strategy and Verification Plan

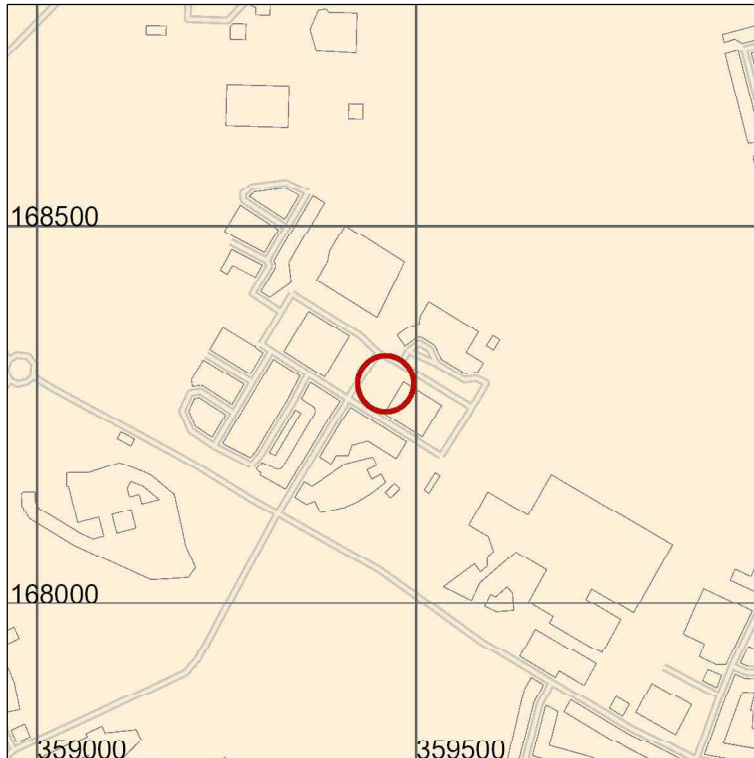
Radon Affected Area

% Homes estimated to be at or above the action level
0-1%
1-3%
3-5%
5-10%
10-30%
30-100%

Contains OS data © Crown Copyright and database right 2023
 Scale: 1:10 000 (1cm = 100 m)
 Search area indicated in red
